Rail Accident Investigation Branch

Rail Accident Report

Collision of a train with a demolished footbridge, Barrow upon Soar 1 February 2008

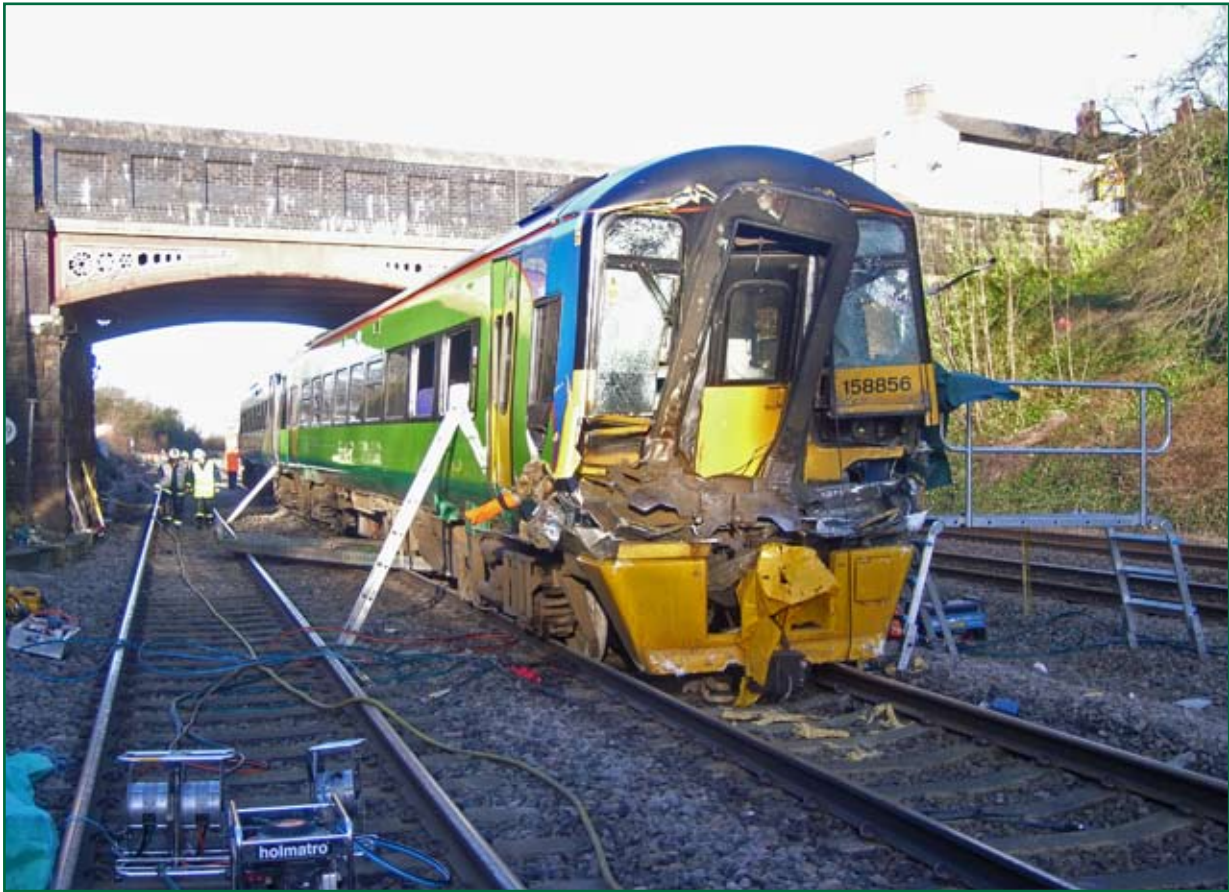
- 20 Train 1L03, which consisted of a two-car Class 158 diesel multiple unit (158856) sustained significant damage to the cab (Figure 2). All four lines of the railway through Barrow upon Soar were obstructed and a lineside equipment cabin was destroyed. Additionally, the cab of the lorry sustained serious damage (Figure 3).

Figure 2: View of the train following collision with the footbridge

- 44 The cab of the train was severely damaged due to the collision with the debris from the footbridge. The trailing vehicle was not damaged. The train did not collide with any other structures or trains. All traffic was stopped in the area by a *National Radio Network* (NRN) emergency broadcast from the *Integrated Control Centre* (ICC) in Birmingham.

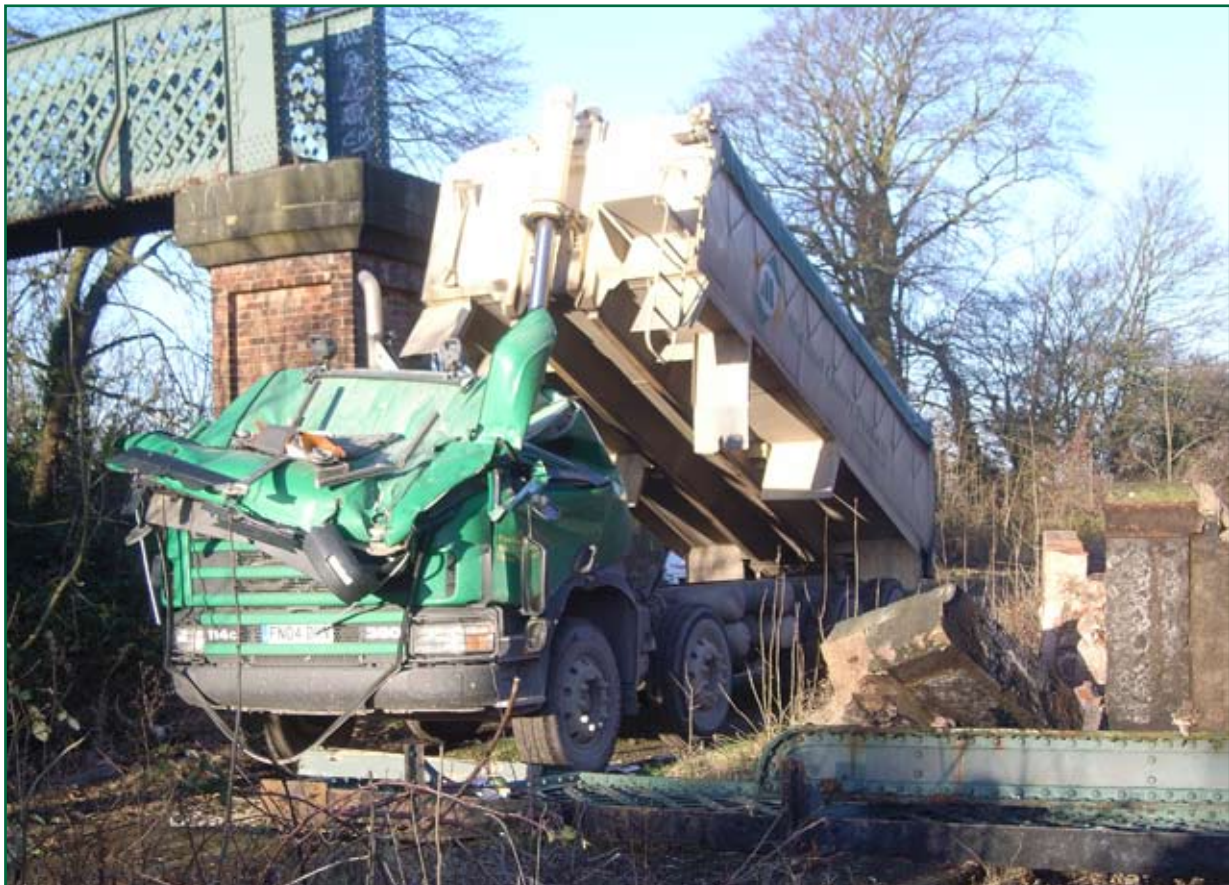
Figure 3: View of the destroyed cab of the tipper lorry

- 42 The cab of the tipper lorry was also severely damaged, however the driver escaped with no injuries.
- 43 The COSS was also taken to hospital suffering from shock and was released later the same day.

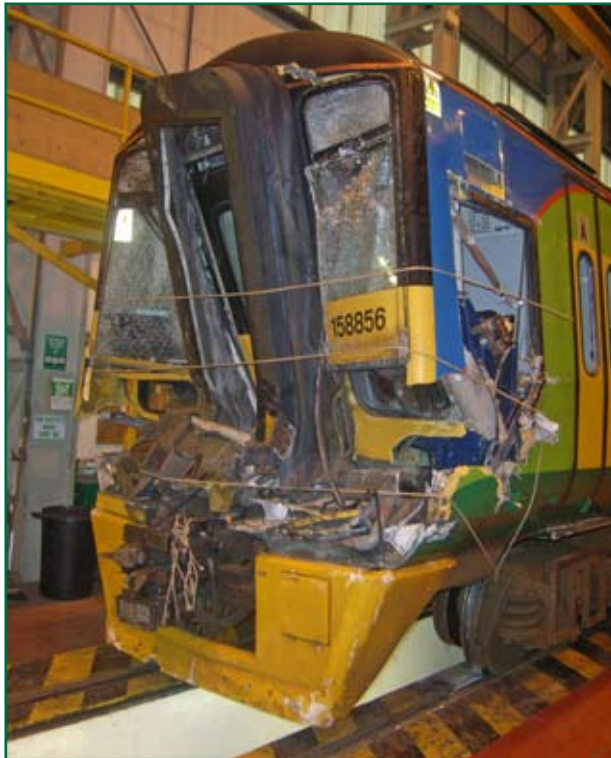
Figure 5: Damage to the leading end of vehicle 1

- 68 The principal structural members available to resist an impact above floor level were the two gangway pillars, which were located behind the uprights of the flexible gangway and the two corner pillars. Each of these pillars were connected to the underframe at the lower end and to a horizontal collision beam at the upper end. There are additional connections from the corner pillars to the bodyside.

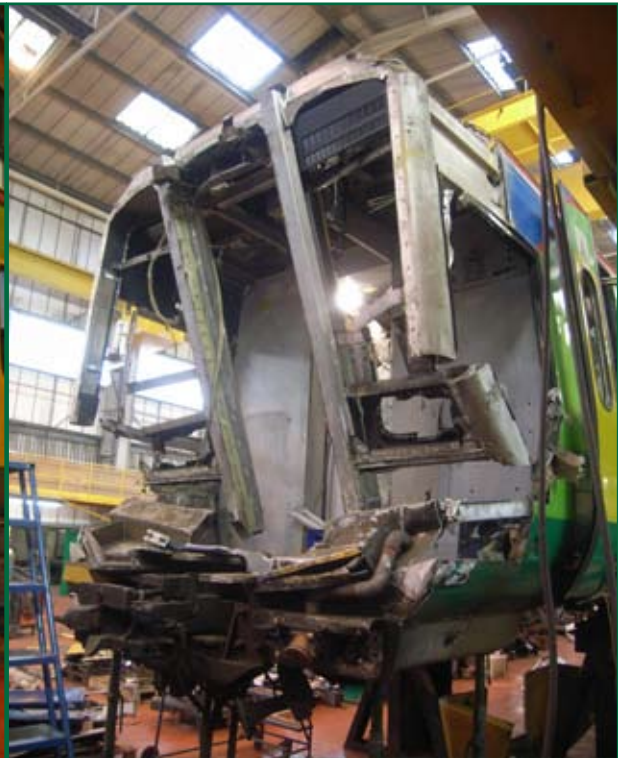
Figure 6: Damage to superstructure (fairings and flexible gangway removed)

- 69 Both gangway pillars sheared just above their welded attachments to the floor structure (Figure 6) and were pushed back 645 mm on the right-hand side and 635 mm on the left-hand side. Both pillars pivoted about their upper welded attachment to the collision beam and were inclined backwards 21 degrees to the vertical. The upper welded attachments to the collision beam fractured at the welds (Figure 6).

- 70 The deformation of the gangway pillars caused the driver's console to be pushed back towards the driver. Pipework located behind a fascia panel on the console came to within 130 mm of the forward edge of the seat. The extent of the intrusion on the left-hand side was just sufficient to trap the driver in his seat without causing serious injury. However on the right-hand side of the cab, there was no remaining survival space.

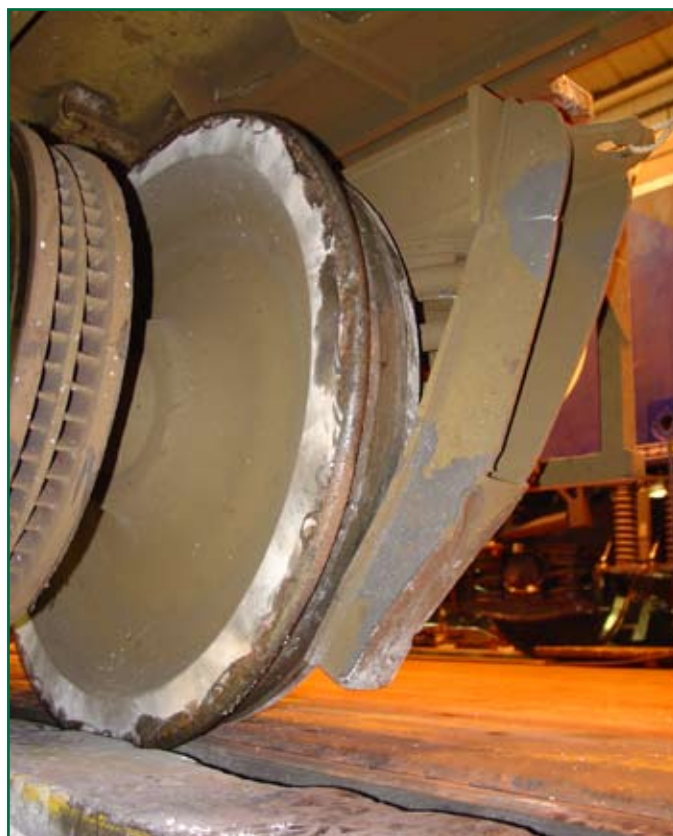
- 73 The steel *lifeguards* attached to the leading bogie frame in front of both wheels (Figure 7) had been bent backwards permanently a distance of 240 mm into contact with the wheels.

Figure 7: Deformation of the lifeguard

- 96 Damage observed on the obstacle deflector and both lifeguards indicate that they had all been active in resisting bridge debris directly impacting the bogie and entering the wheel/rail interface. Despite this, both wheelsets of the leading bogie were lifted into derailment by the bridge debris.
