Collision between two freight trains in a work site near Ivybridge, Devon, 27 February 2016

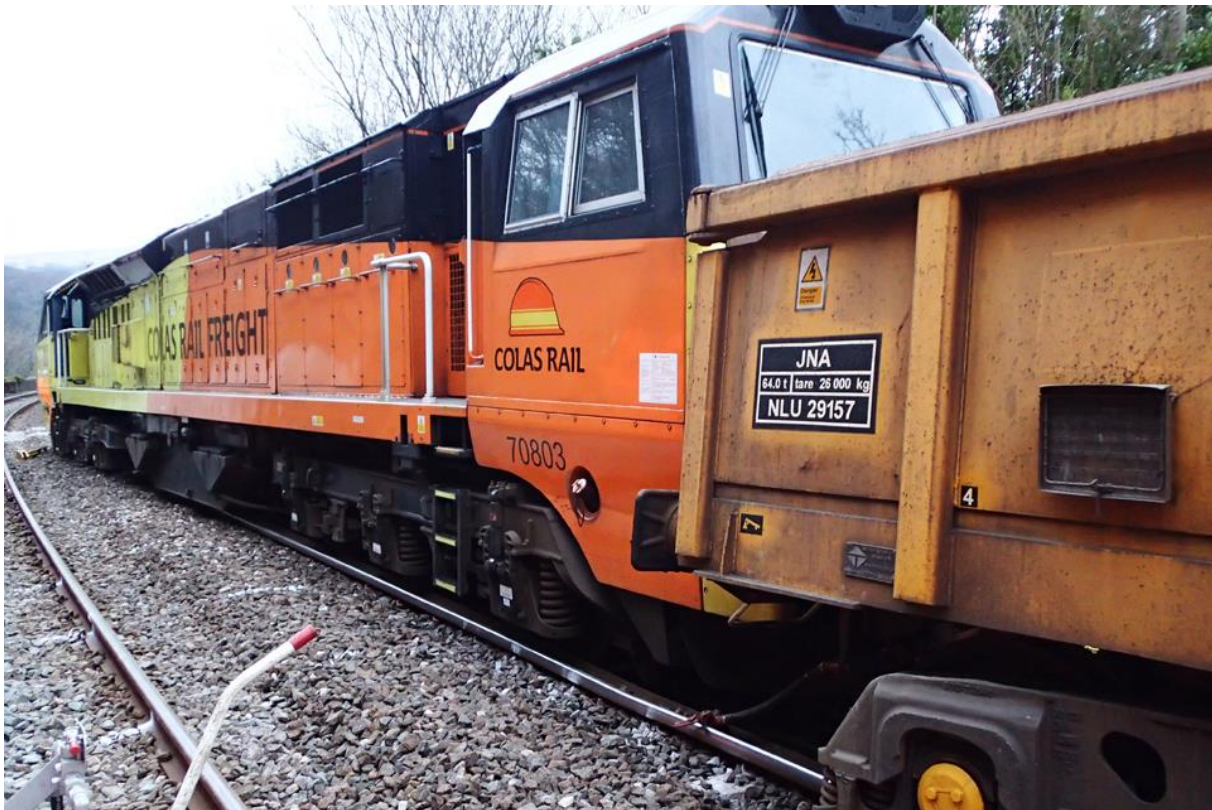
The derailed locomotive and the rear wagon

A freight train operated by Colas Rail collided with the rear of a stationary freight train while travelling at a speed of about 10 mph (16 km/h) within a work site on the Down Main line close to the old Ivybridge station, between Totnes and Plymouth. No one was injured although the freight train driver was badly shaken. The locomotive and the wagon immediately behind it derailed along with the rear wagon of the stationary train. These vehicles and the track beneath them were damaged.

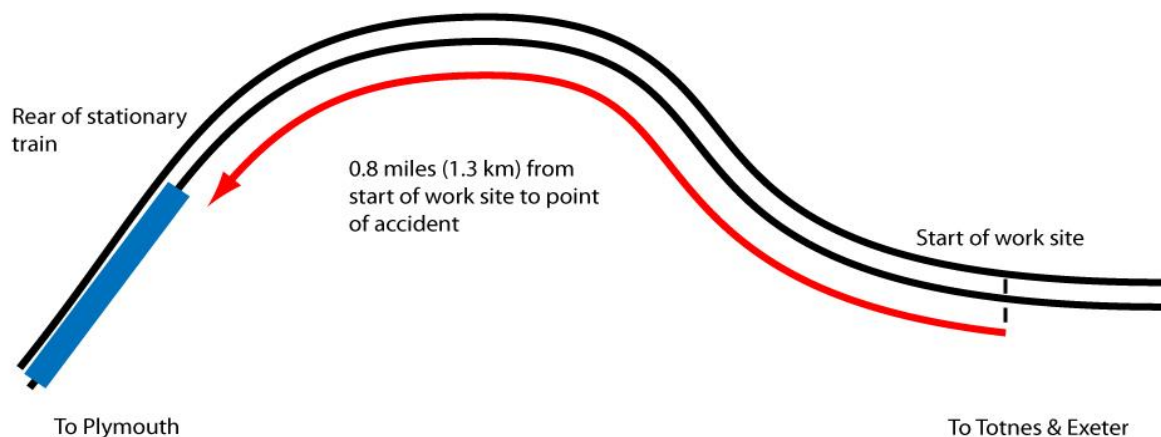
Simplified diagram showing location of the accident

The train set off into the work site and accelerated to 20 mph (32 km/h) with the train ahead standing 0.8 miles (1.3 km) away. As the train rounded a curve, still travelling at 20 mph (32 km/h), the driver saw the rear of the stationary train about 100 metres away and made an emergency brake application. The train was unable to stop in this distance and collided with the stationary train at about 10 mph (16 km/h). The moving train comprised ten wagons loaded with stone and another locomotive at its rear, giving a total train weight of 1118 tonnes. The braking performance of a train of this type and weight, meant its stopping distance at this speed was likely to be between 200 to 300 metres.
