Rail Accident Report

Parting of the live overhead wire at Walkergate station, Tyne and Wear Metro 11 August 2014

Report 09/2015
July 2015

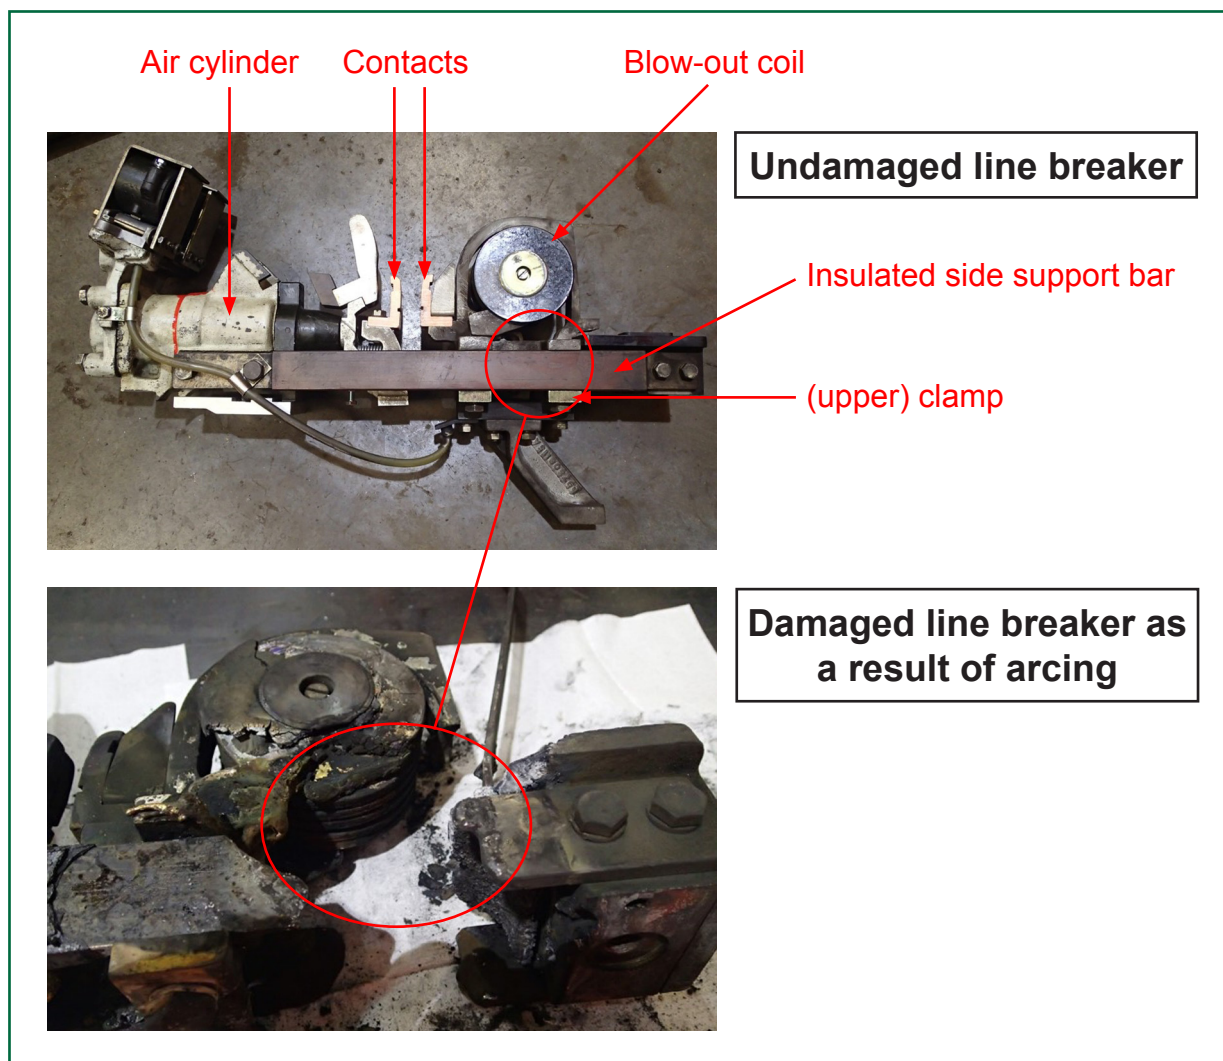
Figure 7: Undamaged and damaged line breakers

- 25 When the contacts of a line breaker are opened, an arc is created between its contacts. This is normal. The arc sustains the flow of current between the open contacts and so, to fully interrupt the current, it is necessary to extinguish the arc. To do this, the arc is deflected along a controlled and lengthening path by means of a magnetic 'blow-out' coil and is dissipated by a blast of compressed air from the exhaust of the cylinder that holds the contacts together (figure 7).
- 26 On-train equipment 'downstream' of the line breakers is protected by an overload monitoring module which automatically opens the contacts of the line breakers if the module detects a fault in traction equipment (figure 6). However, the line breakers themselves are not electrically protected by equipment on the train and rely on protection systems on the DC traction power supply.

61 The arcing which affected LB1 appeared to have occurred in the vicinity of the blow-out coil and the insulated side supports (figure 7). The damage was similar to, but not as extensive, as occurred in the previous accident at South Gosforth.

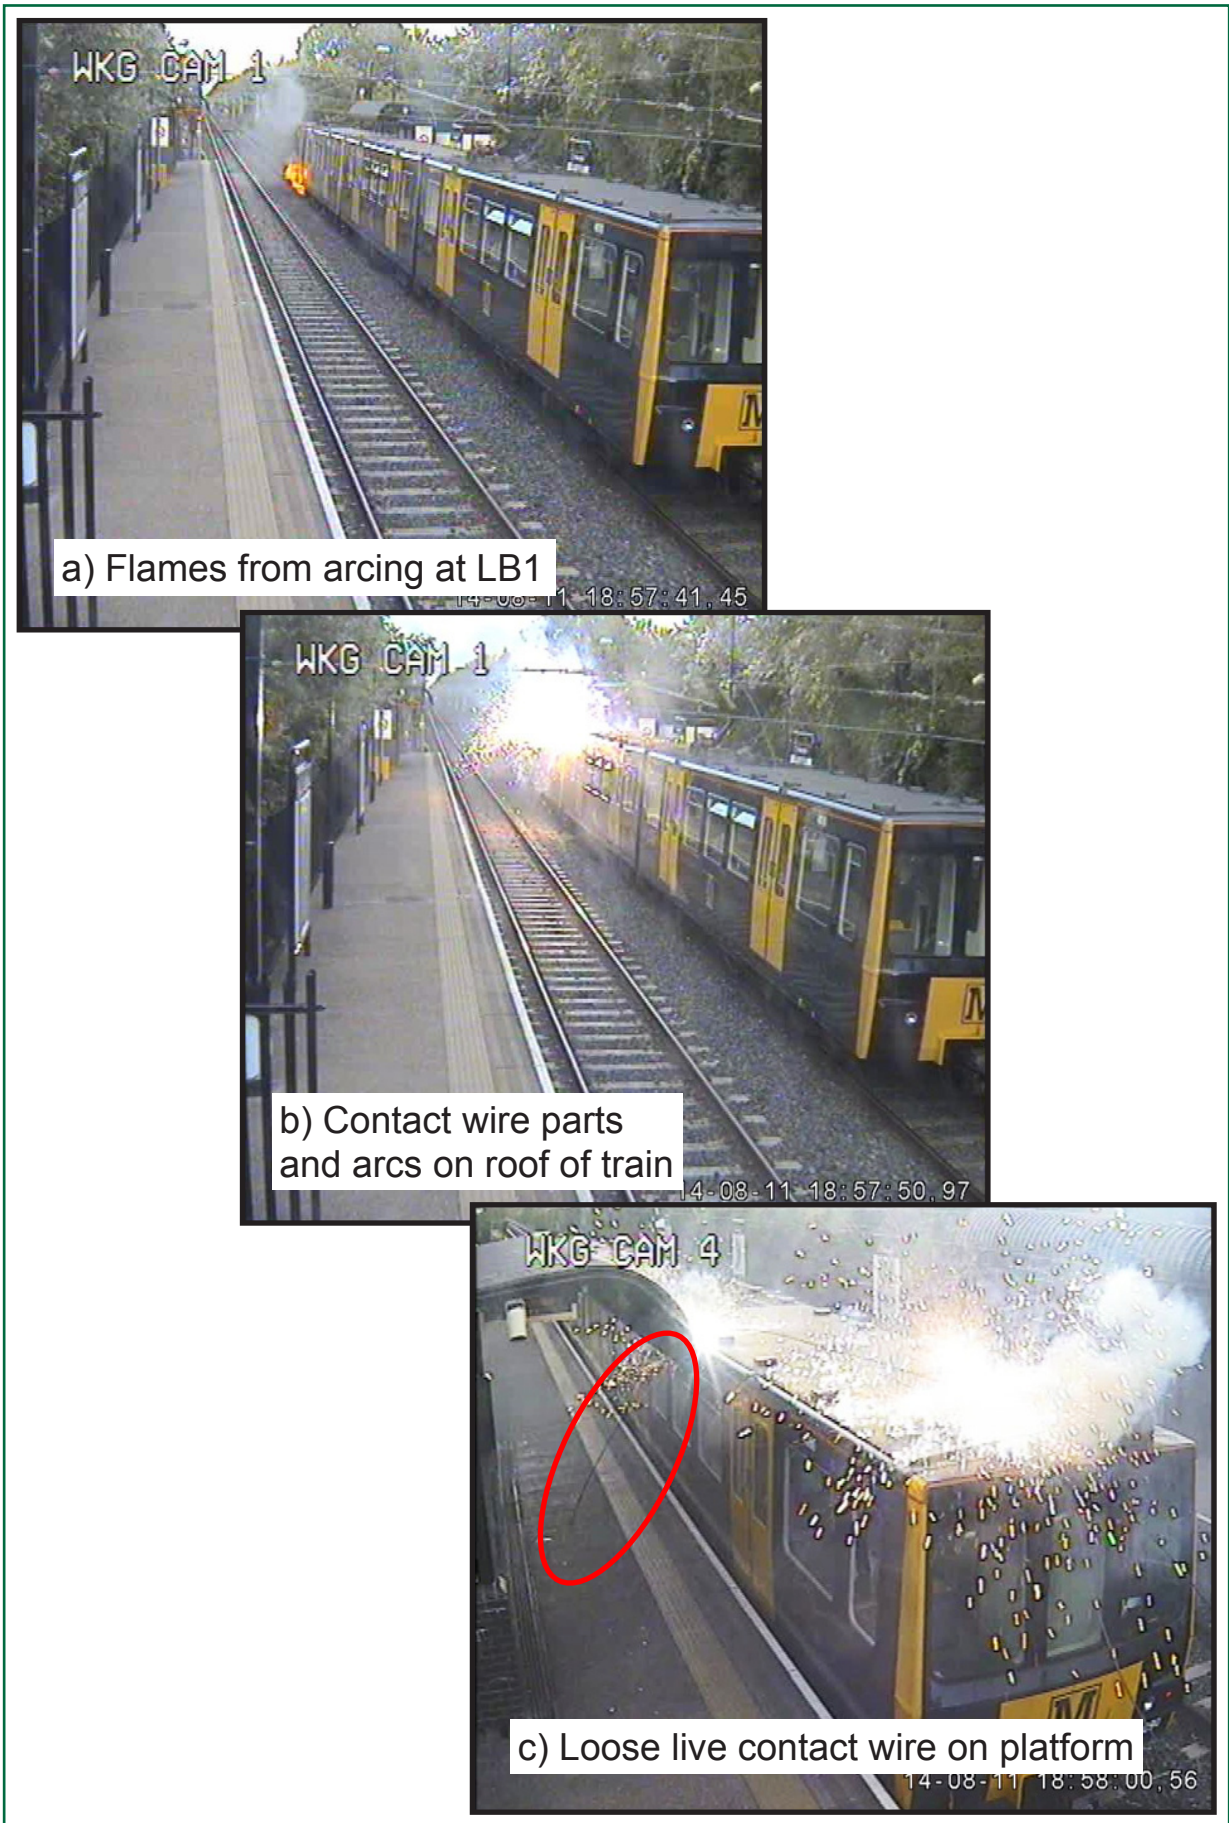
Figure 8: Sequence of events during accident (images courtesy of DB Regio Tyne & Wear Ltd)

- 45 Before he got to the cab a large flash occurred on the contact wire in the area of the trailing pantograph and the contact wire parted. CCTV footage shows the loose ends of the contact wire whipping around the roofs of both cars, causing arcing and cascading sparks (figure 8b). (The contact wire also parted in two other places; around both pantographs and at a mid-point between them.) After about seven seconds one end of the live contact wire fell on to the platform (figure 8c). The electrical protection did not disconnect the power supply and the wire on the platform remained live.

- 48 The power controller immediately opened Percy Main substation circuit breaker to disconnect the traction power supply to the train. Once the power was removed, the smoke from the line breaker box quickly subsided and the de-energised contact wire came to rest on the platform adjacent to the rear-most set of doors, shown in figure 8c.
