**Tether visibility prior to impact**

### Accident sortie, pre-tether strike – summary

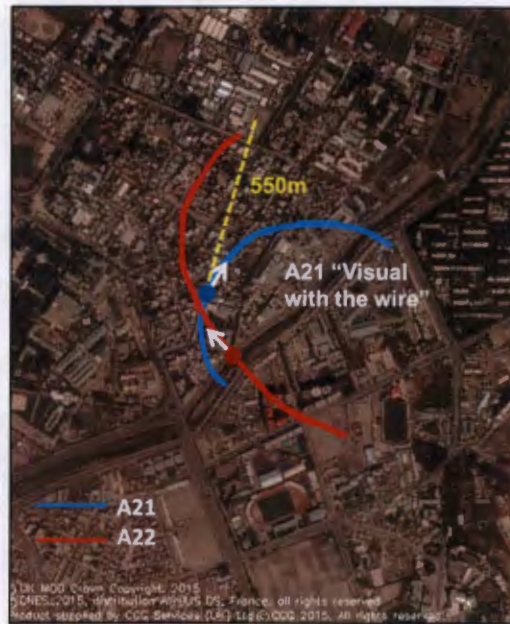
1.4.197 Conversely, analysis of the CVFDR indicated that as A21 commenced the orbit to the south east of HQRS the Captain stated that he was visual with the wire; this was at a range of approximately 0.29 nm (550 m) and 20 sec prior to A22 striking the tether. The relative positions of the aircraft and the tether is shown at Figure 1.4.20.

**Figure 1.4.20 - Relative positions of aircraft and tether when A21's Captain stated that he was visual with the wire**

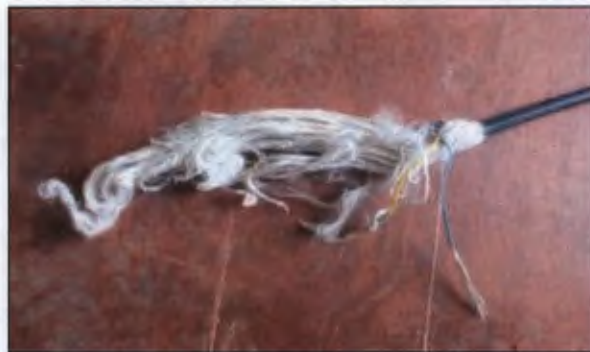
1.4.212 The Panel assessed that a MRB drew the tether onto the right of the tail cone and as it crossed the aircraft's longitudinal axis tension on the tether increased. The Panel judged that the tension would have been further increased by the momentum of the advancing MRB and this caused the tether to part; the PTDS technical specifications stated that the tether was designed to break at a strain of 18,000 pounds (tension). Analysis by 1710 NAS described the failure of the tether as a tension failure due to pulling or stretching, rather than as a result of an instant guillotine-type failure. The end of the tether below the point of failure is shown in Figure 1.4.22.

Figure 1.4.22 - PTDS tether at point of failure

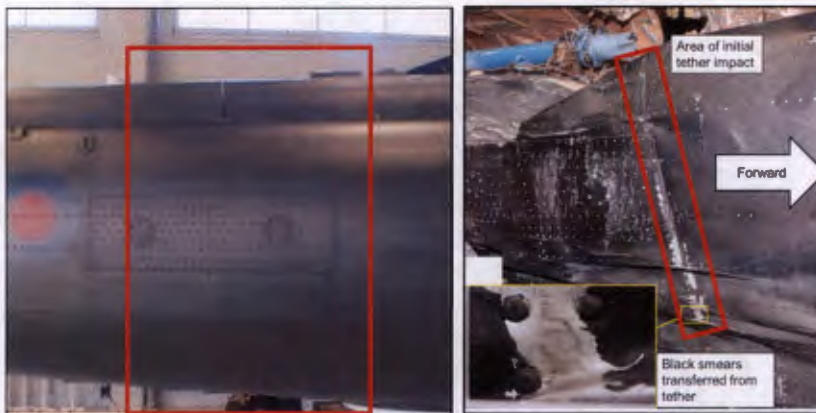
1.4.215 On the right side of the tail cone, there was evidence of a linear dent to the outer aircraft skin; this was assessed to have been caused by the initial impact of the tether. Figure 1.4.23 shows the right side of an undamaged tail cone and the damage sustained to XW229.

**Figure 1.4.23 - Images showing right side of an undamaged tail cone and post tether impact damage to XW229**

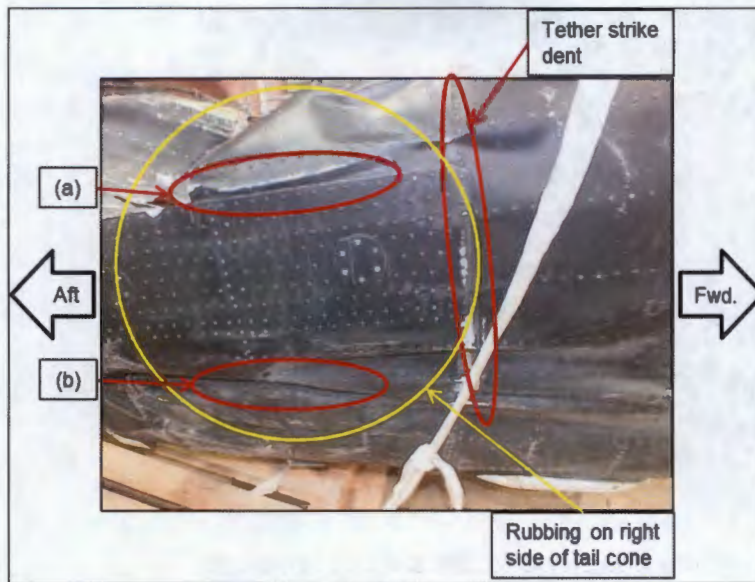
1.4.216 A series of rub marks were identified that commenced at the assessed initial impact point and continued rearwards for approximately 0.44 m, finishing below a join between fairings covering the TRDS. Figures 1.4.24 and 1.4.25 show impact and rub marks on the tail cone. The marks were considered to have been caused by the tether, held taught against the tail cone skin whilst the aircraft continued to move forward, 'skipping' over rivets on the aircraft's surface. Although the right side of the aircraft was damaged on impact with the ground, the rub marks were evident inside folded areas of the airframe structure (crash damage) indicating that they occurred prior to ground impact.

Figure 1.4.24 - Impact and rub marks on right side of tail cone

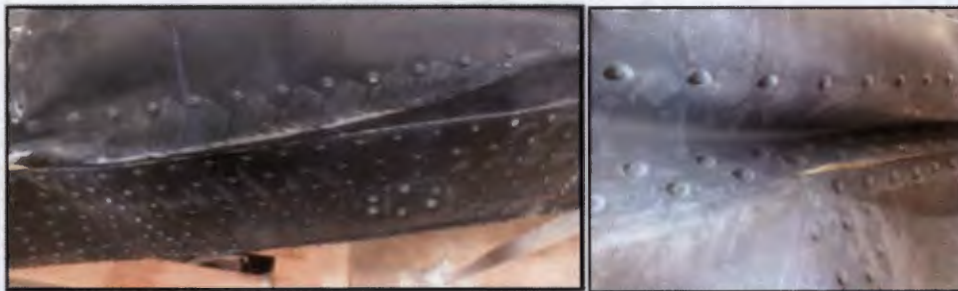
Figure 1.4.25 - Areas (a) & (b) of Figure 1.4.24 showing rub marks on right side of tail cone

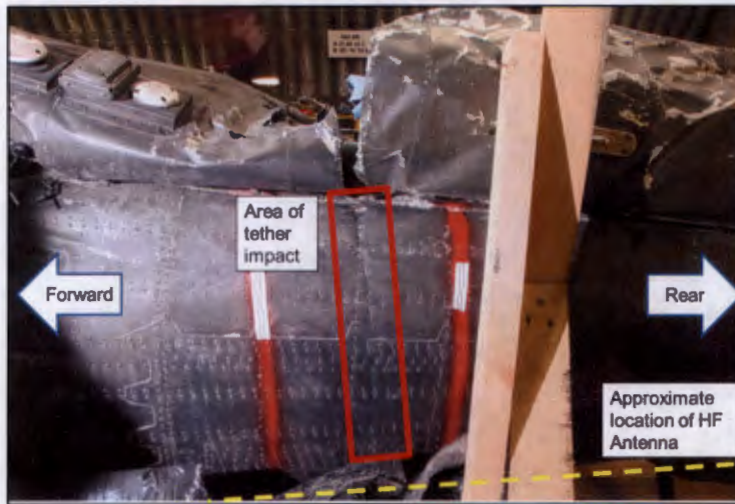
1.4.217 An impact mark/dent was identified on the left side of the tail cone, aligned with the join in the TRDS fairings; this is shown in Figure 1.4.26. The Panel concluded that having failed, and under tension from the base station, with the aircraft moving forward at 82 kts, the tether 'whipped' down the left side of the tail cone and impacted the aircraft's High Frequency Radio antenna and was then pulled back over the airframe; a section of the antenna was recovered from within the PTDS compound. The location of the High Frequency antenna on the aircraft is shown in Figure 1.4.27. Forensic examination of the fracture surfaces of the antenna identified black material, which was chemically consistent with the outer coating of the PTDS tether. This indicated that the antenna was broken by the tether as it came into contact with the left side of the tail cone.

Figure 1.4.26 - Impact damage to left side of tail cone

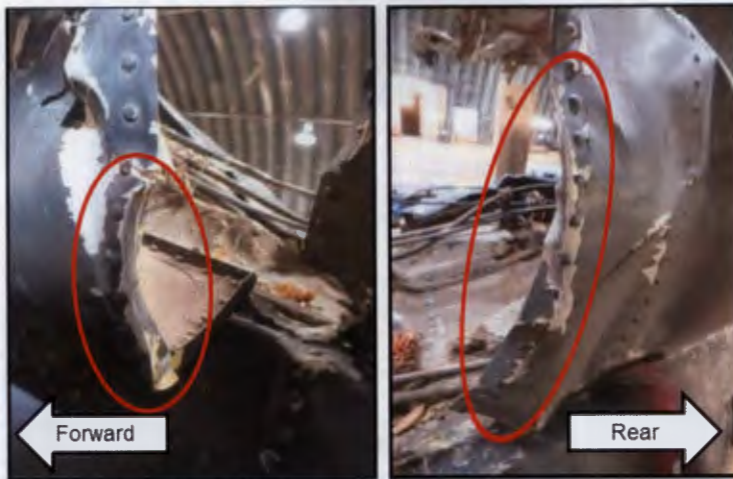
1.4.218 During the rapid sequence of the tether moving rearwards along the tail, being 'pulled' over the tail cone by the MRBs, 'whipping' down following failure and falling to the ground<sup>92</sup>, evidence indicated that it passed between the forward and centre TRDS fairings causing the edges to buckle inwards as shown in Figure 1.4.28. The gap between undamaged TRDS fairings can vary between 2 mm and 4 mm. In the Panel's opinion, and considering that the diameter of the tether was 14.7 mm, it is more likely than not that the gap was sufficient to allow the tether, under tension, to breach the TRDS fairing.

**Figure 1.4.28 - TRDS fairing gap showing damaged edges assessed to be caused by the tether**

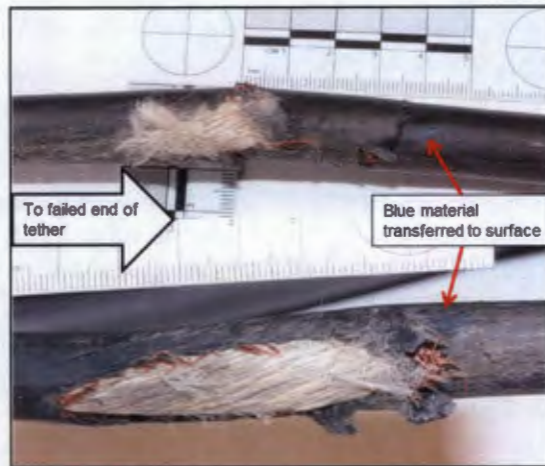
1.4.219 Forensic examination of traces of blue paint found on the section of PTDS tether immediately below its break, confirmed that it was chemically consistent with paint used on the No 5 TRDS indicating that the tether interacted with the TRDS. Images of damaged tether sections where blue paint was identified are shown in Figure 1.4.29.

**Figure 1.4.29 - Images of damaged tether sections where blue paint was identified**

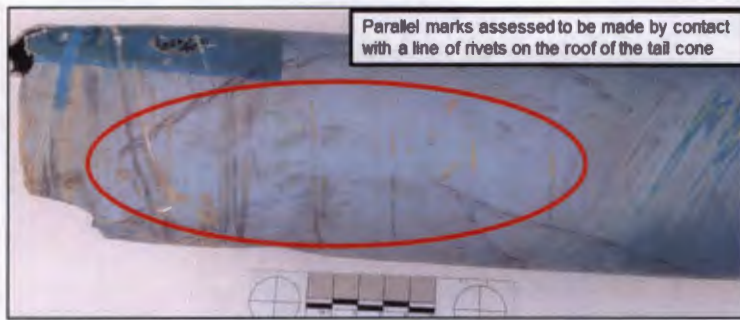
1.4.220 Forensic examination of the aircraft structure immediately beneath the TRDS, and in the vicinity of the gap between TRDS fairings, identified several rivets that had been scuffed and showed traces of blue paint that was chemically consistent with paint from the No 5 TRDS. In addition, the TRDS had physical evidence of parallel score marks that were consistent with the damaged rivets, which is shown in Figure 1.4.30. Technical analysis assessed that the nature of the score marks indicated that the shaft was rotating when it came into contact with the rivets.

Figure 1.4.30 - No 5 TRDS showing parallel scoring from rivets

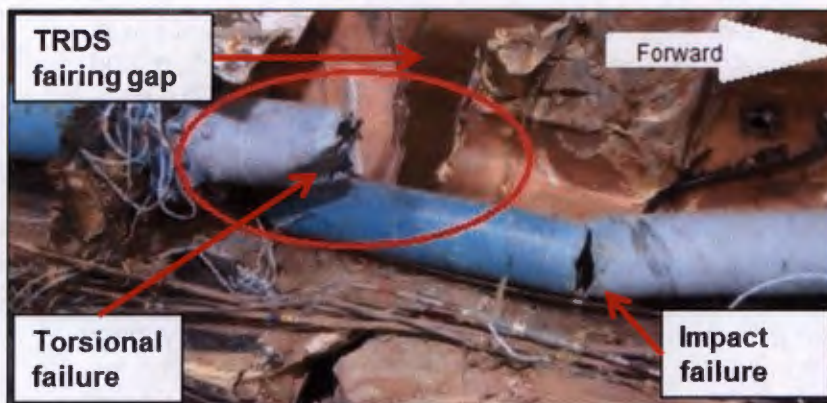
1.4.258 Technical investigation identified a catastrophic torsional failure of the No 5 TRDS directly in line with the TRDS fairing gap through which the tether is assessed to have passed. Figure 1.4.31 shows an undamaged No 5 TRDS; Figure 1.4.32 shows the torsional failure.

Figure 1.4.32 - Catastrophic torsional failure of No 5 TRDS

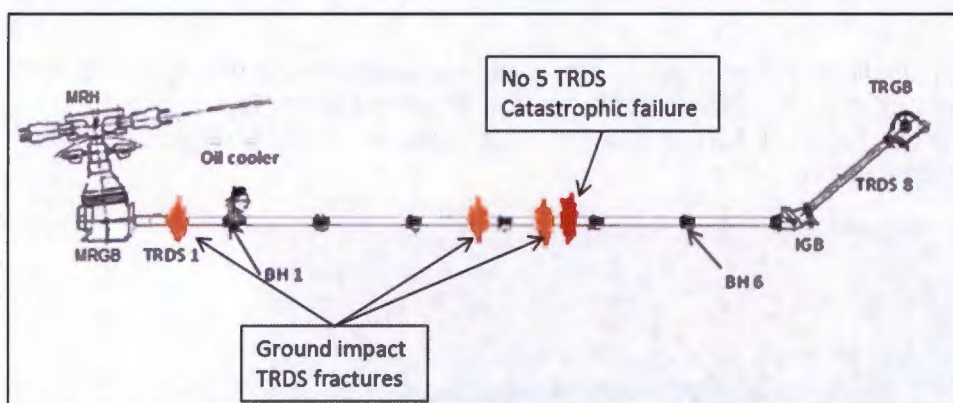
1.4.259 Although there were other breaks in the TRDSs, they had significantly reduced torsional fracture surfaces and on the balance of evidence were likely to have occurred as the aircraft impacted the ground. Figure 1.4.33 is a diagrammatic representation of the tail rotor drive chain showing fracture points.

Figure 1.4.33 - Diagram showing location of TRDS fractures

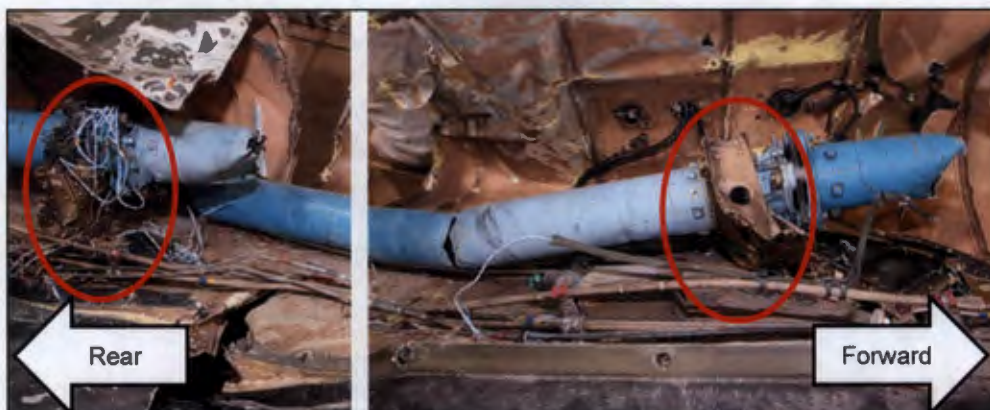
1.4.260 On inspection, the bearings and flexible couplings on either side of the No 5 TRDS were damaged and displaced towards the catastrophic failure point, Figure 1.4.34. It was not possible to positively determine whether this damage was caused by tether strike, TRDS failure or ground impact. However, due to the significant downwards displacement required of the TRDS to interact with the structure immediately beneath it, paragraph 1.4.220, some of this damage is highly likely to have occurred at the time of tether strike and subsequently been exacerbated by the failure of the TRDS and ground impact.

**Figure 1.4.34 - TRDS Bearings and flexible coupling damage**

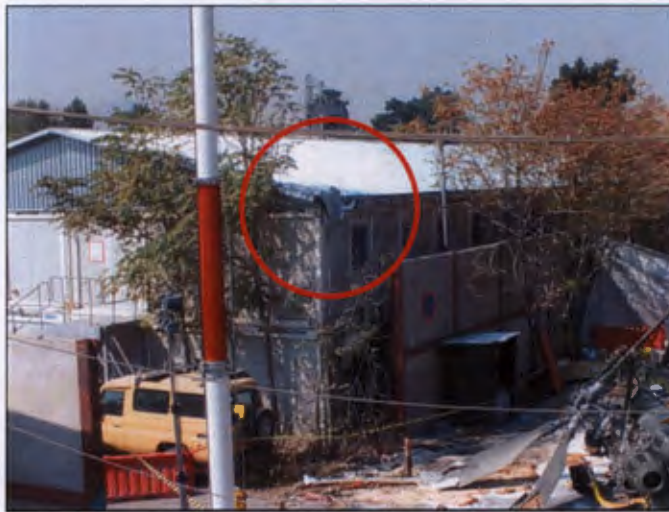
Figure 1.4.35 - Damage caused by MRBs

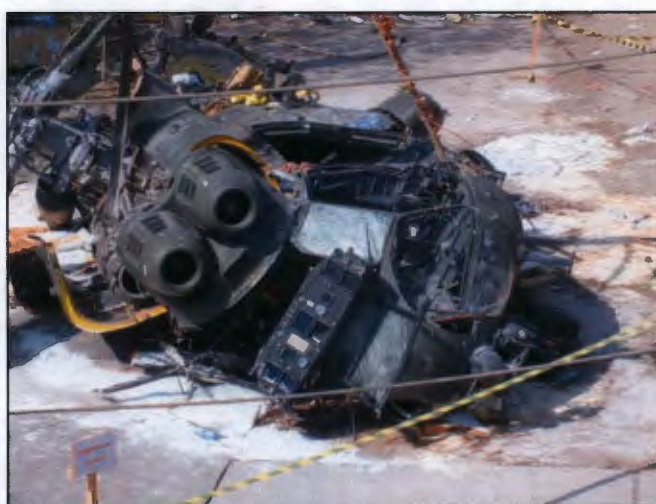
1.4.264 After impact the aircraft was orientated on its right side; the airframe suffered extensive disruption during the accident sequence which was subsequently worsened by the rescue activities, this is shown in Figure 1.4.38.

**Figure 1.4.38 - Distortion to XW229's airframe**

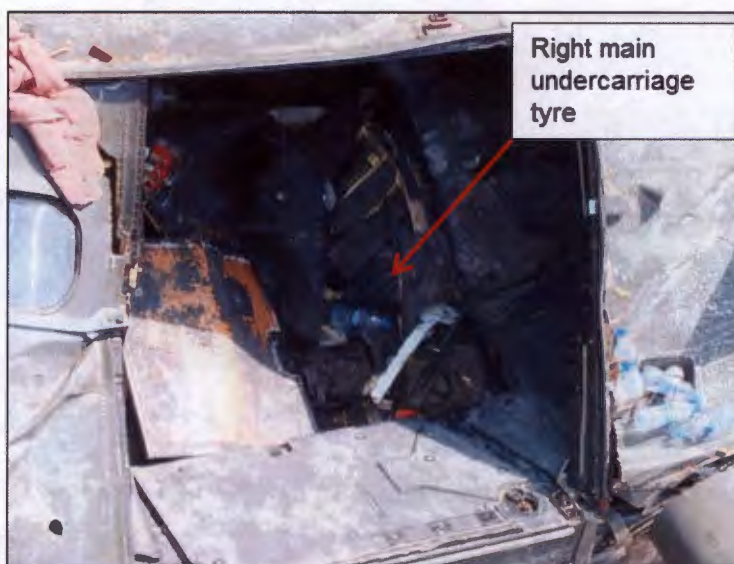
1.4.265 The ground was flat and a mix of hard packed earth and concrete. The tail struck first followed by the right rear wheel and then main fuselage. The force of impact ruptured the fuel bladder under the cabin floor and forced the right rear undercarriage and ballistic flooring into the cabin causing significant loss of survivable space. Figure 1.4.39 shows the inside of the aircraft cabin when viewed from above.

Figure 1.4.39 - View into aircraft cabin from above

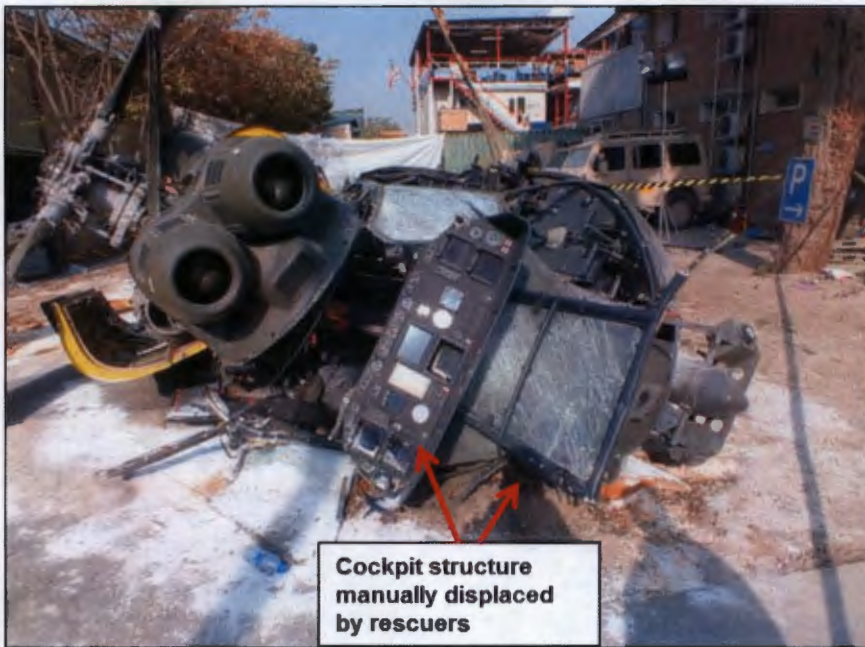
**Figure 1.4.41 - Displacement of cockpit structure**

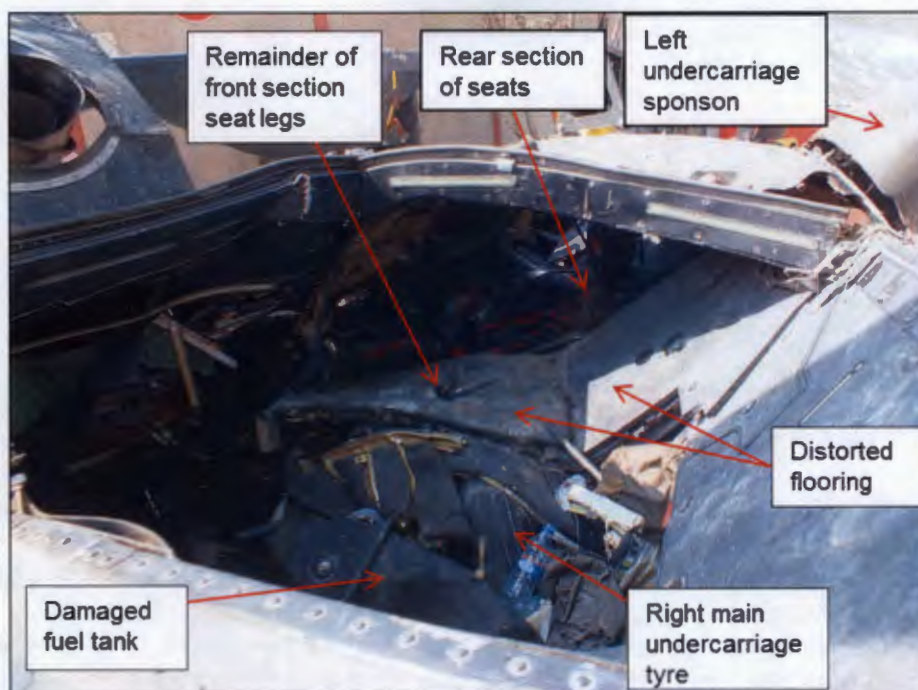
**Figure 1.4.45 - View of XW229's cabin post-accident**

1.4.290 The reduction in cabin volume was the most significant cause of passenger injury. Additionally the orientation of the aircraft and the buckling of the floor collapsed the right side passenger seats causing significant crush injuries to the occupants. The 3 passenger fatalities were all sat on the right of the aircraft; the passengers on the left all survived with varying degrees of injury.

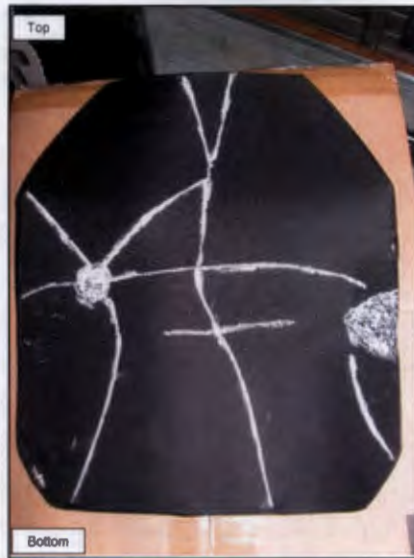
1.4.303 Two passengers sustained injuries that the Aeromedical Report considered were most likely caused by the troop seat. Passenger B's injuries were consistent with a forced hyperextension ie backward flexion of an unsupported neck. The rear ballistic plate (30 cm (height) x 25 cm (width)) of passenger C's personnel protective equipment revealed multiple fractures (Figure 1.4.49) which would have transmitted sufficient force to cause the related injuries. It is probable that the plate was fractured when Passenger C struck the bar at the top of the troop seats; the horizontal fracture mark broadly aligned with the top of the seat.

**Figure 1.4.49 - Fracture Damage to Passenger C's rear ballistic protection**
