# SS RICHARD MONTGOMERY

## Survey and Hull Thickness Report 2013

September 2015

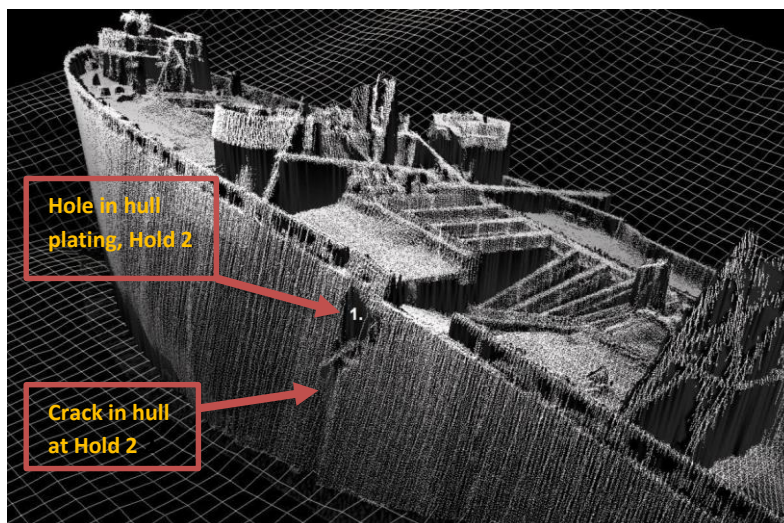
4.4.2 Area 1 is the crack in the hull on the port side of the forward section at Hold 2. This consists of a hole in the hull plating just below deck level and a crack which extends to the seabed. This has been noted in survey reports since at least the 1970s.

4.4.3 The dimensions of the crack in the hull obtained from the 2012 dataset gave a length of 2.69m and a width of 1.29m. The results from the 2013 dataset show that the crack has increased in size and now measures 2.77m in length and 1.54m in width. This represents a change of 0.08m and 0.25m in length and width respectively.

4.4.4 Close examination of the data suggested that the size of the opening may extend past the limits determined by the previous survey. The 2013 data showed that the former base of the crack, when viewed from the west, is actually a piece of metal protruding from inside the hull and that the crack may reach below. There is also a smaller aperture located immediately

to the right of the larger crack and for future surveys it may be practical to measure the full width across both of these, as it cannot be determined from the data whether the section dividing the two cracks has any significant structural integrity. The revised dimensions of this feature can be measured as 3.31m long and 2.16m wide. It is also apparent from the data that the hull directly beneath this crack has become distorted and there is an indented groove extending from this location down to the seabed (hull deformation is discussed in section 4.5).

4.4.5 It should be noted that the diver inspection of this hole and crack in the hull plating determined that the hole is smaller than the MBES data suggests (see section 6).

Fig 4 View of key area 1 - the crack in the hull on the port side of the forward section at Hold 2

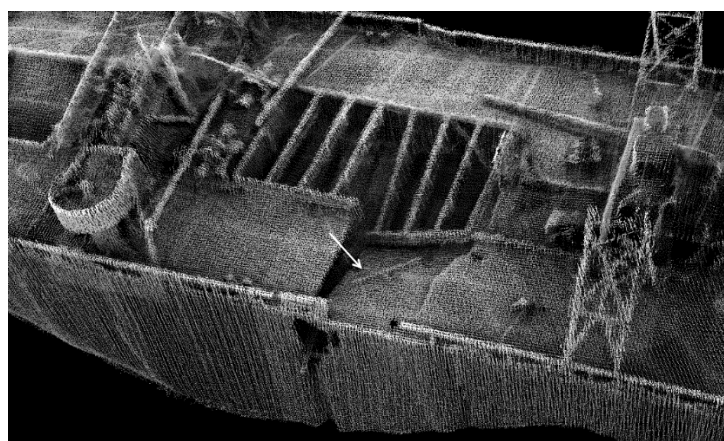
4.4.6 Area 2 is the area of collapsed deck plating along the port side of Hold 2. This area is shown in figure 5 below.

Fig. 5 3D point cloud showing the location of the collapsed deck plate on the port side of Hold 2.

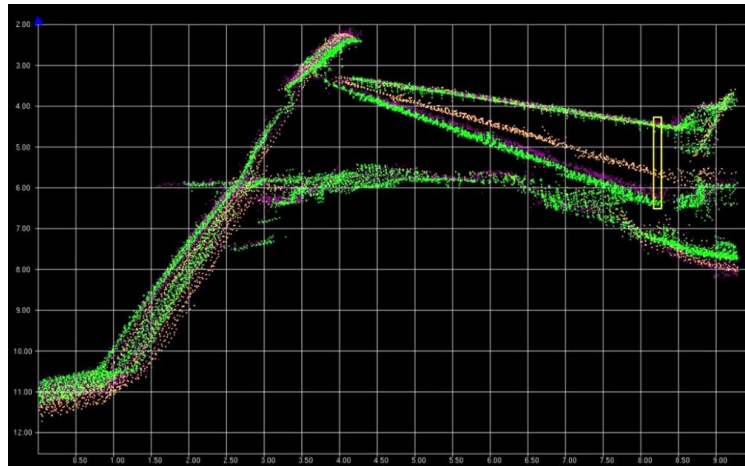
4.4.7 The collapse of the deck plating along the port side of Hold 2 has been well defined in the 2013 dataset. Figure 6 below shows a cross-section through the data from the collapsed deck area with surface difference analysis. The data suggests that the area of collapse has

dropped a further 20cm since the last survey, whilst the deck plating forward and aft of the collapsed section has not moved in the last year. Table 1 below shows the depths of the collapsed sections from the 2010, 2012 and 2013 datasets. The results suggest that the rate of collapse of the deck at this location is reducing.

Fig. 6 2013 data (green) of the collapsing deck plate with 2010 (orange) and 2012 data (purple). The yellow box marks the position where the measurements were obtained.

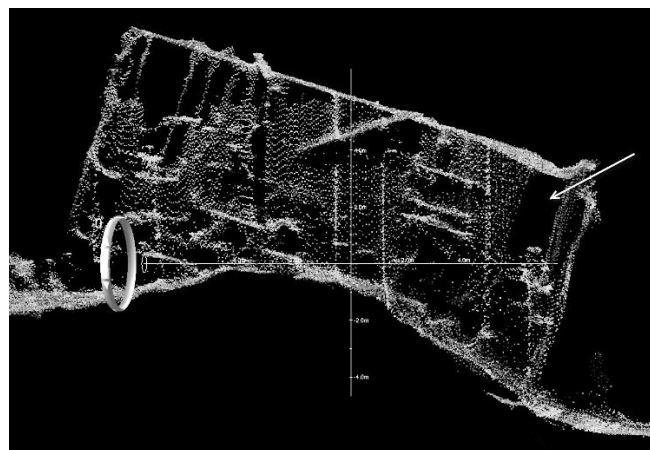
4.4.8 Area 3 is the aperture in the starboard side of the bulkhead at the aft end of Hold 3. Comparison of the 2012 and 2013 datasets indicate that there has been no increase in the dimensions of this aperture between the two surveys.

Fig. 7 Aperture in the fractured aft end of the forward section.

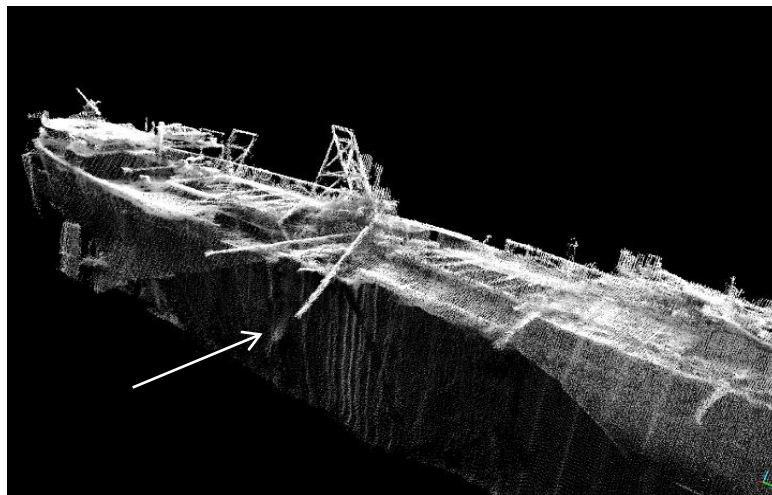
4.4.9 Area 4 is an area on the starboard side of the stern section which, in the 2009 dataset, appeared to show a split in the hull plating. Subsequent surveys did not relocate this split in hull plating and it was thought that the angle of list and overhanging debris may have created a shadow in the dataset which gave the appearance of a split. The 2012 survey data indicated the presence of a feature of some kind at this location but was inconclusive.

4.4.10 In the 2013 data an irregular sheet-like flap of metal can be seen protruding from the hull (figure 8 below). In order to determine what this data was showing, this section of the data was extracted and examined in the Fledermaus 3D editor where the distorted hull plate was seen above a hole in the wreck measuring 1.2m long and 0.9m wide. The data also suggested the presence of a split in the hull which extends from the top of the distorted hull plate to deck level. Although difficult to discern accurately, the split was measured to be 0.40m wide when viewed along the line of the hull looking towards the stern of the ship.

**Fig. 8 Starboard side view of the aft section. Severe splitting is represented by a sheet of metal protruding from the hull (arrowed).**

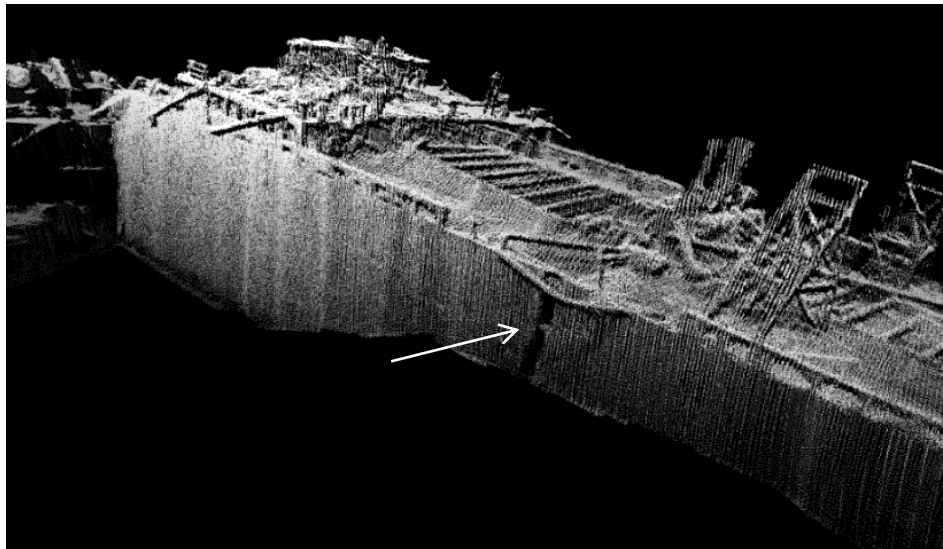
4.4.11 The results of the 2013 survey have suggested that a fifth area should be added to the list of key areas of focus. This Area 5 is a split in the deck plating on the port side of the stern section.

deck has subsided to 5.58m depth, a partial collapse of 1.05m from the 'normal' deck position. The full extent of the collapse observed to date at 7.35m depth which is 2.82m below the 'normal' deck level. Comparisons with the 2012 dataset show that the collapsed decking at this location has not moved since the last survey, however the deck plate forward of the split is exhibiting ongoing subsidence.

**Fig. 9** View of the split in the port side of the aft section, in the 2013 dataset.

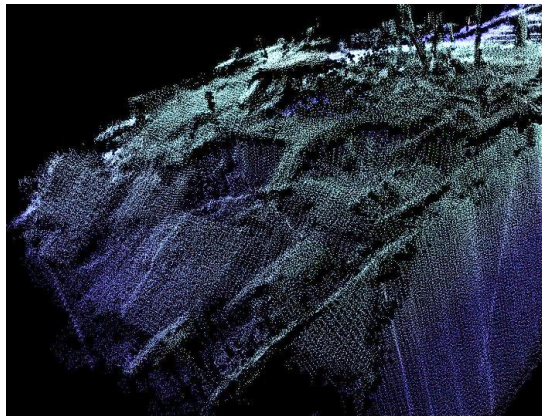
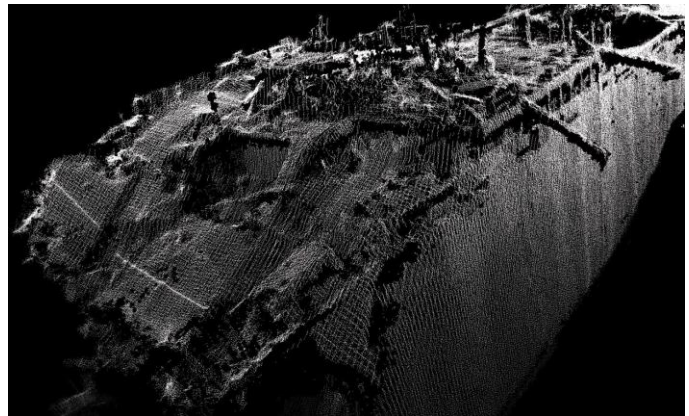
4.4.15 Survey data from the area around the collapsed boat deck did not indicate that any significant shifts in the position of the wreck structure had occurred. When viewing cross-sections through combined datasets in Caris it could be seen that a small amount of subsidence had taken place; up to 0.15m. Surface difference analysis shows that the poorly supported forward end of the aft section of the wreck has subsided by up to 0.30m since the last survey.

Fig 10 & 11 3D point cloud imagery showing the port side of the boat deck on the aft section of the wreck.

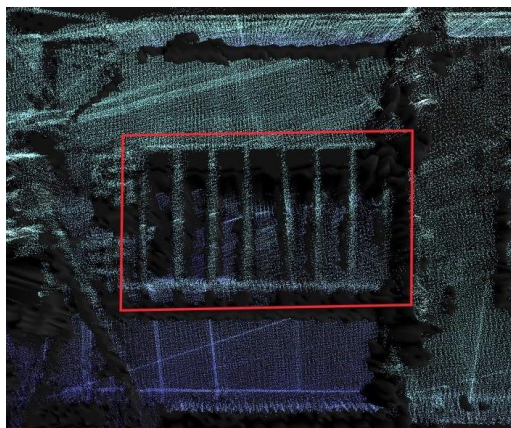
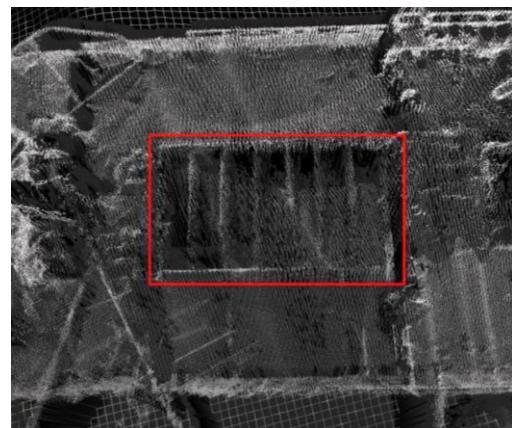
4.4.16 Examination of the Hold 4 hatch cover supports in the 2013 dataset shows that the six hatch cover supports are in place and remain in a similar condition to the 2010 and 2012 datasets. The results of the surface difference analysis indicate that there is widespread subsidence of this hatch and the cover supports. This is associated with the subsidence of the deck observed along the port side and the large split in the hull at this section of the wreck. Comparison of the datasets in Caris indicated that the aft-most spar had subsided by 0.5m since the 2012 survey. Also see section 5.9 regarding sediment build-up inside the holds.

Fig. 12 & 13 Hatch Cover Supports over Hold 4 on the aft section of the wreck.

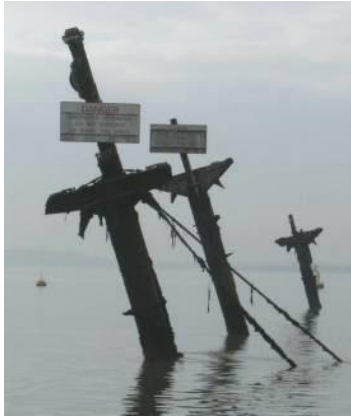
Fig 15 2011 – two stays in place

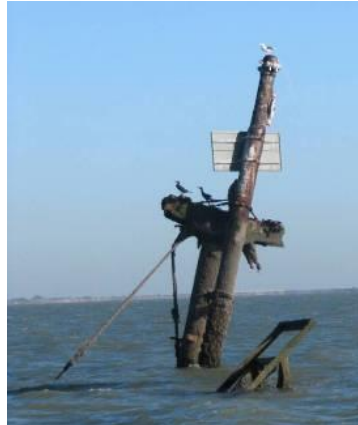
4.6.2 During the 2012 survey, it was noted that one of the two stays on the forward mast had broken at deck level but was still attached to the mast. It can be seen in the photographs at figures 15, 16 and 17 below that this broken stay is now completely detached. During the

Fig. 16 2012 – one stay broken at deck level

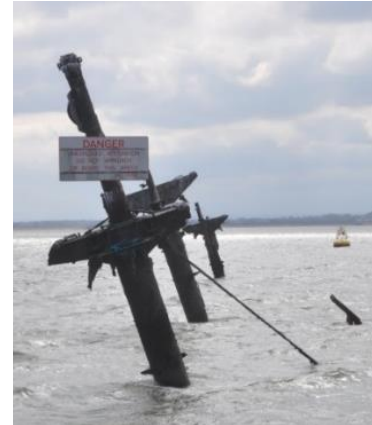
hull thickness assessment, divers noted that the broken stay is now lying on the deck. The second stay remains in place.

Fig 17 2013 – stay detached completely

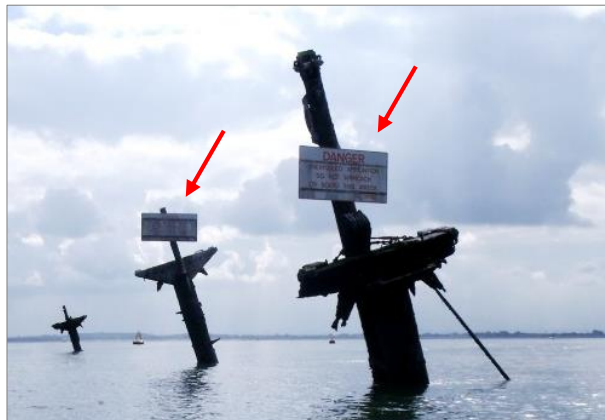
Fig 18 – 2013, two signs visible during diving operations

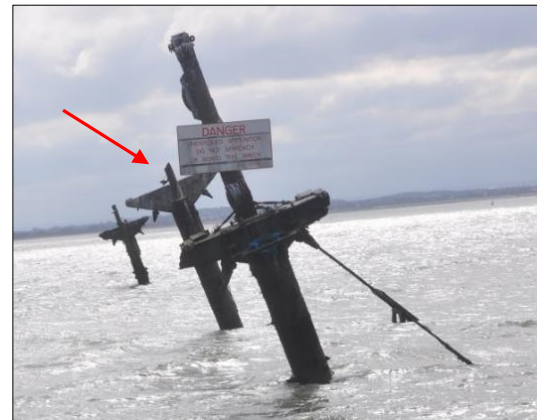
4.6.3 The laser data and photographic record also demonstrates that the warning sign on the main mast is no longer in situ. This was in place during both phases of diving operations for the hull thickness assessment in March and September of 2013, but was not in place in January of 2014 when laser scanning took place. Consideration will be given to reinstating the sign.

Fig 19 – 2014, only one sign in place

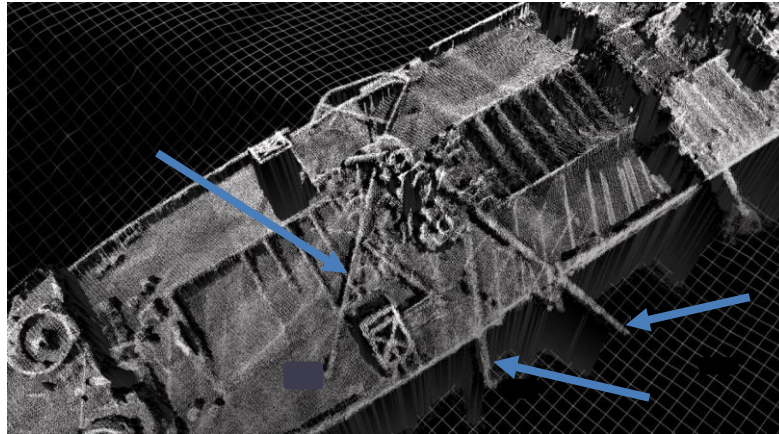
4.6.4 Cargo handling booms were attached to each mast. Whilst one of the booms can be seen still attached to the forward mast, most can now be seen in the multibeam sonar data lying across the deck. All of the features identified in the multibeam data as cargo handling booms were assessed and all appeared unchanged from previous surveys.

**Fig. 20 Mizzen mast cargo handling booms lying across the deck**

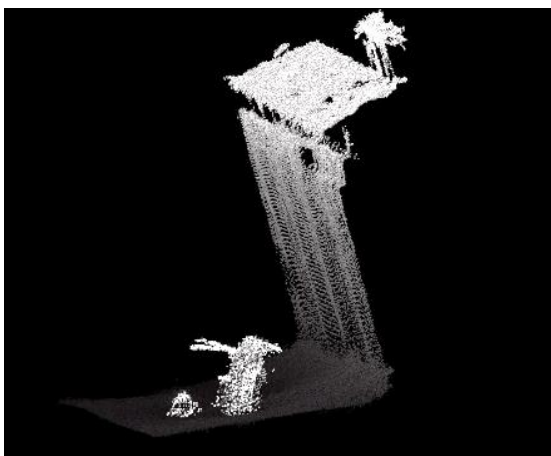
4.7.10 The forward gun tub and gun have been well defined in the 2013 dataset. No evidence of collapse or deterioration was apparent. The stern gun and gun tub have also been well defined in the data. Comparison with the 3D point cloud imagery indicated that there has been no deterioration of this feature. All other gun tubs were assessed and compared to previous survey data and all data suggests little or no deterioration has occurred.

Fig. 22 20mm gun tub lying on seabed on stbd side of the stern section

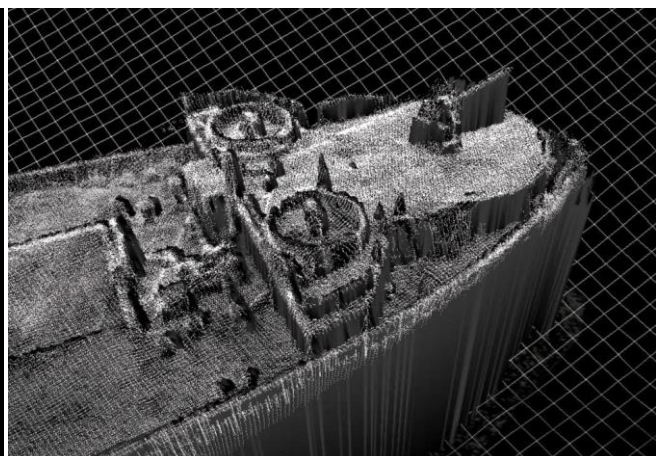
Fig. 23 Stern gun and gun tubs

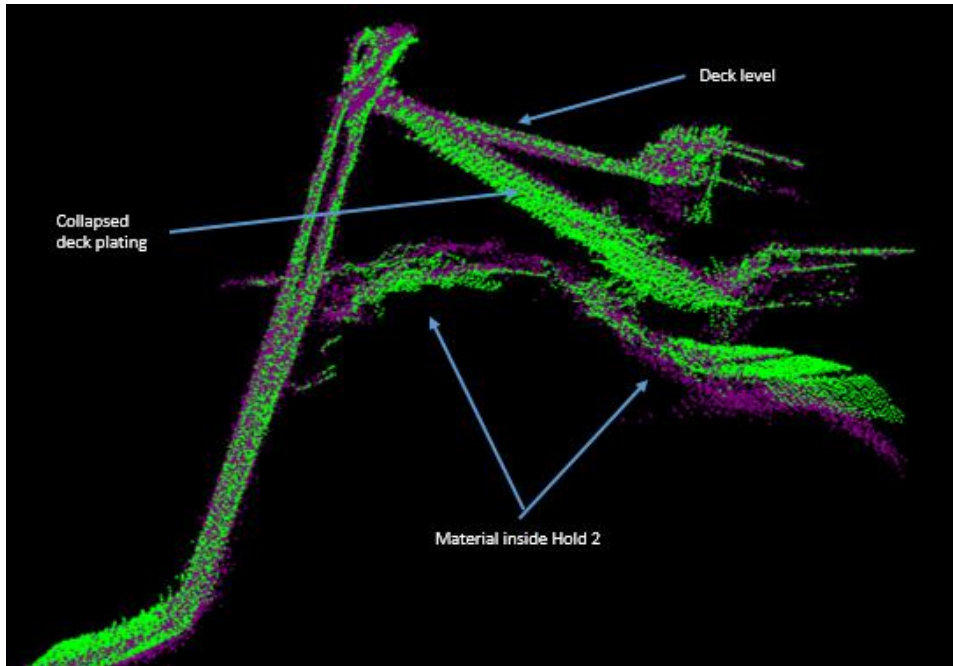
4.8.3 The large crack in the port side hull at Hold 2 and the collapsed deck plating above it allow for the acquisition of sonar data from inside the hold. The data collected in 2013 very closely resembles that from 2012. This suggested that there has been little change during the period between surveys as.

Fig. 24 A cross-section through Hold 2. 2012 data shown in purple and 2013 shown in green.

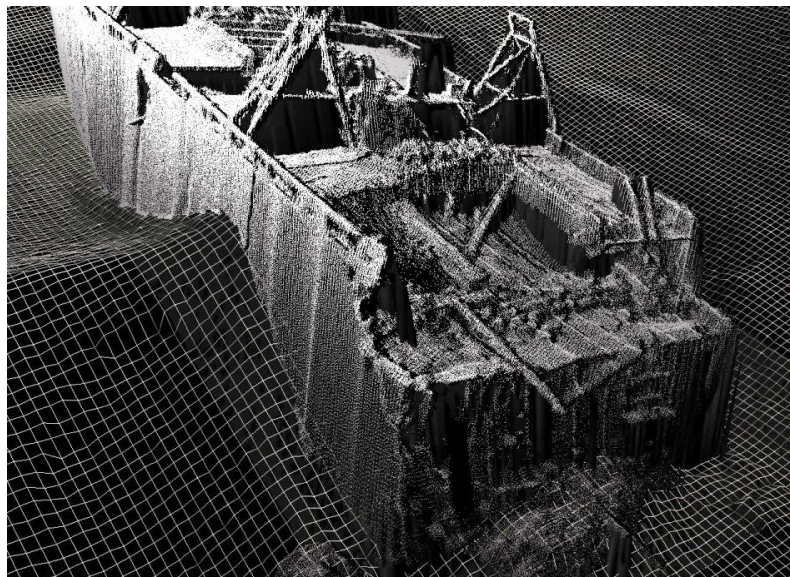
4.8.4 Comparison between point cloud imagery taken of the fractured, aft end of the forward section shows debris strewn across the exposed deck and overhanging the edges. This tangle of wreckage was caused when the ship broke into two sections in 1944 and is likely to contain cargo material. This area appears to remain in the same condition as shown by the 2010 and 2012 datasets and can be seen in figure 23 below.

Fig. 25 2013 – Point cloud data showing Hold 3, aft end of the forward section

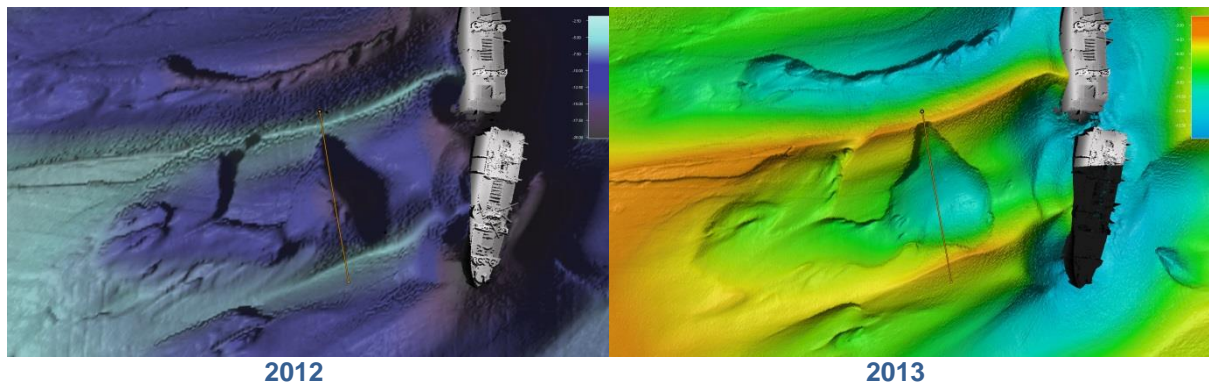
5.6 Although there has been no change in the height of the sand wave crests which form the north and south limits of the scour pit, there has been a great deal of sediment accumulation within the pit itself.

**Fig. 29 & 30 Close up views of the scour pit between the sand waves to the west of the wreck**

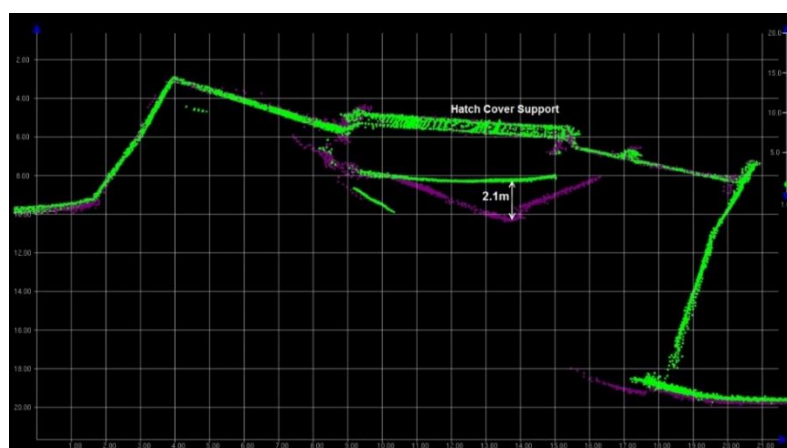
5.9 Survey data focussed on the hull structure also showed evidence of sedimentation since the 2012 survey. Data from all of the holds demonstrated sediment build-up inside the hold since the previous survey. In Hold 1 there was marked increase in height along the port side at the aft end of the Hold 1 hatch. This surface has risen by 0.80m when compared to 2012. In Hold 2 the greatest difference in depth was located near the aft end and showed an increase in height of up to 2.1m. Holds 4 and 5 also showed some increase and in Hold 3 both upward and downward movement was noted in close proximity. This probably represents fluctuations in mobile sediment. As with sediment movement around the wreck, this is assumed to have been caused by sediment build-up during the autumn storms and tidal surges which preceded the 2013 survey.

Fig. 31 Cross section through the combined datasets of 2012 (green) and 2013 (purple) of Hold 2 showing the difference in surface positions between 2012 and 2013.

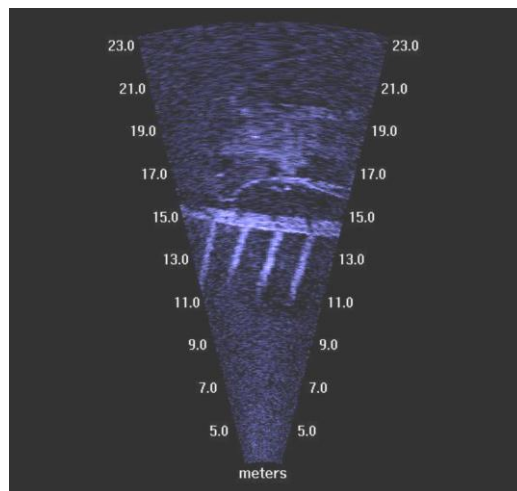
**Fig. 36 Image from Didson sonar showing Hold 4 hatch beams and debris on deck**
