Rail Accident Investigation Branch

Rail Accident Report

Derailment of a freight train at Stoke Lane Level Crossing, near Nottingham 27 August 2013

Report 02/2015
April 2015

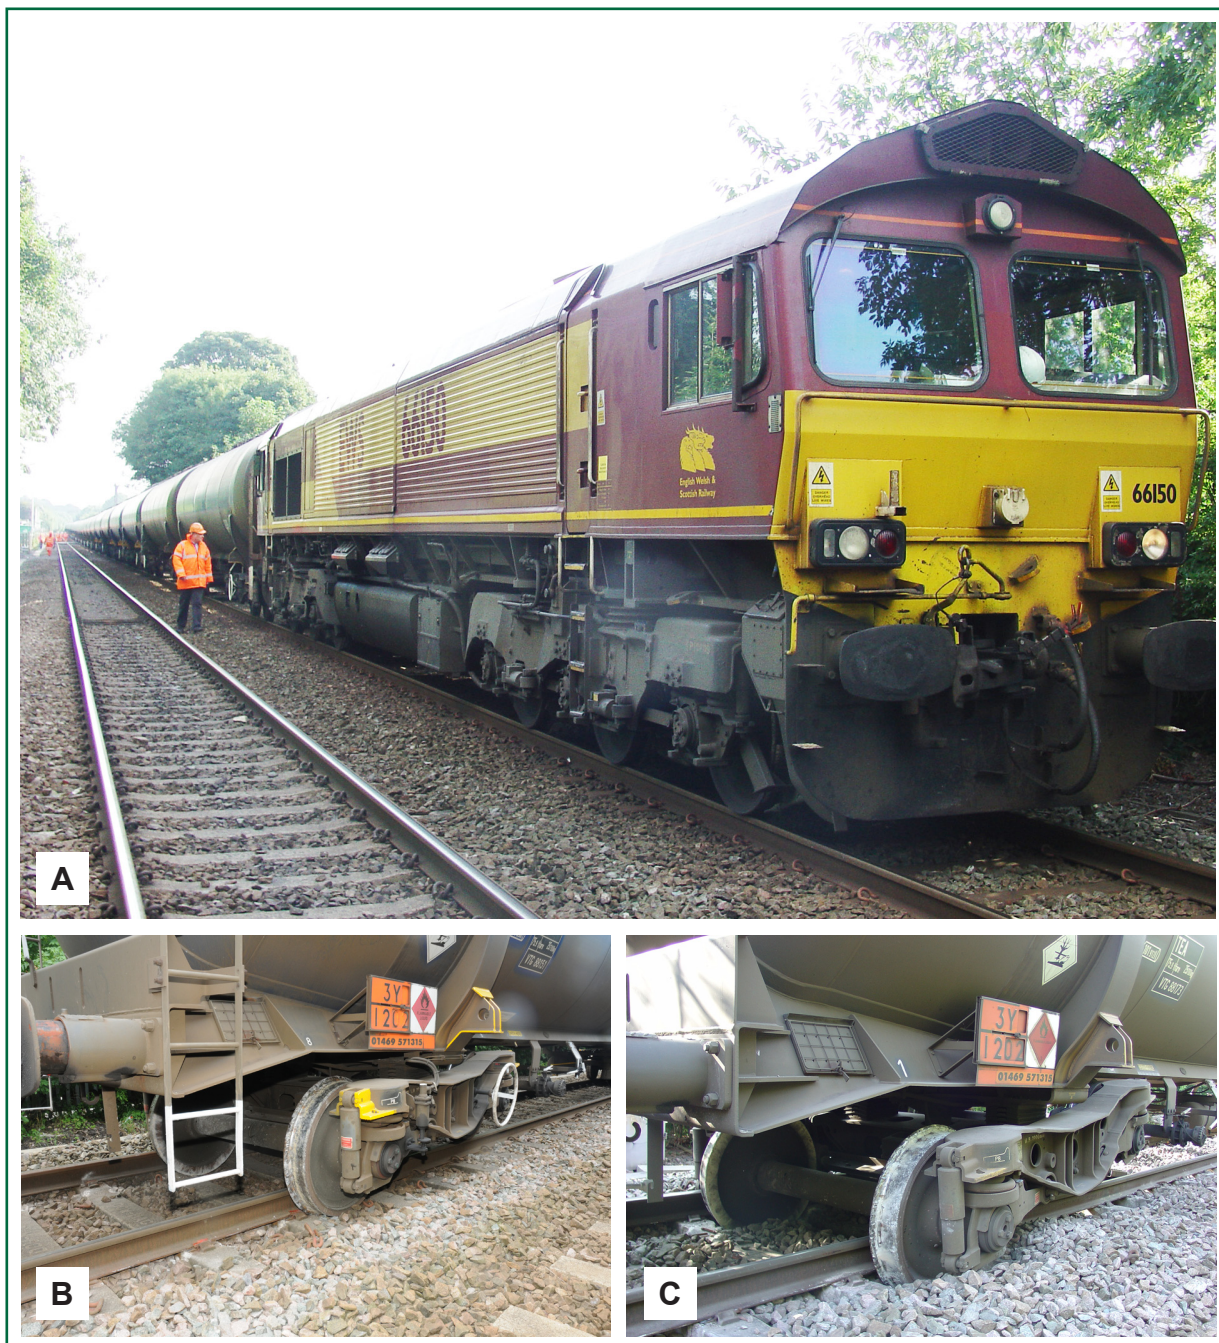
- 8 After informing the signaller of the automatic brake application, the driver went to investigate. He found the trailing axles of the 26th and 28th wagons had derailed toward the *six foot* (figure 2). The wagons had remained upright and in line and had not fouled the adjacent running line. There was no leakage of diesel fuel from any of the tank wagons, but the buffers on some had been damaged. The track was damaged by the derailed wheelsets for a distance of around 800 metres. The driver was not injured.

Figure 2: Train 6M35 (a) and its derailed wheelsets on 26th wagon (b) and 28th wagon (c)

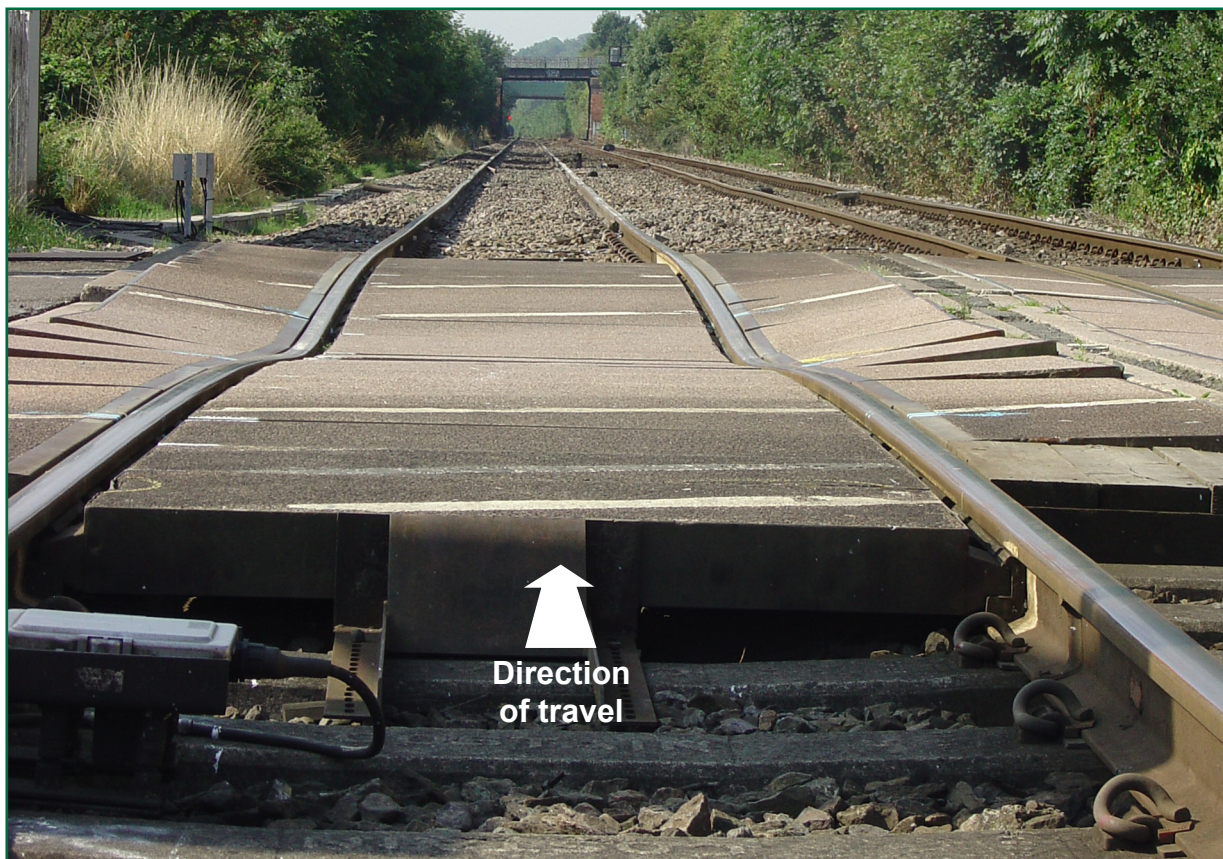
- 9 Examination of the site revealed severe dips of about 100 mm in both rails of the up line at Stoke Lane level crossing (figure 3). The rails had deformed over a void in the ground. Because of this void the track was not supported over a length of around 3 metres (figure 4). The railway remained closed for repairs until 15:30 hrs on 8 September 2013.

Figure 3: The dip in the rails at the point of derailment

- 45 The severe distortion in the rails of the up line (figure 3) was found at around 06:00 hrs. Later that day, the *level crossing panels* were removed and this revealed the large voids below both railway lines around the centre of the road (figure 4). In the following days, a significant amount of ground investigation and repair work was carried out by Network Rail and Morgan Sindall Underground Professional Services, in consultation with the RAIB, to document the voids and repair the track before the line was reopened to traffic on 8 September 2013.

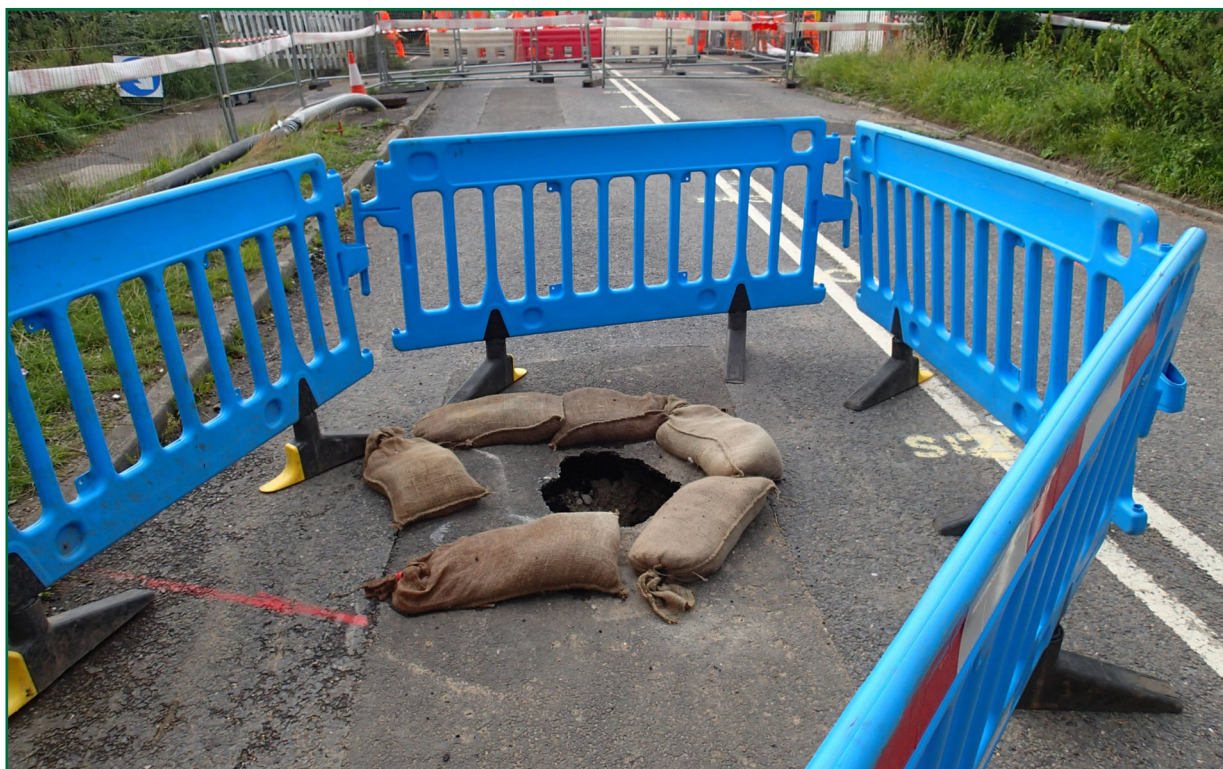
- 37 On 8 August, Bridgeway Consulting staff found a hole in the road located at one end of the trial excavation (paragraph 29) over the twin siphon closest to the launch shaft (figure 8). The position of the hole in relation to the siphons is shown in figure 5. On closer examination, the Bridgeway Consulting staff found the hole had loose material inside it which appeared to come from the reinstated road sub-base material and that there was a void below the surface which sloped downwards and toward the centre line of the road. Bridgeway Consulting called a site meeting the same day with representatives from Morgan Sindall Utilities and Nottinghamshire County Council, to examine the hole and determine the likely cause of the defect. The opinion of the two contractors' representatives at the meeting was that the hole had originated at the trial excavation due to inadequate reinstatement of the excavation and that both the hole and the void were not linked to the tunnelling activity. Nottinghamshire County Council's representative was uncertain as to the cause of the hole and subsequently sought further views from the involved parties. However no party accepted responsibility and the matter was unresolved when the derailment occurred. Severn Trent Water and F&B Tunnelling Solutions were informed of the hole. Network Rail was not informed and remained unaware of the hole until after the derailment.

Figure 8: Hole in the road found on 8 August 2013 (photograph taken on day of accident)

- 71 There were two other factors which affected the decisions made by the involved parties about the severity of the settlement problem:
- a) The hole that was discovered in the road on 8 August (paragraph 37) was not reported to Network Rail by either Morgan Sindall Utilities or Bridgeway Consulting, despite the joint meeting on 1 August to discuss Network Rail's concerns about the settlement. Interview evidence indicates that the reason it was not communicated to Network Rail was because it was considered by the parties at the site meeting of 8 August, that the hole had been caused by poor reinstatement of the trial excavation carried out prior to the tunnelling work and because it was quite far from the crossing. Examination of the hole after the derailment revealed that the trajectory of the void was steeply downward towards the centre of the road and the tunnel and not into the remainder of the trial excavation. Had more rigorous consideration been given to the cause of the void, a possible link to the tunnelling operation should have been apparent. This was a missed opportunity to provide potentially valuable information to Network Rail about what was happening at Stoke Lane almost three weeks before the derailment. Had Network Rail been informed about the hole in the road, and the trajectory of the void below, it may have led to lifting the level crossing panels sooner than the planned 9 September possession.

- f) Where there is an unexpected event such as the appearance of a surface hole in the vicinity of a tunnel, this should be investigated immediately and thoroughly, to identify the cause and any associated risks.

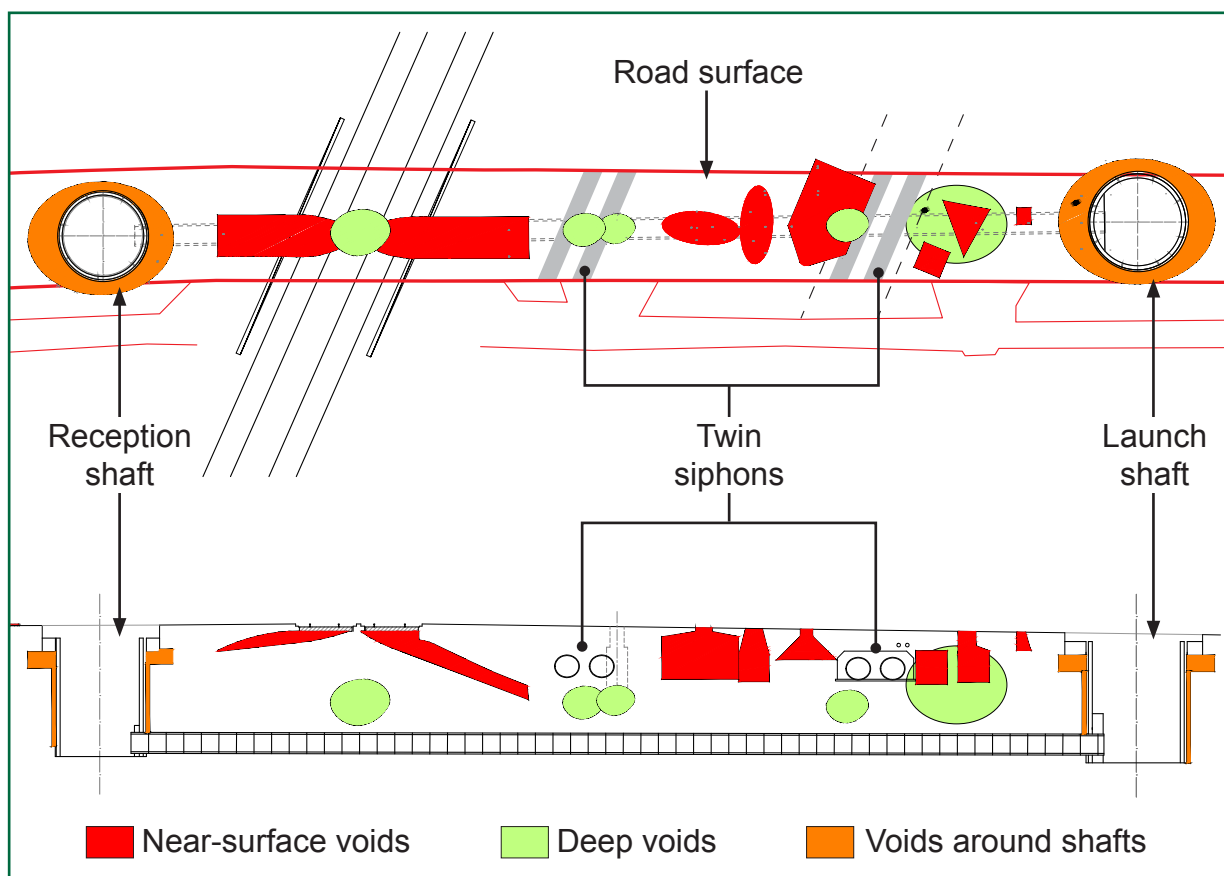
- 53 Ground investigations carried out following the derailment revealed that the voids under the railway were not isolated but were part of a series of voids which ran between the launch and reception shafts of the UTX, generally along the centre line of the road as shown in figure 9. Most of the voids were just below the road surface, but there were also voids found under the railway and the twin siphons and around the shafts. The volume of each void was estimated by Morgan Sindall Underground Professional Services from the amount of grout that had to be pumped into them during the remedial work. The combined total volume of the voids was estimated at around 63 m³ comprising:

- Voids near the surface (shown in red): 46 m³
 - Deep voids below the railway and twin siphons (shown in green): 8 m³
 - Voids around the launch and reception shafts (shown in orange): 9 m³

Figure 9: Map of voiding found during ground investigations undertaken by Morgan Sindall

- 58 The positioning of the voids above the path of the microtunnel (figure 9) is the strongest indication that the voids had been caused by overmining of the ground during the tunnelling activity. Most of the voids along the road and across the railway between the launch and reception shafts had migrated from the depth of the tunnel to a level just below ground level. Normally such voids would be expected to break through the surface soon after the tunnelling had been completed but the road and its foundations effectively bridged the voids, except for one hole which appeared in the road on 8 August (paragraph 37). The deep voids found below the railway and each of the twin siphons do not appear to have risen higher because they were bridged by those structures.

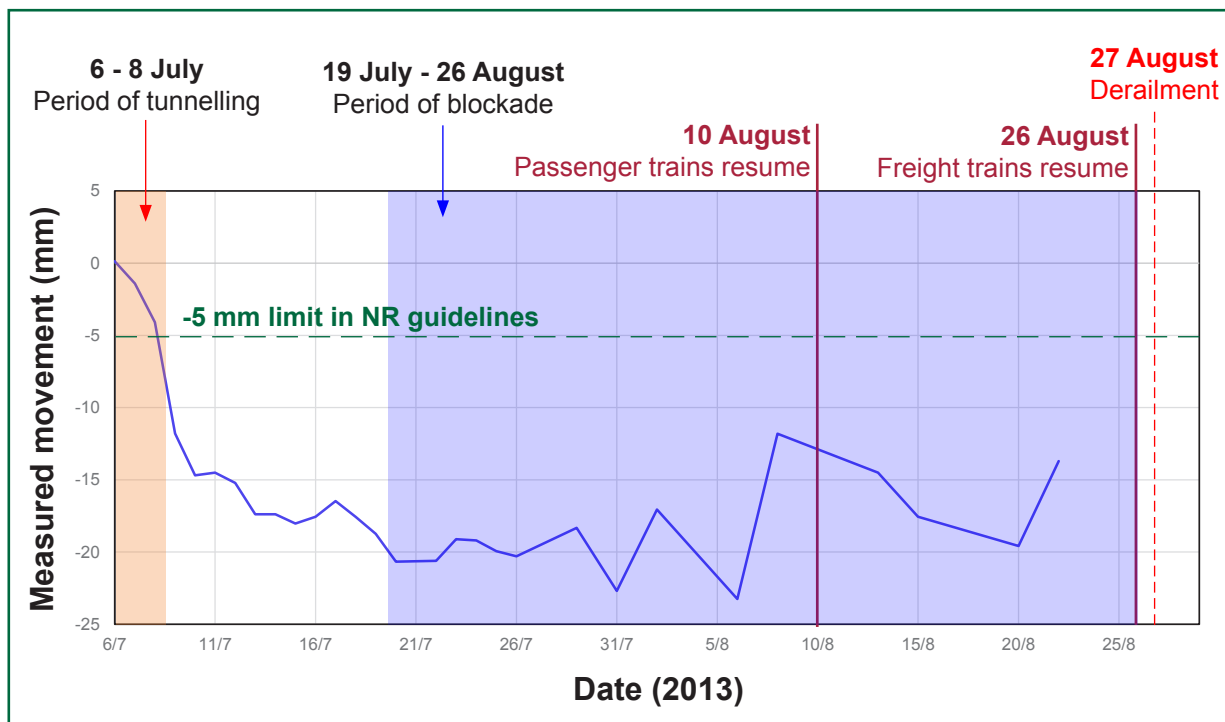
68 As detailed at paragraphs 34 to 38, monitoring of the railway showed a trend of increasing track settlement from 9.5 mm on 8 July when the tunnelling operations finished, to around 23 mm on 31 July. A graph of settlement against time from the start of tunnelling (6 July) for the six foot rail of the up line at the road centre line (which generally showed the greatest amount of settlement) is shown in figure 11. After 31 July, this measurement position and some others around it indicated some fluctuation⁷ between 23 mm and 12 mm. The last measurements taken before the derailment were on Thursday 22 August when the settlement recorded for position LX5 was 14 mm and those at other rail measurement positions at the centre of the level crossing were similar. The next set of readings were due on the day of the derailment. By 29 July, the monitoring had been reduced in frequency to three times per week (paragraph 34). The Nottingham station blockade, which had started on 19 July and continued until 26 August, had resulted in reduced rail traffic over Stoke Lane level crossing. Despite the reduced rail traffic flows there had been a further increase in settlement up to 31 July.

Figure 11: Movement of rail during and following tunnelling (on six foot rail of up line at road centre line)
