IAM REPORT No 648

A REVIEW OF ROYAL NAVY HELICOPTER ACCIDENTS
1972 - 1984

P. VYRNWY-JONES and J.C.D. TURNER

November 1989

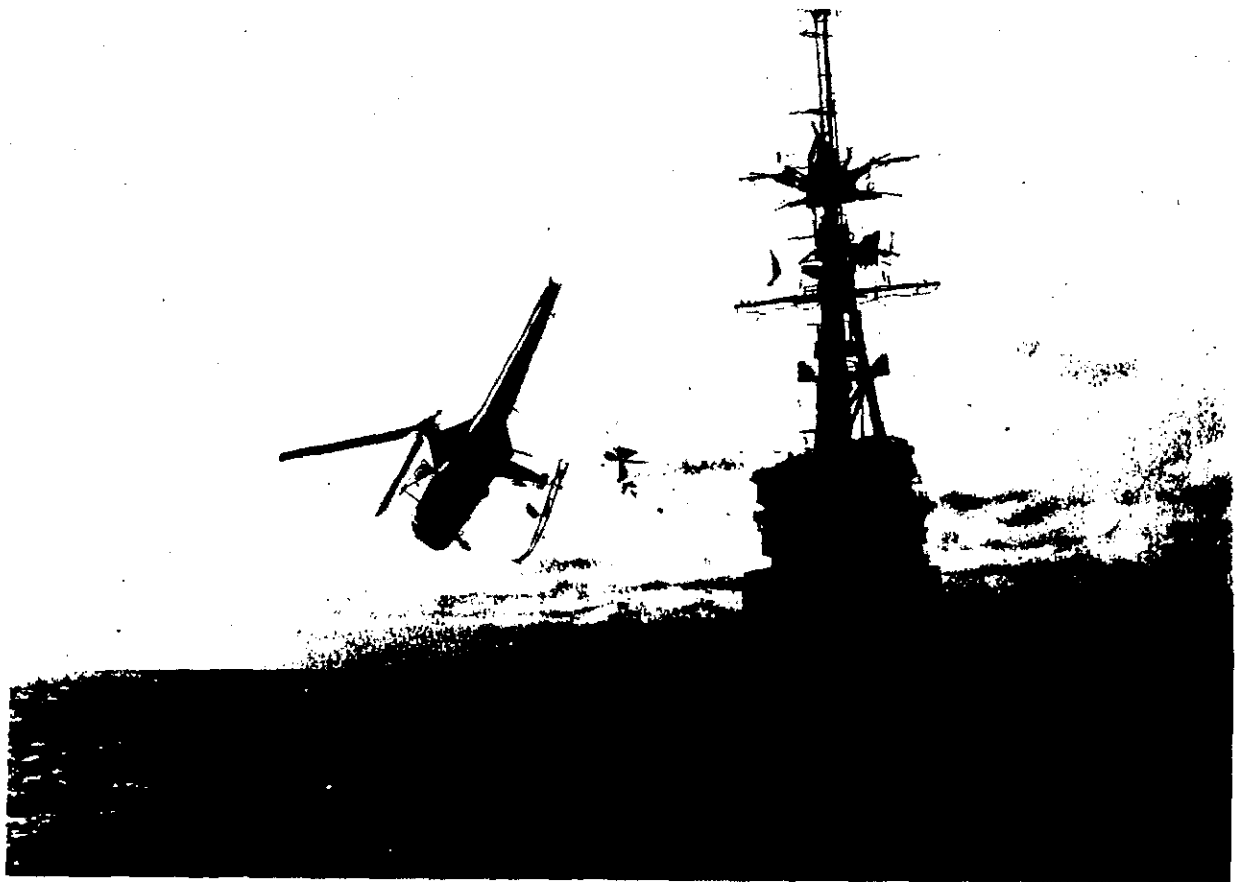
FIG 1 DISASTER AFTER A SNATCH TAKE OFF ABOARD
HMS GLORY OFF KOREAN COAST IN 1952. THE PILOT
OF THE DRAGONFLY WAS UNFORTUNATELY KILLED
