AAIB Bulletin

6/2016

Bombardier DHC-8-402	G-FLBC	16-Dec-14	3
----------------------	--------	-----------	---

Aircraft Type and Registration:	Bombardier DHC-8-402, G-FLBC
No & Type of Engines:	2 Pratt & Whitney Canada PW150A turboprop engines
Year of Manufacture:	2009
Date & Time (UTC):	16 December 2014 at 1832 hrs
Location:	En route Glasgow to Belfast
Type of Flight:	Commercial Air Transport
Persons on Board:	Crew - 4 Passengers - 76
Injuries:	Crew - None Passengers - 1 (Minor)
Nature of Damage:	Damage to left engine and engine nacelle
Commander's Licence:	Airline Transport Pilot's Licence
Commander's Age:	36 years
Commander's Flying Experience:	7,847 hours (of which 6,820 were on type) Last 90 days - 185 hours Last 28 days - 59 hours
Information Source:	AAIB Field Investigation

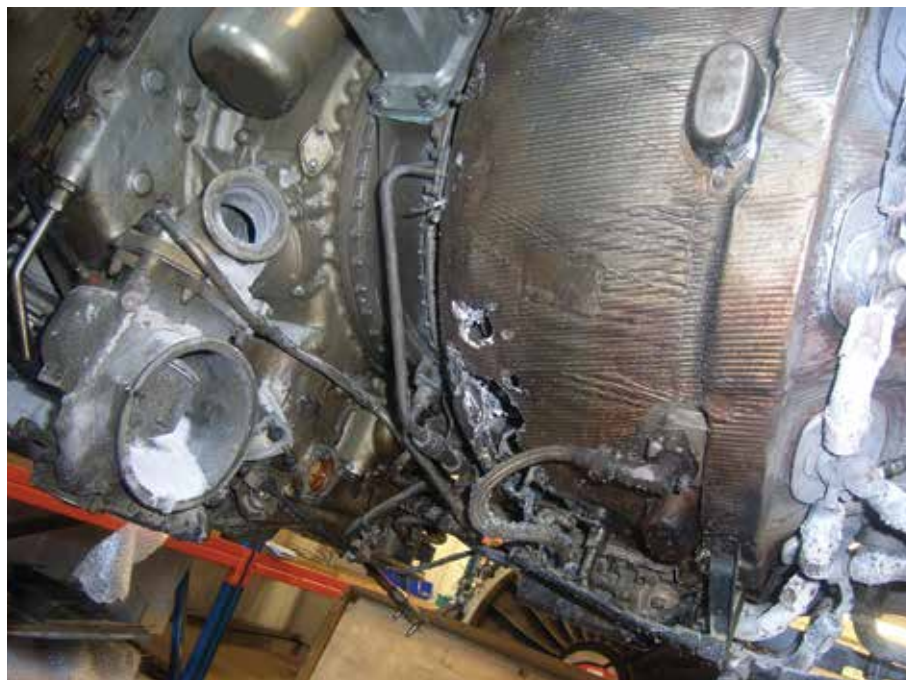
Figure 5

The engine was transported to the operator's engineering base for examination. The complete nacelle structure and the cowlings, from the firewall forward, were similarly transported to enable detailed examination to take place. Once the engine was suspended, without the intake system decking in position, it was possible to see the damage to the combustor area more clearly and large holes in the insulating cover could be observed close to the 6 o'clock position (see Figure 5).

Substantial burn damage and disruption was evident to pipes, cables and other services external to the engine casing at a number of locations. In particular, a hole was evident in a fuel pipe adjacent to the large hole in the combustor. The pipe in this area was coated in metal splatter.

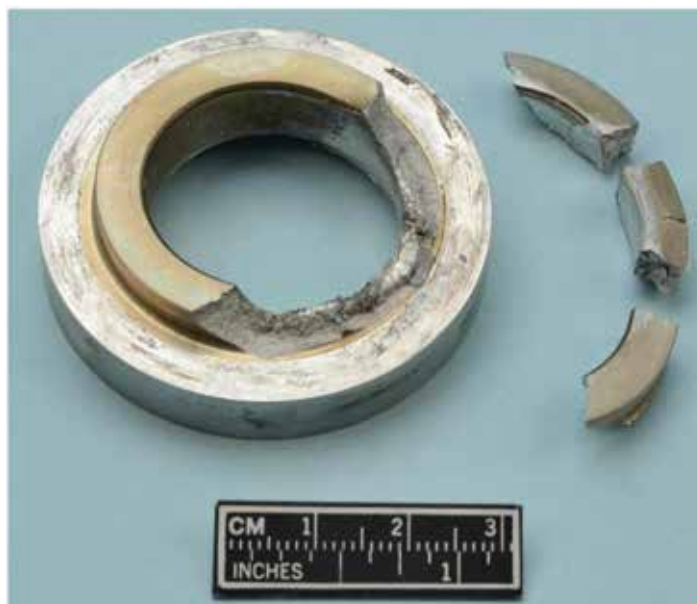
Figure 6

The oil pressure/scavenge pump unit was subjected to X-ray computed tomography (CT) scanning, before being forwarded to its manufacturer for examination. That examination revealed that a lateral breakout failure of the upper bearing of the driven stack (see Figure 6) had allowed its axis to be displaced, permitting disengagement of the gears.

This had resulted in loss of drive to all the scavenge pumps, except for No 2/2.5, 5 and 7, and that for the accessory gearbox. Dismantling revealed that numerous vanes were jammed in their slots in the rotors and evidence of significant overheating was present.

Failed upper bearing
No 3/4 scavenge pump

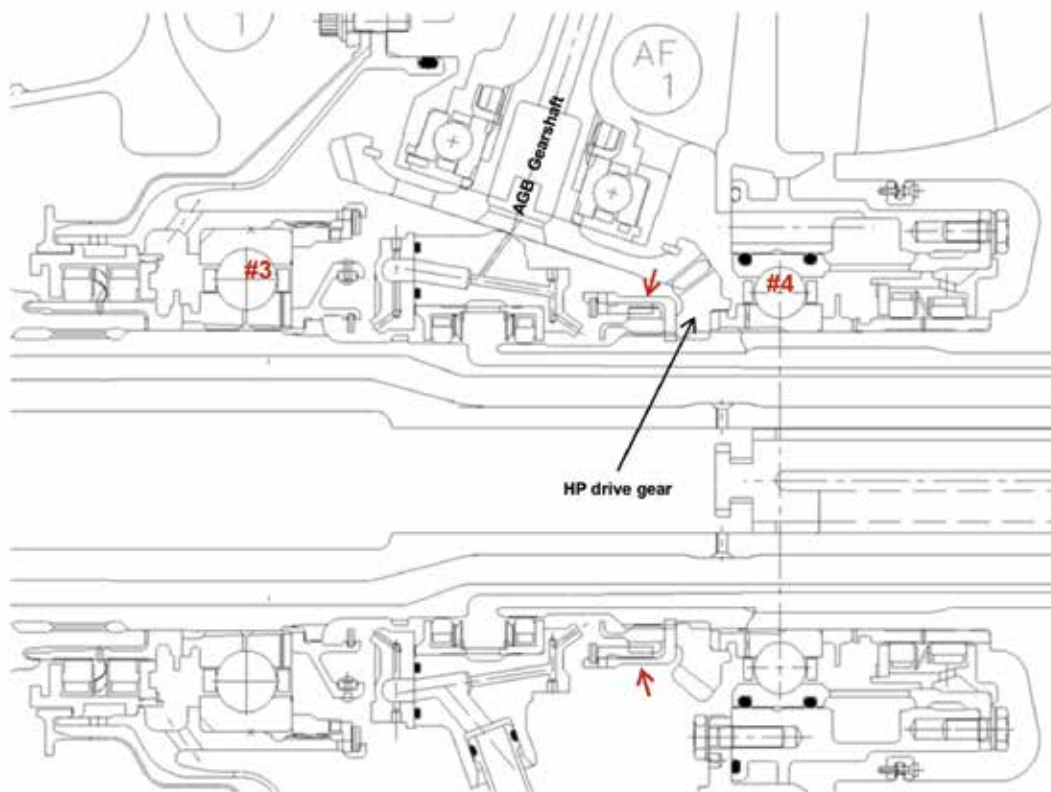
Figure 7

The close similarities between features of the above two engines led to a laboratory examination of the key washer salvaged during dismantling of the G-FLBC engine. It was confirmed that fatigue cracking had been present in the component (situated immediately forward of the No 4 bearing - see Figure 7). Consequently, overload failure had ultimately occurred, releasing part of the washer. The released fragment then appeared to have travelled through the gallery to the 3/4 cavity scavenge pump. Such an eventuality would normally result in seizure of the pump assembly and failure of the shear neck on the driveshaft. On this occasion, however, (in G-FLBC) it appeared that the action of lubricant within the pump assembly coupled with the geometry and orientation of the fragment did not create sufficient torque reaction to fail the shaft. Nonetheless, it created sufficient side load on the uppermost 3/4 cavity vaned scavenge pump to fail the top bearing in the driven scavenge pump stack.

Red arrows show position of failed key washer
(between bearings #3 and #4)

It was confirmed that fatigue cracking had been present in the engine's No 4 bearing key washer (situated immediately forward of the No 4 bearing). Consequently, overload failure ultimately occurred, releasing part of the washer. The released fragment then appeared to travel through the gallery to the No 3/4 bearing cavity scavenge pump in the oil pump assembly. It appeared that the action of lubricant within the pump, coupled with the geometry and orientation of the fragment, created sufficient side load on the uppermost 3/4 cavity scavenge pump to fail the top bearing in the driven scavenge pump stack. On this occasion, the particle did not create sufficient torque reaction to cause a failure of the shear neck on the oil pump's input driveshaft.

In December 2015, the engine manufacturer issued an Alert Service Bulletin requiring specialist internal inspection of engines to be carried out, in a time span dictated by the service life of the relevant key washer. In addition to this on-wing inspection, a revision to the engine manual has been made requiring replacement of the key washer upon access, and a Service Bulletin has been issued requiring replacement on engine shop visits, for any reason. A new, improved key washer has also been introduced.

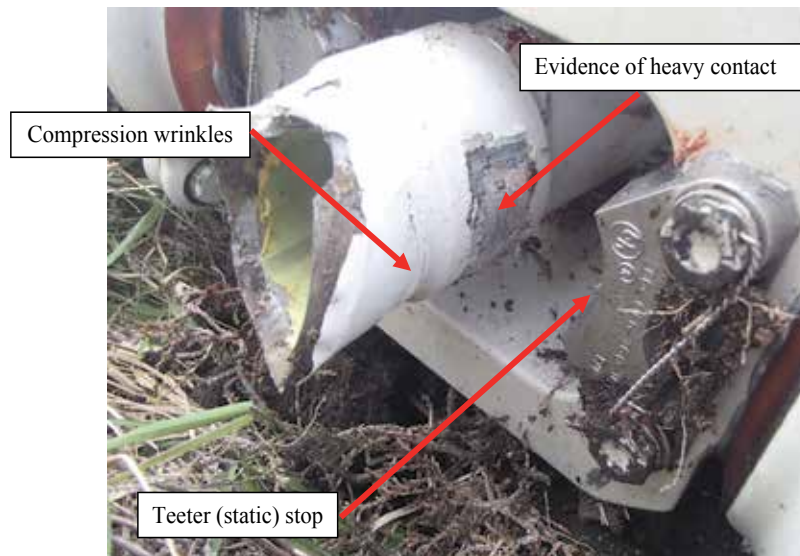
Figure 3

Examination of the main rotors and rotor head revealed that the rotor mast had failed approximately 3 inches below the rotor head lower surface. It was evident that the mast had failed as a result of bending overload after coming into violent contact with one of the teeter, or static stops; see Figure 3. A deep cut in the ground close to where the rotors

View of fractured mast, showing evidence of contact between mast and teeter ('static') stop

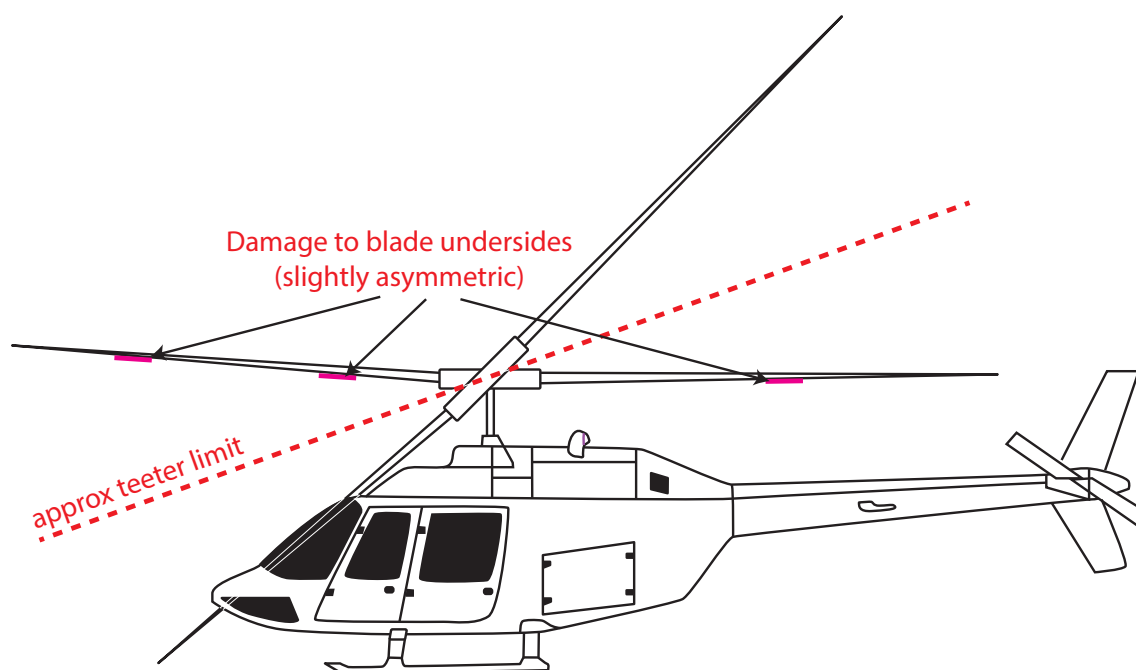
Figure 4

As already noted, there were areas of scuffing and paint transfer on the underside of both blades. These areas started approximately 90 and 104 inches from the centre of the hub and were not symmetrical. The paint marks were consistent with the blades having struck the right side of the nose of the helicopter, this conclusion being supported by the observed damage to the structure and that fragments from the nose were recovered from the furthest downwind part of the debris trail. Additional confirmation was provided by the VOR instrument, which had been located in the upper right area of the instrument binnacle but was found some distance from the main wreckage as a result of being struck by a blade, leaving a characteristic indentation in the casing. One blade exhibited a scuffed region that began a relatively short distance, 42 inches, from the hub centre, the result of the blade underside coming into contact with the front of the glassfibre fairing on the cabin roof. The combined information enabled a precise assessment of where the rotor blades had struck the airframe, illustrated in Figure 4.

Showing blade strike location on fuselage

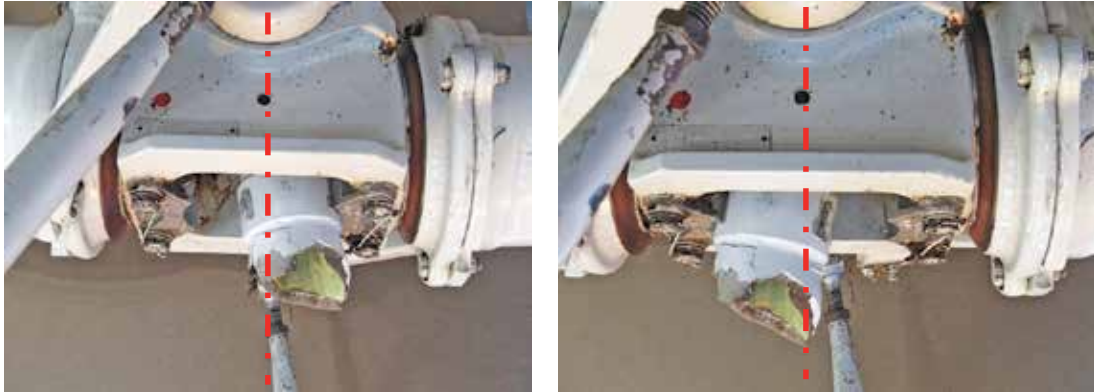
The hub assembly had remained intact although it was clear that the static (teeter) stops had come into heavy contact with the mast, such that they applied severe, reverse bending loads in the spanwise plane of the blades. Figure 5 shows the relative angular motion that occurred between the mast and hub.

View of hub showing angular movement between hub and mast, resulting in heavy mast contact with teeter stops

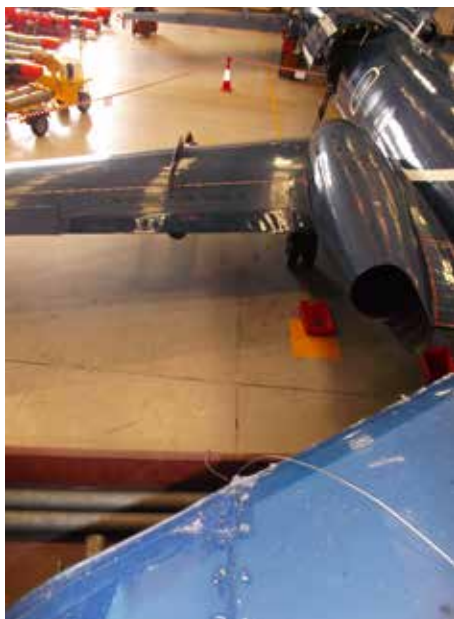
Figure 3

Image showing damage to the tailplane leading edge

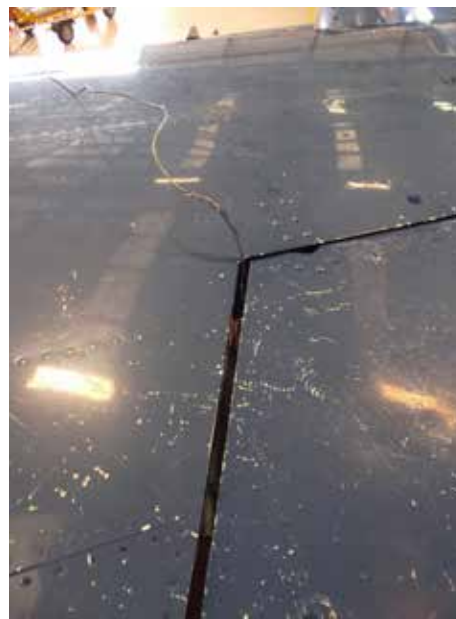
Figure 4

After the flight the TTO discovered that one end of the 10 m length of cable was lodged between the elevator and the horizontal tailplane, and that there was a loop in the cable that had snagged on the winch (Figures 1 to 4). The cable was removed from the gap between the elevator and the horizontal tailplane; this was a simple task and there was no evidence to suggest that the elevator had not been operating effectively during the incident.

Image showing cable lodged in the gap between the horizontal tailplane and the elevator

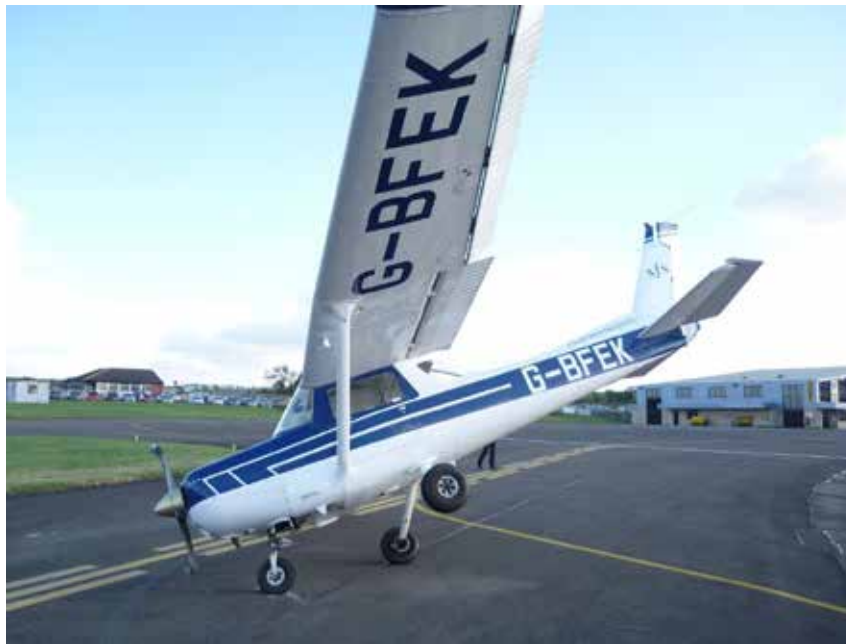
G-BFEK came to rest on the right wheel, wingtip and propeller spinner, following which the pilot transmitted a PAN call informing the tower of his situation. He then shut down the fuel and electrics and, because of the attitude of the aircraft, vacated via the passenger door. Figure 2 shows the aircraft after it had come to rest.

The pilot was in no doubt that his aircraft had been blown over by wake turbulence from a helicopter that had passed behind him. He estimated that the distance between his aircraft and the helicopter was around 20 m.
