Near miss at Maesyfelin bridge, near Pontyclun, 8 April 2016

2. Summary of the accident

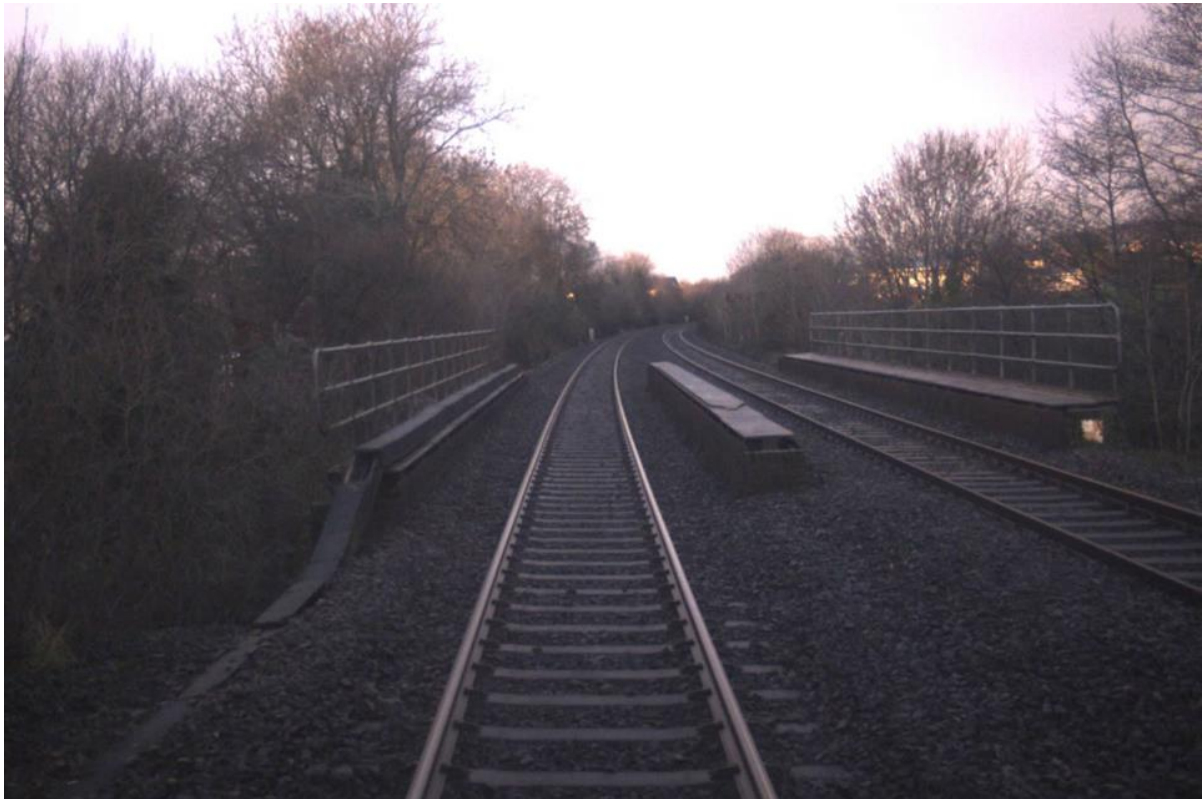
Library image of Maesyfelin bridge (courtesy Network Rail)

Although both of the proposed SSOW for the inspections had been planned, approved and verified, a preliminary investigation undertaken by the rail industry found that there was inadequate space between the bridge parapet and the nearest running rail for a person to stand in while maintaining the required 1.25 metres clearance needed to implement a red zone with warning given by lookout SSOW. The investigation also concluded that there was not enough space in the cess on the immediate approach to the bridge to implement a separated green zone SSOW.

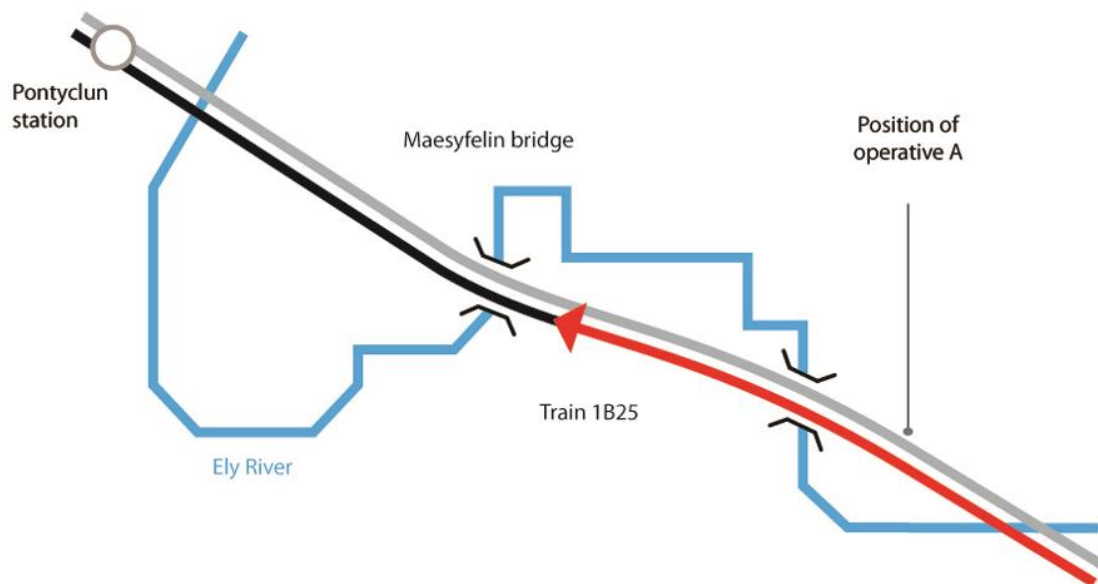
Simplified map showing route of the train and position of operative A (not to scale)

On the morning of 8 April 2016, the work group initially went to sidings where the COSS briefed the workgroup on the SSOW and the group completed a RT9909 'Record of arrangements and briefing' form to confirm that this had been done. The work group then drove to several different locations to undertake inspections before arriving at the Miskin scout hut access point, where they inspected two bridges. After these inspections were completed, the COSS asked one of the probationary lookouts in the group, operative A, to remain at the access point while the COSS and the remainder of the group drove up to the nearby Pontyclun station and walked down from there to Maesyfelin bridge. The COSS briefed operative A on the direction of traffic and line speeds and asked him to provide a warning of any approaching trains using a hand-held back-to-back radio.

The work group reached the bridge where the COSS undertook an inspection on the Pontyclun side. He then decided that he needed to make a further inspection on the Cardiff side of the bridge and used his radio to contact operative A to confirm that the line was clear of approaching trains. Operative A confirmed that no trains were approaching and, after a delay of about 30 seconds, the work group started to walk over the bridge using the down main. However, as they crossed the bridge, the work group felt the track vibrate and the COSS saw a train coming towards them. The COSS shouted a warning to the group and he then ran back off the bridge with another member of the group. The three remaining members of the group had to jump onto the bridge parapet to avoid being struck by the train.
