Rail Accident Report

**Derailment at Birmingham Snow Hill,
Midland Metro
29 January 2007**

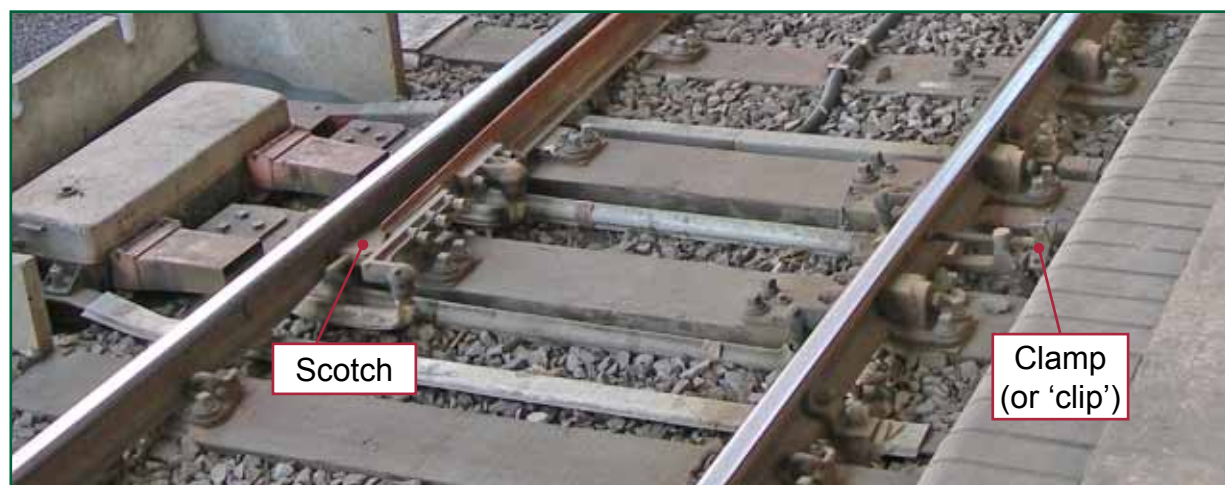
- 17 In summer 2006, Carillion informed TMM that the left hand switch rail of the Birmingham Snow Hill S&C had failed its sidewear inspection; it was then *clipped and scotched* to take the diverging track, and thus Birmingham Snow Hill platform four, out of use. Soon afterwards, a TMM manager decided to reinstate the S&C without rectification, increased inspection or any other measure put in place to take account of its condition.
- 18 On 21 December 2006 a Carillion track worker again found that the left hand switch rail failed its sidewear inspection, clipped and scotched it out of use and advised Midland Metro in writing of this course of action. See Figure 6.

Figure 6: The S&C clipped and scotched out of use

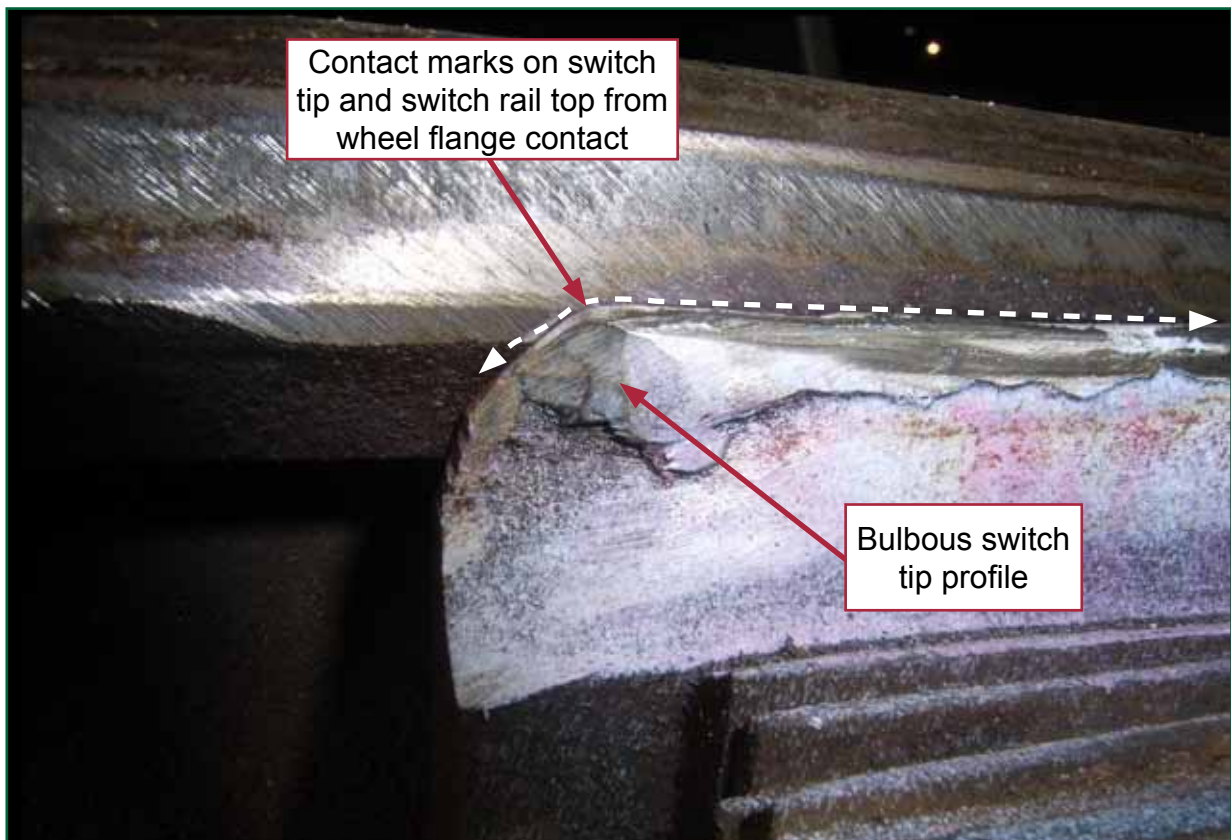
- 29 As tram 06 traversed the S&C, the centre bogie's leading left hand wheel struck and climbed the left hand switch tip and ran along the switch rail. Figures 7 and 8 show wheel flange contact marks on the switch tip and switch rail top respectively.
- 30 The wheel flange travelled 2.6 metres along the switch rail top then dropped into the widening gap between switch and stock rails. The centre bogie trailing wheel derailed in the same manner, resulting in the derailment of all wheels. See Figure 9.

Figure 7: Left hand switch tip

- 31 The immediate cause of the derailment was the interaction between the wheel and the switch tip, causing the wheel to climb onto the top of the switch rail.

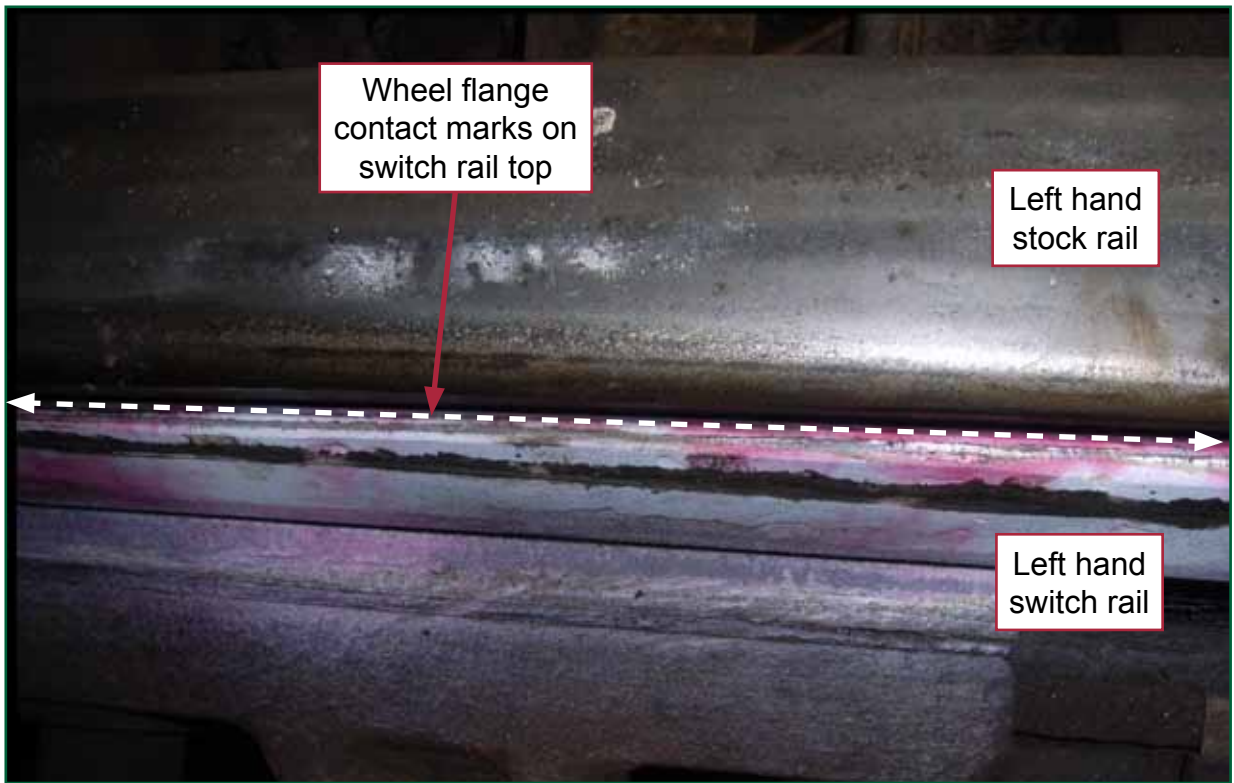
Figure 8: Left hand switch rail

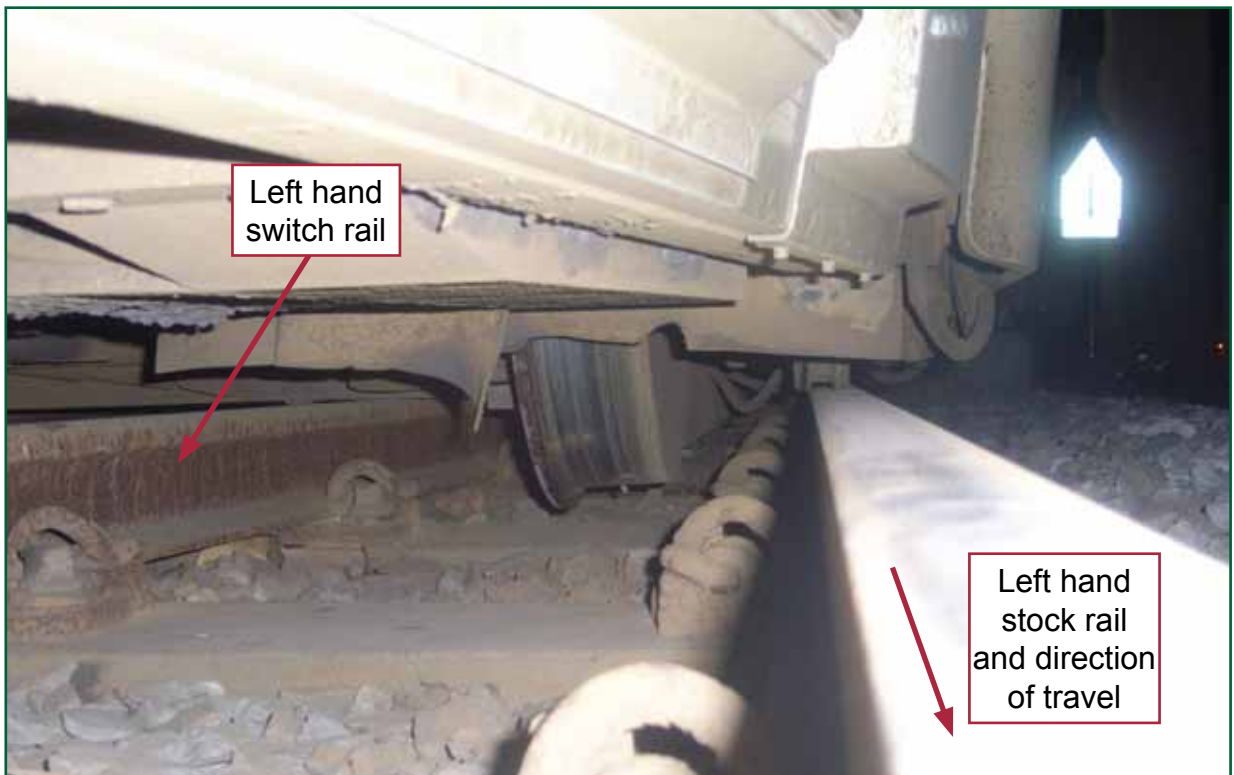
Figure 9: Articulation unit centre bogie derailed all wheels

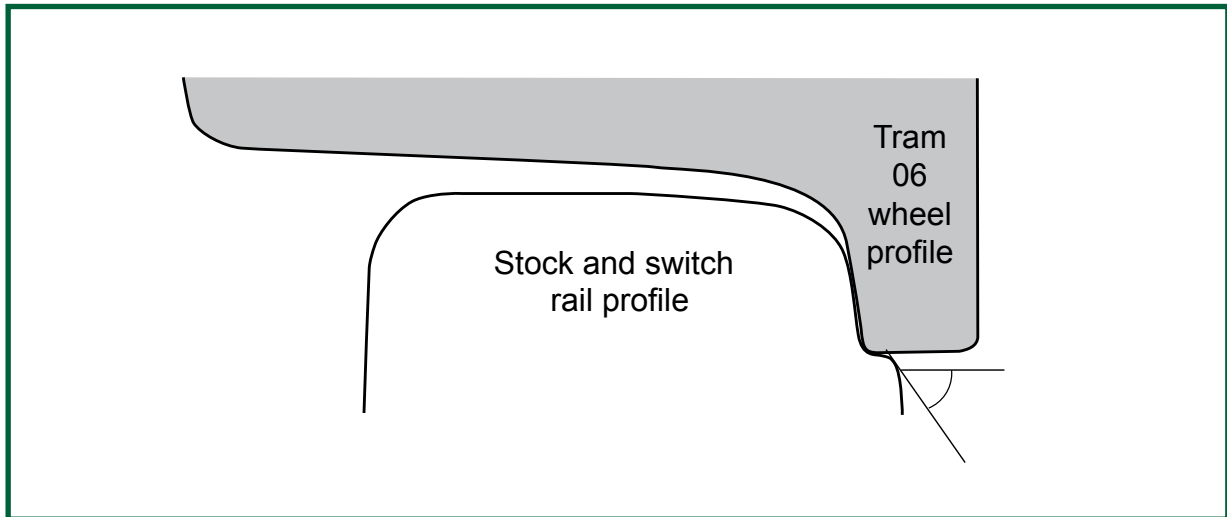
38 The repaired switch tip had a rounded and bulbous profile, was not chamfered to a 'knife edge' and did not undercut the stock rail. It was a derailment hazard as its profile was flatter than that of the stock rail and had an angle of less than 60° where indicated. See Figures 7 and 11. Contact marks from the passage of a number of wheels from trams 02, 12 and 06 can be seen in the *dye penetrant testing* material left from the welding repair. See Figure 12.

Figure 11: As repaired switch tip and tram 06 centre bogie leading left hand wheel

40 A causal factor was that the left hand switch rail had not been restored to its as-designed geometry following weld repair.

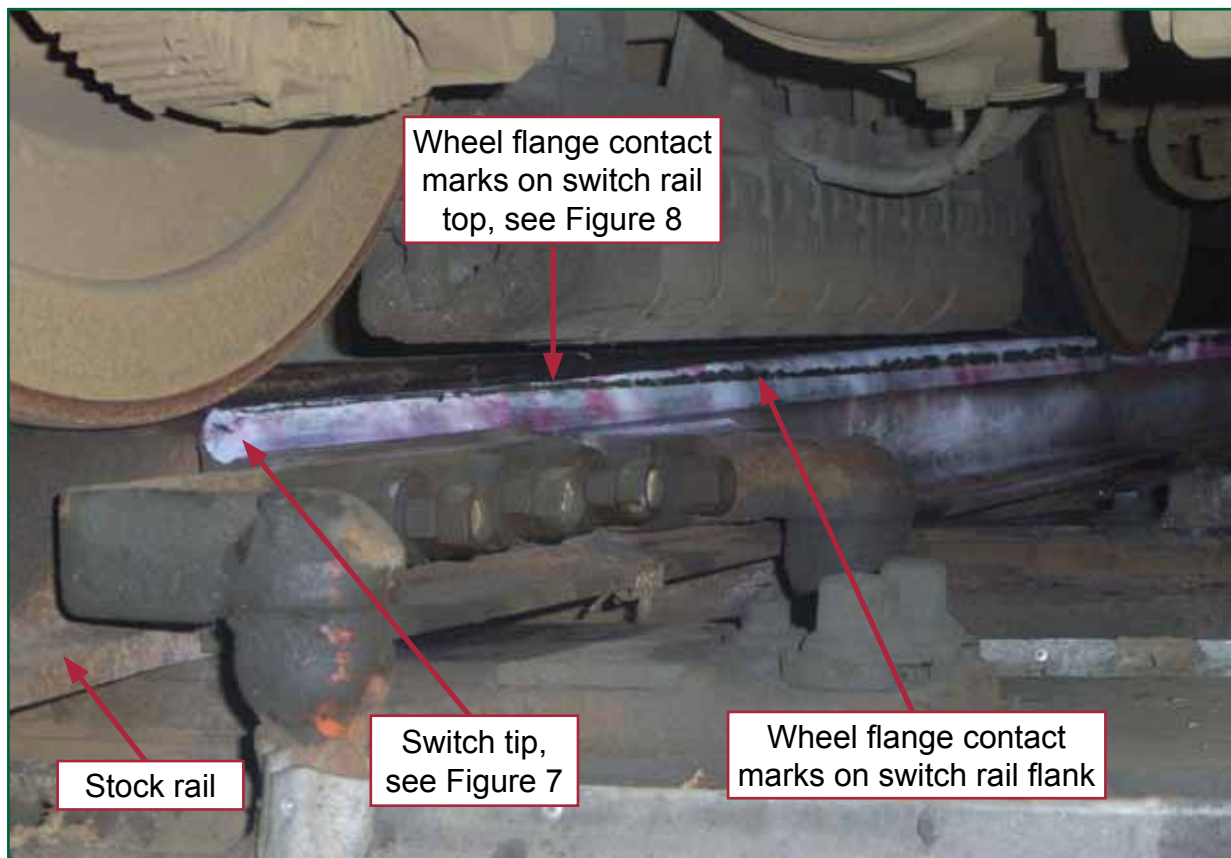
Figure 12: Wheel contact marks in residual dye penetrant material

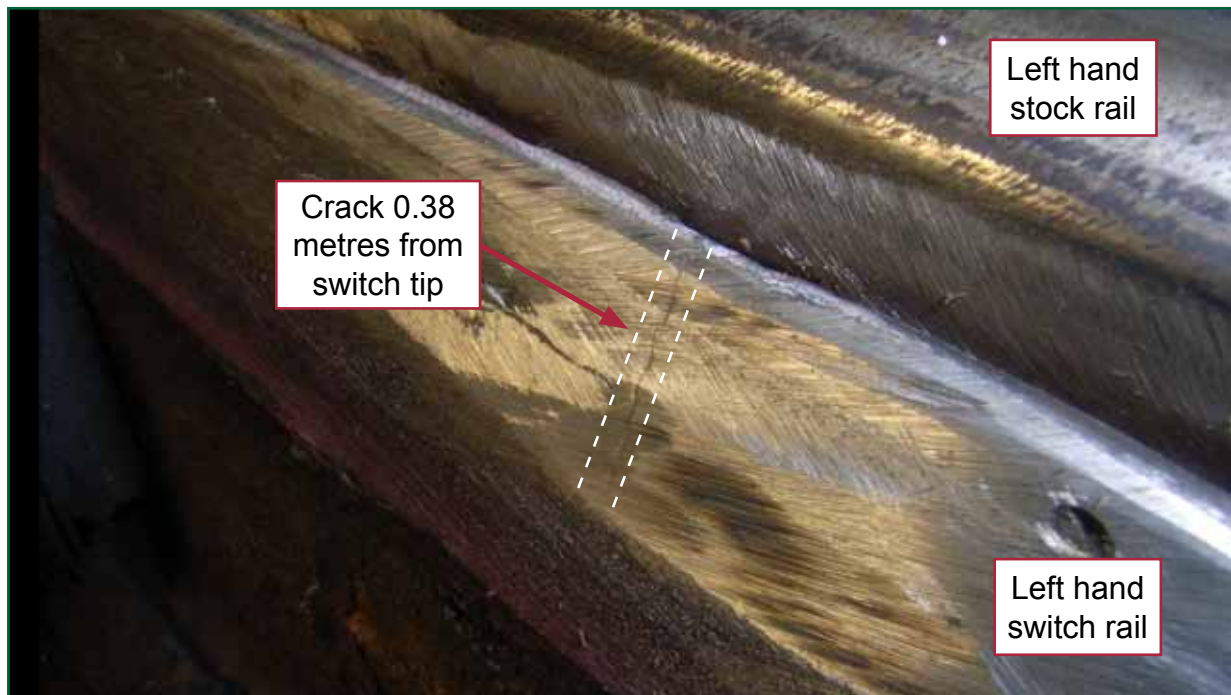
39 Impact forces from a number of wheels from trams 02, 12 and 06 were sufficient to crack the switch rail 0.38 metres from the switch tip. The crack was not present before or during the weld repair as it contains no dye. See Figure 13.

Figure 13: Left hand switch rail fracture
