Rail Accident Investigation Branch

Rail Accident Report

Collision between a train and a tractor at Oakwood Farm User Worked Crossing, Knaresborough 14 May 2015

Report 07/2016
April 2016

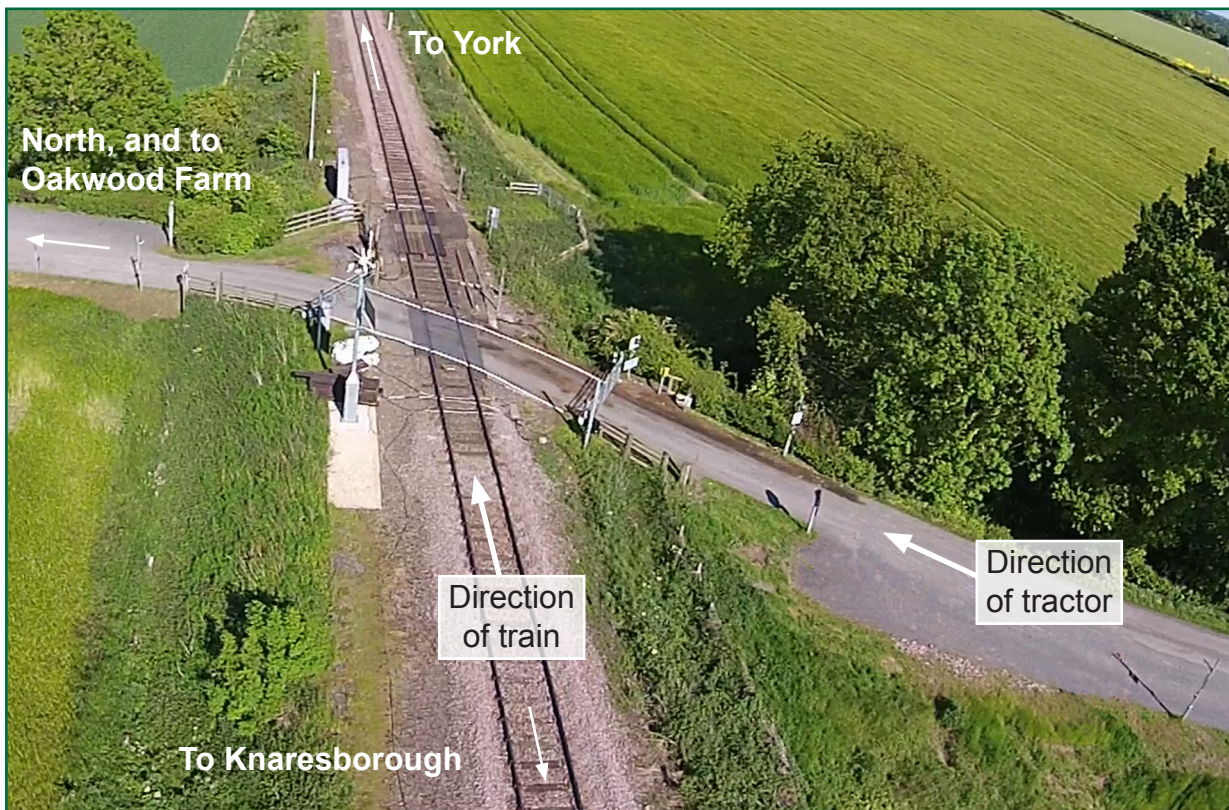
Figure 2: Oakwood Farm UWC

- 15 Oakwood Farm crossing is a user worked crossing on a private road. It consists of two crossings, ten metres apart (figure 2). Immediately to the east of the crossing on which this accident occurred, is another user worked crossing giving access from the private road on the north side of the railway to the fields on its south side. This crossing played no part in the accident, and this report is only concerned with the western crossing which allows users to travel along the private road between the A59 and Oakwood Farm.

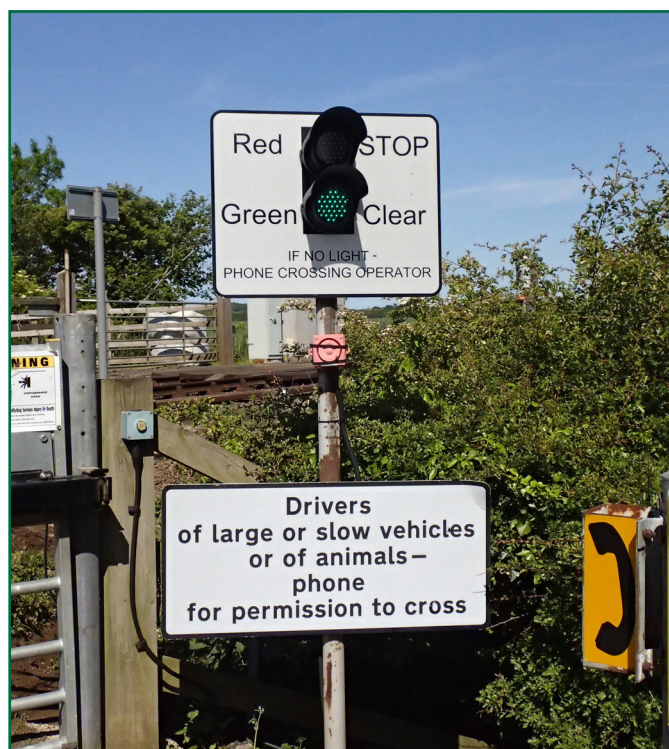
Figure 3: The MSL on the approach to the crossing

- 16 The private road crosses the railway at an angle of approximately 35 degrees. The crossing is fitted with miniature stop lights (MSLs) situated on each side of the crossing. Each MSL fixture consists of a red and a green *LED* light fitted to a post-mounted backboard (figure 3). The green light illuminates when it is safe to cross the railway. When a train approaches the crossing, the green light extinguishes and the red light illuminates, warning users not to cross.

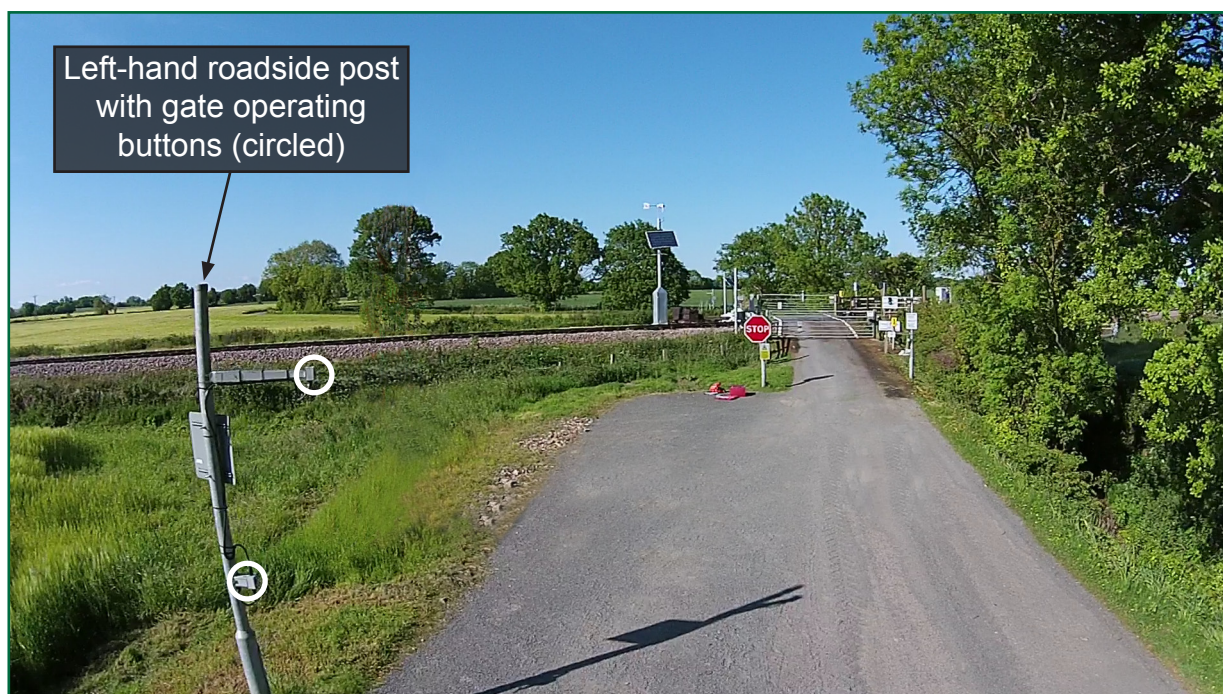
Figure 4: The approach to the crossing towards Oakwood Farm showing the left-hand roadside post

- 25 Shortly after 18:15 hrs the tractor arrived at the crossing. The driver stopped the tractor on the left-hand side of the road beside a post on which were two buttons to operate the gates (figure 4). He opened the left-hand side tractor door, stood on the step of the tractor and pushed the higher of the two buttons. He then re-entered the cab, closed the door and drove slowly towards the crossing as the gates were opening.

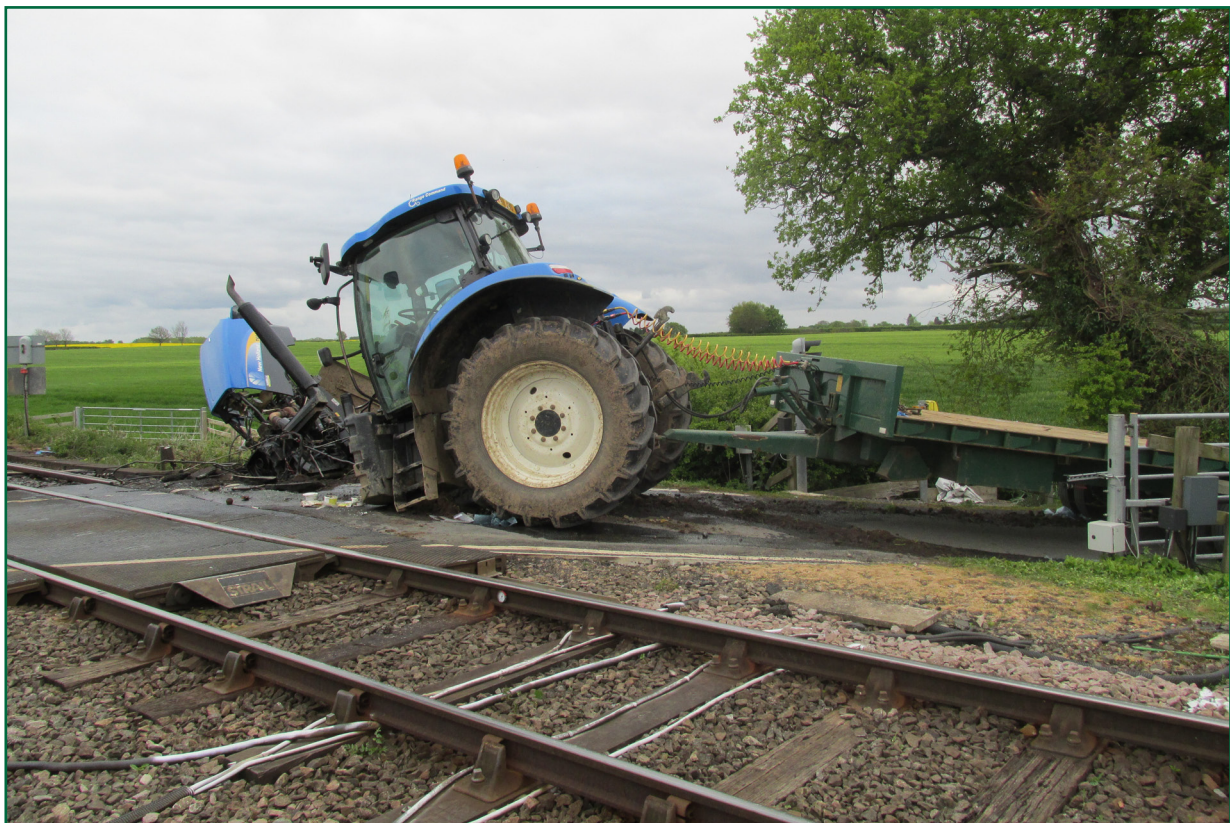
- 29 The train's speed was not reduced in the short period between the emergency brake application (paragraph 27) and train's arrival at the crossing and it collided with the front of the tractor at around 18:18 hrs, still travelling at 65 mph (105 km/h) on impact. The right-hand side front corner of the train collided with the front left-hand wheel of the tractor. The impact caused the portion in front of the cab to become separated from the rear portion (figure 5).

Figure 5: The damaged tractor following the accident (image courtesy of British Transport Police)

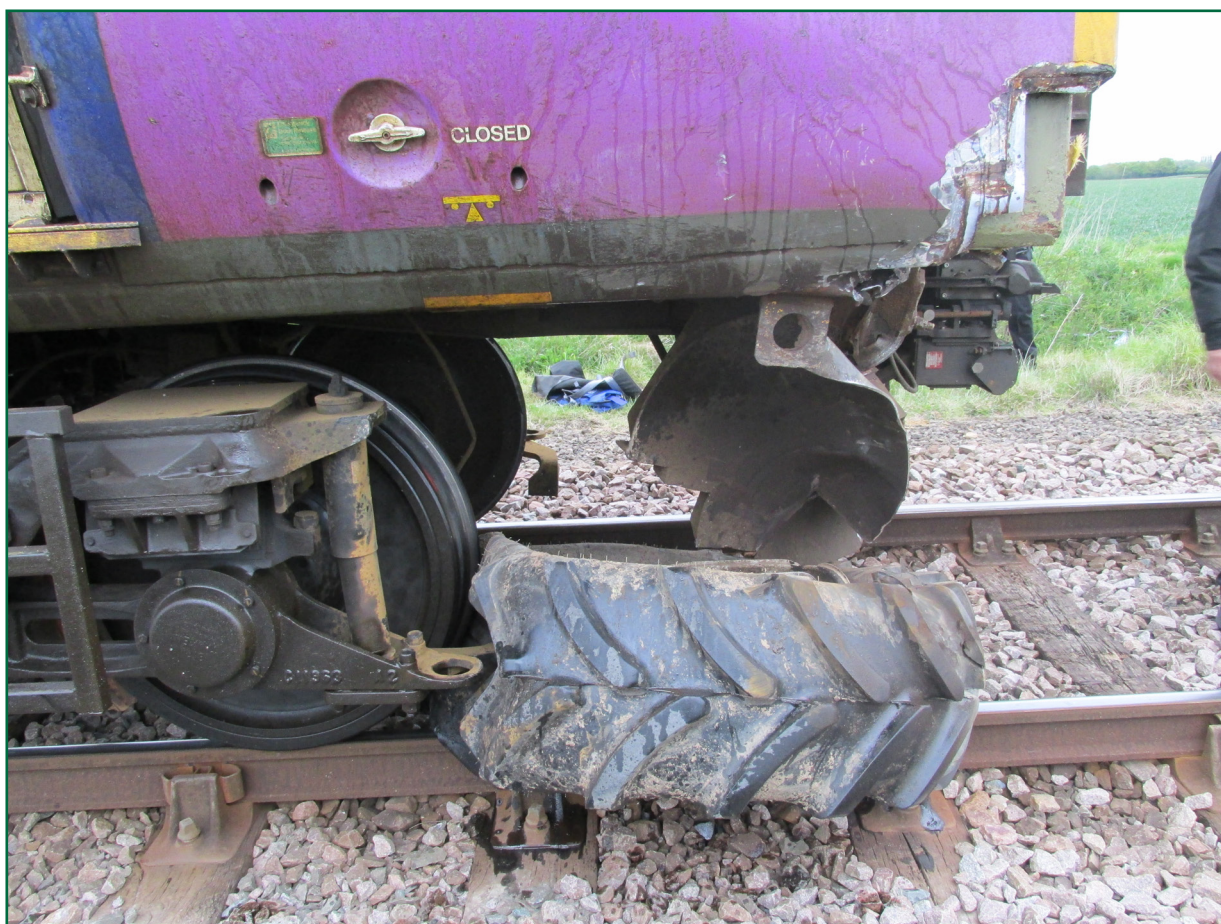
- 30 The tractor's front left-hand wheel detached and became wedged under the right-hand side of the train's *obstacle deflector*. Although the tyre was in contact with the leading right-hand train wheel, the *lifeguard* is likely to have prevented the train from derailing (figure 6).

Figure 6: The tractor's front wheel and tyre wedged under the front right-hand side of the train (image courtesy of British Transport Police)

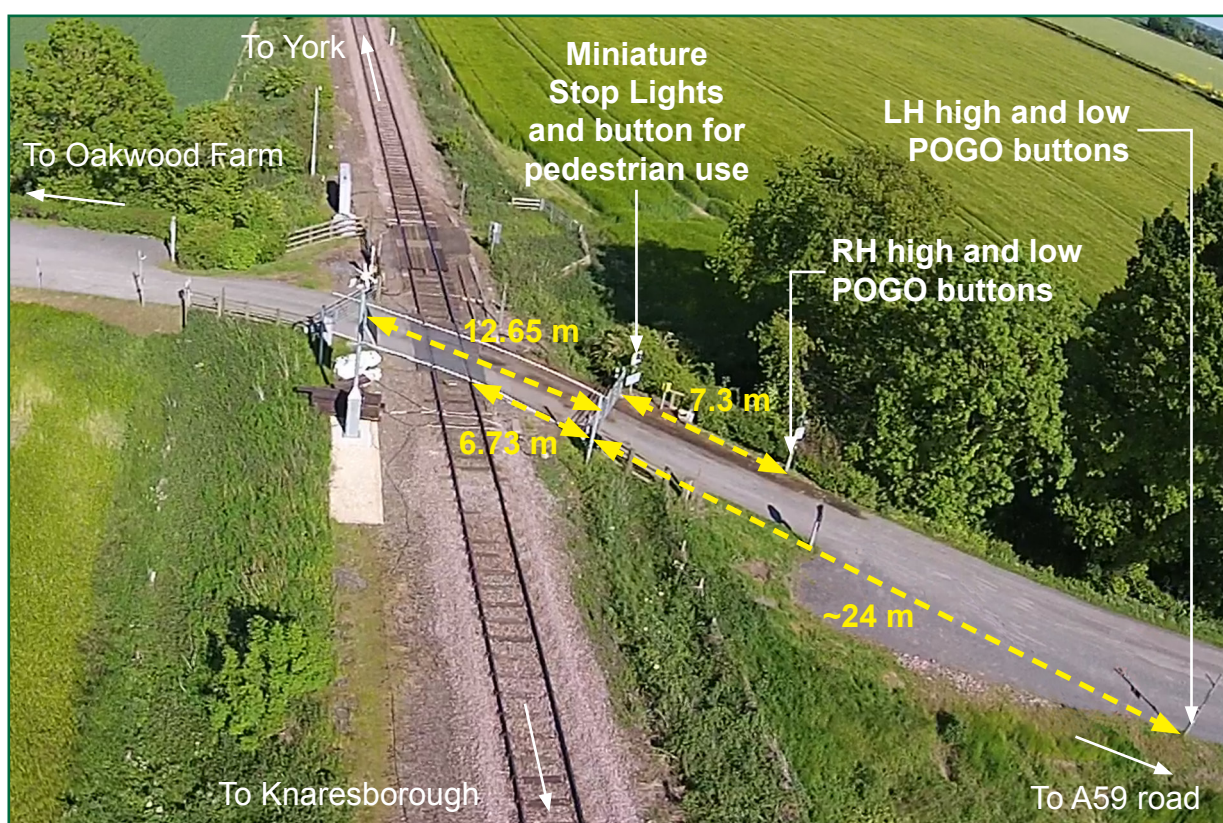
Figure 7: Location of the POGO operating buttons

- 40 On the southern approach to Oakwood Farm crossing there is one button for pedestrian use located by the latch on the gate post. Two buttons are located on a post on the right-hand side of the road approximately 7 metres from the gate (figure 7). The remaining two buttons are on a post on the left-hand side of the road, 24 metres from the gate. The purpose of these buttons is further discussed in paragraph 53. The buttons mounted on each of the road-side posts are at different heights; the lower button is for use by car and van drivers, and the upper button is for lorry and farm vehicle drivers. At the time of the accident, any of the buttons could be pressed to either open or close the gates, depending on their pre-existing position. Each single opening or closing operation takes approximately 15 seconds.

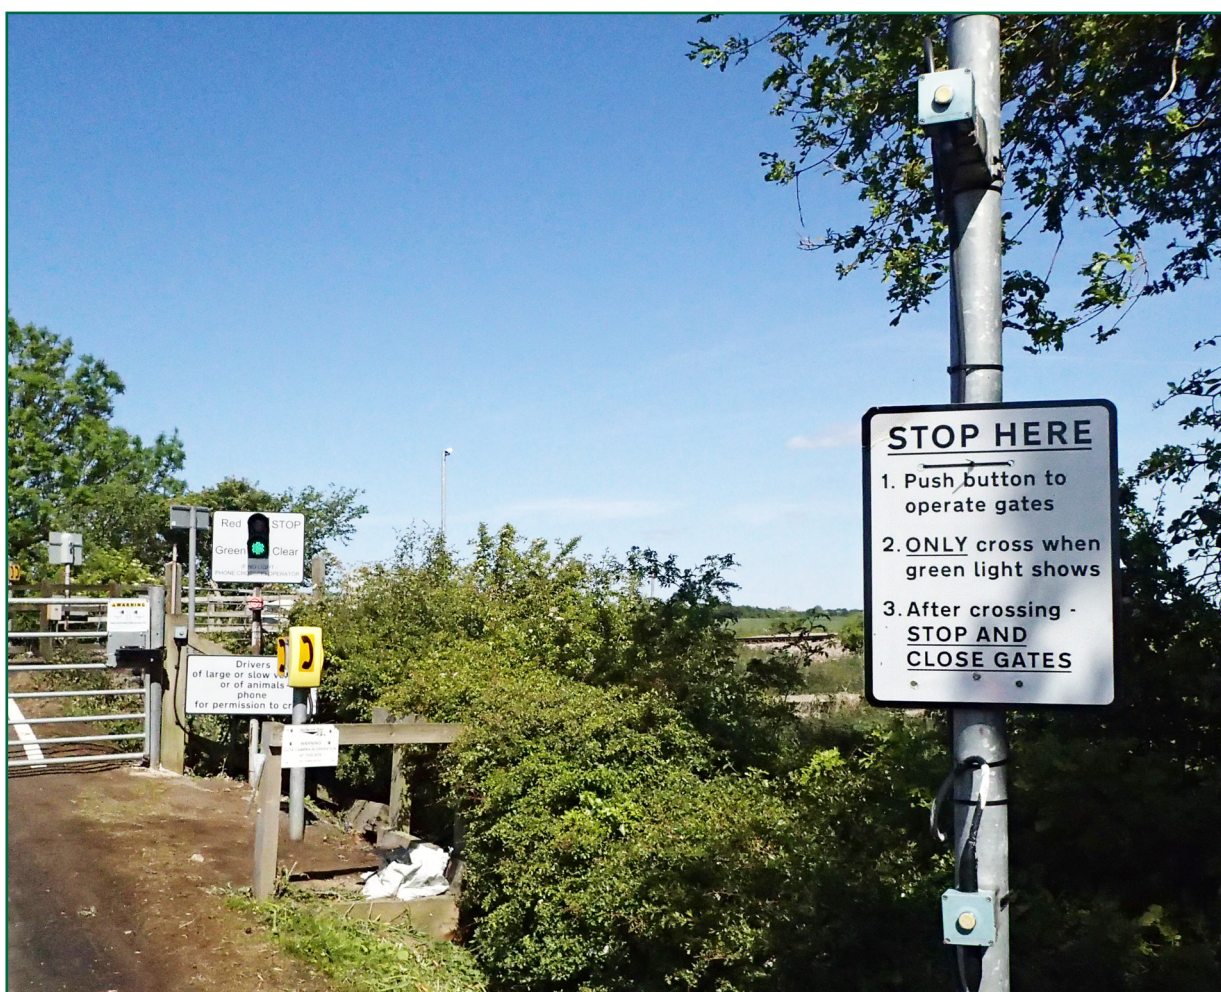
Figure 8: The instruction sign on the right-hand roadside post

- 57 There was a sign mounted on the right-hand roadside post instructing users how to use the crossing (figure 8). This sign, although not of the correct type authorised by Network Rail in September 2013 for the nationwide use of the POGO equipment, instructed users to push the button and to cross only when the green light was showing. Although there is conflicting evidence, the RAIB's view is that the tractor driver did not see these instructions because he had already used the button on the left-hand post. There was no such sign on the left-hand post as Network Rail did not consider that this button would be used to open the gates (paragraph 74). Had there been a sign at the left-hand post, it might have prompted the driver to recheck the MSL before crossing.

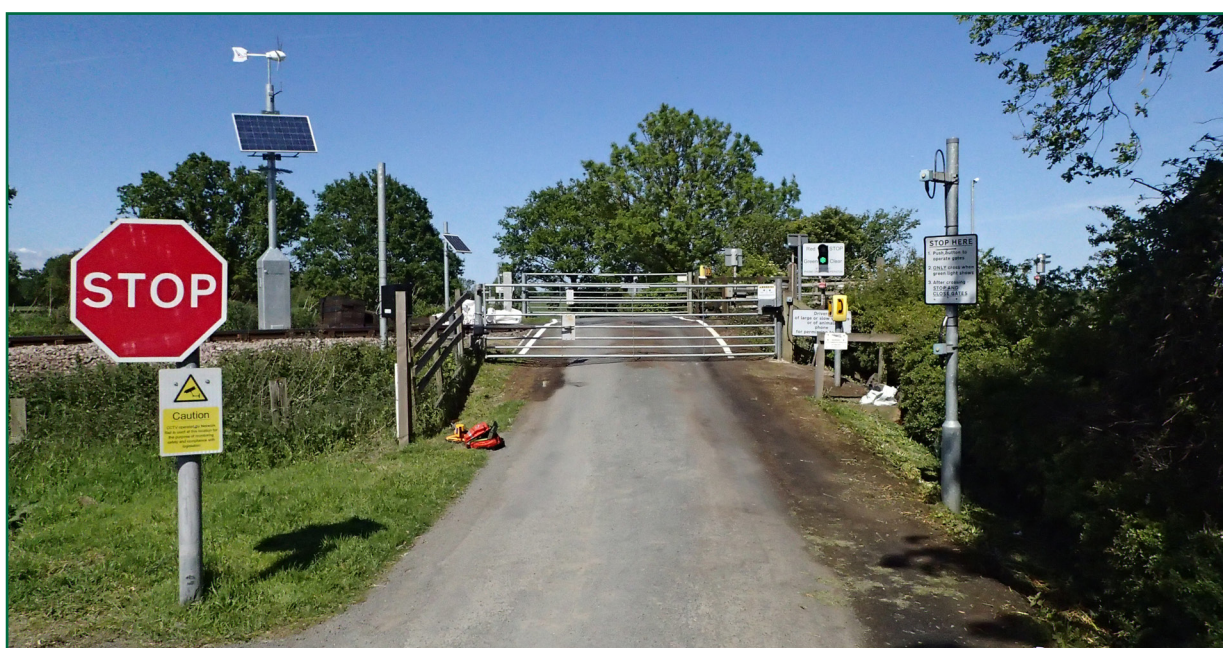
Figure 9: The signs present on the approach to the crossing

- 62 Watching the gates opening may have distracted him, causing him not to notice that the light had changed from green to red. At this time he may also have been checking that the far gate was open before crossing, that there was not a vehicle on the other side of the crossing, and have been manoeuvring his tractor to the centre of the road to pass through the gates. Additionally, the RAIB observed that there were many signs on the approach to the crossing (figure 9) which could distract an unfamiliar user from checking or rechecking the MSLs before crossing.

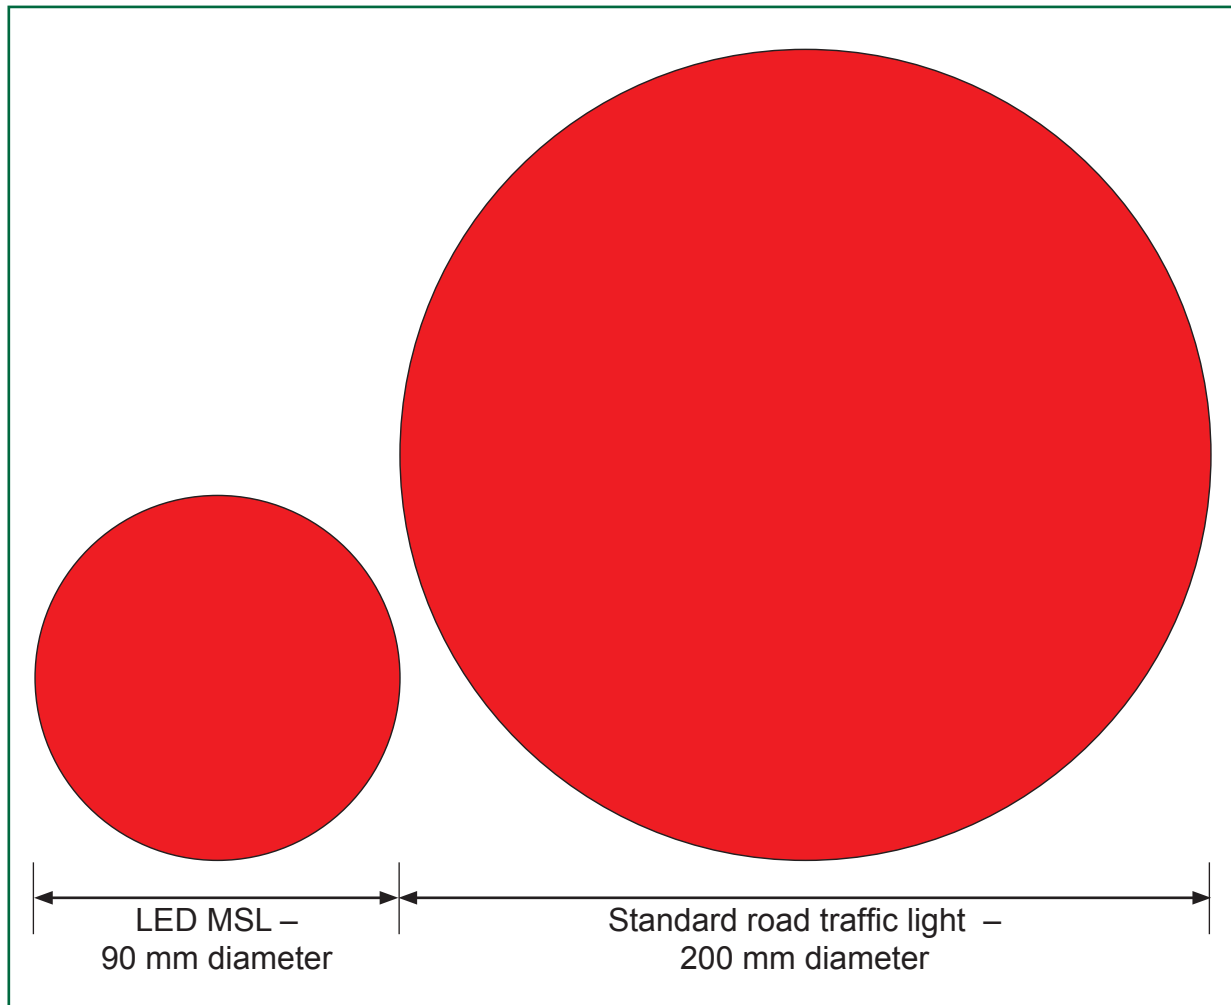
Figure 10: Relative sizes of a LED MSL and a standard road traffic light

- 64 The red light of the LED MSL is a single light, situated on the right-hand side of the road. It has a diameter of 90 mm and is small compared to a public road traffic light which has a diameter of 200 mm (figure 10). It is below the tractor driver's eye line. It is likely that it was fitted at this location and height to be visible to pedestrian users of the crossing. In addition, the lights of the MSLs are mounted on a board on which there is text (figure 3). That, combined with the many other signs present, cause the MSL's to be less conspicuous (figure 11).

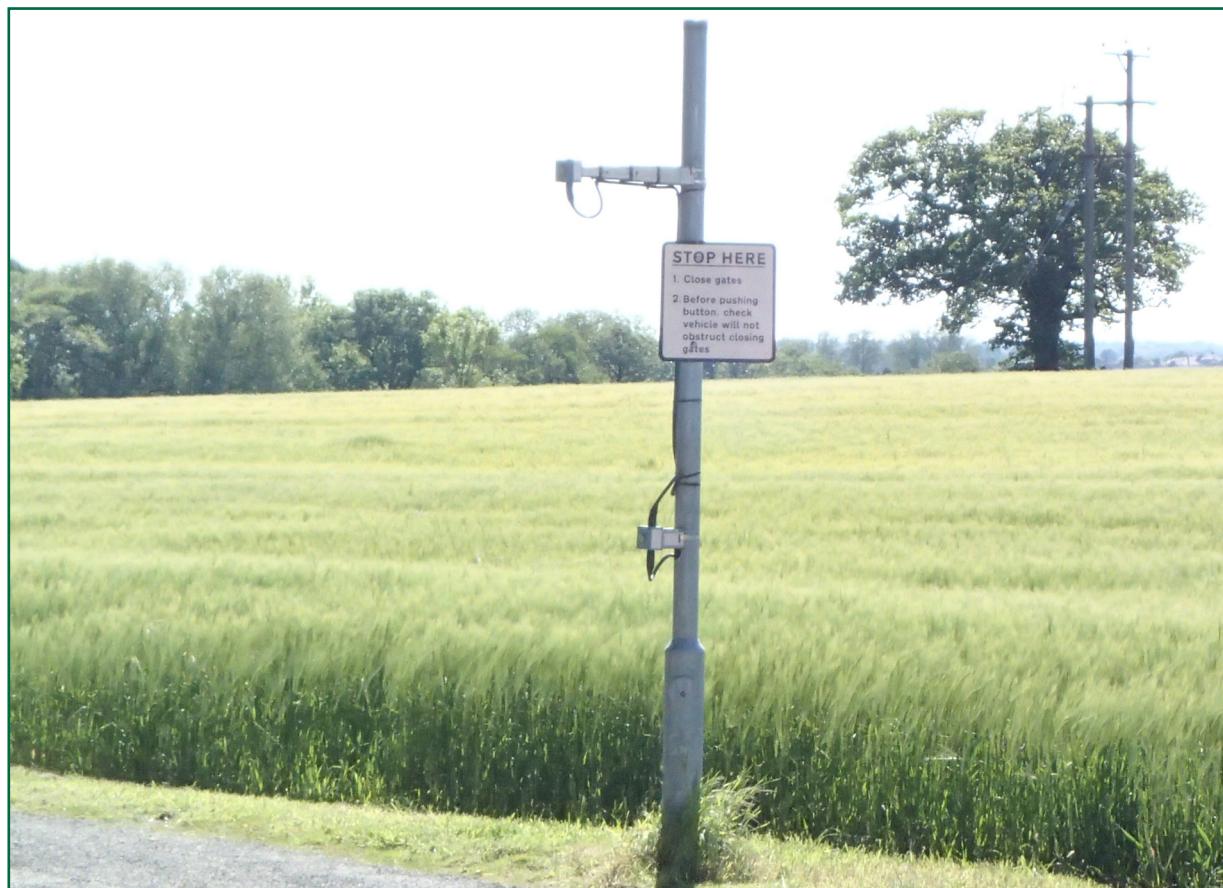
Figure 13: View looking away from the crossing towards the left-hand roadside post showing the sign instructing users to close the gates

- 75 The layout plan also shows that a sign was to be fitted to each left-hand roadside post, facing towards users leaving the crossing, instructing them to stop and close the gates. Such a sign was on the post that the tractor driver stopped at to operate the gates (figure 13), although he would not have seen it on his approach as it was facing in the opposite direction.
