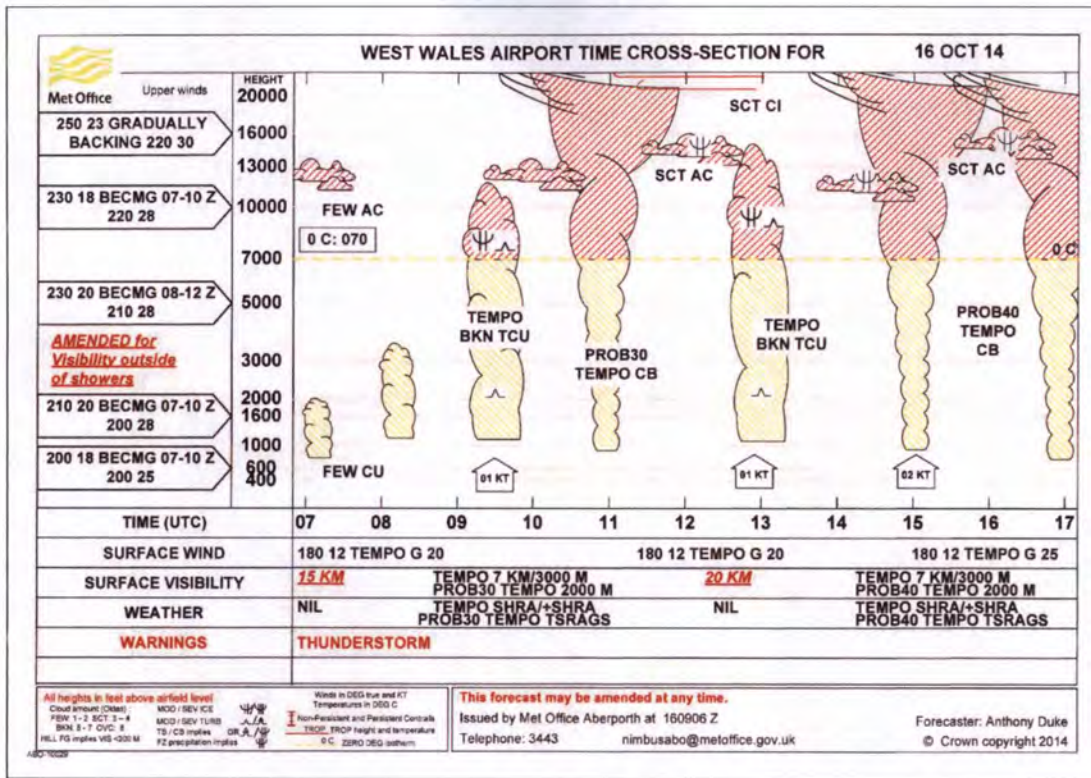
Figure 13 – West Wales Airport Weather Cross Section dated 16 Oct 15

1.4.88. **Weather Brief.** The crew of WK031 received a MET brief prior to the sortie which reflected the earlier forecast and indicated that there would be showers, cumulonimbus cloud and thunderstorms during the planned flying period. The forecast (Fig 13) stated that there would be a 30% probability that for a period of no more than 2 hours within the forecast period where thunderstorms and associated hazards of severe icing and turbulence would be present with winds of 180°/12kts temporarily gusting 20kts. The Panel considered this forecast in context of the weather limitations that the operators had to adhere to as stated in the MFTP, Thales FOB and Hot Poop.

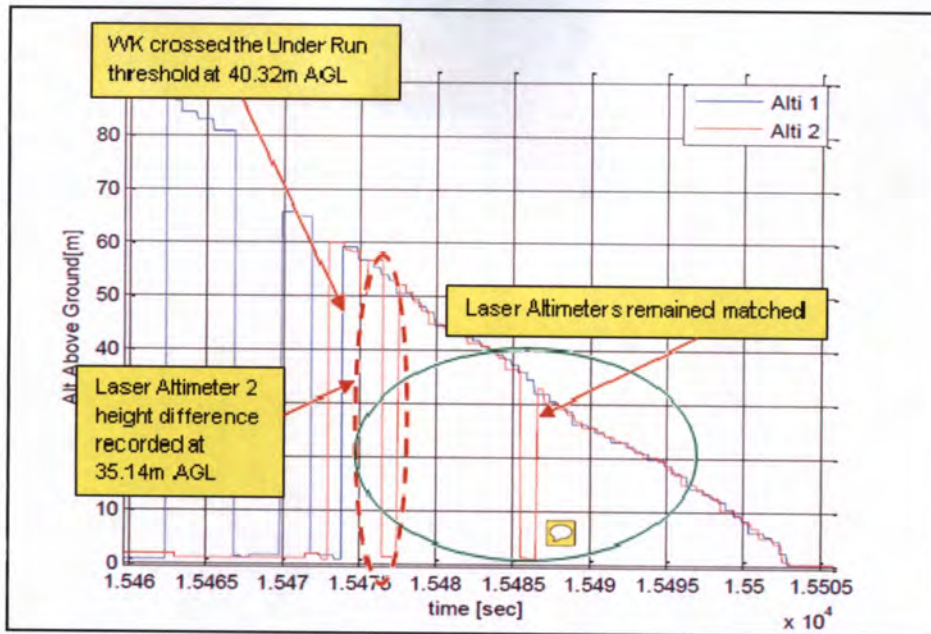
Figure 15 – Laser Altimeter Readings WK031 Accident Flight

Laser Altimeter 2 height difference

1.4.147. **Laser Unit Performance Capability.** As mentioned previously, the Noptel laser altimeters were designed to be effective up to a range of 30m, even though laser returns could be possible at greater ranges. The figure below (Fig 16) presents the results from one of the WK031 laser altimeters tested by Noptel that shows signal amplitude dropping off rapidly after 6m and continuing to tail off significantly by 30m. These results were considered typical and within the original unit specification. Therefore, if the UAV was being operated in MO with the associated disqualification window open from the UR point then the laser altimeters were more likely to suffer poor or no returns from the ground, due to the UAV being at a greater height than the specified (effective) maximum of 30m. This in turn would increase the likelihood of Altimeter Difference and subsequent disqualification as well as the opening of the 20m 'Ground Touch' window. Therefore, the Panel concluded that the disqualification window with MO selected was too high for the laser altimeters to be effective and was a **Contributory Factor**.

1.4.145. **Recommendation.** The Panel recommends that the Hd UAST should consider modifying the landing logic when Master Override is selected, to reinstate disqualified laser altimeters if both laser altimeter readings become valid post disqualification.

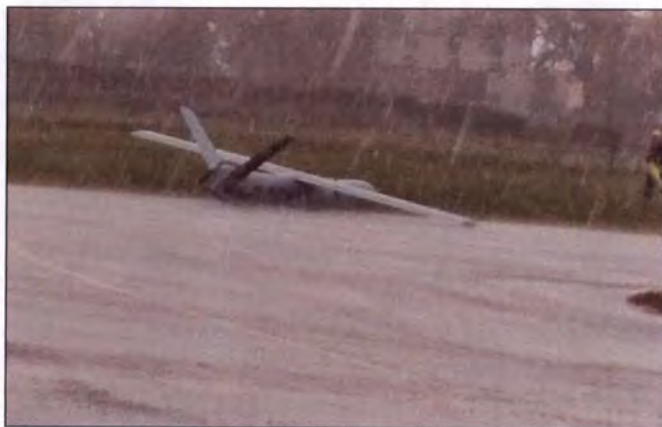
Figure 17 – Photo taken of WK031 shortly after impact

1.4.150. **Analysis of Laser Altimeter Performance Over Wet Tarmac.** A review of the sensor video footage confirmed that the weather conditions at the time laser altimeter 2 failed was commensurate with the Thunderstorm Moderate warning and that the runway was very wet (Fig 17).
