Rail Accident Investigation Branch

Rail Accident Report

**Near miss involving a track worker at Tinsley
Green Junction
17 March 2007**

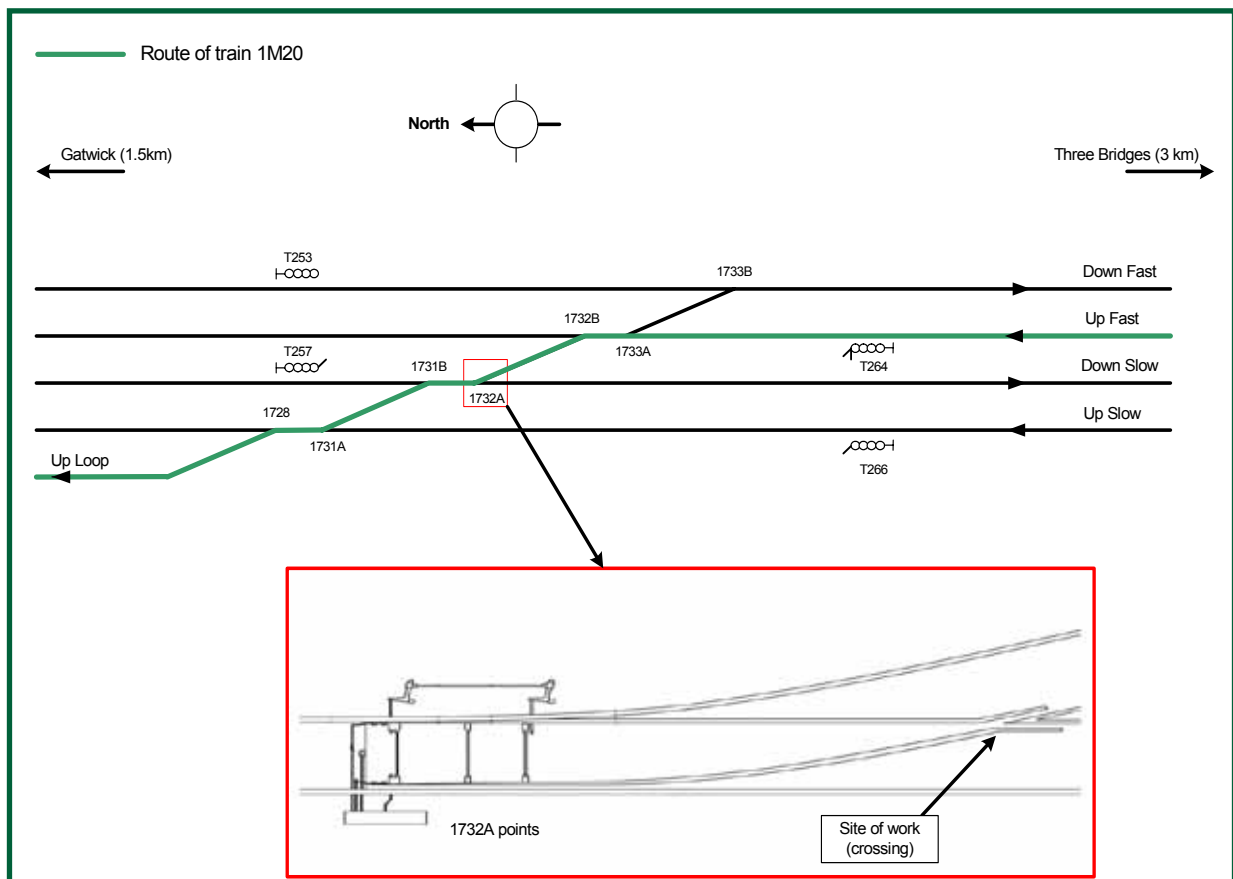
Figure 2: Track and signalling layout at Tinsley Green Junction, showing route of train 1M20

- 24 At this location the main line consists of four parallel lines (see Figure 2). These are listed below in order, from west to east:
 - up slow (used by trains travelling towards London);

- *down* slow (used by trains travelling towards Three Bridges);
 - up fast (used by trains travelling towards London); and
 - down fast (used by trains travelling towards Three Bridges).

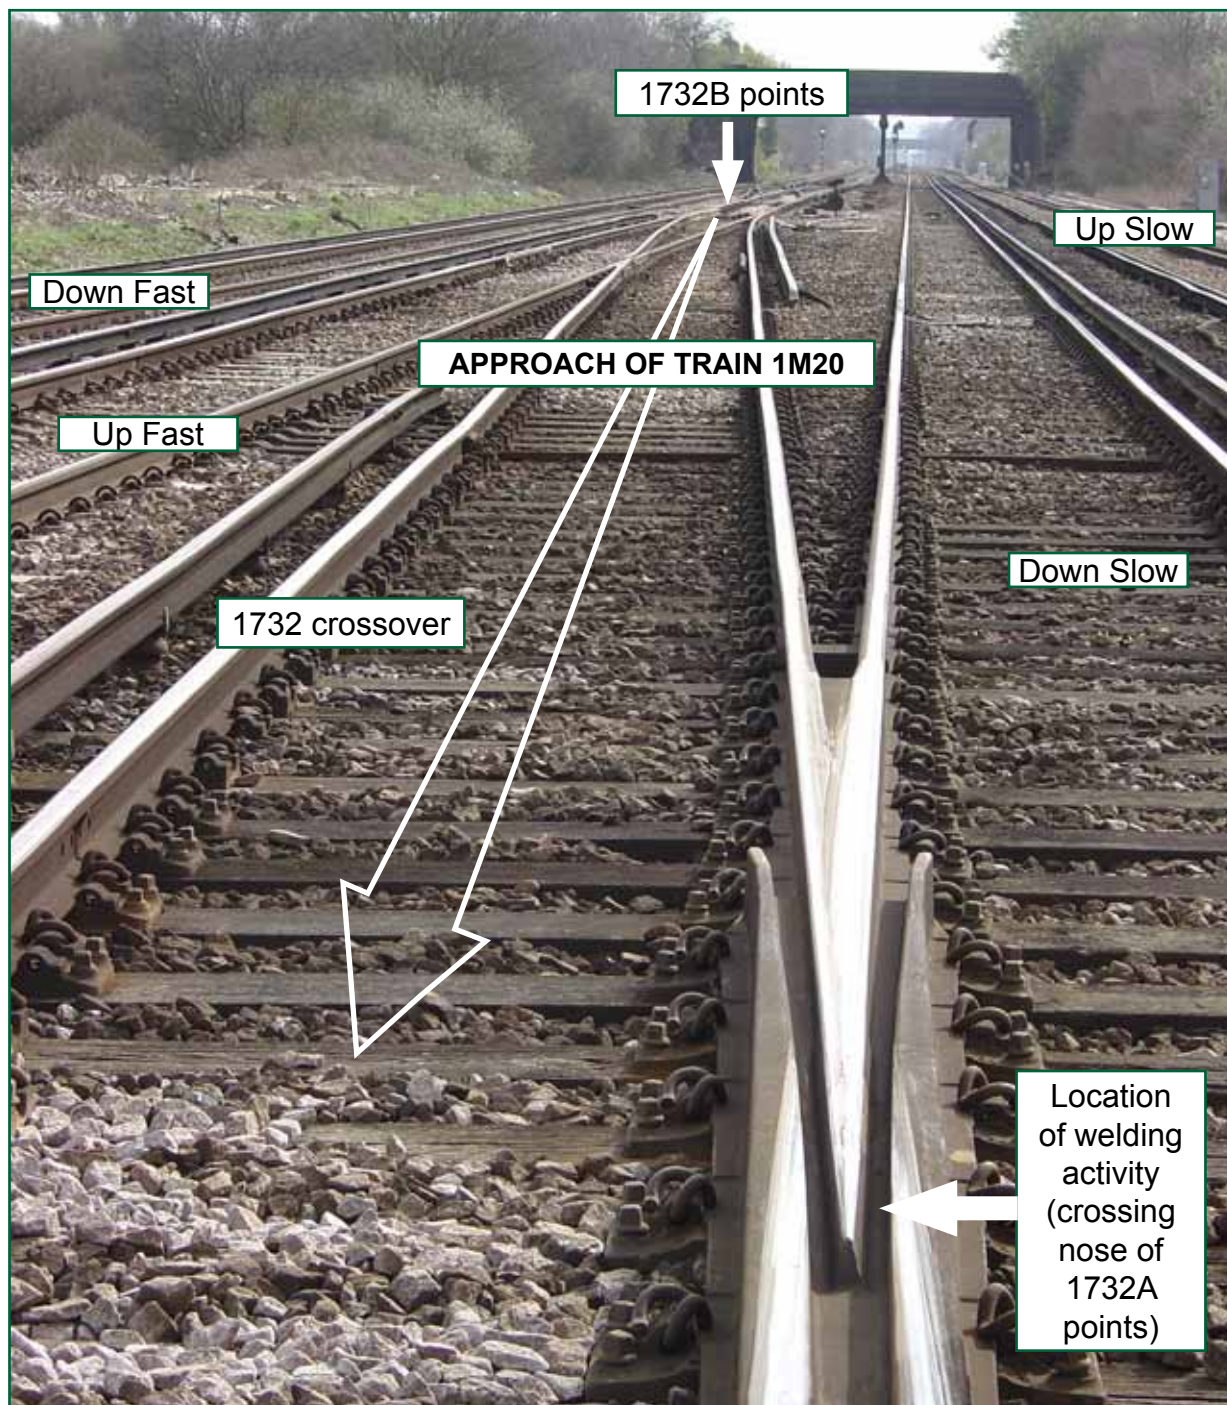
Figure 3: Tinsley Green Junction (looking south at the crossing of 1732A points)

- 91 The condition of the crossing nose of 1732A points was observed by the local track maintenance managers to be deteriorating in the early part of 2007. As a consequence repairs were planned to take place within an engineering possession during week 44 (Saturday 27 January 2007 to Friday 02 February 2007). These repairs did not take place because of a combination of defective planning and a lack of manpower.

- 92 By week 50 (Saturday 10 March 2007 to Friday 16 March 2007) the crossing had deteriorated further and the Assistant Section Manager decided that repairs were now urgent. He looked for a suitable engineering possession to permit the work to be carried out in the absence of service trains. No such possession was planned within the next few weeks and he decided to request that the work be done with service trains still operating (ie in the Red Zone).
