Rail Accident Investigation Branch

# Rail Accident Report

## Fatal accident at Frampton level crossing 11 May 2014

Report 05/2015  
May 2015

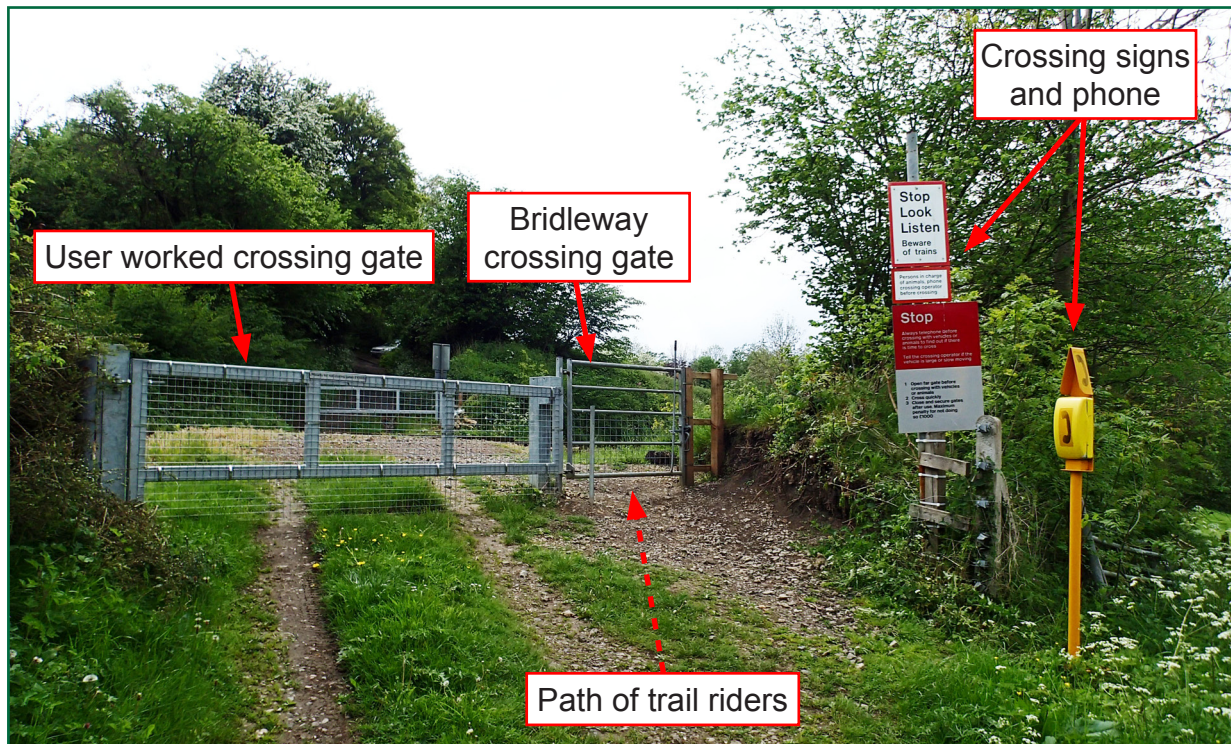
- 8 Frampton level crossing (figure 2) comprised a wide-gated crossing, known as a *user worked crossing* intended for use by *authorised users* with vehicles such as cars and tractors, and a smaller *bridleway crossing* gate intended for use by pedestrians, pedal cyclists, and equestrians (horse riders and persons leading horses). The bridleway gate has a latch and closing spring to prevent it being left open. Both gates gave access to the same crossing surface. Telephones on the approach to the crossing provided a direct line to the signaller controlling train movements in the area. Signs at the crossing instructed people to use the telephone if crossing with vehicles (which includes trail bikes<sup>2</sup>) or animals. The signs did not instruct pedestrians to use the telephones.

Figure 2: Photograph showing the arrangements on the north side of the crossing at the time of the accident

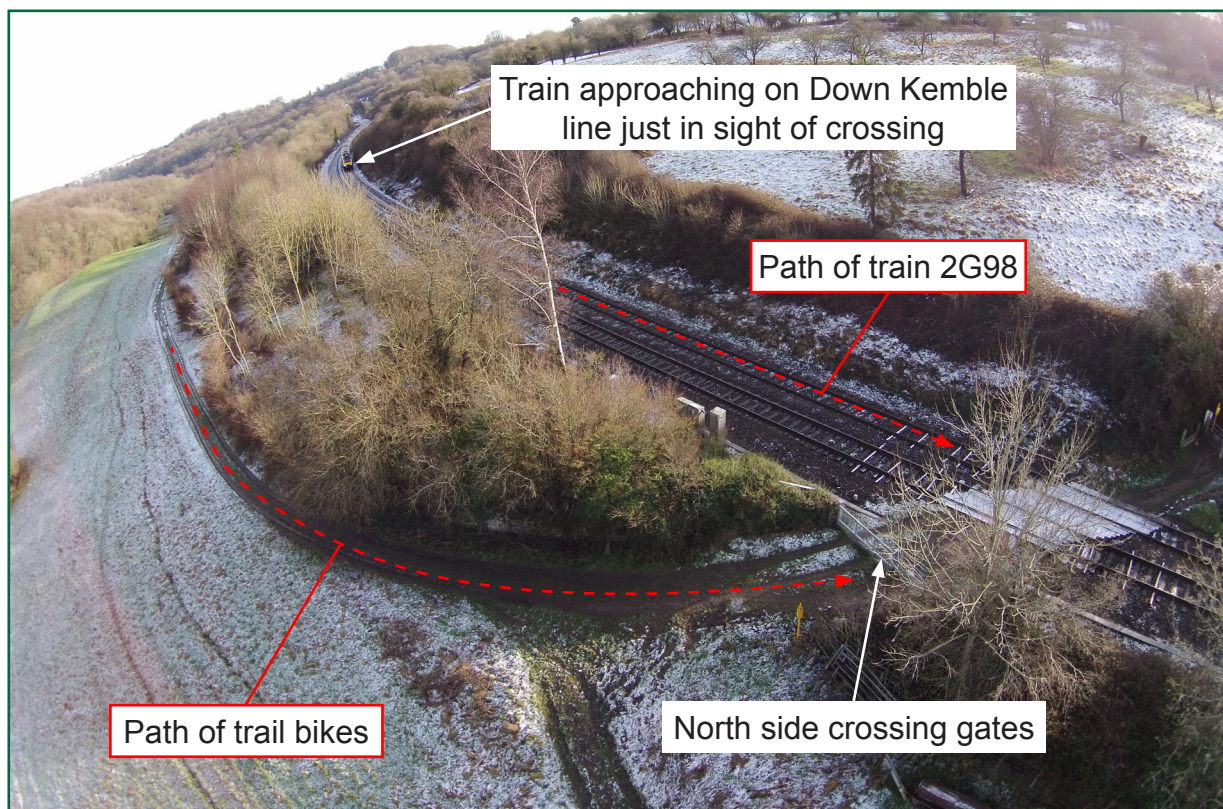
- 9 Trains travelling from Swindon approached Frampton level crossing on a curved section of track which meant that train drivers could not see the crossing until the train was around 175 metres from it (figure 3).

Figure 3: The curved approach to Frampton crossing (January 2015 photograph, altered to show crossing signs at the time of the accident)

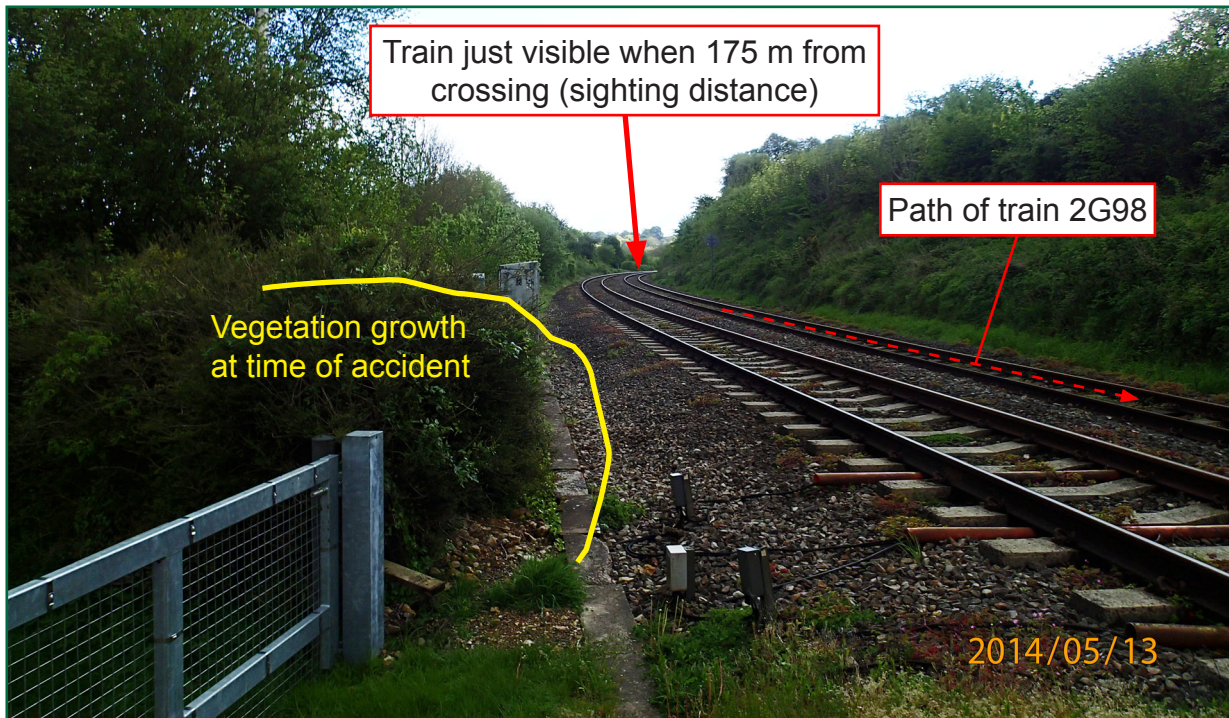
Figure 5: View from north side of crossing towards trains approaching from Swindon (May 2014 photograph)

- 74 At Frampton level crossing, the level crossing signs and brideway gate were not located at the decision point. On the north side of the crossing the brideway gate was located around 5.3 metres from the nearest rail, and the signs were located around 9 metres from the nearest rail. When standing at the brideway gate or at the level crossing signs, it was not possible to see approaching trains because vegetation blocked the view (figure 5).

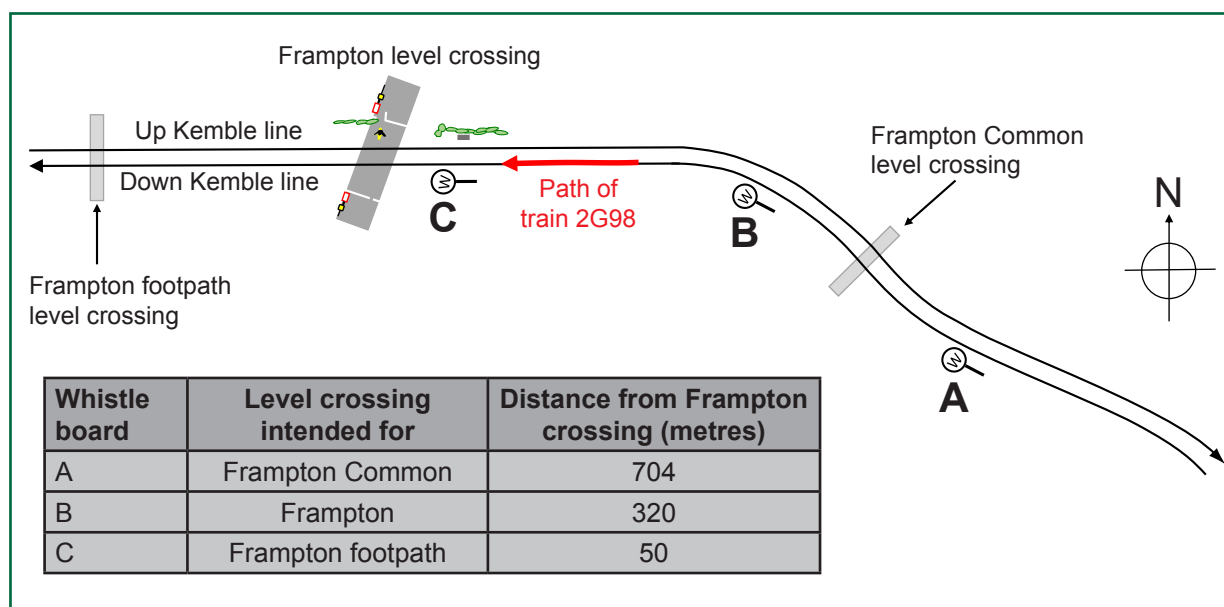
Figure 6: Locations of whistle boards approaching Frampton crossing (not to scale)

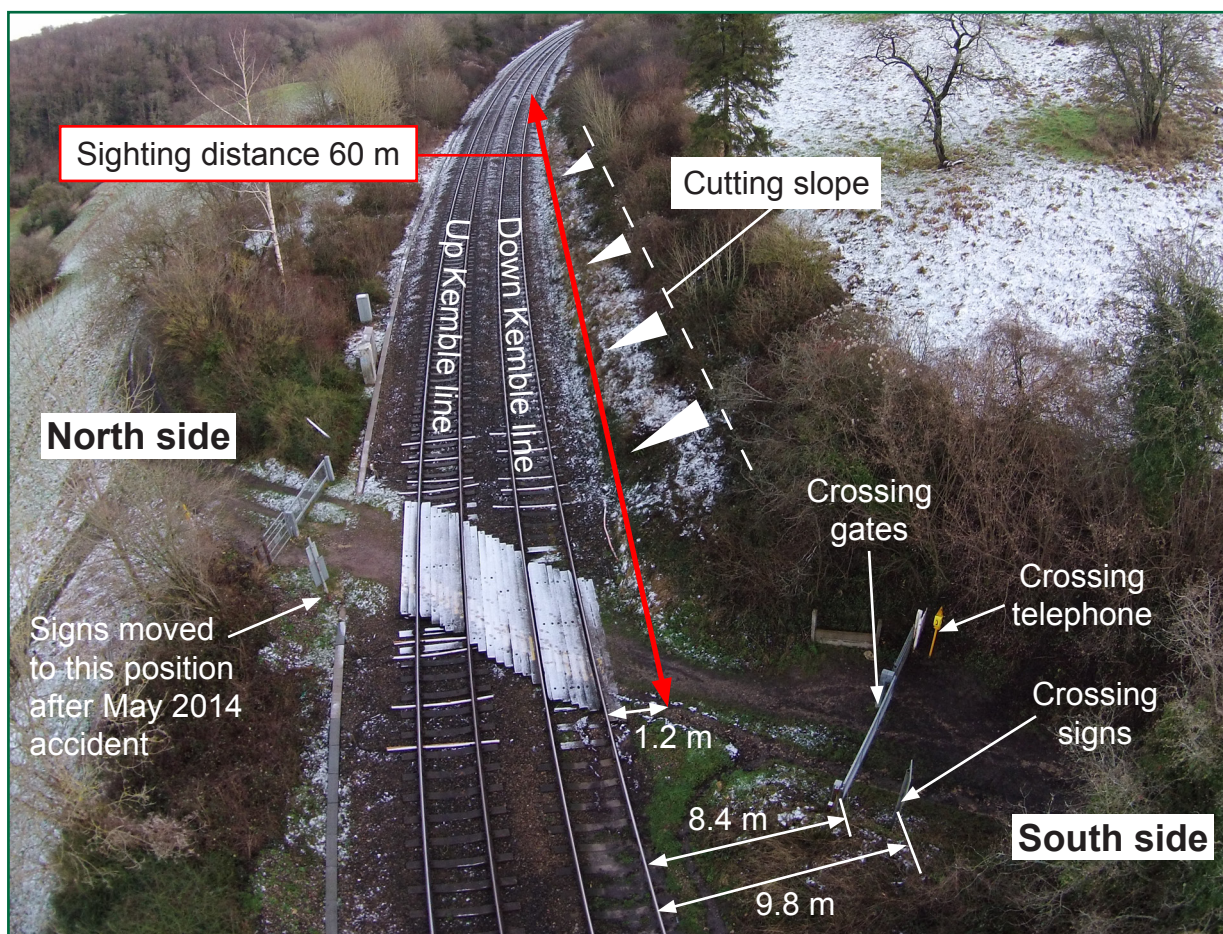
- 75 Although the approach to the south side of the crossing was not relevant to the accident on 11 May 2014, the RAIB noted that the brideway gate on this side was located around 8.7 metres from the nearest rail, and the signs were located around 10 metres from the nearest rail. Approaching trains could not be seen until a crossing user was around 1.2 metres from the nearest rail because foliage obscured the view in both directions. Even with the foliage removed, sighting distance was limited by track curvature and cutting slopes to around 110 metres (around 5 seconds sighting time) when looking for trains travelling from Gloucester on the Up Kemble line, and to around 60 metres (around 3 seconds sighting time) when looking for trains travelling from Swindon along the Down Kemble line (figure 9).

Figure 9: South side of crossing

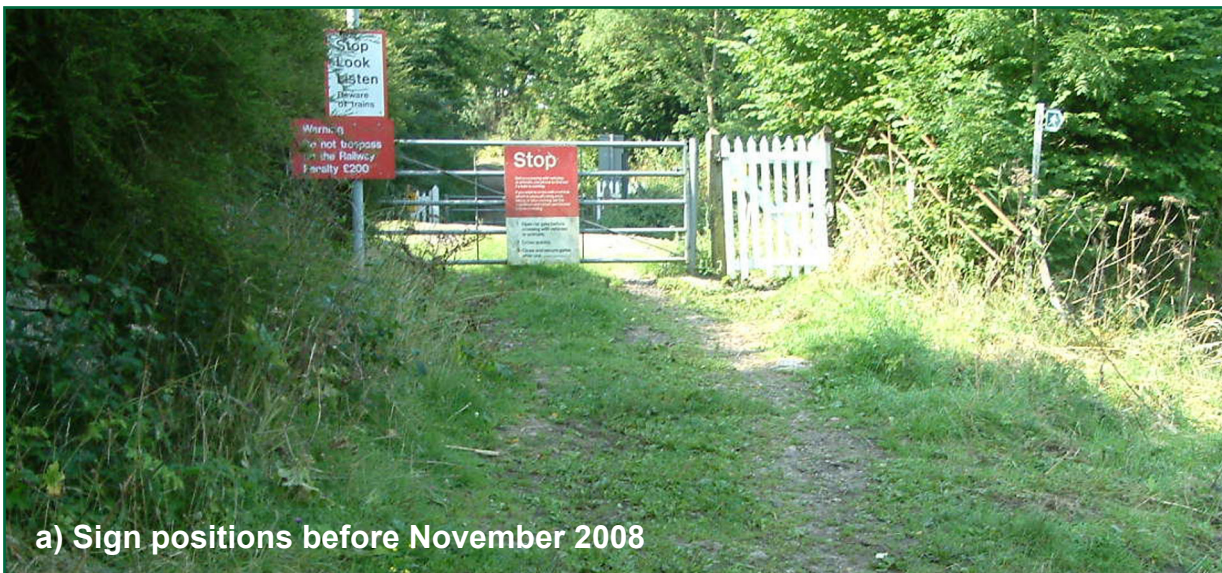
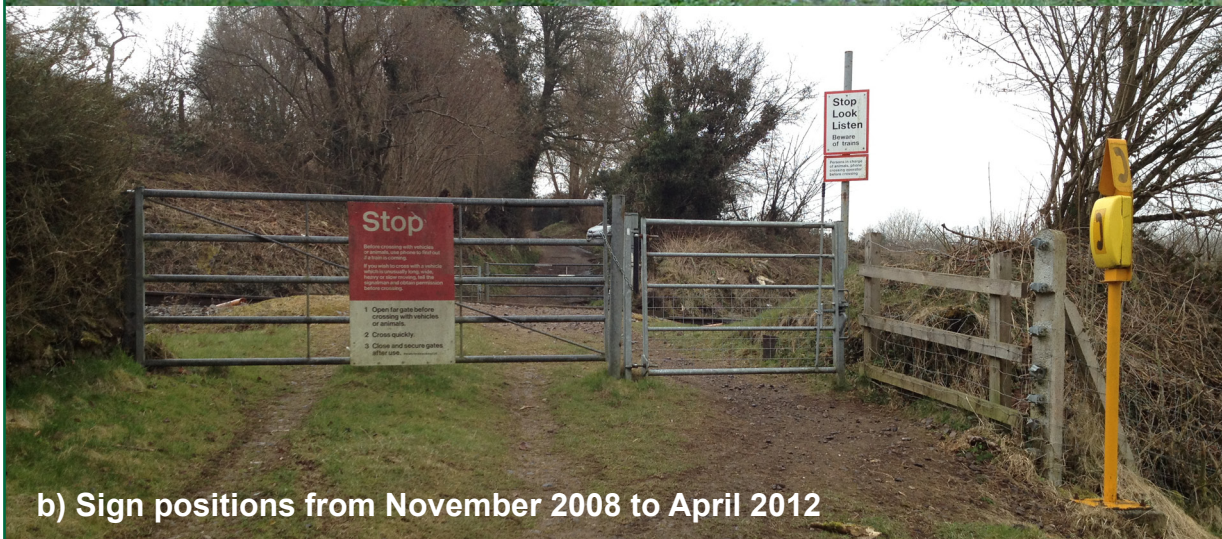
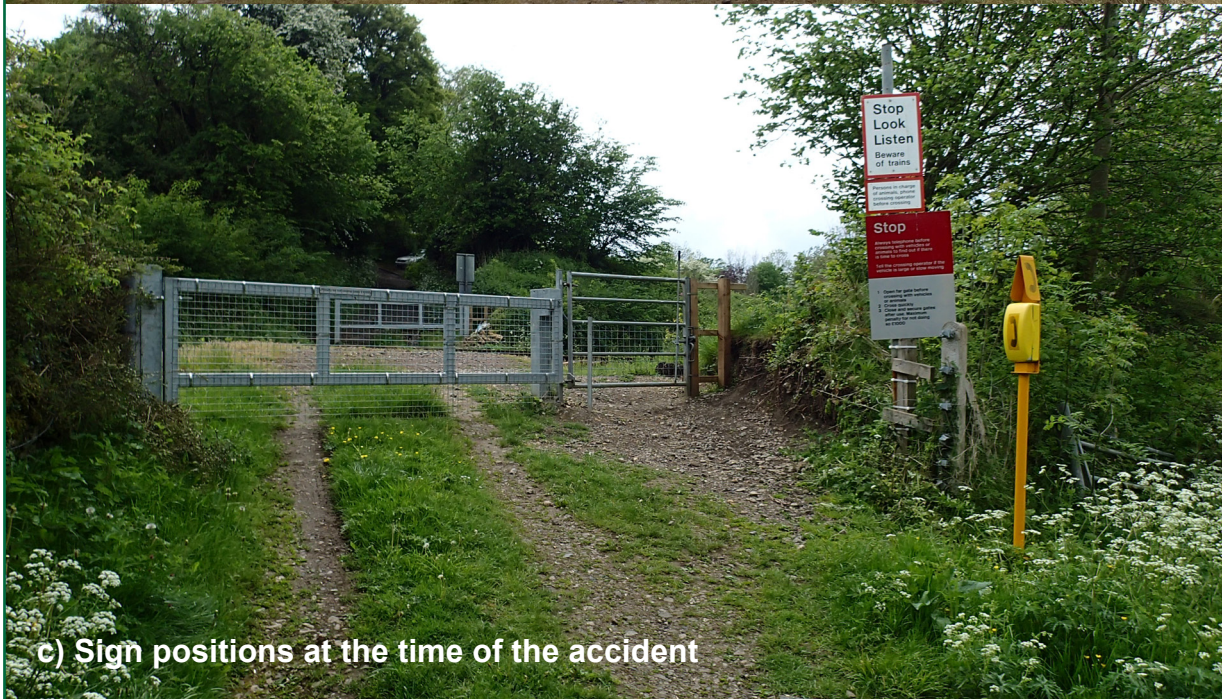
Figures 10a, 10b and 10c: Frampton crossing north side signs

- 82 The route over the level crossing could be accessed from the village of Frampton Mansell, or from the road that leads out of Sapperton village (paragraph 14). There were no road signs on either approach to indicate that the general public were not permitted to take vehicles over the level crossing (figure 11).
