Rail Accident Investigation Branch

Rail Accident Report

**Passenger trapped and dragged by a train at
Hayes & Harlington station
25 July 2015**

Report 12/2016
June 2016

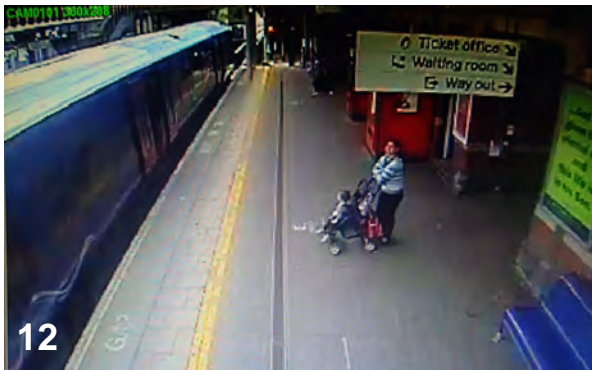
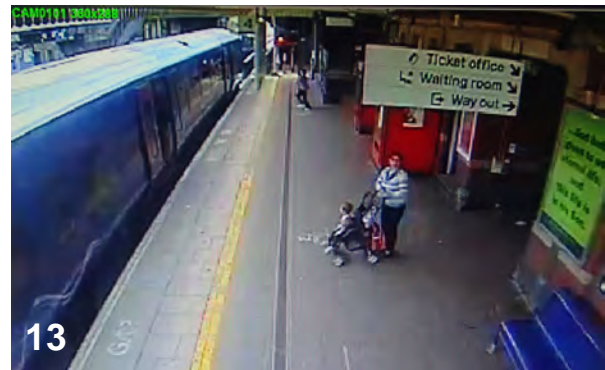
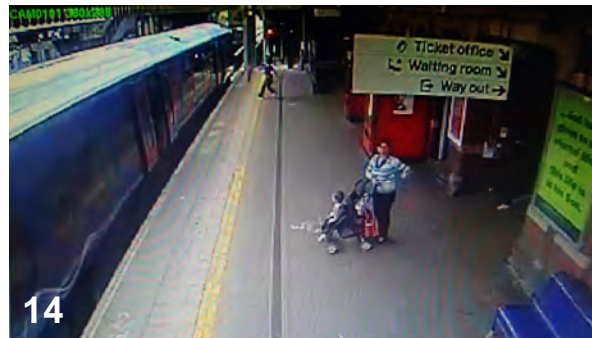
16 At 13:09:48 the passenger involved in the accident ran from the stairwell onto platform 4 (figure 12). The RAIB has established using CCTV evidence that this is around the same time at which the train driver pressed the door close button to initiate their closure. The passenger continued to run (figures 13 and 14) towards the train doors which were still open, but with the audible 'hustle' alarm sounding indicating imminent closure.

Figures 12 to 14: CCTV images showing the passenger running from the stairwell and onto the platform towards the stationary train as the doors were closing (courtesy of GWR)

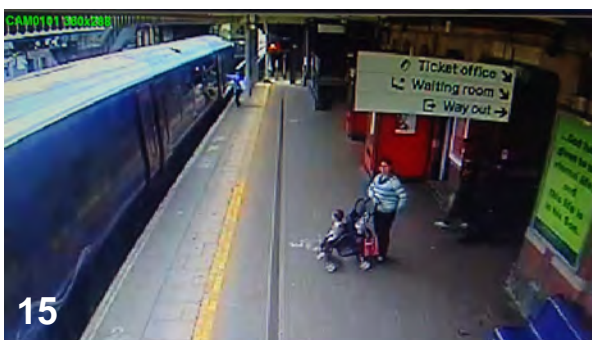
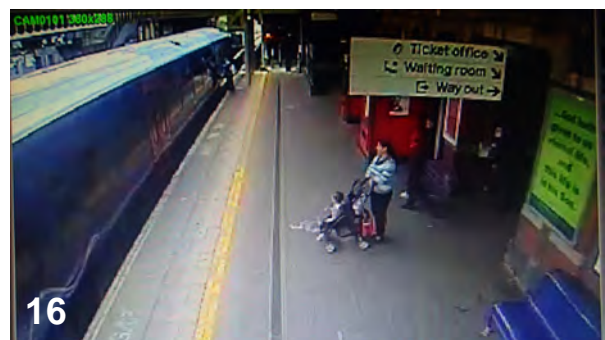
17 At 13:09:50 the passenger put her leg and left hand between the rear door leaves (which were by now almost closed) on the last coach of the train, in an attempt to prevent them from fully closing. Almost immediately, she retracted her leg, leaving her left hand in the door (figure 15). At 13:09:51 the *Body Side Indicator light* on the rear carriage was extinguished. The driver's *door interlock light* illuminated in the cab a second or two later, once the safety circuits had identified that all the train doors were closed and locked (figure 16) (the CCTV evidence does not show all of the doors on the train so it is not possible to be precise about the time that the door interlock light illuminated).

Figures 15 and 16: CCTV images showing the passenger running towards the train and trapping her hands in the door of the rear carriage of train 2P48 (courtesy of GWR)

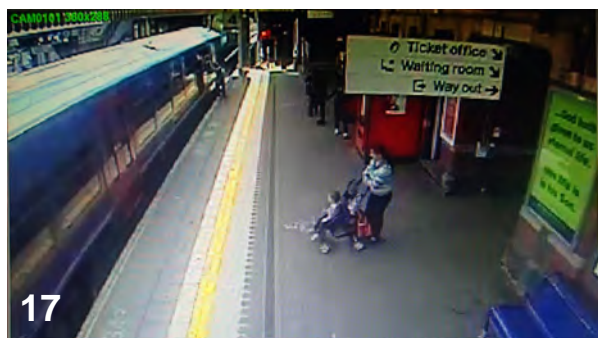
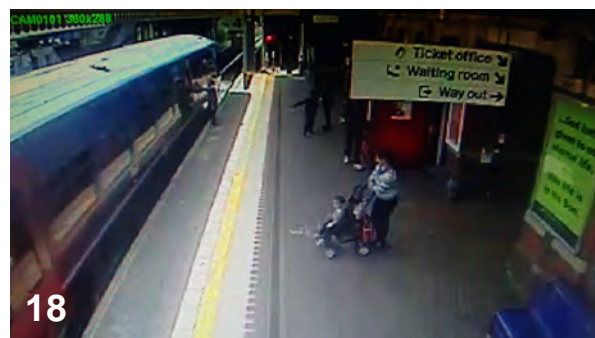
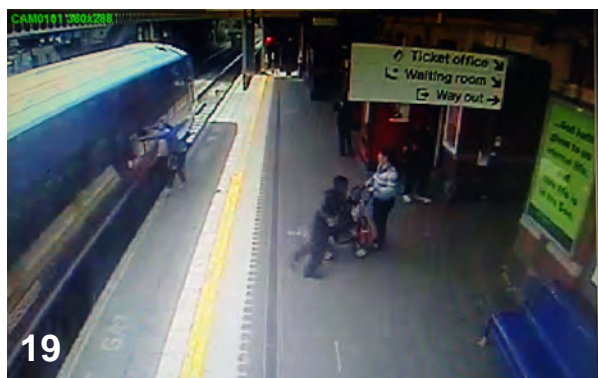
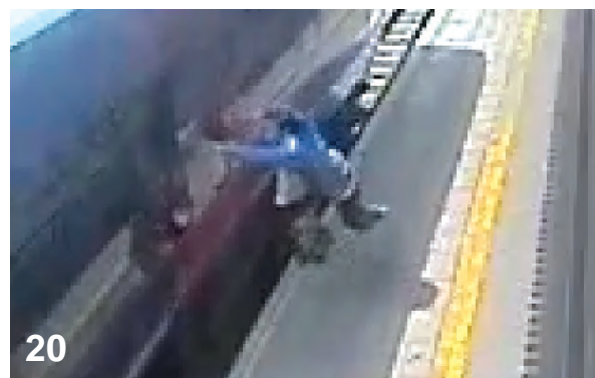
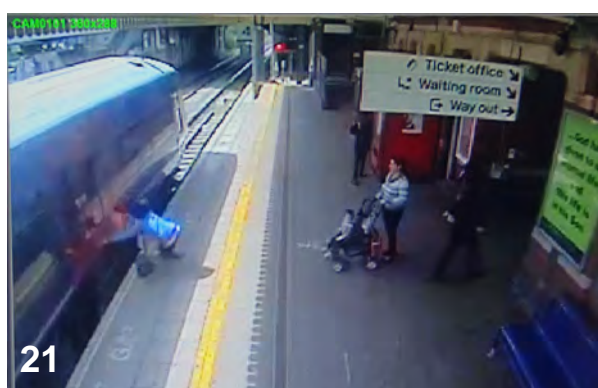
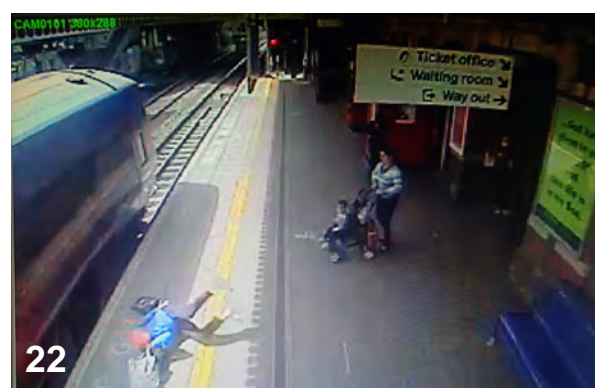
- 19 At approximately 13:10:01, the train started to move. At this time other passengers on the platform became aware of the trapped passenger (figures 17 and 18). The train gathered speed, dragging the passenger along the platform (figure 19) until 13:10:07 hrs, when the speed of the train caused her to lose her footing and she became airborne (figure 20). The weight of her body falling and the angle of her trapped left hand resulted in her hand becoming free from the doors, and she fell heavily onto the platform. Fortunately, she rolled away from the platform edge (figures 21 and 22).

Figures 17 to 22: CCTV images showing the passenger being dragged along the platform and falling away from train 2P48 (courtesy of GWR)

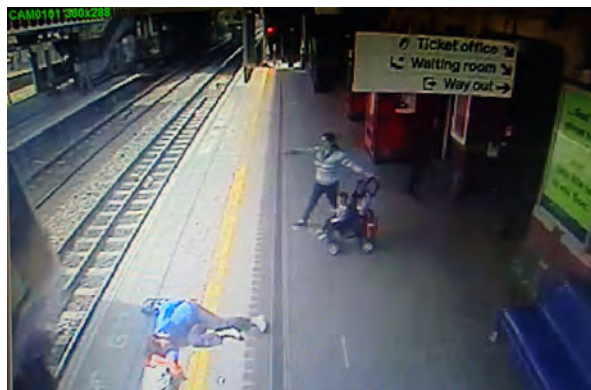
Figure 23: CCTV images showing the passenger on the platform after falling away from train 2P48 (courtesy of GWR)

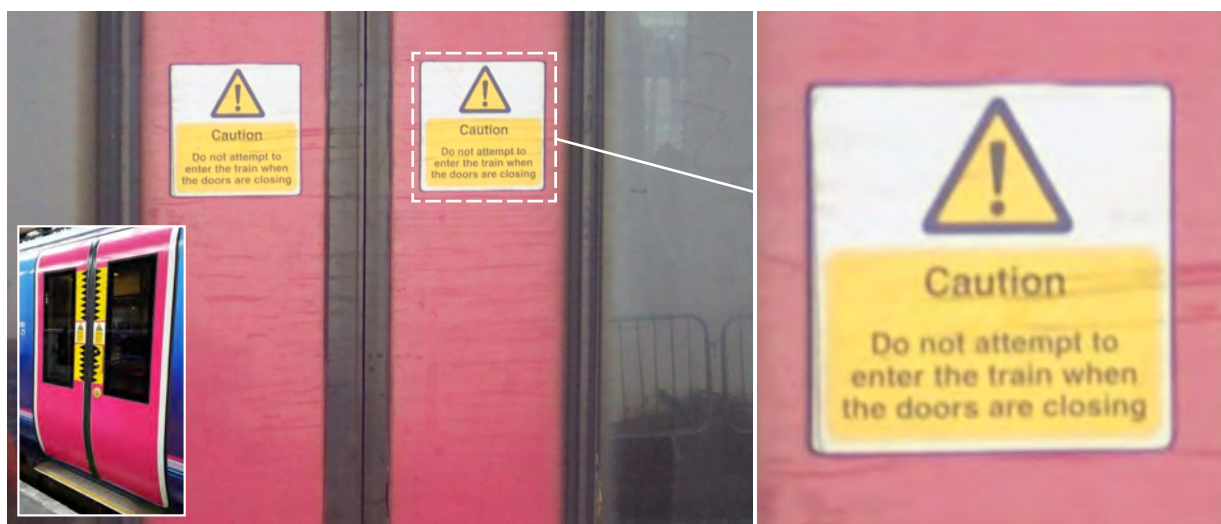
- 36 The passenger placed her hand into the gap between the door leaves as they were closing.**
- 37 CCTV and witness evidence shows that the passenger attempted to board the train as the doors were closing. The passenger believed that if she placed her hand into the gap between the door leaves, it would cause them to re-open. She said that as she ran towards the train she did not see the cautionary sticker (figure 24) placed on the outside of the door requesting passengers not to attempt to board the train as the doors are closing. Although she was aware that obstructing the doors was potentially unsafe, she thought that the train would not be able to move if her hand was caught in a door, and that in any case the driver would see her and would re-open the doors. As a result, when her hand first became trapped and the train was still stationary, she made no attempt to pull it out of the doors⁴.

Figure 24: Cautionary sticker on the outside of the class 165 trains requesting passengers to not attempt to board the train when the doors are closing. Inset image showing 'sharks teeth' graphic design on the livery of a TransPennine Express train to warn passengers of the dangers of obstructing a door.

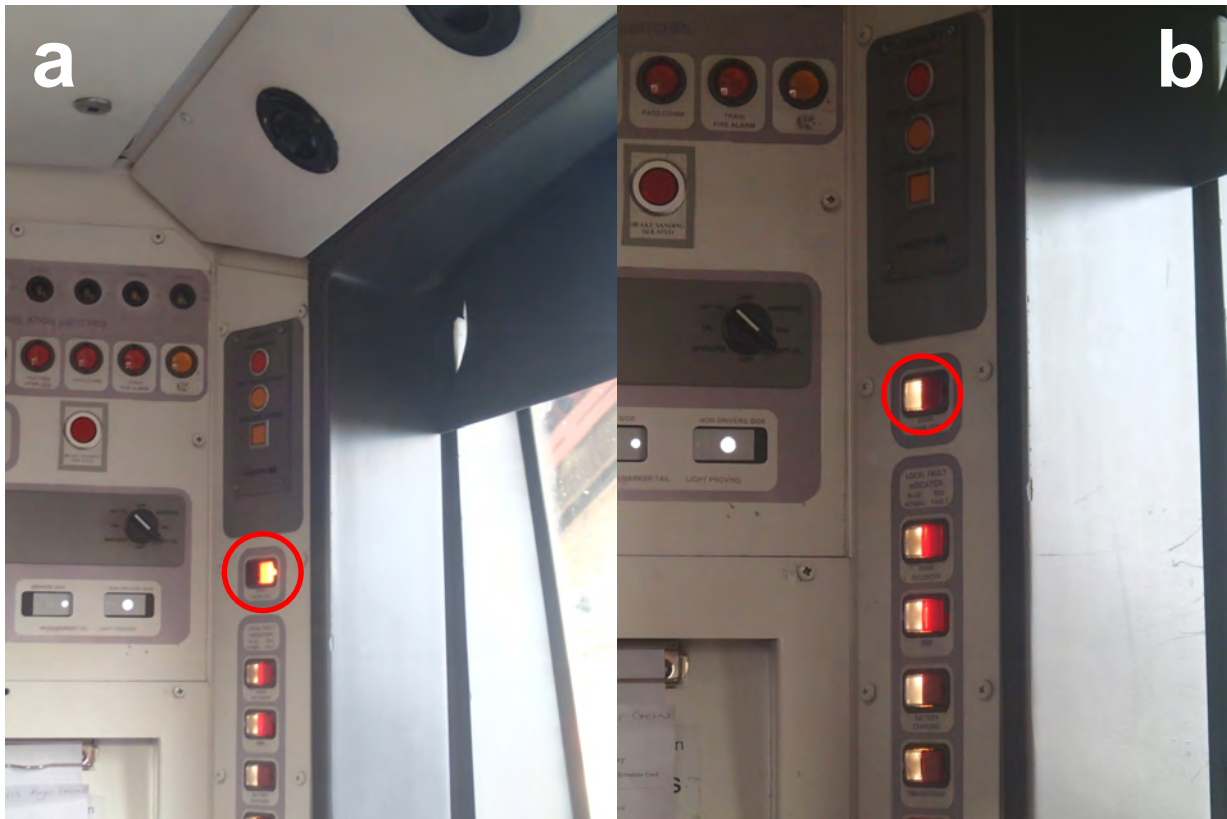
Figure 26: (a) Interlock light providing the driver with indication that the doors are closed and locked and (b) interlock not obtained

- 50 When FGW tested the door involved in the accident to determine if it met the requirements of its test specification, the door passed the test; interlock could not be obtained when the object of 25 mm width was inserted into the closed door leaves. However, because the passenger's hand was less than 25 mm thick, the interlock circuit could be made, which illuminated the door interlock light in the driving cab and enabled the driver to start the train. This was confirmed by the reconstruction exercise at Hayes & Harlington referred to in paragraph 43. In all three tests, the driver was able to obtain door interlock and move the train. One further test was undertaken, involving the member of staff placing a foot in between the closing doors. Because the width of the obstruction exceeded 25 mm, the doors partially re-opened and the driver was unable to obtain door interlock and start the train. This was consistent with a further requirement of GM/RT2473 which required that the 150 N door closing force be reduced, or the door automatically reopen, if the door leaves detect an obstacle of a given width or greater (25 mm or greater in the case of class 165 doors).

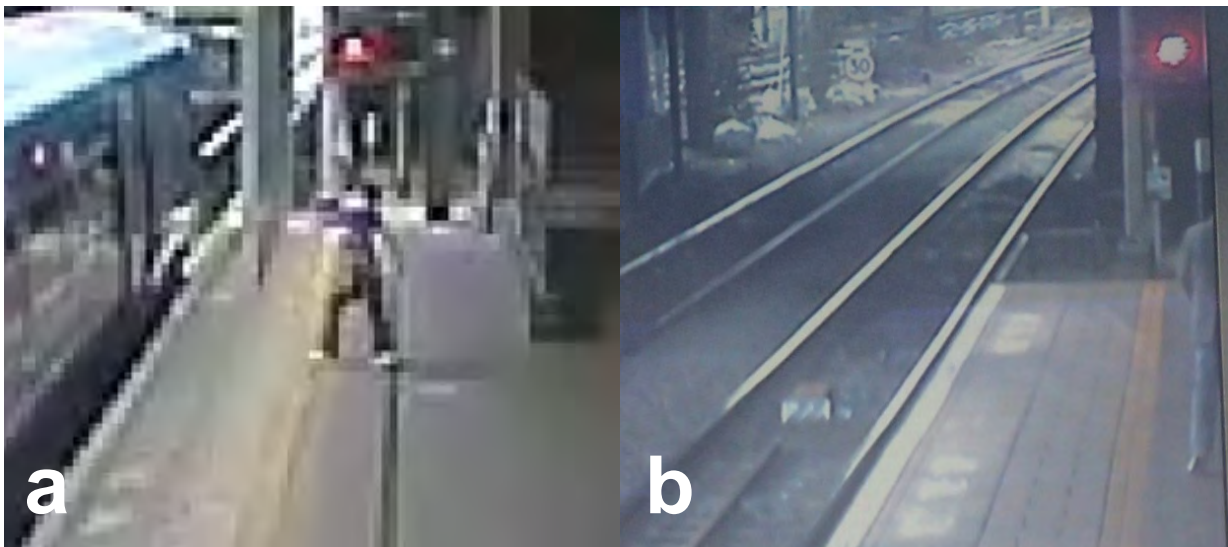
- 68 Analysis of the CCTV evidence shows that at the time the train driver pressed the button to close the doors, he could not see the passenger involved in the accident on the monitors (figures 28 (a) and (b) show that he would not have been able to see the passenger until she crossed the yellow line). He may have formed an expectation, having previously seen an empty platform, that there would be no-one in the vicinity of the train once the doors were closed and locked. As a consequence of this expectation, when he checked the monitors before starting the train he only glanced at them without really noticing what they were showing.

Figure 28: (a) showing Platform CCTV images of the rear portion of the train (note the position of the passenger running towards the train and yellow line) and (b) image of the same location on platform 4 from the drivers view of monitor 4L36 (note the position of the yellow line) (courtesy of GWR)

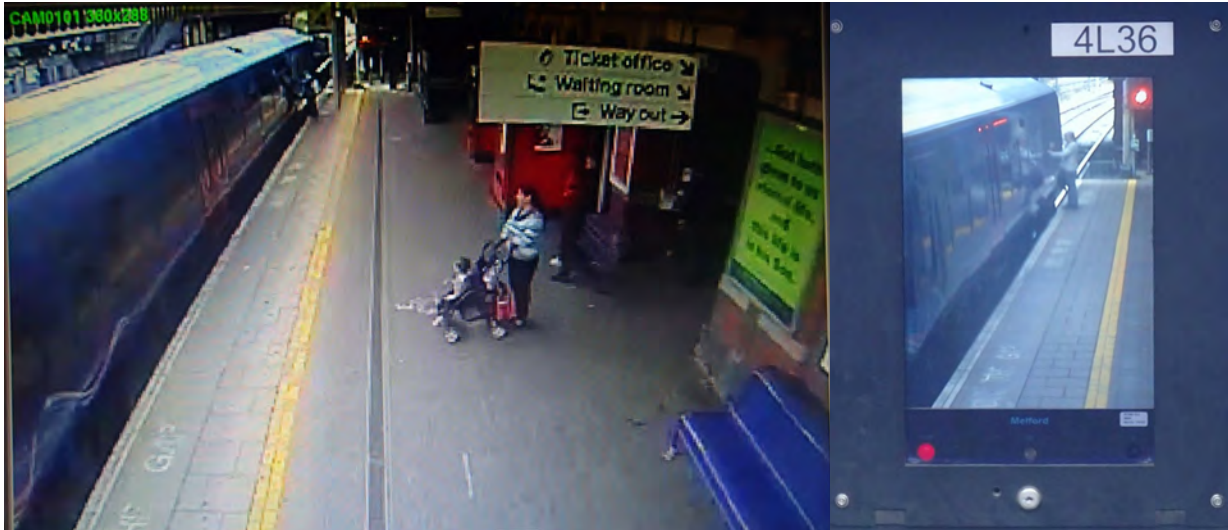
- 75 Analysis of CCTV evidence from the platform shows that as the train driver pressed the door close button, the passenger was not visible in the CCTV monitors. However after the passenger had reached the train door, she would have been clearly visible in the centre of one of the screens during the time of the train driver's safety check (figures 29a and 29b).

Figure 29: (a) showing the passenger at the rear portion of the train on the platform CCTV image (courtesy of GWR), and (b) an image taken during the RAIB reconstruction of the events at the same location on platform 4 (from the driver's view of monitor 4L36)

- 76 Although the CCTV monitors would not have been clear enough to show the train driver that the passenger's hand had become trapped, they would have shown that she was in very close proximity to (and possibly touching) the train over a period of 8 to 9 seconds.

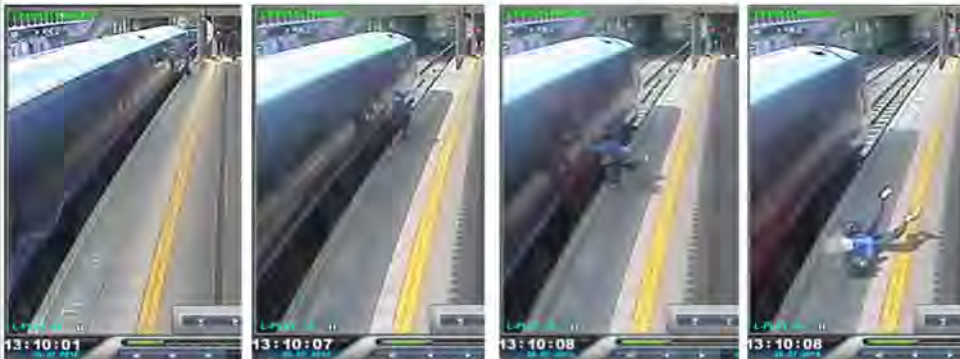
<p>Sequence of four photographs showing train before departure with passenger's hand trapped in the door, the train moving with the passenger's hand still trapped and the passenger falling to the platform, releasing her hand in the process.</p>

2. URGENT SAFETY ADVICE	
USA DATE:	30 November 2015
TITLE:	The importance of drivers performing the final safety check when responsible for the dispatch of trains under DOO arrangements, even when they have obtained a door interlock indication.
SYSTEM / EQUIPMENT:	Train doors, door interlock equipment and DOO train dispatch monitors
SAFETY ISSUE DESCRIPTION:	<p>The RAIB's investigation into the circumstances of this accident indicate that after the driver had closed the train's doors and obtained the door interlock light, he either did not look at the monitors, or looked at the monitors but did not see that the passenger was in an unsafe position, before departing from the platform at Hayes & Harlington station.</p> <p>Subsequent discussions with other train drivers and driver managers indicates that there is a common misconception held by some drivers (and some other staff such as those in the Control Room and on stations) that it is not possible to obtain door interlock and for a train to depart if a person's hand is trapped in the door of the train. This is not the case, as illustrated by this incident.</p> <p>Historical and current Railway Group Standards have specified that train doors should reopen, or there should be a reduction in the closing force, when they close upon an obstruction that is a minimum of either 25 mm or 30 mm wide (depending on which standard is being applied) and that the doors should not be indicated (to the driver) as locked. The fingers of a hand trapped in a door, when the palm of the hand is parallel to the door seals, will sometimes measure less than 25 mm. An individual's ability to remove their trapped hand before the train moves is then dependent on the pulling force they apply and the force exerted on their hand by the closed door(s).</p> <p>Additionally the RAIB has noted in a number of investigations that members of the public often do not immediately attempt to pull trapped hands, wrists, coats, bag straps, etc. out of doors, expecting either that the door will reopen (like a lift door) or that the train is unable to move with the trapped object in it. These expectations exacerbate the danger.</p>
