SAFETY FLYER TO FISHING INDUSTRY

Fishing vessel *Harvester* (M999), fatal man overboard accident, 28 April 2016

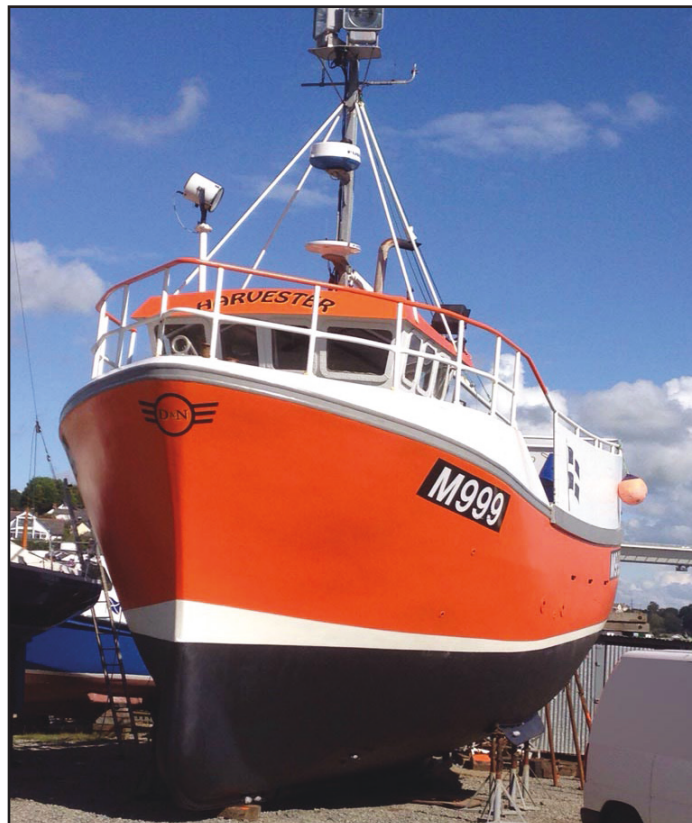
Figure 1: Fishing vessel *Harvester*

At 1424 on 28 April 2016, the 11.6 metre potter *Harvester* (**Figure 1**) grounded on rocks in Abereddy Bay, North Pembrokeshire, and foundered a short time later. There was no indication of any crew on board at the time of the grounding. A large-scale search and rescue operation commenced and the body of one crew member was recovered from the water 3 miles from where *Harvester* had foundered. He was not wearing a lifejacket or other buoyancy aid. The second crew member has not been found despite an extensive search.

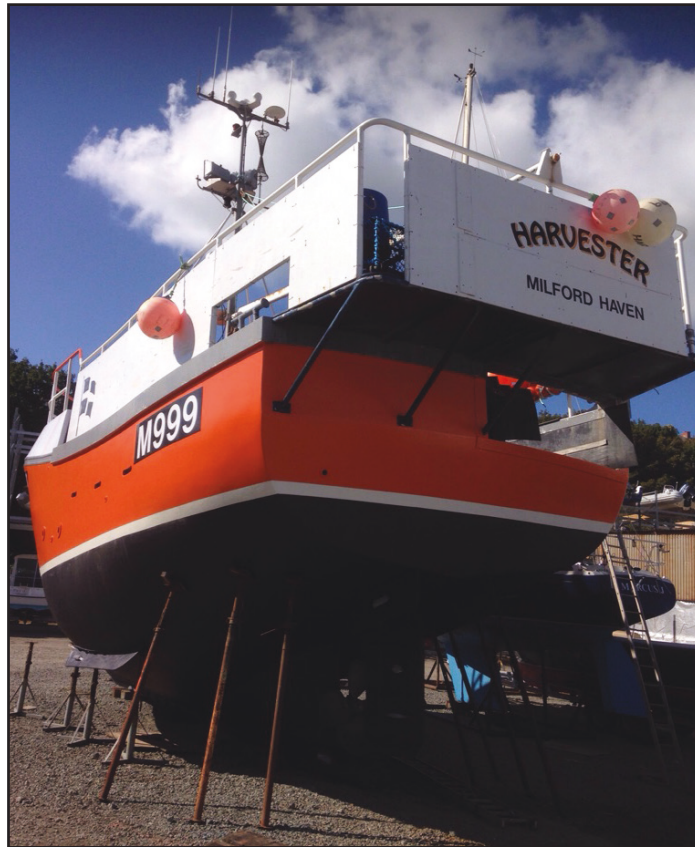
A likely scenario is that a crew member working on deck became entangled in the back rope as a fleet was being shot. The other crew member could then have gone to his assistance, resulting in both men going overboard through the large opening (**Figure 2**) in the transom.

Figure 2: Opening in transom

1. The assumed system of work for shooting pots on *Harvester* did not sufficiently separate the crew from the running gear to prevent the accident.

Crew should ensure that they have a sharp knife to hand and are standing in a safe area during shooting operations. The danger of becoming entangled in the running gear can be reduced or eliminated by providing a physical separation from the back rope, working the gear in a controlled fashion, or adopting a system or work that requires no manual intervention.
