RAF IAM LETTER REPORT NO. 013/89

An assessment of the immersion  
suits and lifejackets worn by  
survivors from the ditching of  
G-BDES on 10 November 1988

(Project 95/07)

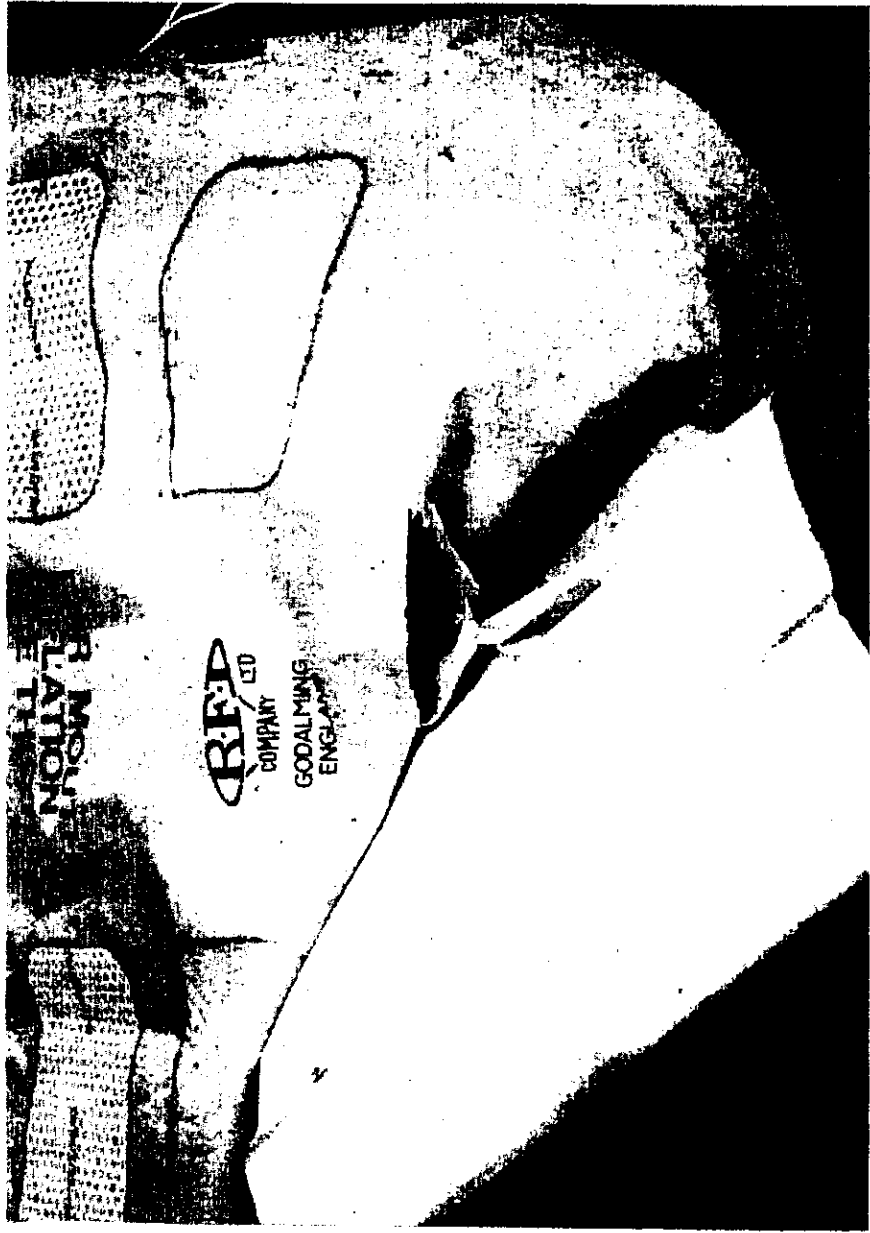
15. The lifejackets worn by the passengers also gave cause for concern. Of the 8 which could be tested by inflation 3 were found to be punctured. One had a large rip in the stole which was almost certainly caused by the pouch containing the CO<sub>2</sub>

Figure 3. Passenger's Lifejacket - Tear in Stole

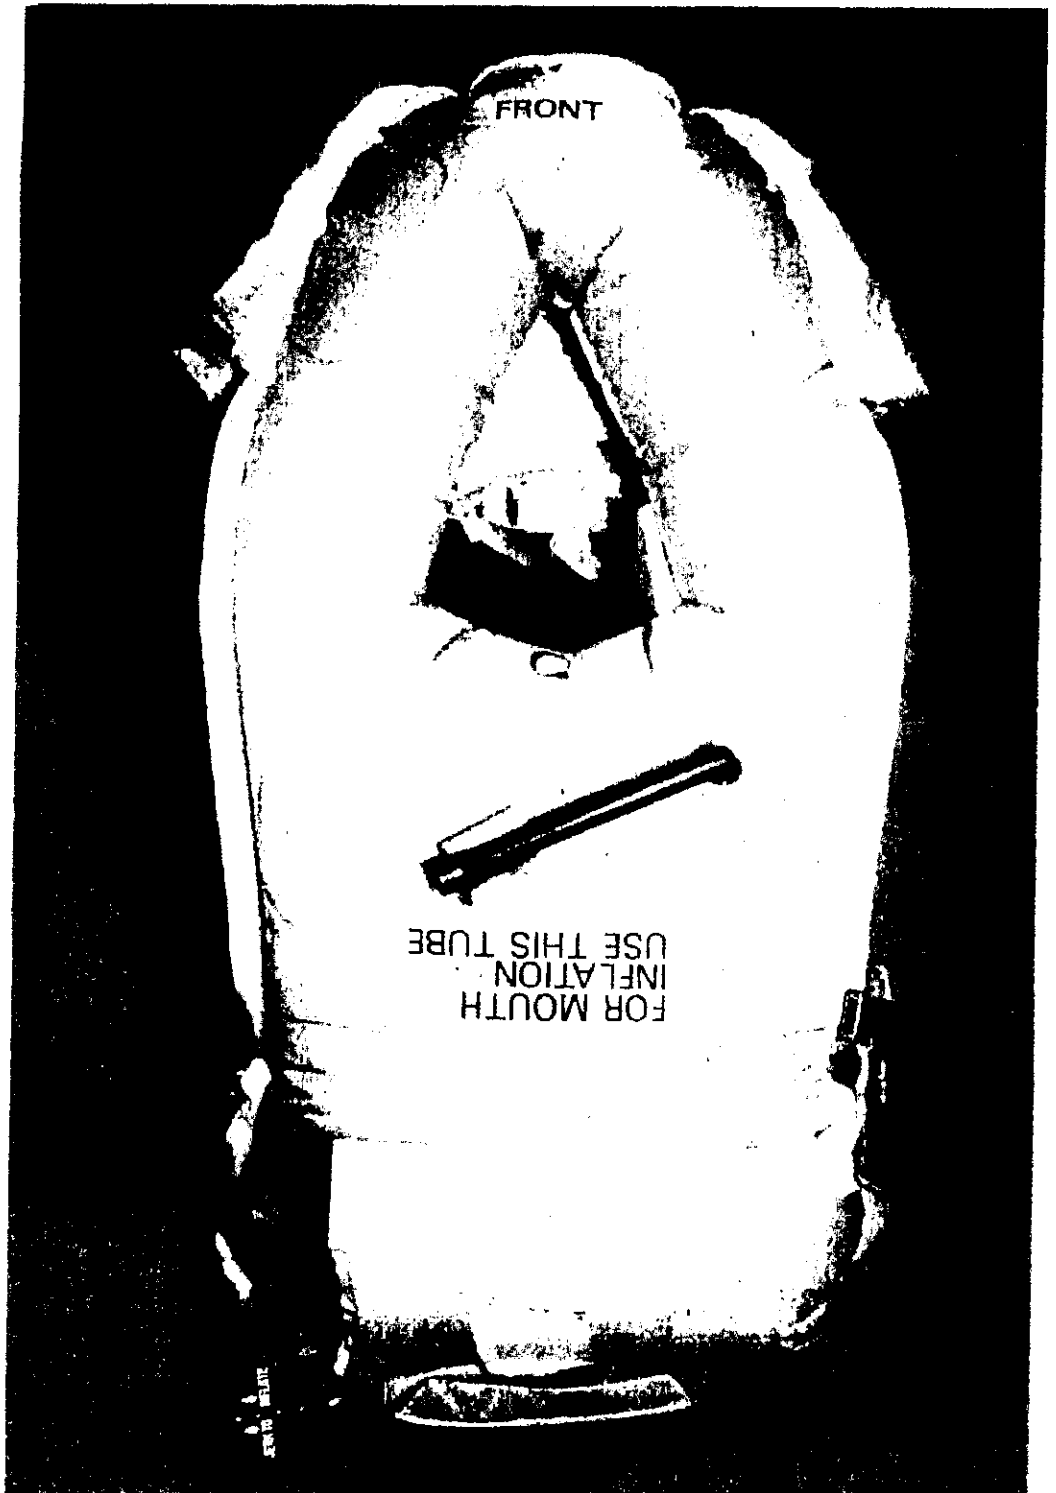
10. Passengers' lifejackets. Three of the 11 lifejackets had been cut in order to remove them from the survivors which meant they could not be subjected to inflation tests. Visual inspection showed that all the lifejackets had been fired and still had the toggle and lanyard connected to the firing mechanism. One lifejacket had a tear 6 cm long at the attachment point of the CO<sub>2</sub> bottle pouch and the stole (Figure 3), while another had an abrasion and a hole on the right side of the stole below the central reflective patch. Three of the lifejackets were found to have no reflective patches, although positions had been marked for their attachment (Figure 4). Finally, inflation tests showed a third lifejacket to be punctured; this being a pinhole in the front neck of the stole (circled in Figure 4).

bottle snagging on something during the escape, whilst the second had an abrasion mark and a puncture which also probably resulted from the struggle to escape. The third, (Ser. No. 211929) however, had a pinhole at the front of the neck and, although impossible to prove, because of its size and location it is unlikely to have resulted from snagging or abrasion during escape from the helicopter. The records show that this particular lifejacket had undergone an annual service only days prior to the ditching. (Annex A-13).

16. Another defect present in 3 of the lifejackets was the absence of reflective patches. Inked outlines showed the positions they should have occupied but no traces of any adhesive were found. It is understood that the patches are normally applied by the manufacturer.

23. Three of the passengers' lifejackets had no reflective patches; positions had been marked for their attachment but no traces of adhesive were present.

Figure 4. Passenger's Lifejacket - Missing Reflective Patches  
and Site of Pinhole Leak (circled)
