## **TECHNICAL INVESTIGATION REPORT**

**Concerning the fire on Eurotunnel  
freight shuttle 7340  
on 17 January 2015**

Affaire n° BEATT-2015-001

**Technical investigation report  
Concerning the fire on Eurotunnel freight shuttle 7340  
on 17 January 2015**

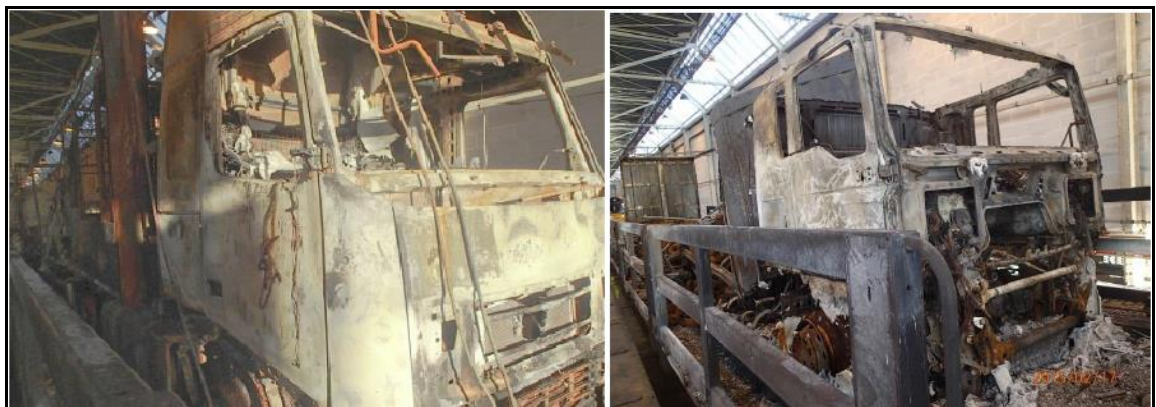
The two lorries situated on wagons 14 and 15 of the front rake have completely burnt.

The two lorries loaded on wagons 14 and 15 of the front rake have completely burnt.

*Figure 1: Lorries loaded on wagons 14 (left) and 15 (right)*

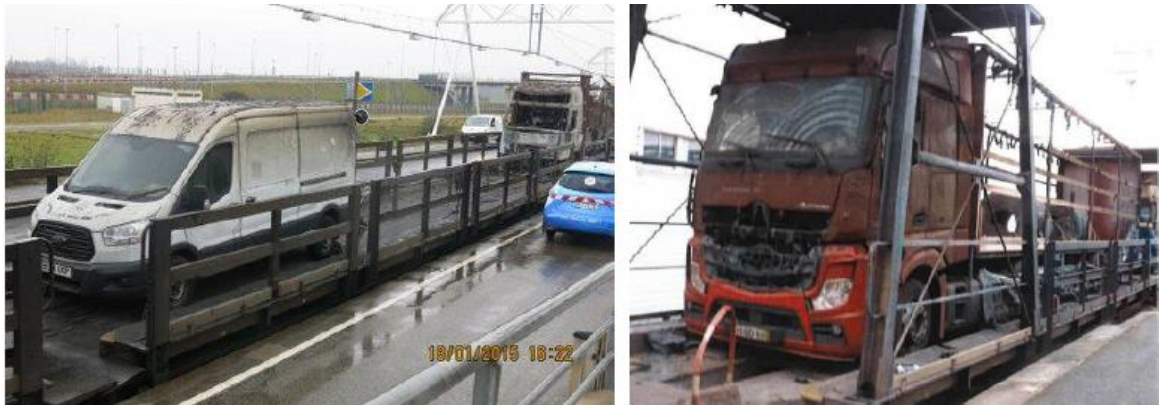
The first three vehicles situated behind the burnt out lorries have sustained significant heat damage but they have not burnt. The subsequent vehicles have not sustained any obvious damage other than traces of smoke.

*Figure 2: Van on wagon 13 and first lorry on the rear rake*

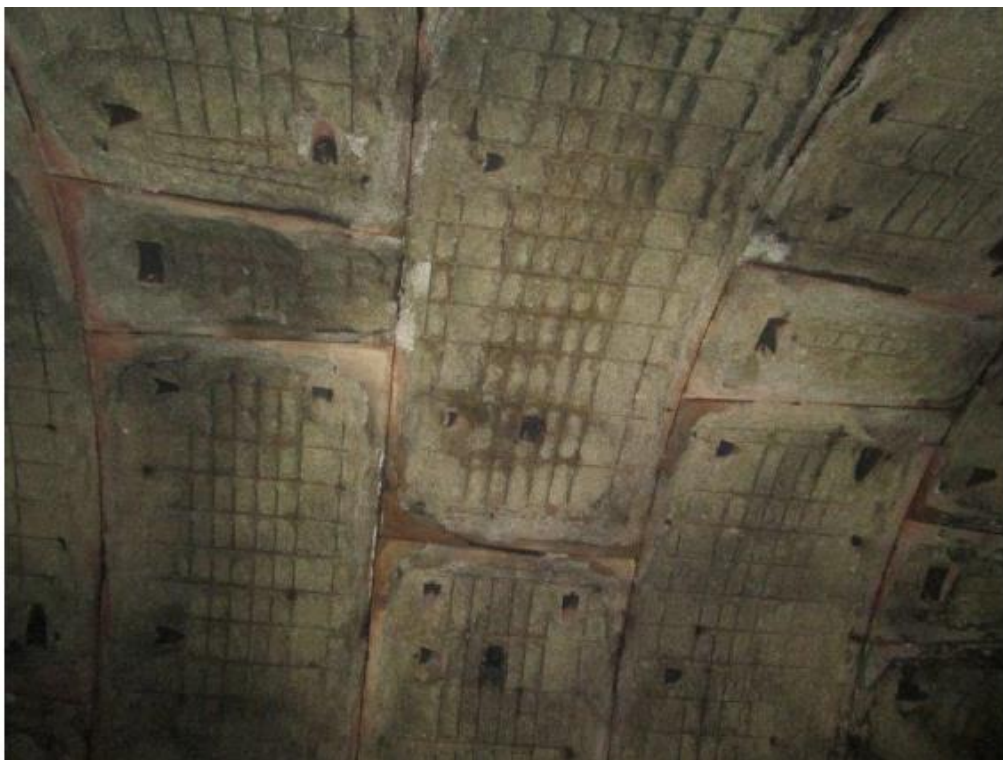
The running tunnel North has been damaged. In addition to the overhead power line and electric cabling which are beyond repair, the reinforced concrete ceiling has been damaged by the fire. The tunnel lining has become detached exposing the reinforcing bars over a length of approximately sixty metres.

*Figure 3: Damage to the tunnel above the burnt out lorries*

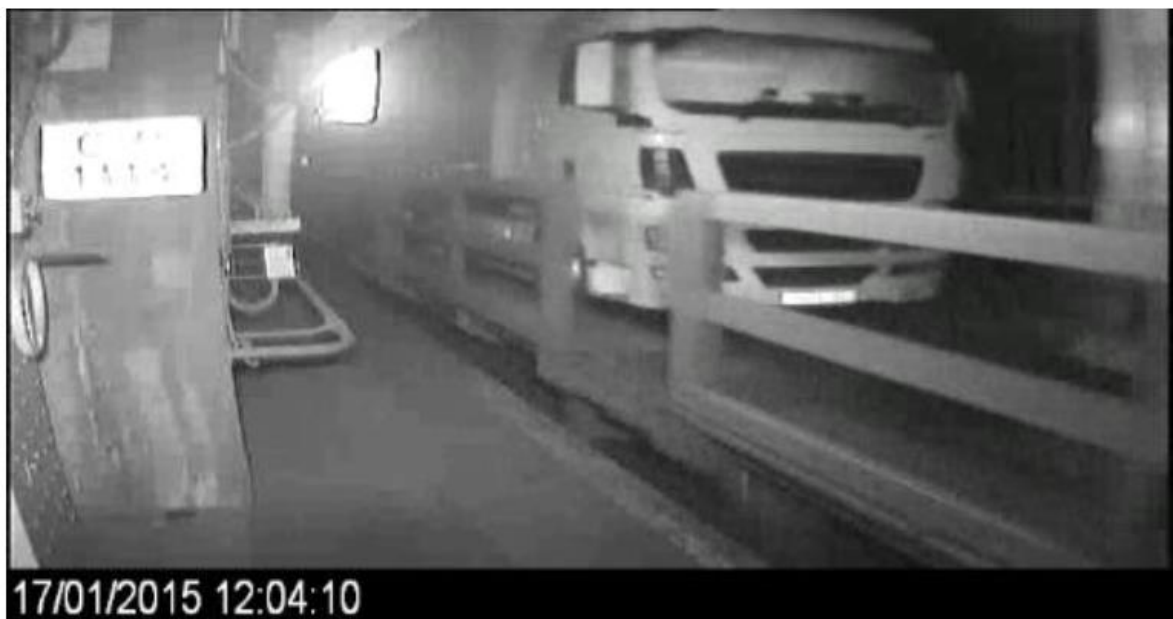
Subsequently the camera situated in the tunnel at CP 1114 showed that at 12:04:10 hrs that the cab of this lorry appeared to be full of smoke.

Figure 4: View of lorry B139CAL at CP 1114

It therefore quickly became obvious that the fire originated from the lorry, registration number B139CAL which was situated on the 15<sup>th</sup> and penultimate wagon of the front rake, and that the fire was caused by an electrical arc between the overhead power line and a part of this lorry.

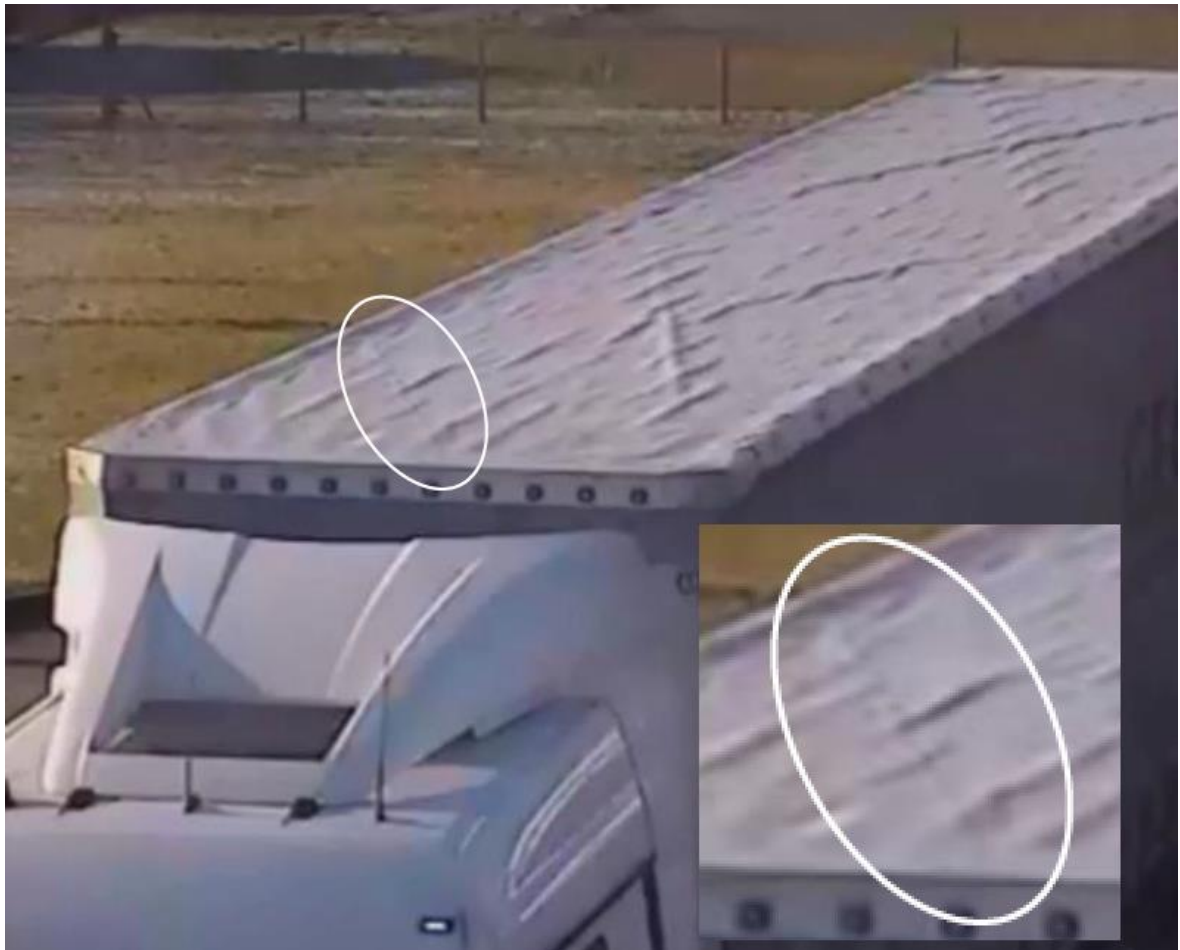
The CCTV footage of the incident lorry passing at 10:43 hrs the tarpaulins check area shows what appears to be a whip aerial standing higher than the leading edge of the trailer.

*Figure 30: Extract from CCTV footage at tarpaulins check area*

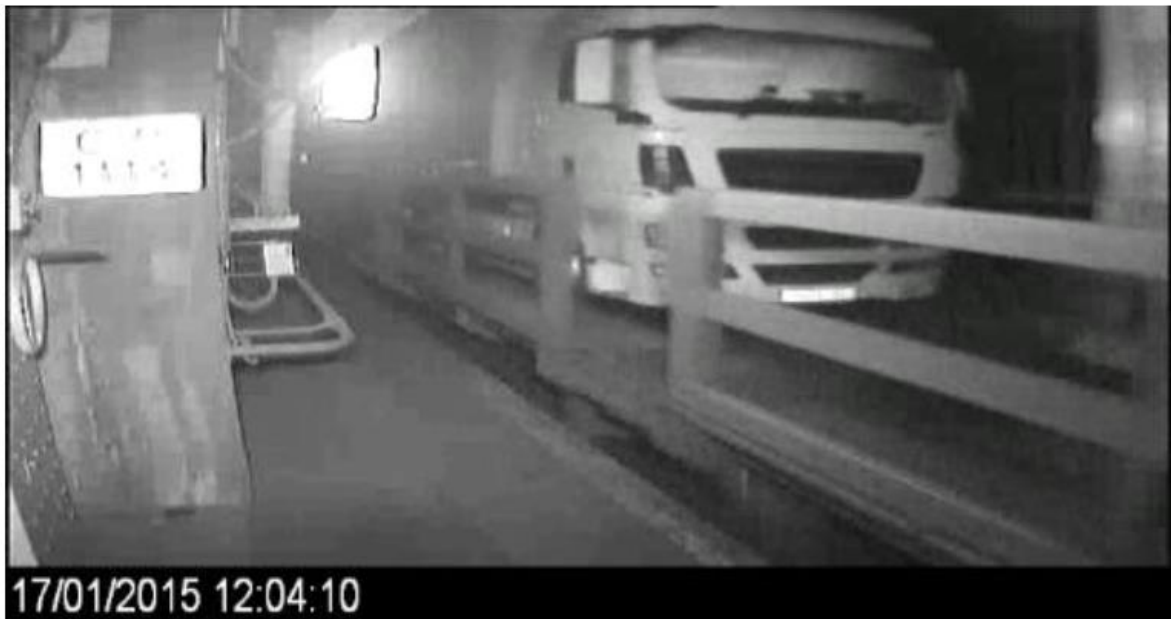
At 12:04:10 hrs, as the cab of the incident lorry passes in front of CP1114, the inside of the cab of the tractor unit appears to be filled with smoke.

Figure 33: Passage of incident lorry at CP 1114

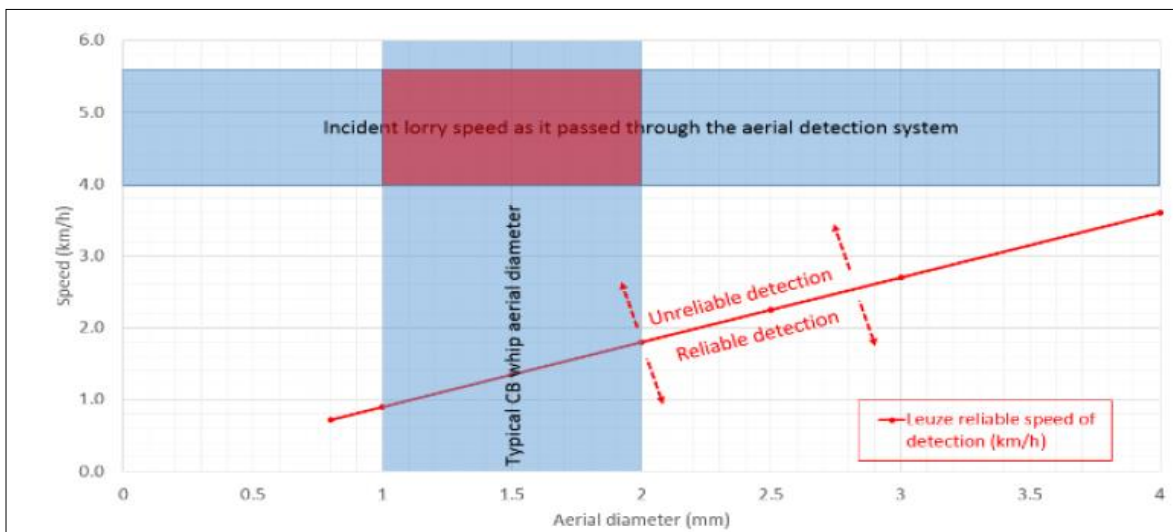
This speed range (4 km/h and 5.6 km/h) is significantly higher than the speed declared by Leuze for reliable detection (1 km/h to 2 km/h depending on aerial size) and may explain why the aerial detection system did not activate for the incident lorry on the day of the incident. Figure 35 shows graphically the range of speeds for reliable detection for different diameter aerals (based on the calculation technique provided by Leuze) together with the speed at which the lorry was travelling.

Figure 35: Graph showing the typical CB aerial diameter and the speed of the incident lorry against the declared speed for reliable detection

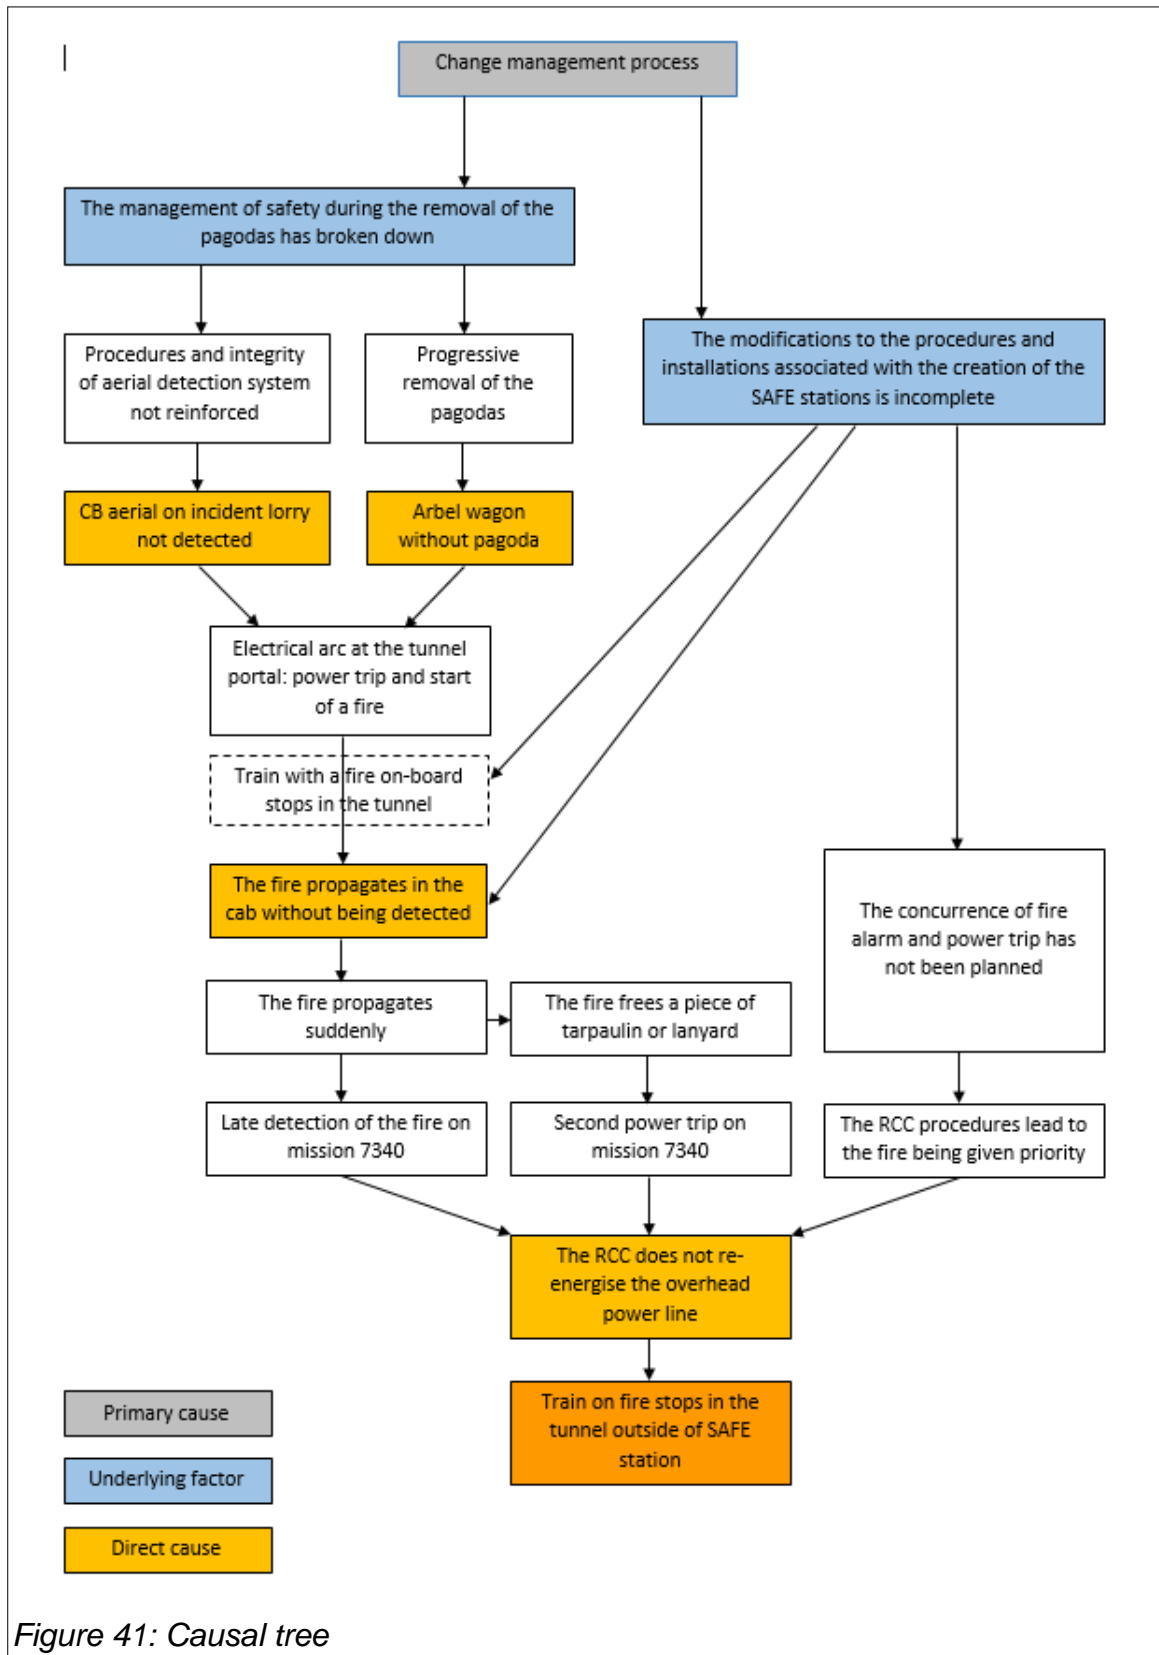
The fire was caused by an electrical arc between the overhead power line and a CB aerial which had not been detected by the aerial detection system and which was mounted on a lorry which had been loaded onto an Arbel wagon without pagoda.

Figure 41: Causal tree
