# ***AAIB Bulletin***

***1/2015***

Published: 8 January 2015

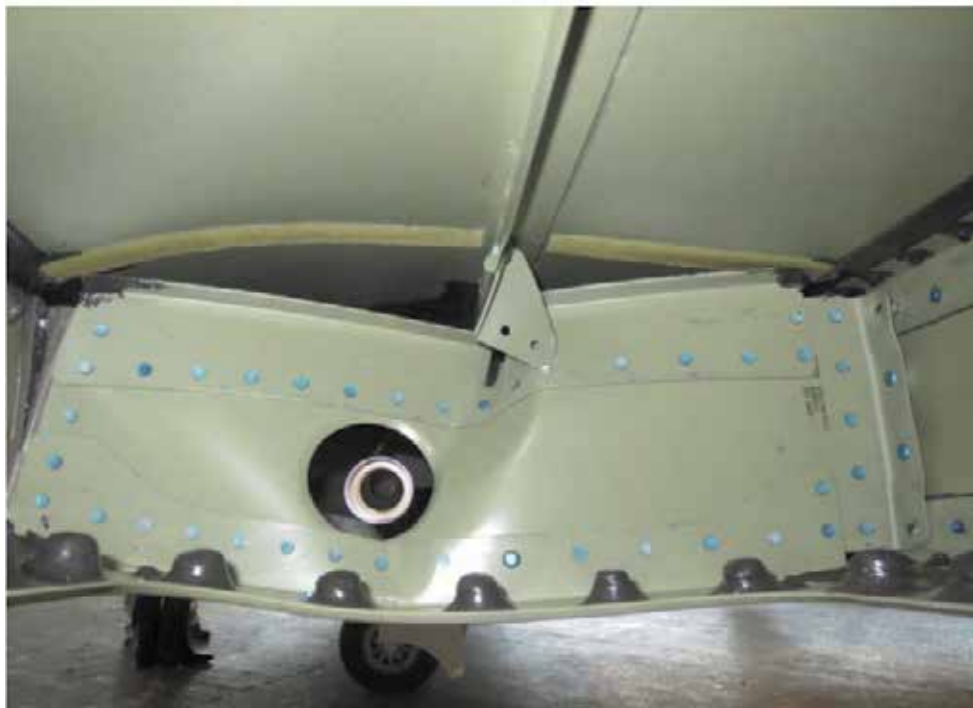
**Figure 2**

Inspection after the accident flight showed that the aircraft's wings were damaged in a manner consistent with overload in positive symmetrical bending. Five ribs in the outboard wingbox of the left and right wings were damaged by buckling in a manner similar to that shown in Figure 2, and the bonded joints between the ribs and the upper and lower wing skins had failed in overload. The upper and lower outboard wing skins of both wings were permanently deformed with a significant loss of aerofoil shape. Despite the disruption to the wing structure, which on this aircraft type forms an integral fuel tank, no fuel had leaked from the wings and the wing skins remained firmly attached to the front and rear spars. The upper wing skins above the main wheel wells, at the inboard end of the wing close to the fuselage, were also found buckled due to overload. The damage was consistent with symmetrical 'pullout' manoeuvre loads between +3.6g ('limit' load) and +5.4g ('ultimate' load).

Right wing internal damage at WS255.25, at approximately mid-span of the aileron

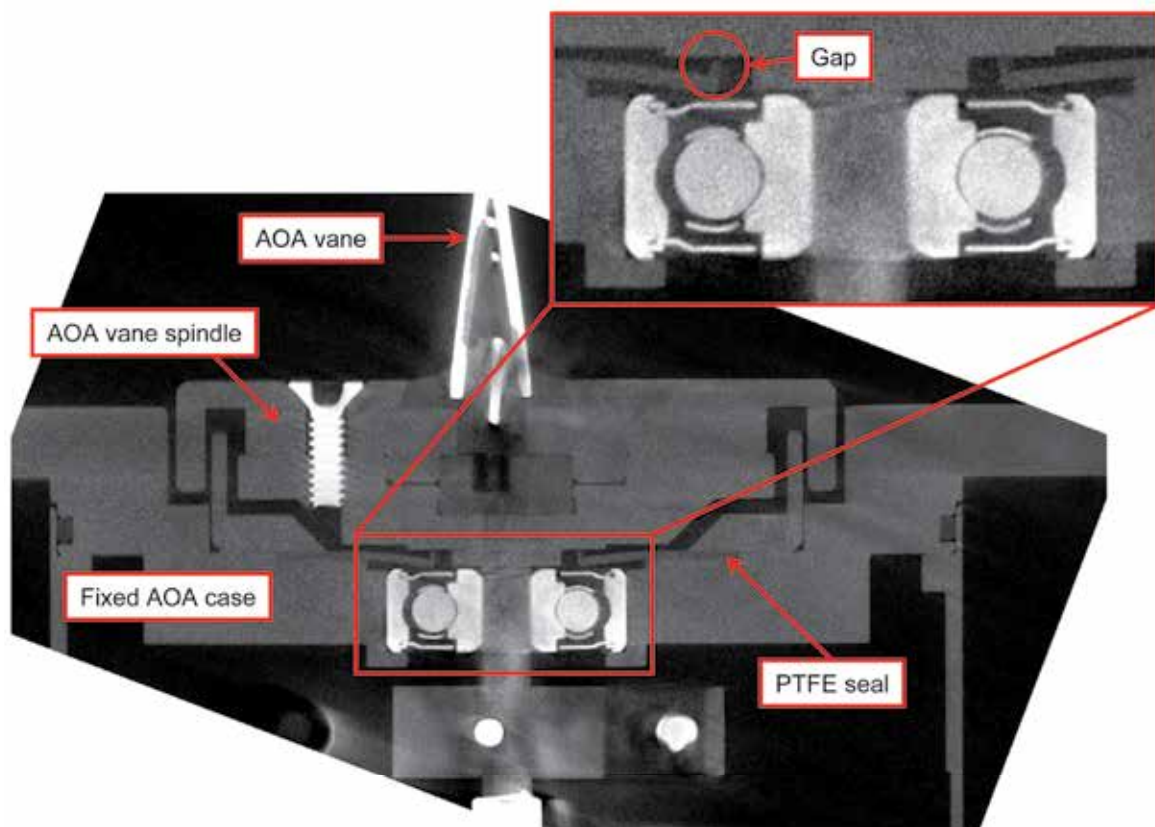
**Figure 10**

CT-scanned<sup>17</sup> prior to disassembly to record its internal condition. The CT scans showed that an internal PTFE (polytetrafluoroethylene – a synthetic fluoropolymer) seal was laterally displaced and was not concentric with the vane spindle assembly or the AOA vane case, Figures 10 and 11. When viewed from the side, a gap was visible between the PTFE seal flange and the vane spindle assembly, which is not intended by the design, as the PTFE seal is required to prevent moisture and foreign objects from entering the AOA vane case from outside the unit.

Gap between AOA seal and vane spindle

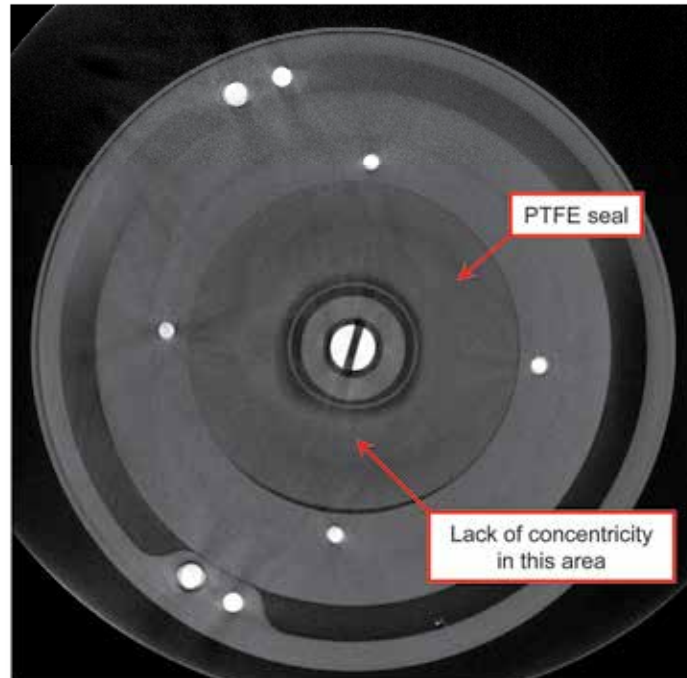
**Figure 11**

2.6 times the factory acceptance limit value of 500 cm<sup>3</sup>/min. Application of a soap bubble solution showed that the leaking air was escaping past the internal PTFE seal and through the annulus formed between the AOA vane spindle and the AOA case.

Lack of concentricity of AOA seal

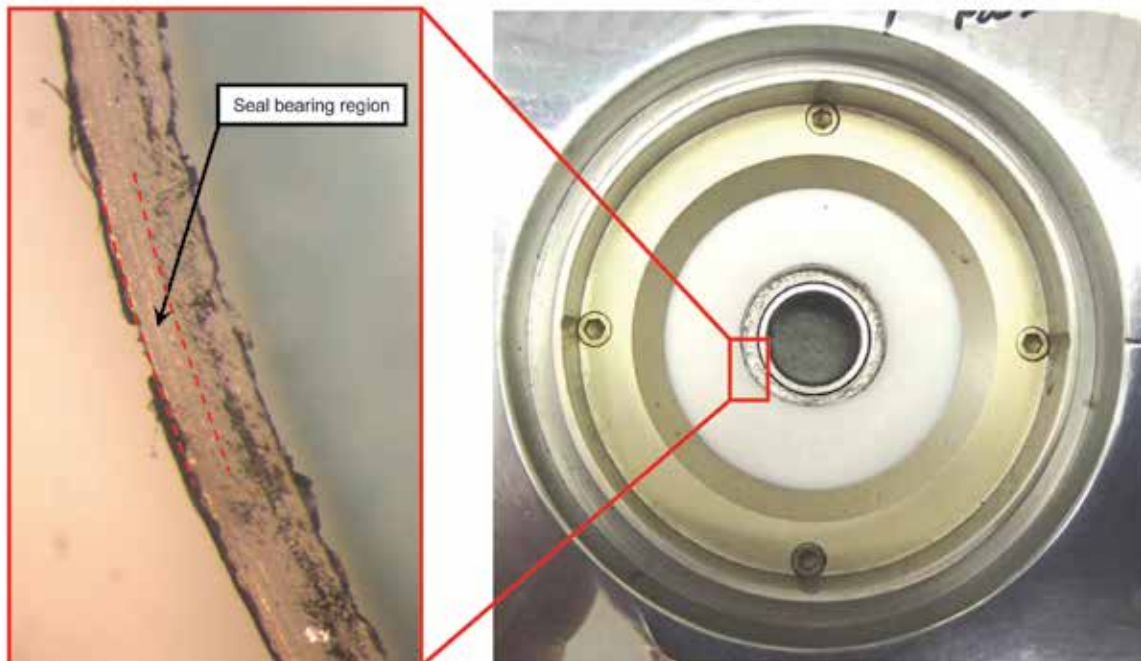
**Figure 12**

AOA seal condition showing circumferential wear marks on the bearing region

The sealing flange of the PTFE seal exhibited surface wear marks around the complete circumference of the flange, indicating that at some point following manufacture, the entirety of the seal's flange had been in sliding contact with the AOA vane spindle. It was therefore determined that the PTFE seal flange had moved to its deflected position at some point during the unit's service life on N380CR.

CT-scanning images of the AOA vane showed that an internal PTFE seal was displaced and was not sealing correctly against the vane spindle, and leak testing of the unit confirmed the lack of sealing capability of the PTFE seal. Witness marks on the PTFE seal's flange showed that, at some point since the AOA vane unit was manufactured, the seal had been in full circumferential sliding contact with the vane spindle. It must, therefore, have moved position at some point during its service life in N380CR.

**Safety Recommendation 2014-041**

It is recommended that the Federal Aviation Administration requires the Cessna Aircraft Company, as the Type Certificate holder for the Citation CJ2+ aircraft, to conduct a survey of recorded flight data from Safe Flight Instrument Corporation model C-12717-1 angle-of-attack vane units, to determine the frequency of 'sticking' (static) angle-of-attack data.

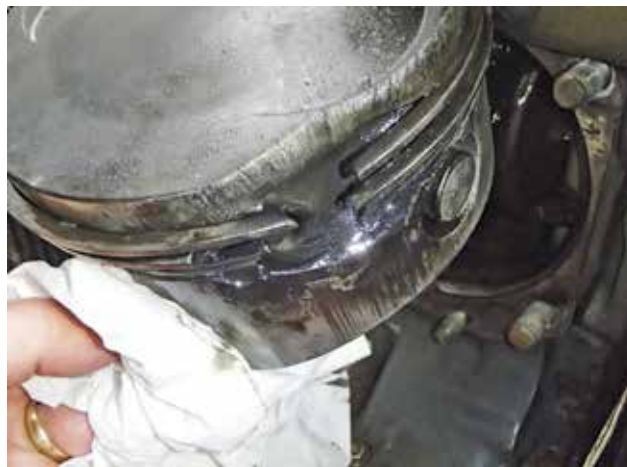
**Figure 1**

On removing the cylinders it was found that the No 6 piston (rear left) had sustained severe damage, in the form of burning and melting, around a portion of its circumference and this extended to the piston skirt and rings; see Figure 1. There were two compression rings and one oil scraper ring and it was apparent that the gaps in the rings were aligned, whereas normal practice is to install the rings such that the gaps are positioned well apart from each other around the piston circumference.

It was apparent that the ends of the rings had been eroded to the extent that the gaps had widened to between 0.5 and 1.0 in.

Left engine No 6 piston, showing damage to crown, skirt and rings

The damage was indicative of 'blow by', where the combustion gases find a

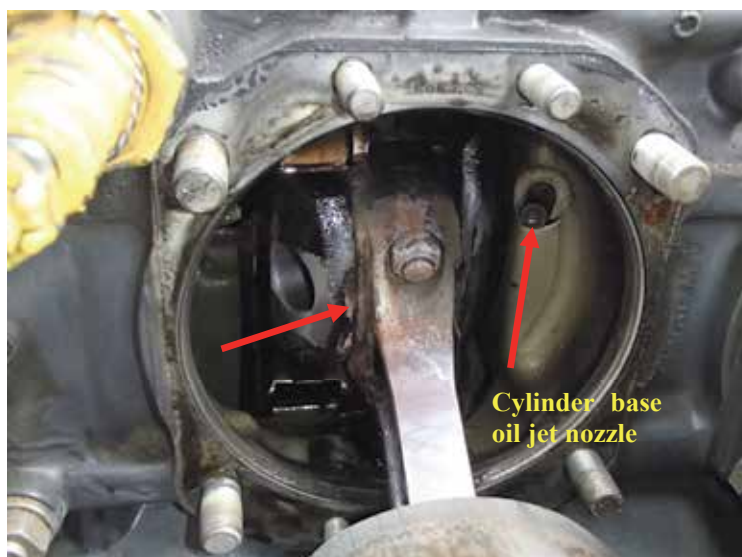
**Figure 2**

way past the piston and into the crankcase. After removing the piston it was found that the connecting rod, together with that of No 5 cylinder opposite, had been severely heat-affected. Removal of the No 5 cylinder revealed that the big end bearing shell material had become extruded onto the flanks of the connecting rod, where it had solidified into flakes; see Figure 2. Similar debris was also found in the oil filler shaft.

No 5 piston connecting rod showing flakes of extruded bearing shell material and oil jet nozzle

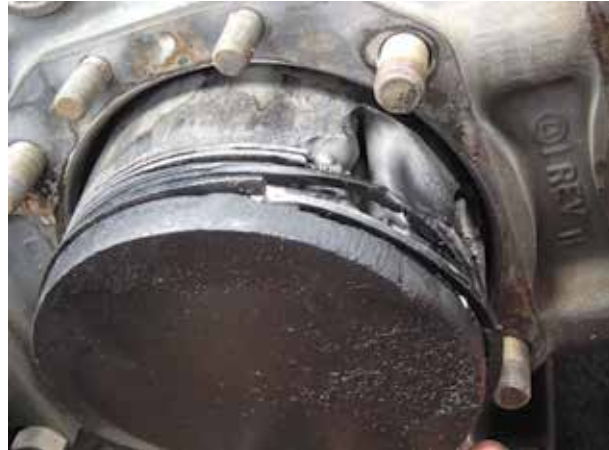
**Figure 3**  
Damaged No 3 piston  
on right-hand engine

On removing the cylinders it was found that the No 3 piston had sustained almost identical damage to the No 6 cylinder from the left engine (see Figure 3).

The piston crown was perhaps less severely damaged in comparison with the left engine's No 6 piston, although the skirt appeared in worse condition, and the observed damage was again indicative of 'blow by' of the combustion gases. It was noted that, although the gaps in two of the rings had become aligned, this was away from the area of burn damage. It was also noted that the rings had broken into a number of segments, a likely consequence of the piston damage.

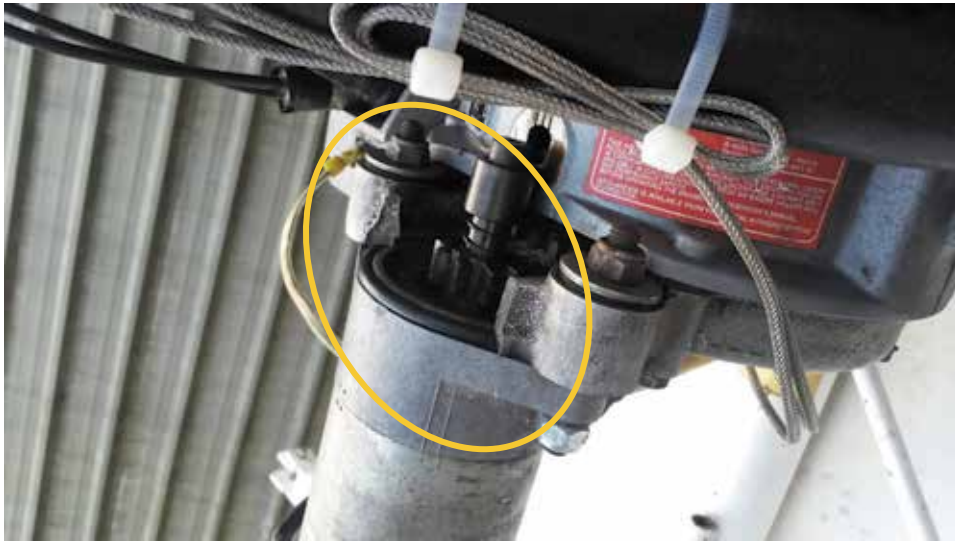
**Figure 1**

Starter motor mounting flange showing missing section
