## SAFETY FLYER TO THE FISHING INDUSTRY

### Fishing vessel *JMT*, capsized and sinking with the loss of two crew 9 July 2015

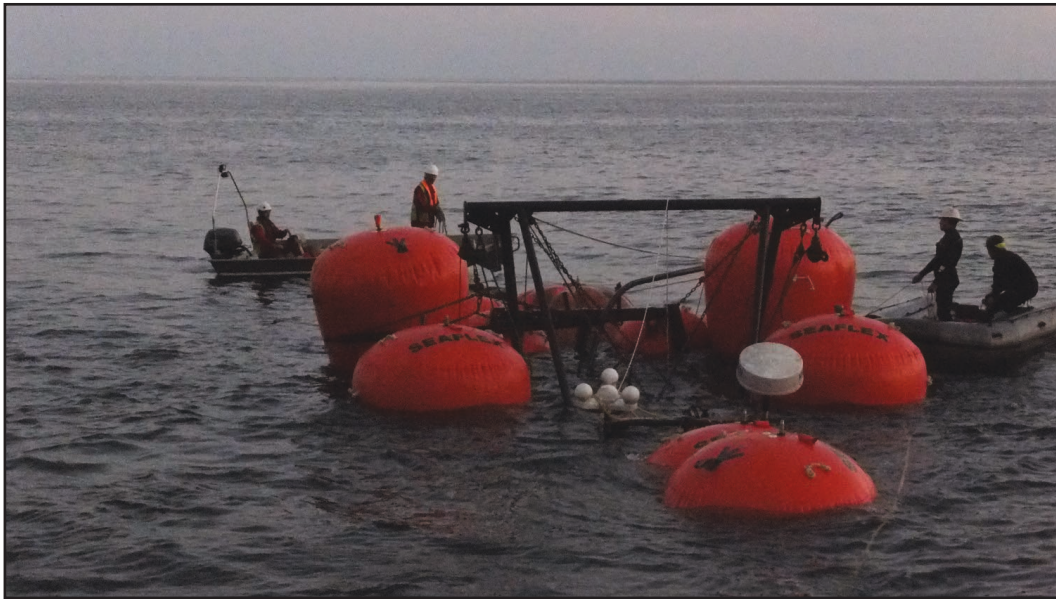
During the afternoon of 9 July 2015, routine contact was lost with the skipper and crewman on board the 11.4m scallop dredger *JMT* that was fishing off Plymouth, UK. A search and rescue operation was initiated the following morning when the vessel did not return alongside as expected. The body of the crewman was found floating in a life-ring; he was not wearing a lifejacket. The wreck of the vessel was located 3.8 miles off Rame Head and was later recovered. The skipper was not found.

- *JMT* capsized and sank at around 1501 on 9 July 2015; the weather was good at the time, with slight seas.
- The vessel had only 25% of the reserve of stability required by larger fishing vessels.
- The vessel's stability had been adversely affected by structural modifications and by aspects of the vessel's operation.
- Capsize was possibly triggered by emptying the starboard dredges while the port dredges and their contents remained suspended.
- The crew's likelihood of survival was reduced by not having the opportunity to broadcast a distress message, release the EPIRB from its stowage, lifejackets not being worn and the failure of the liferaft to surface.

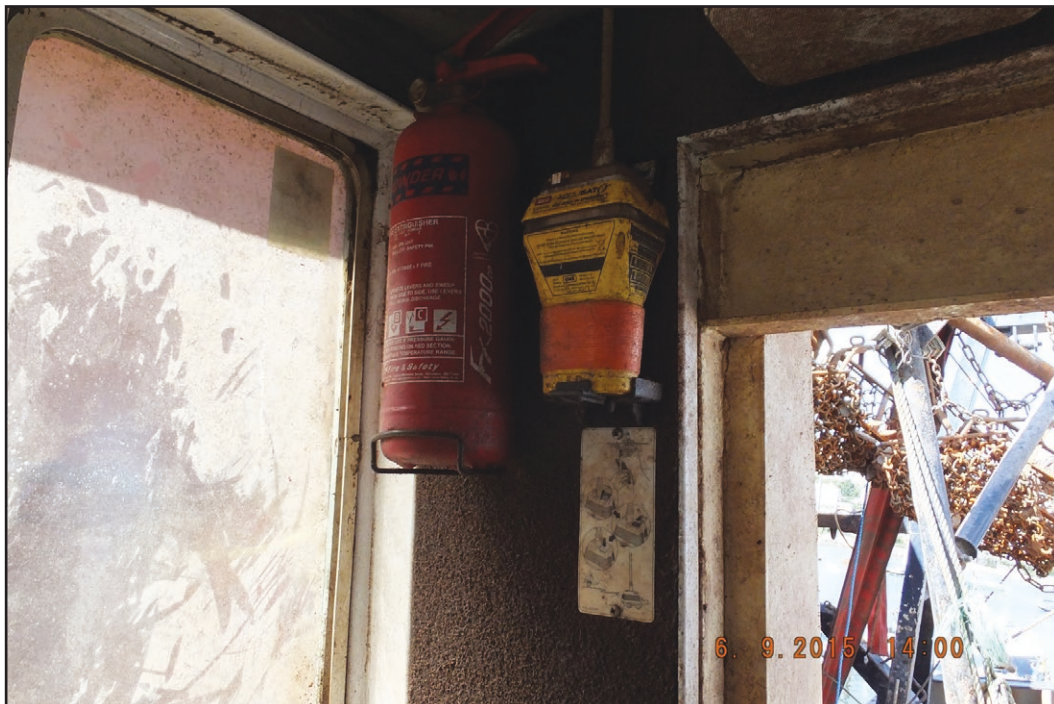
6. It took over 18 hours for the crewman to be found because the EPIRB was kept in the wheelhouse and was not float-free. The fitting of a float-free EPIRB would have alerted the coastguard almost immediately and would have dramatically increased the likelihood of the crew's survival.
