PART 1.4 – ANALYSIS AND FINDINGS

1.4.1 On 11 Oct 15 at 1623 hours (hrs), a Royal Air Force (RAF) Puma HC Mk2 Helicopter, tail number XW229, struck the tether of a Persistent Threat Detection System (PTDS) aerostat and crashed within the confines of the NATO Headquarters in Kabul, Afghanistan. The aircraft was the subordinate element of a formation of two Pumas that were operating with the callsign [REDACTED]; the lead aircraft, ZJ955, was [REDACTED] (A21), and XW229 was [REDACTED] (A22). Two crew members and 3 passengers were killed. The third crew member and 3 additional passengers suffered various major injuries; one bystander was also injured.

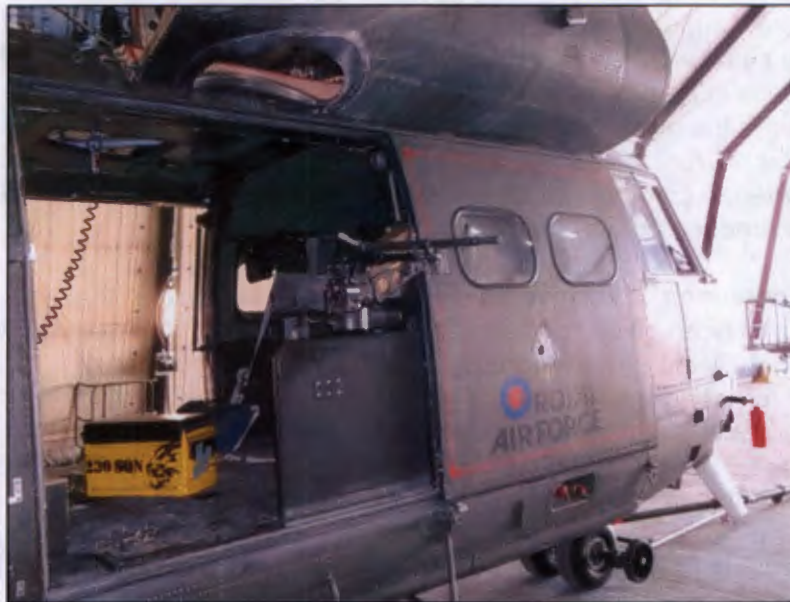
Figure 1.4.3 Image showing restricted access to passenger Cabin caused by Crew Served Weapon

1.4.92 The 2 front right passenger seats were unoccupied and were therefore available for the Crewman in the event of an emergency.

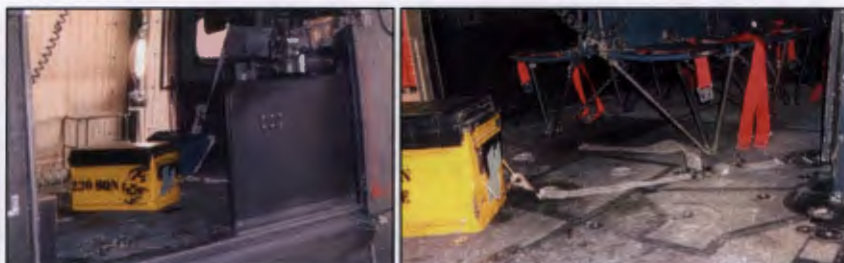
1.4.100 The Panel became aware that the Puma Force was utilising an ammunition container⁴⁹ within the aircraft cabin as a seat/knee rest for the crewman. It was also utilised to hold small items such as water bottles. The use of the container had become common practice for deployed operations⁵⁰, particularly when a crew served weapon system was fitted to the aircraft. Due to the nature and size of the Puma cabin, the container was used to provide a degree of relief to knee/back discomfort. The container was secured to the cabin floor by 2 x 'P' stops; it was reported that during passenger embarkation and deplaning the container was released and moved clear. An example of the use of a container is shown in Figure 1.4.5.

Figure 1.4.5 Ammunition Container in Puma HC Mk2 Cabin

The Panel could find no evidence within the Puma HC Mk2 RTS or Aircrew Manual that the container was cleared for use as an approved aid to the crewman. The Panel considered there were potential safety risks⁵¹ associated with the practice that may not have been appropriately considered and accepted by the Duty Holder chain; this was raised by the Panel in a Safety Advice Note.

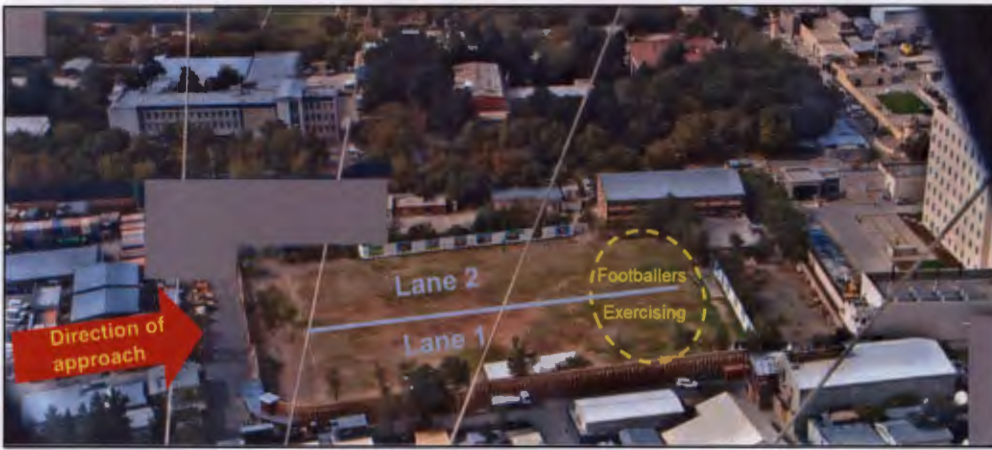
Figure 1.4.8 Location of footballers on SOC HLS

1.4.131 Although the formation had an approved PPR and was scheduled to arrive at circa 1605 hrs, it did not prevent sporting activity from taking place. The PPR was valid for 15 min and was a 'no earlier than' time. Irrespective of the PPR, the HLS should have been cleared 5 min prior to arrival or at least when the aircraft established radio communications with SOC OPS. However, as this was not achieved until the aircraft were 1 min away from SOC, the field was not clear of footballers to enable an immediate approach to be made. As a result the Panel concluded that the formation had no option other than to go around.

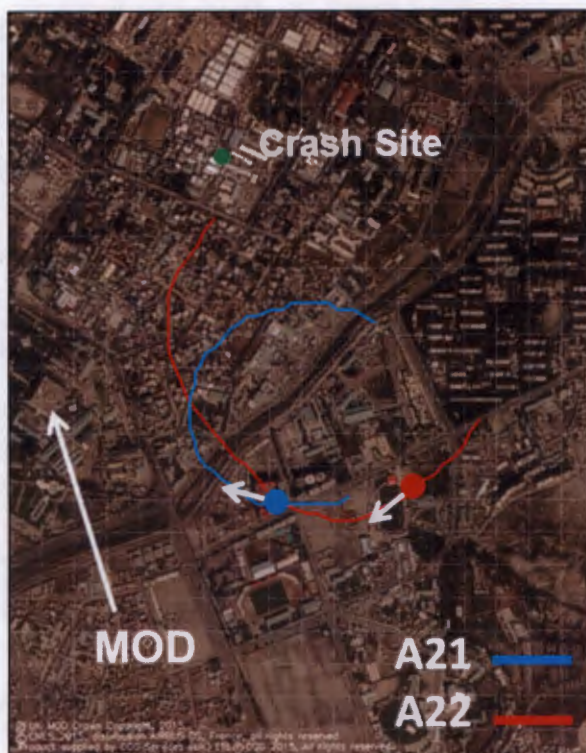
1.4.146 The positions of the aircraft in relation to each other and the MOD at the time the Co-pilot made the palace statement are shown at Figure 1.4.10. The direction of the aircraft headings are represented by the white arrows but is a snap shot as both aircraft are in right turns.

Figure 1.4.10 Position of aircraft when Co-pilot states ‘Don’t go over the Palace..’

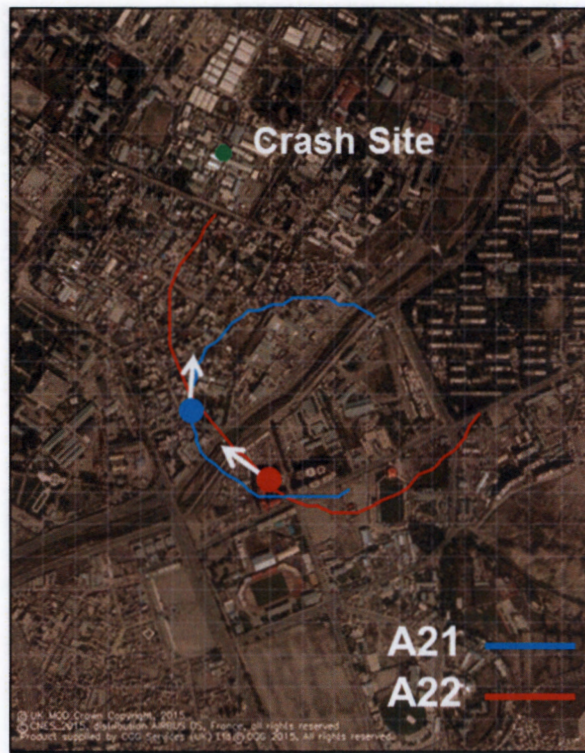
The relative positions between the aircraft as the pilots discuss the MOD is shown in Figure 1.4.11. The CVFDR evidence showed that this was the moment that the aircraft started to diverge from each other.

Figure 1.4.11 Image showing the start of aircraft track divergence; 11 sec after Figure 1.4.10

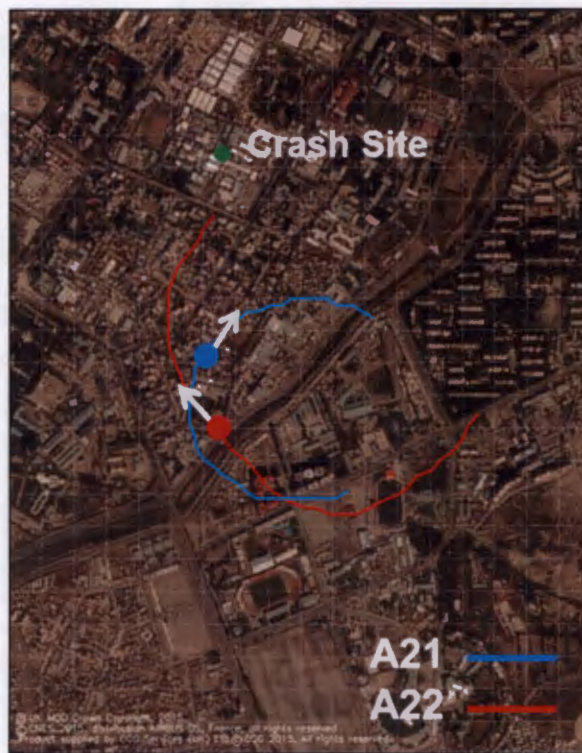
As A22's Captain mentioned being north of the road, the divergence between the aircraft's tracks increased, at this moment the aircraft were 230 m apart; this is shown at Figure 1.4.12.

Figure 1.4.12 Increasing track divergence; 5 sec after the positions shown in Figure 1.4.11

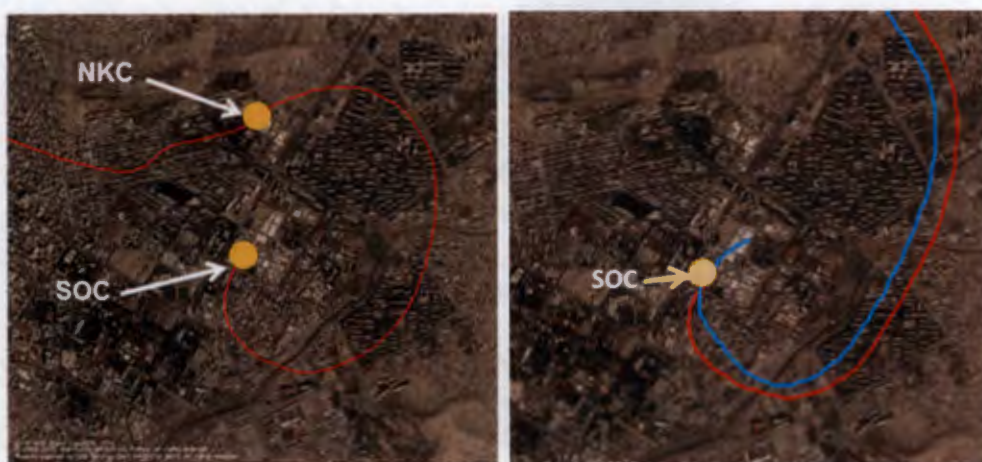
1.4.150 A22 had been into SOC on 3 previous occasions that day and the pilots had been there circa 25 times in the previous 3 weeks. The approach profile flown on the previous sortie was similar to that executed during the accident sortie and is shown in Figure 1.4.13. As a result the Panel could not determine why the Co-pilot of A22 misidentified building locations.

Figure 1.4.13 Comparison of approach profiles. Sortie 3 on left at 1449 hrs and arrival from HKIA(N) on right at 1620 hrs

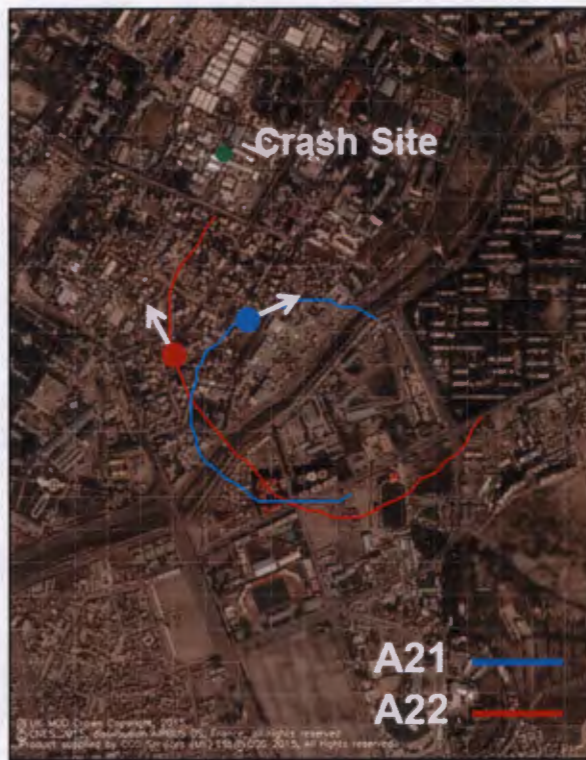
Figure 1.4.14 Relative positions of A21 and A22 when A22's Captain declared he was "off lead"

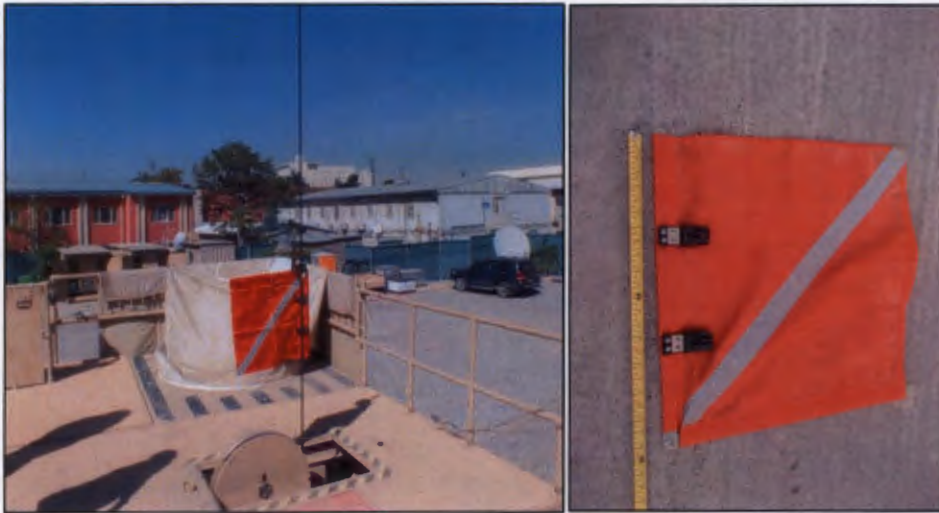
1.4.180 During daylight hours white flashing obstruction lights were affixed to the aerostat tail fins and orange flags attached to the tether. Each flag was 23 inches square with a 2 inch strip of reflective tape secured on each side and a stiffener used to expose the flag and prevent drooping in calm wind. Flags are shown in Figure 1.4.17. The flags were attached 1000 ft below the aerostat and thereafter at 200 ft intervals with a final flag at 100 ft AGL; they were affixed to the tether as the aerostat ascended to operating altitude. The flags were not free to rotate with the wind but were attached at varying angles to provide differing aspects to aid conspicuity. At night either red visible or infra-red obstruction lights were used, these were located slightly above each flag so as not to impede observation of the other and were activated automatically by light sensors.

Figure 1.4.17 - PTDS flags

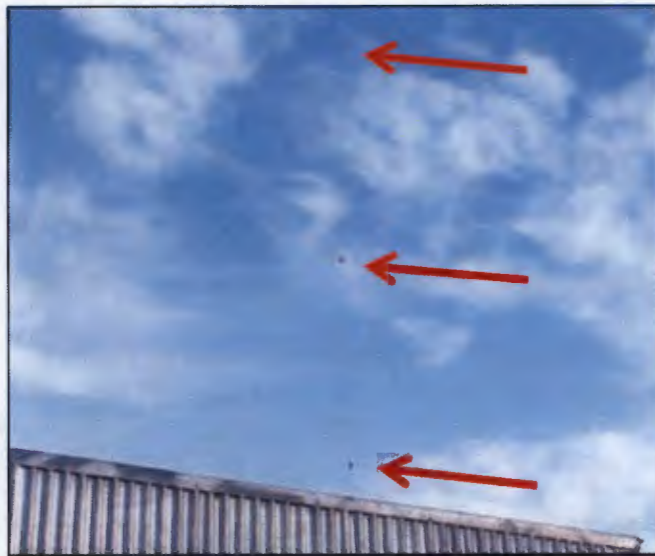
1.4.185 It was reported to the Panel that the tether and flags could be difficult to see. In interview a TAD pilot stated that the tether could be seen when contrasted against a clear sky, however when set against the urban backdrop it was harder to detect. Figure 1.4.19 shows the flags on the PTDS tether when viewed from the ground at a horizontal distance of approximately 120 m.

Figure 1.4.19 - Flags on PTDS tether viewed from the ground at a distance of approximately 120 m
