AAIB Bulletin

10/2015

Published 8 October 2015

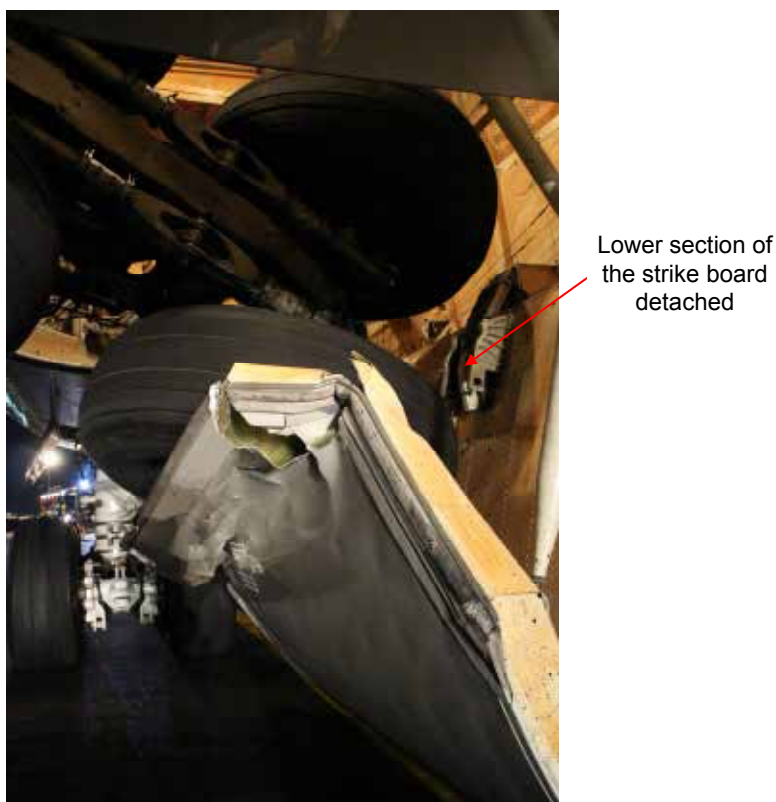
Figure 2

Once the passengers had been disembarked, an initial inspection of the landing gear was conducted. The right wing landing gear door was partially open, with the outboard rear wheel of the wing gear resting on the outboard section of the door. The outboard section of the door was significantly deformed, but the door itself was still firmly attached and the gear was securely held in a partially deployed position. (Figure 2) Evidence of leaking hydraulic fluid was found around the upper section of the gear leg, but there was no obvious damage to the wing gear in the areas visible during initial inspection. The lower section of the strike board in the right wing landing gear bay was missing.

The left wing gear door was in the fully open position, as were the two body landing gear doors. None of the landing gear doors showed evidence of contact with the ground. Both the body landing

Right wing landing gear door and gear leg as found just after landing.

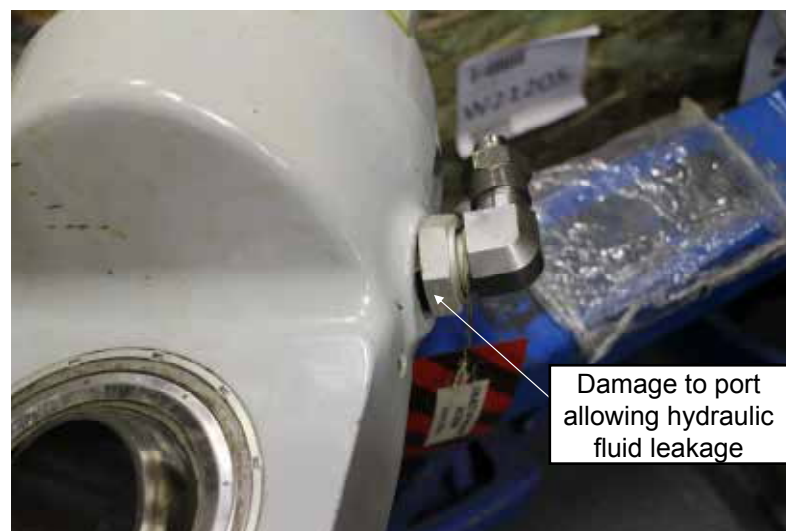
Figure 3

The aircraft was recovered from the runway and towed to the operator's hangar for further investigation. The damaged wing landing gear door was removed and the right wing landing gear leg fully extended. The right wing landing gear actuator was found installed 180° out of alignment. The hydraulic port boss fitting on the head end of the actuator was distorted and damaged (see Figure 3).

Damaged hydraulic port on landing gear actuator

The significance of this maintenance error was that the hydraulic fluid ports on the actuator were now transposed, with the port at the head end of actuator facing upwards. The AMM did not require the gear to be fully cycled following maintenance. Consequently, the insufficient clearance between the hydraulic port and the top of the landing gear bay, when the gear was in the retracted position, was not identified until the first time the gear was retracted fully during the incident flight the following morning. The force exerted on the hydraulic port as the gear retracted, caused it to distort and release hydraulic fluid at the full system pressure of 3,000 psi. This rapidly depleted the reserve of hydraulic fluid in system 4, generating a low quantity and then low pressure warning in the flight deck.

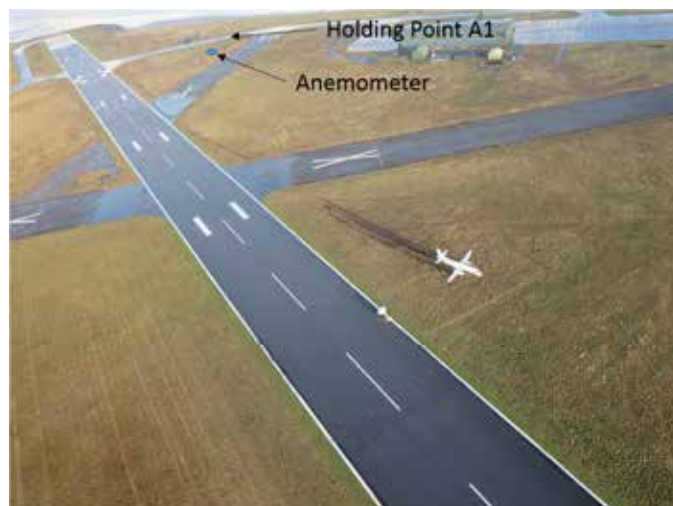
**Figure 1**

General view of accident site

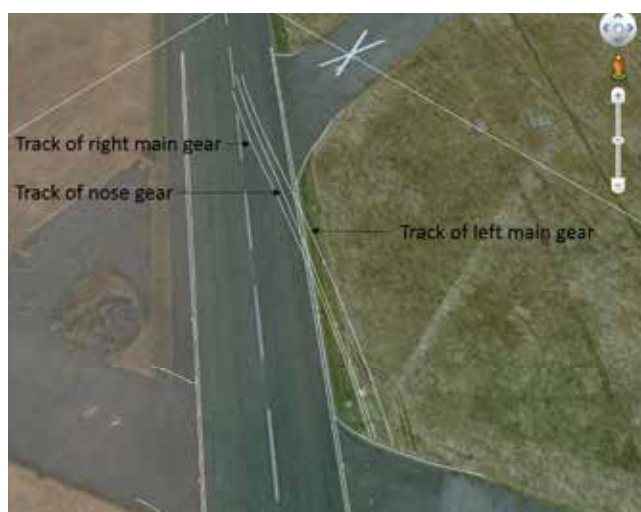
**Figure 2**

The rubber marks left by the tyres indicated that the tyres were not rolling straight ahead and, as the aircraft approached the side of the runway, the geometry of the marks indicated that the aircraft was progressively yawing to the right of its direction of travel (Figure 2). Calculations indicated that this yaw angle reached a maximum of approximately 14° just after the aircraft entered the grass beside the runway and it remained fairly constant until the aircraft reached the disused runway. There were no tyre marks across the disused runway but when they reappeared in the grass on the far side the aircraft was no longer yawed. Shortly after this point the ground markings indicated where the nose landing gear collapsed.

Tracks of the aircraft landing gear (Police Scotland)

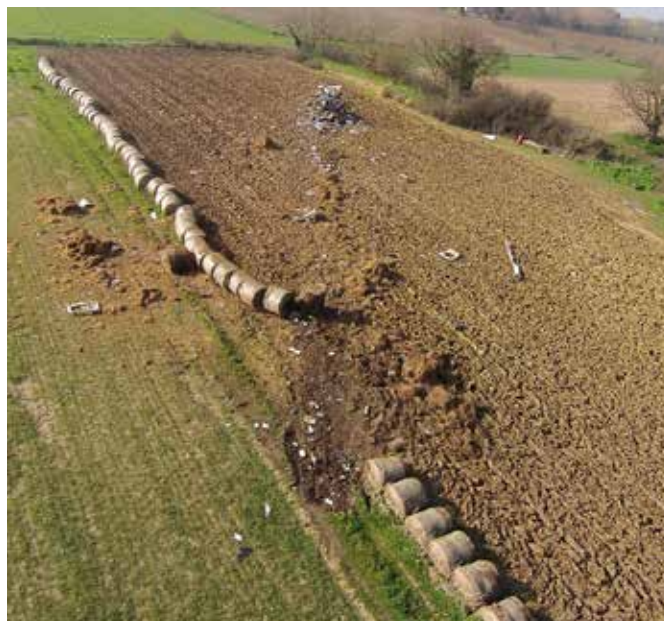
Figure 7

A second impact mark, which contained elements of the forward fuselage and passenger cabin structure, was identified 45 m beyond the first ground mark. Several items from the nose avionics bay, including both batteries, had been released between the first and second impact marks. The fuselage came to rest 18 metres beyond the second impact point facing

180° to its direction of travel. The ground markings and distribution of wreckage between the second impact point and the fuselage's resting place indicated that the helicopter had become airborne again after the second ground impact. During the impact sequence three of the five main rotor blades had detached from the rotor head.

General view of the accident site

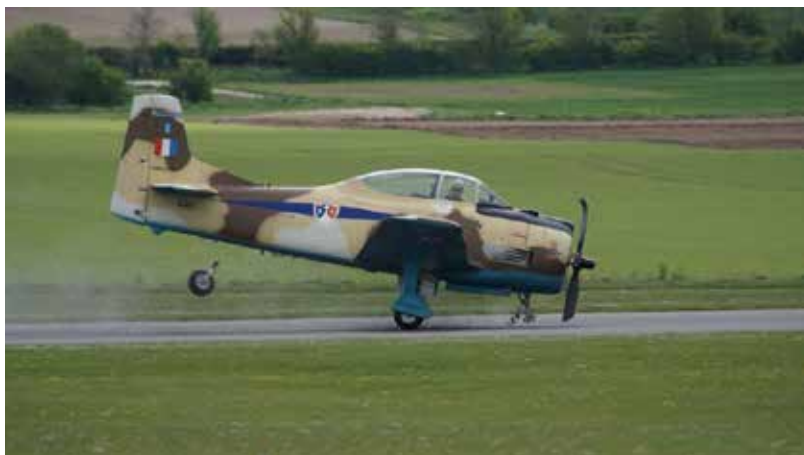
The aircraft was on its takeoff run for an air test after annual maintenance and, as it accelerated through 80 kt IAS, the pilot became aware of a pronounced and severe lateral vibration through the airframe. The pilot immediately closed the throttle and the nose of the aircraft simultaneously dropped as the nosewheel and yoke detached. The propeller struck the runway and stopped; the aircraft continued an estimated 150 yards before coming to a stop on the runway, resting on its main landing gear and the remains of the NLG strut. The pilot made the aircraft safe and exited without further incident. Figure 1 shows the nosewheel and yoke detaching during the takeoff run.

Nosewheel and yoke detachment during the takeoff run
(Picture courtesy of Mr Brian Marshall)

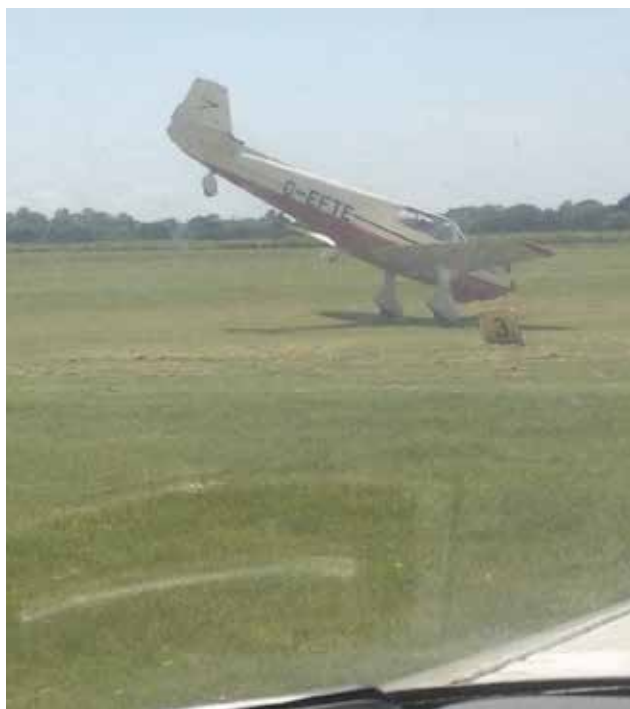
Figure 2

An eye witness to the event was a pilot conducting pre-flight checks while sitting in the left front seat of a Piper PA-28 parked on row 2 in position A or B as shown in Figure 1. She observed G-EFTE taxi in front of her aircraft and stop next to the row 3 sign. She then saw G-AXOJ taxi through a gap of parked aircraft on row 3 and taxi towards her in front of row 2. G-AXOJ then stopped in front of her aircraft and she believed the pilot was looking for somewhere to park. The aircraft then taxied behind G-EFTE and at some point "put on a fair bit of power", and as they did this the tail of G-EFTE began to lift into the air. She reported that the pilot of G-AXOJ did not appear to look at G-EFTE and taxied away to park. She took a photograph of G-EFTE resting on its propeller, before the fire service arrived (Figure 2).

Photograph of G-EFTE taken by the eyewitness in the parked Piper PA-28

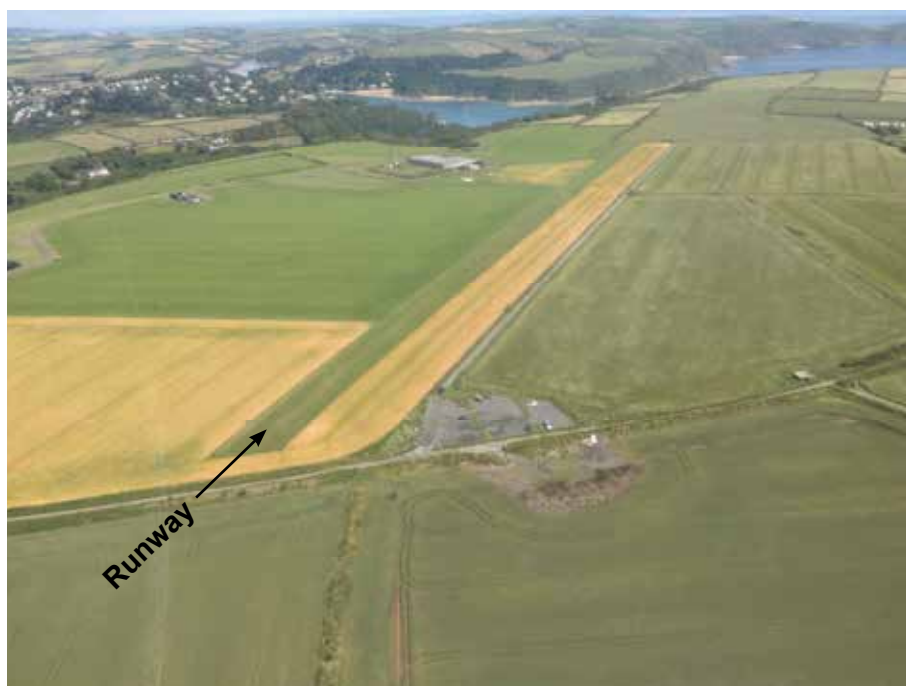
Figure 1

'JULY 2015 - WARNING - THE STRIP OF CROPS TO THE SOUTH OF THE RUNWAY CAN BE DECEPTIVE AND CAN APPEAR TO BE RUNWAY - IT IS NOT , IT IS 3FT HIGH CROPS - INBOUND PILOTS MUST POSITIVELY IDENTIFY THE RUNWAY AND LAND ON THE MOWN GRASS PER OUR PLATE AND PHOTOS, NOT ON THE CROPS .'

View looking along Runway 11 showing a barley crop growing along its southern edge, with more barley and a green corn field to the north. Pictures taken at different times of the year show that contrast and colours vary with ripeness of the crops.
