Rail Accident Investigation Branch

# Rail Accident Report

**Passenger trapped and dragged under a train at  
West Wickham  
10 April 2015**

Report 03/2016  
February 2016

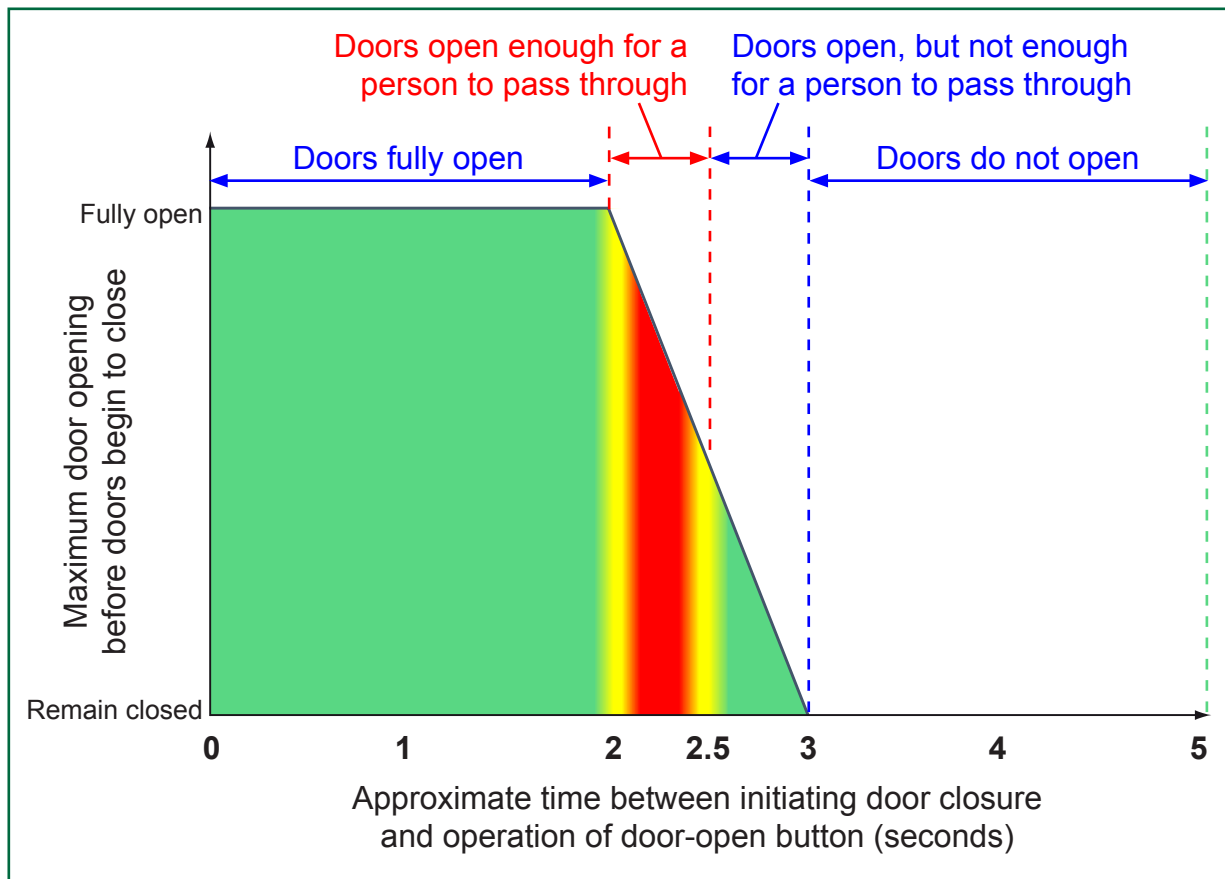
- 46 The testing also showed that the door-open buttons adjacent to closed doors remained illuminated during the closure cycle. If a door-open button was pressed during the first two seconds of the cycle, the doors reached the fully open position, but then closed almost immediately. Pressing the door-open button between about 2.0 seconds and 2.5 seconds after initiation of closure resulted in the doors partially opening, to a width sufficient for a person to pass through, and then suddenly closing. Beyond 2.5 seconds, the doors may open, but not enough for a person to pass through (figure 8).

Figure 8: Amount doors open if passenger presses open button after driver initiates door closure

- 47 Testing also showed that, compared to the normal door closure speed, the door closing speed was significantly faster if the doors had only partially opened. During normal door closing the average door closing speed of fully-open doors was 0.44 m/sec. The closing speed increased to around 0.62 m/sec if the doors began closing from a partially open position with a gap of about 0.7 m between the door leaves. The faster door closing speed reduced the total time the doors were open as the passenger got off the train.

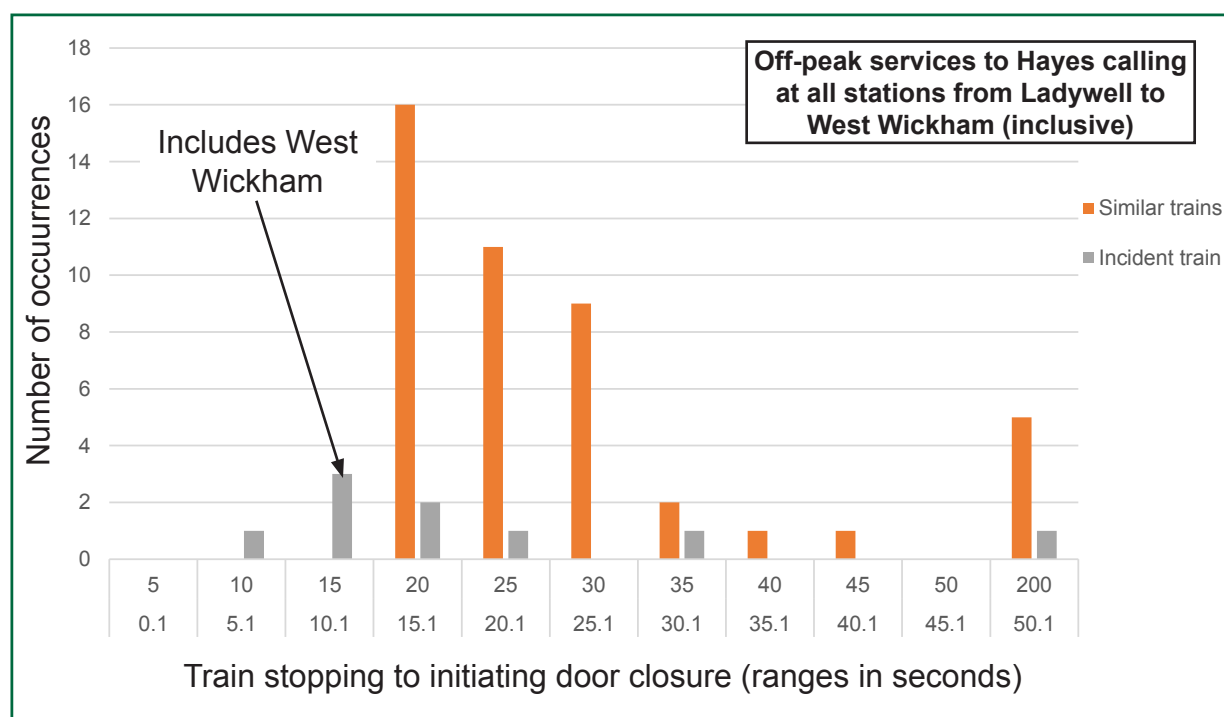
61 Analysis of data from five similar services (paragraph 93) showed that door closure on the incident service was sometimes initiated earlier than on all other services included in the sample (figure 9). Four of the nine closure sequences on the incident service were initiated less than 15 seconds after the train stopped, including the 10 second period at West Wickham, and a shorter period at one other station. A period of at least 15 seconds was allowed at all stops made by all other trains in the sample. The RAIB has not established the particular circumstances associated with each station stop included in figure 9 (eg whether drivers could see passengers disembarking for a considerable time period, and instances when drivers were waiting for their booked departure time). However, comparison with RAIB testing (paragraph 58), shows that at some stations the incident train driver did not allow sufficient time for mobility impaired people to disembark safely. This leads to Learning point 1 (paragraph 135).

Figure 9: Time interval between train stopping and driver initiating door closure sequence

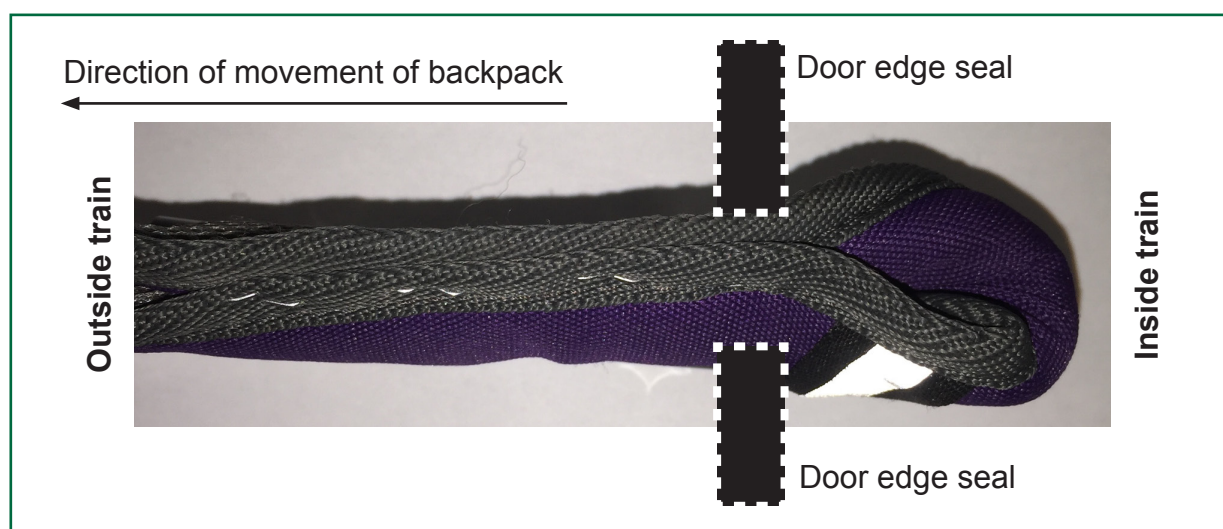
- 72 CCTV footage from the platform and the train shows the passenger trying to pull her trapped backpack from between the closed doors. The images show that the bag was outside the train, but the strap was trapped and she was not able to generate enough force to free it, even when she was seen leaning away from the train (without pushing off the side of the train). The RAIB used the backpack that was involved in the accident in a series of tests to determine the likely reasons why the passenger was not able to pull the thin backpack shoulder strap free. The tests indicate that either the backpack shoulder strap became twisted and trapped against the inside of the closed doors, or a buckle on the strap became trapped flat against the inside of the closed doors (figures 10 and 11).

Figure 10: Twisted strap trapped on the inside of the closed doors

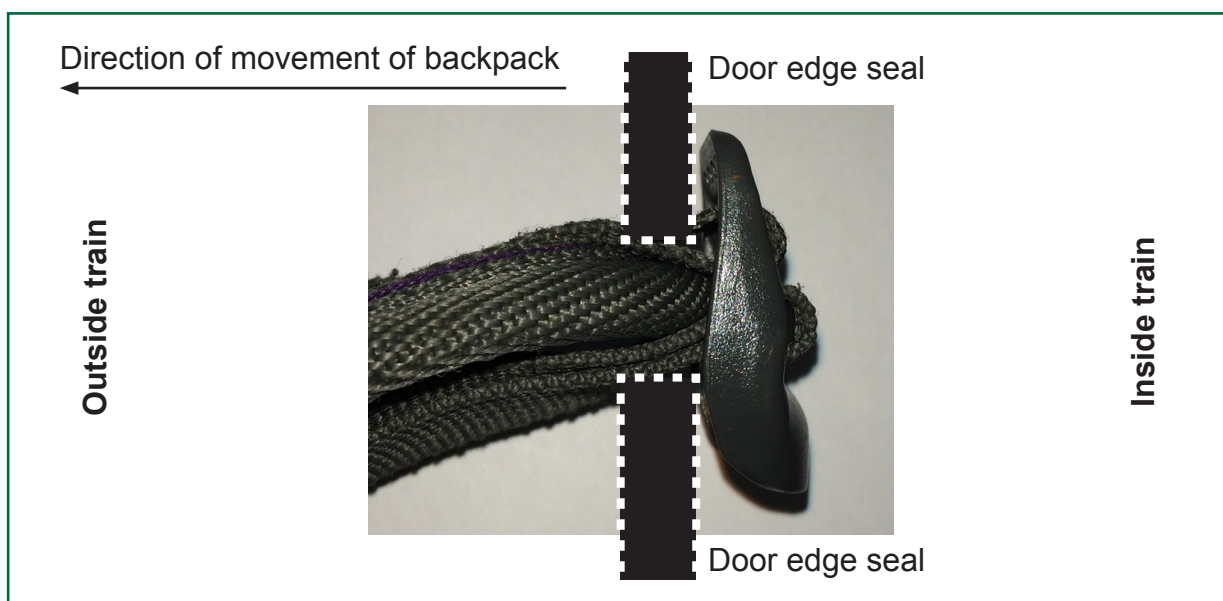
Figure 11: Buckle lying flat against the inside of the doors

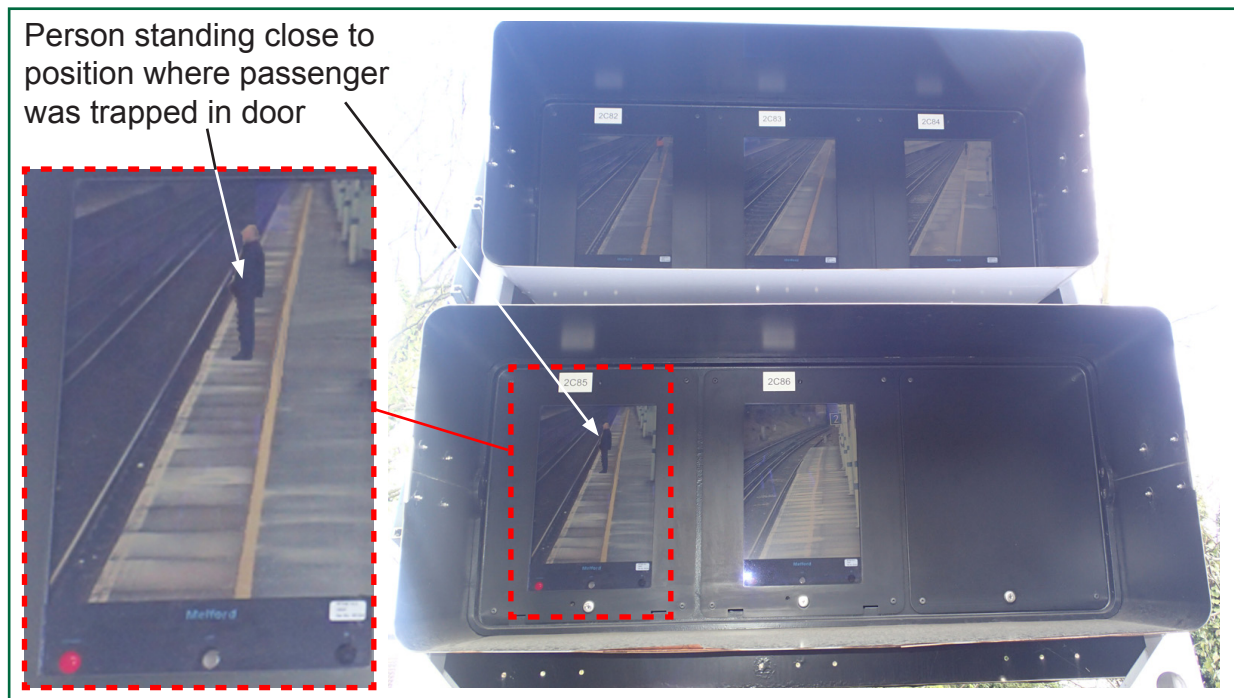
- 78 **Although shown on the DOO monitors, neither driver was aware of the trapped passenger when the train doors were closing, or afterwards.**
- 79 The RAIB established that the train stopped in the correct position with the DOO monitors visible from the driving cab. The monitors were functioning correctly and a person standing at the location where the passenger got off the train would have been visible on two of the five monitor screens, with the view of her in the top right-hand screen being less discernible than in the bottom left-hand screen (figure 12). DOO train drivers departing from West Wickham are required to use these monitors to complete a train safety check after all doors are closed, and before the train departs (paragraph 37). This check should always be carried out after the door interlock light is illuminated and is intended to make sure that the train is safe to start (eg there is no one trapped in the doors).

Figure 12: Location of passenger on the DOO monitor images (position of person superimposed on to image)

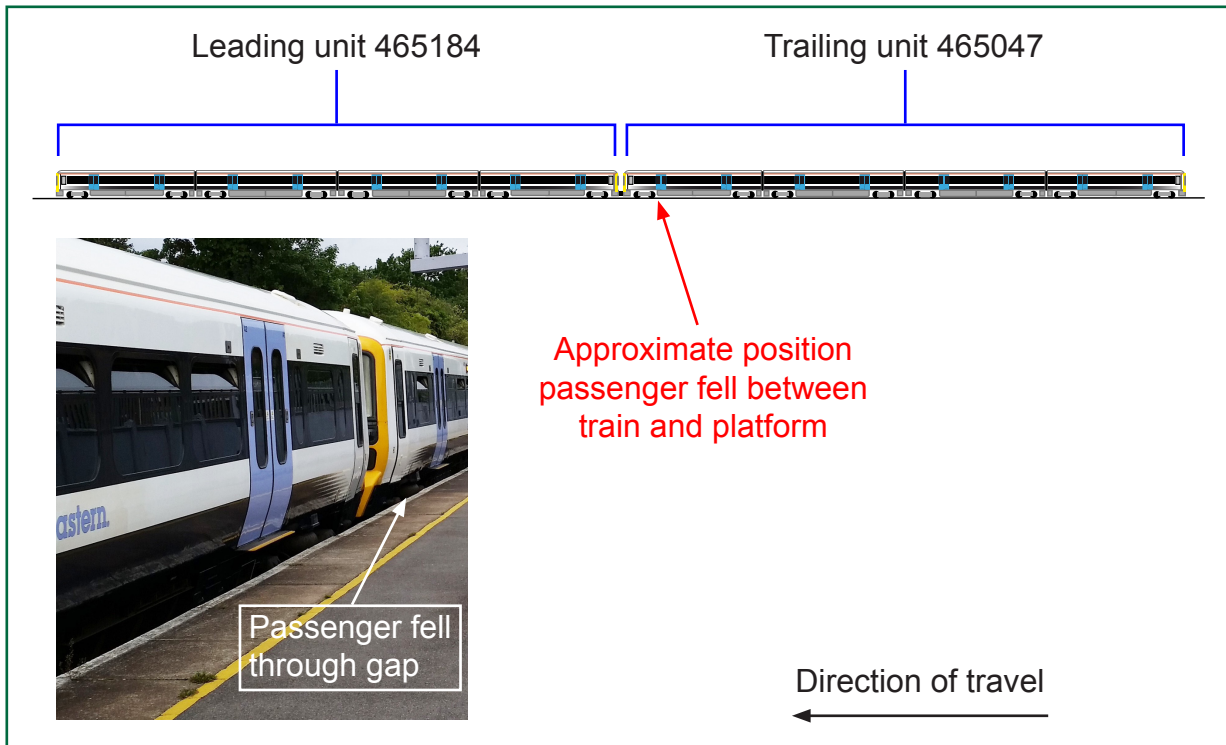
98 The RAIB measured a horizontal gap of 305 mm between the platform edge and the body side of a class 465 train at the approximate location where the passenger fell. The average gap between the body side of a class 465 train and platform 2 over the length of the platform was about 330 mm.

Figure 14: Approximate location where the passenger fell between the platform edge and train

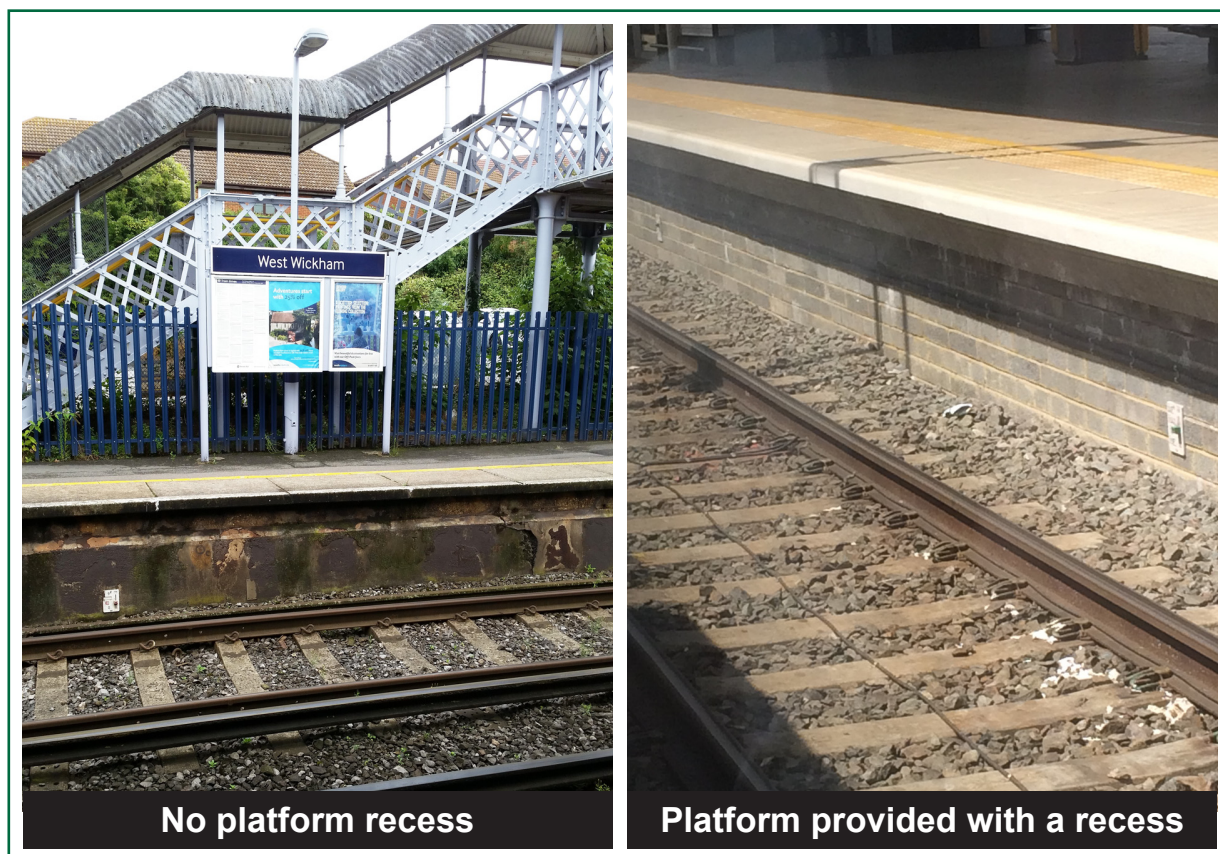
103 When the passenger fell through the platform edge gap she could not roll away from the train because, at the location where the accident occurred, there was no recess in the platform face beneath the platform edge (figure 15). It is possible that a recess would have allowed the passenger to move further from the train, and reduced the severity of her injuries.

- 104 This part of the platform was built before railway standards introduced a requirement for recesses in new platforms. The current Railway Group Standard GI/RT7016 'Interface between station platforms, track and trains' requires that new platforms, or existing platforms that are modernised, shall have a recess with a minimum width of 300 mm, and a minimum height of 480 mm, formed beneath the platform edge.
- 105 In 2015, the RSSB completed research into recesses under platforms<sup>10</sup>. The research recommendations included increasing the recess width in certain circumstances. Output from this research will also feature in the implementation of the *platform-train interface* (PTI) strategy (paragraph 126).

Figure 15: Recess providing survival space beneath platform

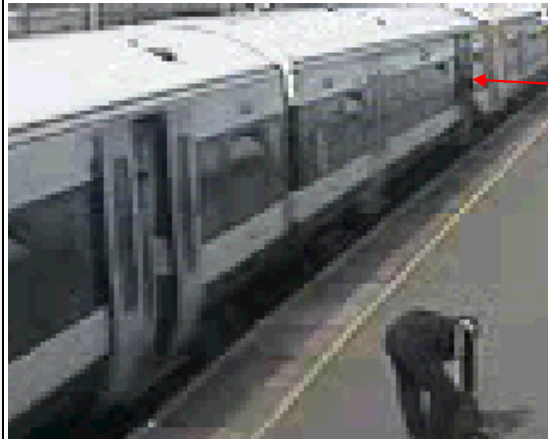
Passenger exiting through a door opened during the door closure sequence

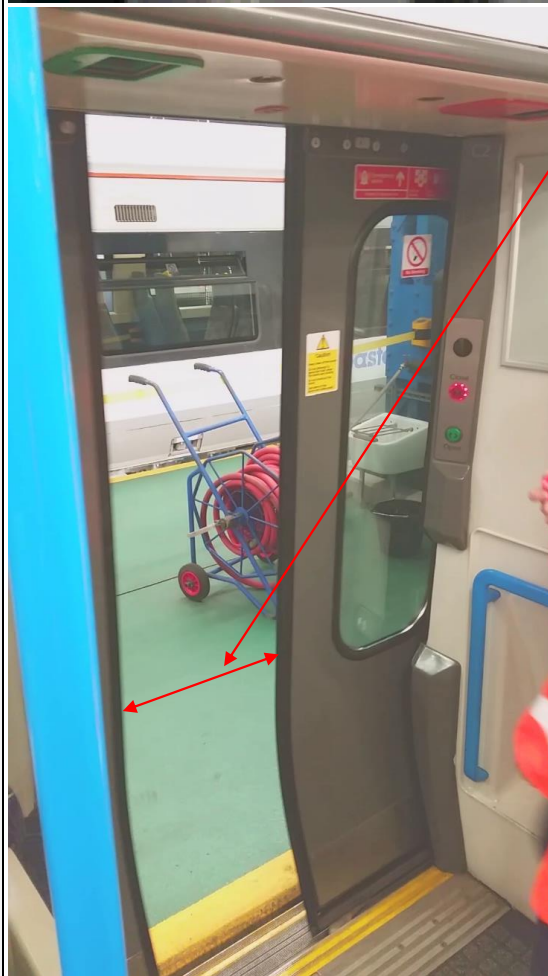
Extent to which the door opened when requested to open during hustle sequence, before reclosing rapidly (as observed during testing)
