# Rail Accident Report

**Collision between a train and a road vehicle,  
M20 overline bridge, Aylesford  
5 February 2007**

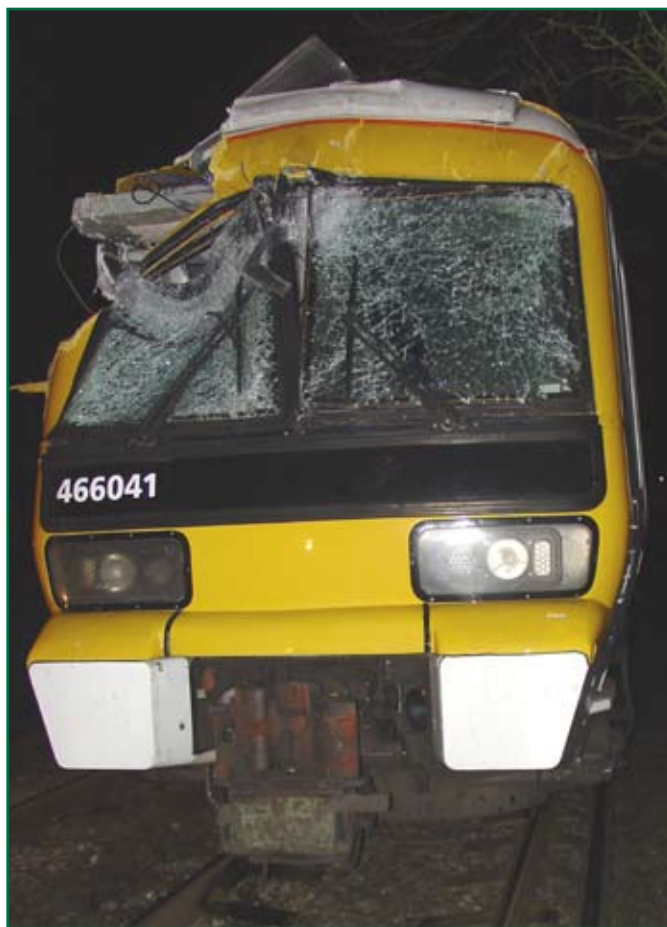
- 9 InterRoute hired in a 'Moog' 25 m long under-bridge inspection gantry from E.S. Access Platforms (NE) Ltd. This gantry is deployed from a large road vehicle (see Figure 3).
- 10 The Moog operator lowered the gantry from the motorway bridge span that crosses the railway when the railway line was open for normal traffic operation.
- 11 At 22:25 hrs on 5 February 2007 Southeastern train 2T83, the 21:57 hrs Paddock Wood to Gillingham (Kent) struck the 'Moog' gantry which was foul of the *up line*. The train was a 2 car electric unit of class 466, and was carrying a driver and one passenger.
- 12 The collision speed was 65 mph (105 km/h). The leading carriage suffered substantial damage to the cab and forward saloon areas. The driving cab roof was ripped open at the right hand side (see Figure 2).

Figure 2: Leading carriage 78352 of unit 466041 showing the external damage sustained

- 37 Before the Moog operator could climb down onto the inspection platform it was struck by train 2T83. The impact ripped two of the three sections off the platform and left the damaged parts strewn north along the railway line for over 100 m. The train driver did not see the obstruction before impact due to the area being in darkness and there being a left hand curve in a cutting on the approach to the M20 bridges over the railway.

- 39 The lowest point of the Moog gantry remaining after the impact was measured at 3100 mm above rail level. The class 466 vehicles forming the train are built to 3800 mm static height above rail level. The lowest point of impact on the train was at 2915 mm above rail level.

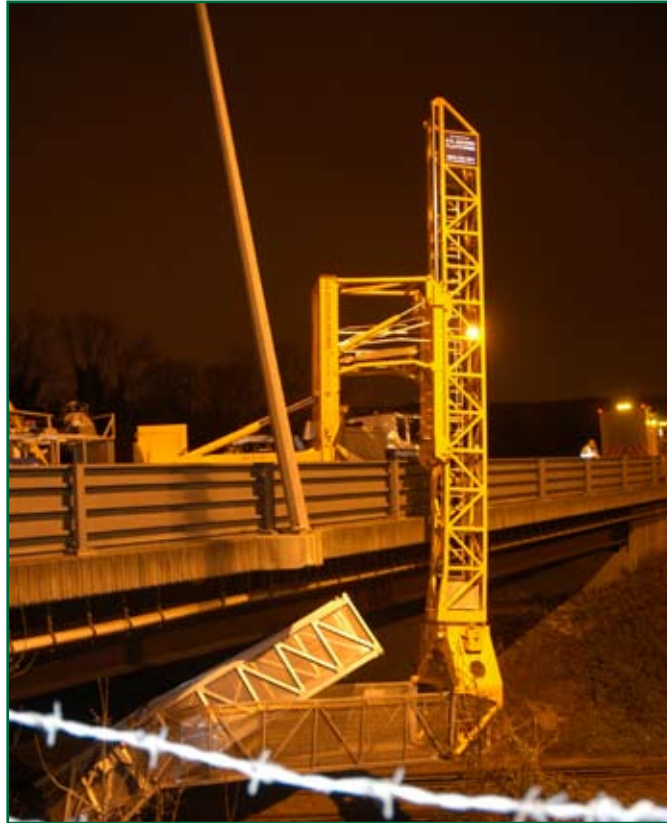
Figure 3: 'Moog' bridge inspection gantry viewed from motorway level after the collision (Photograph courtesy of the British Transport Police)

- 38 The Moog lorry unit on the M20 rocked so severely that witnesses reported that they believed anyone who was on it would have been catapulted off it.

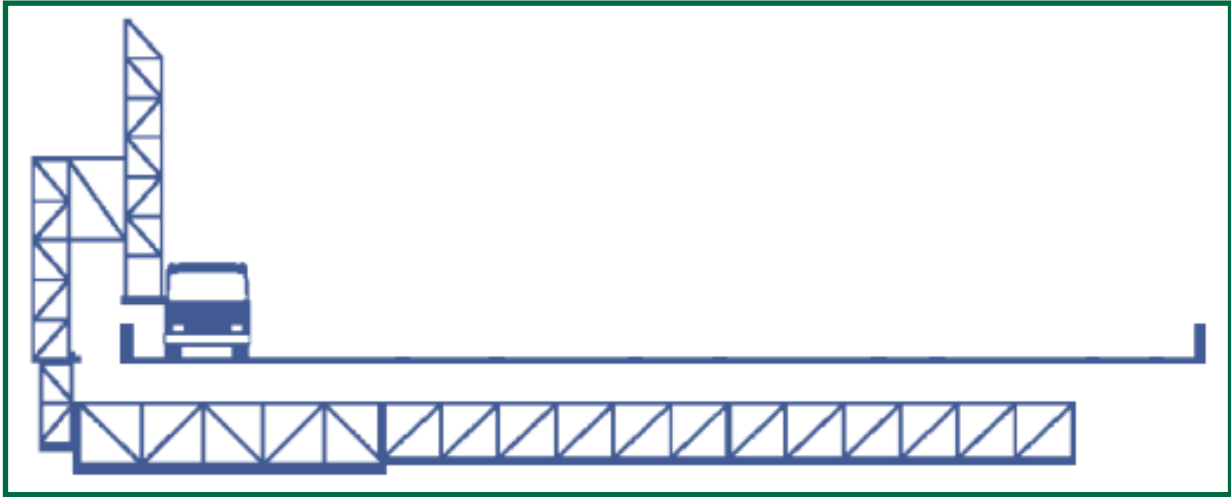
- 20 InterRoute's staff at its Coldharbour (Aylesford) office identified the requirement for specialist equipment for the bridge inspection (see Figure 4). They passed this requirement to staff at their Gillingham (Kent) office. Gillingham staff approached a regularly used subcontractor to procure an under-bridge inspection unit, but there was not one available for hire on the specified night. Gillingham staff then telephoned E.S. Access Platforms (NE) Ltd to arrange the hire.

- 21 A suitable unit was available and the hire was agreed orally on 29 January 2007. Neither InterRoute nor E.S. Access staff had confirmed the hire contract in writing with each other prior to the incident. There was no template or call-off written contract in place between the two companies. Neither company asked for or prepared a *method statement* for the hire.

Figure 4: Sketch of how the under-bridge inspection gantry should look when deployed (courtesy of E.S. Access (NE) Ltd)

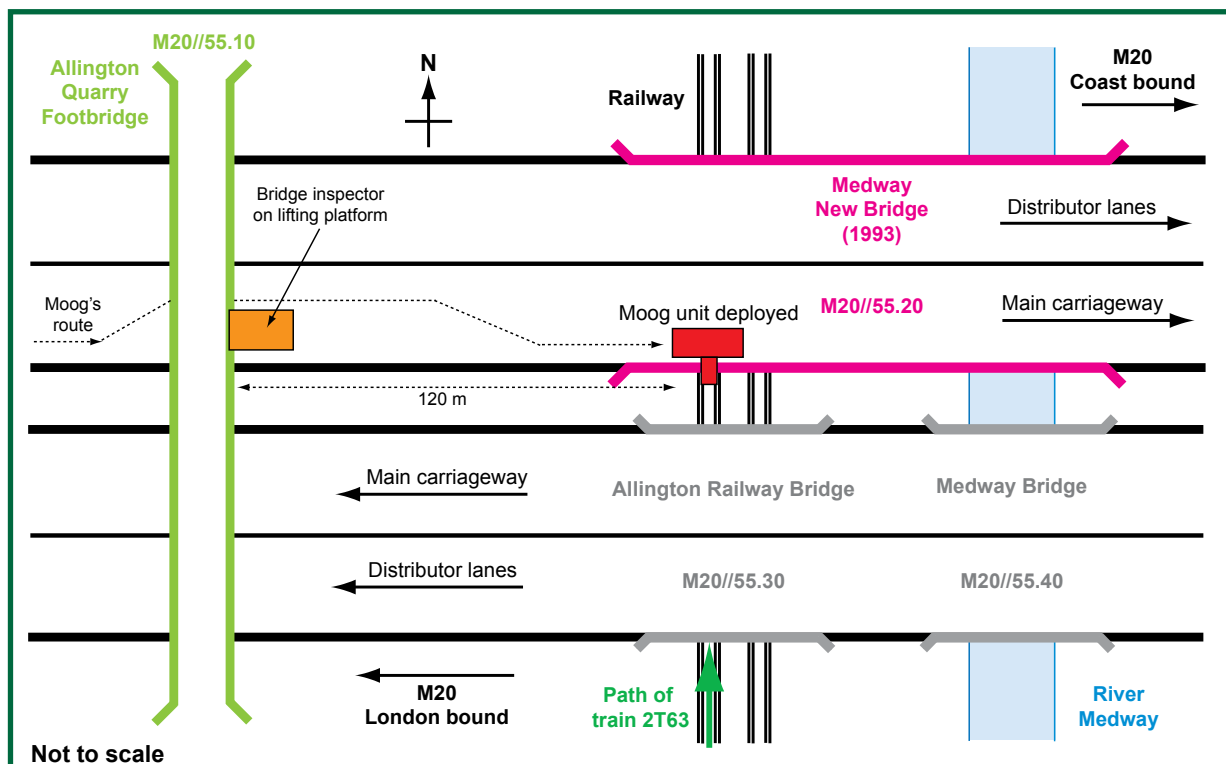
- 32 The bridge inspector did not mention that the first span of next bridge was over the railway line (see Figure 5) as he did not expect the Moog to deploy.

Figure 5: Layout of M20 Medway viaducts

- 33 The River Medway Viaduct spans both the railway and river and has the same bridge identity for all the spans. The RAIB have observed that contrary to Highways Agency standard BD 45/93, the Medway River Viaduct did not have its unique bridge number applied and visible. It is the responsibility of the 'Maintenance Agent' (InterRoute) to apply the numbers to meet the standard. This however was not significant because the bridge inspector did not refer to the bridge number when instructing the Moog operator. There is nothing in the bridge identity number (M20//55.20, structure key 20162 'Medway New (1993)') to draw attention to the bridge inspector that it crosses a railway line.
