Rail Accident Investigation Branch

Rail Accident Report

Unauthorised train movement and subsequent derailment at Haymarket, Edinburgh 14 January 2006

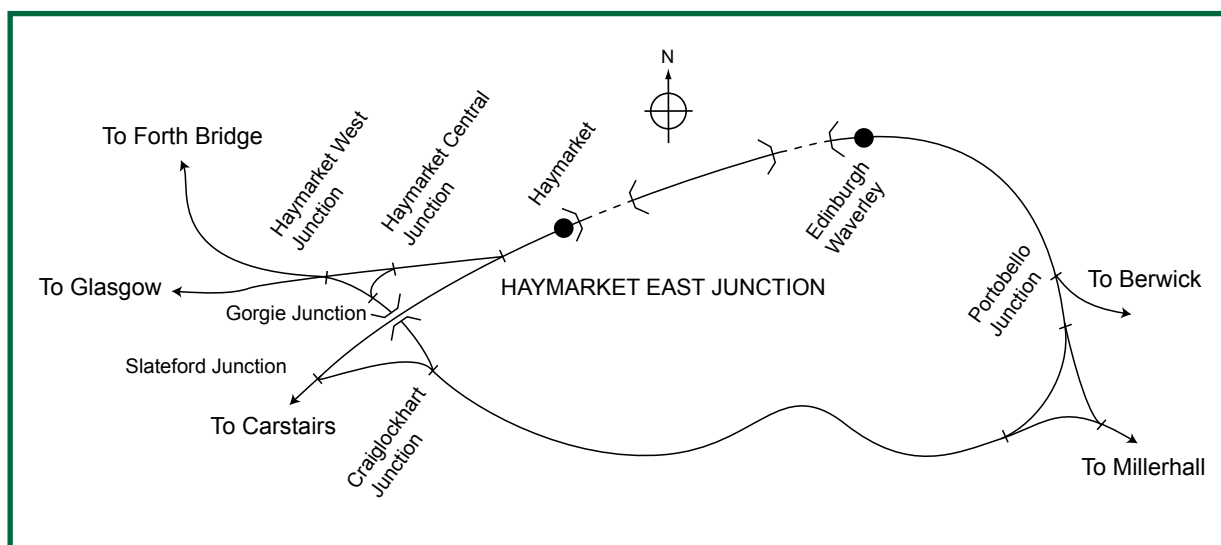
Figure 2: Diagram of the area.

- 5 During engineering work on the railway between Haymarket East Junction and Curriehill on 14 January 2006, a train loaded with *spent ballast* left the section of line that was under *engineers' possession* without authority and ran onto a line open to other traffic. On reaching Haymarket East Junction it was diverted onto a line on which a passenger train was approaching in the opposite direction. The ballast train stopped in Haymarket station when the driver realised that he was travelling on the wrong line. The passenger train was stopped by the action of the signaller.
- 6 Subsequently, during tests on the brakes of the ballast train, one wagon became derailed by one set of wheels. There were no injuries, and minor damage to a set of *points*.

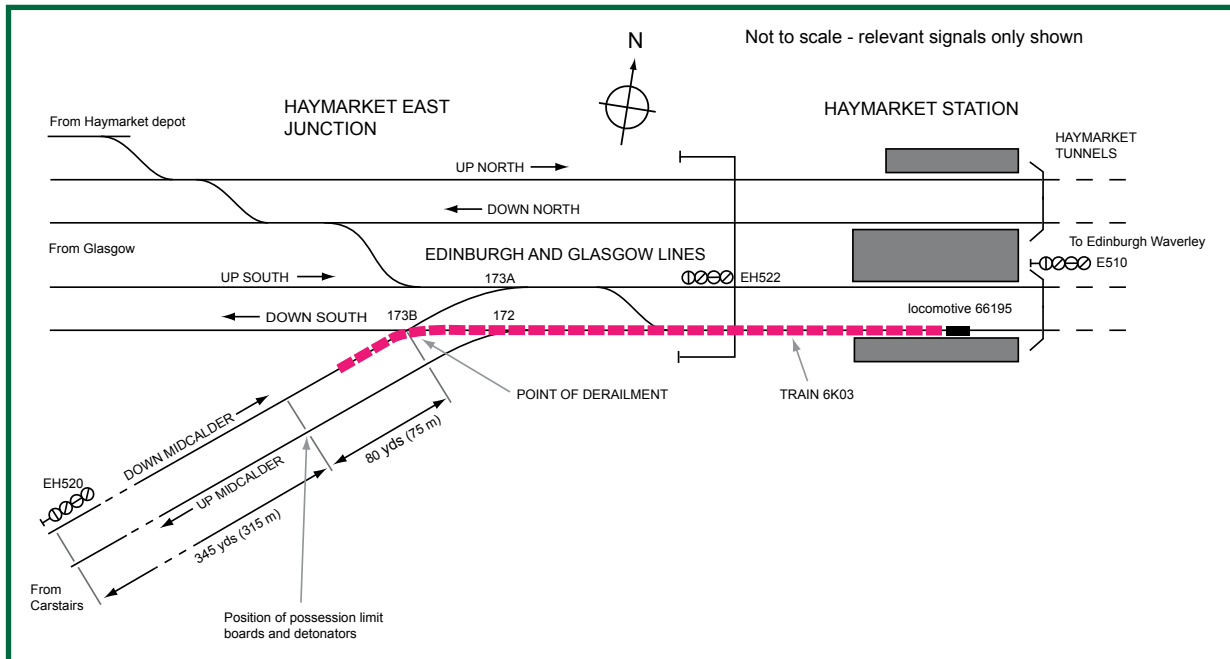
Figure 3: Track layout and possession limits.

23 The last signal on the down Midcalder line protecting Haymarket East Junction, EH520, is located at the 100¼ milepost, 390 m (425 yards) on the approach to the junction. At Haymarket East Junction the designation of the eastbound direction of travel changes from ‘down’ to ‘up’. The next signal for a train travelling in this direction is EH522, which is between the junction and Haymarket station, followed by EH510 at the east end of Haymarket station.

- 26 PICOP 1 was responsible for setting up the possession on the morning of 14 January 2006. He had attended meetings on the preceding Wednesday, Thursday and Friday in connection with the work to be done and the arrangements for the organisation of the possession and the work sites within it. After the meeting on the Thursday (which had been chaired by the Network Rail Possession Assurance Manager), PICOP 1 was approached by a member of contractor's staff with a request for the possession limits to be moved closer to the junction at Haymarket to enable access to overhead line switching equipment near the junction. He agreed to the change, although it had not been discussed at the meeting and no record of it was published, contrary to section 11.5 of module T3 of the Rule Book. The revised possession limits were 75 m (80 yards) from the junction, and thus 315 m (345 yards) ahead of signal EH520. A diagram of the area showing the possession limits is at Figure 3.

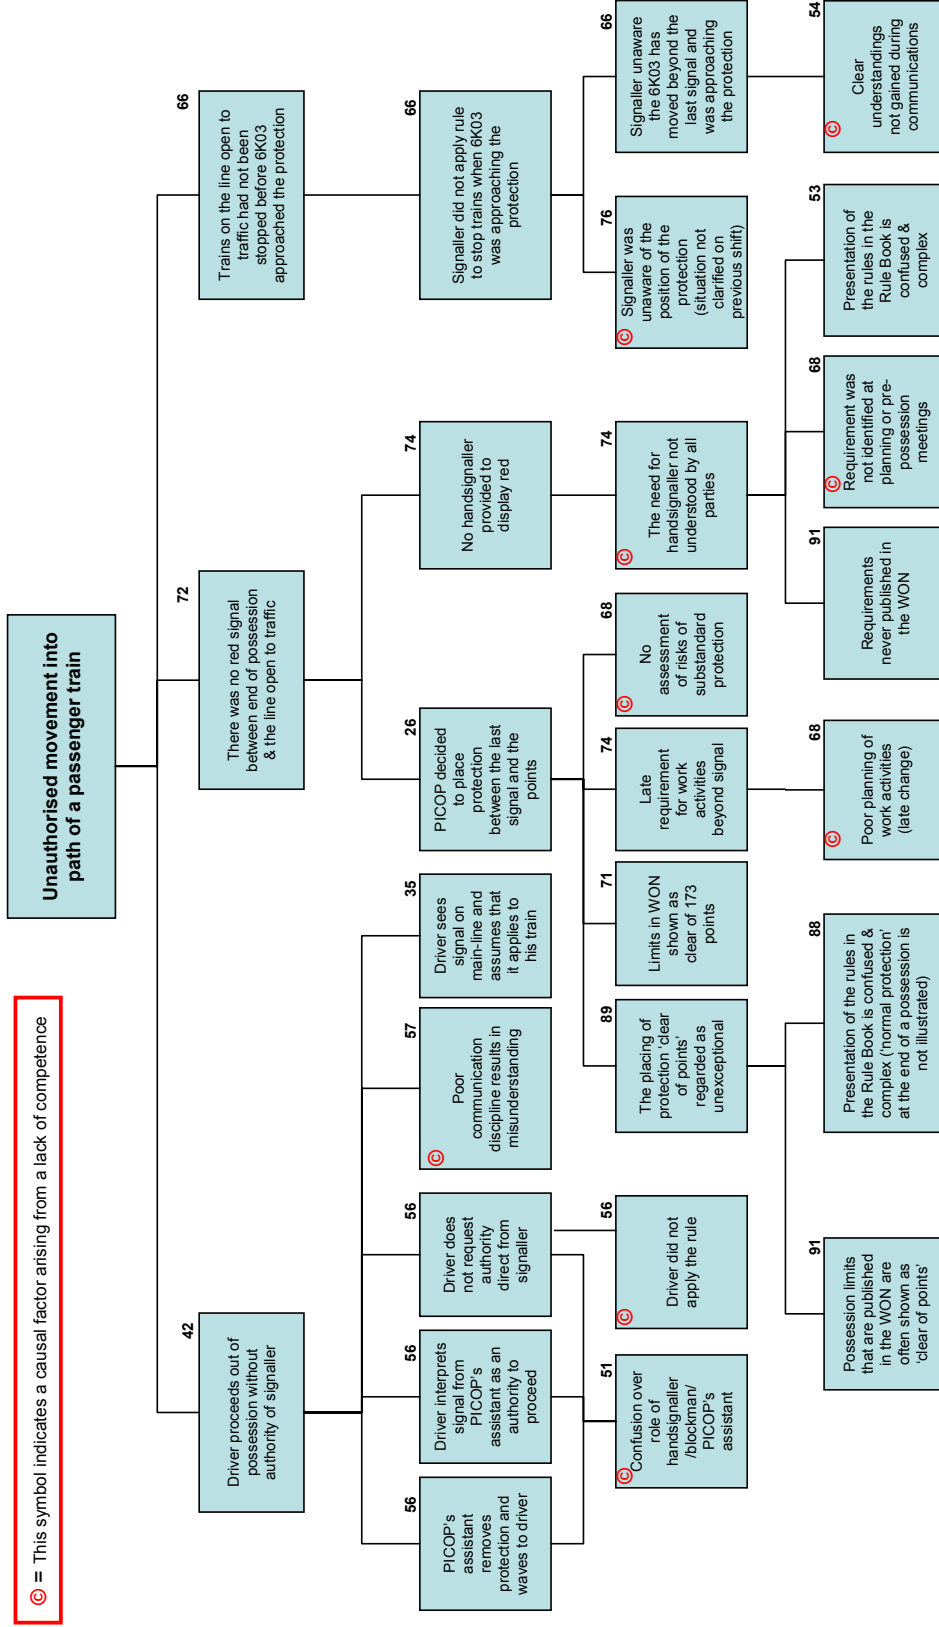
Near-miss incident at Haymarket on the 14 January 2006

- 96 There are a number of causal and contributory factors involved in this incident. For this reason a diagram has been prepared showing the relationship between the factors identified in this report. This diagram is to be found at Appendix D.
