Royal Navy Flight Safety
& Accident Investigation Centre

Accident Report 3/01 (Field)
Hind Mi24V SL202
On 19 October 2001

Reference: FSAIC/R3/01

ACCIDENT TO HIND Mi24V SL202 ON 19 OCTOBER 2001

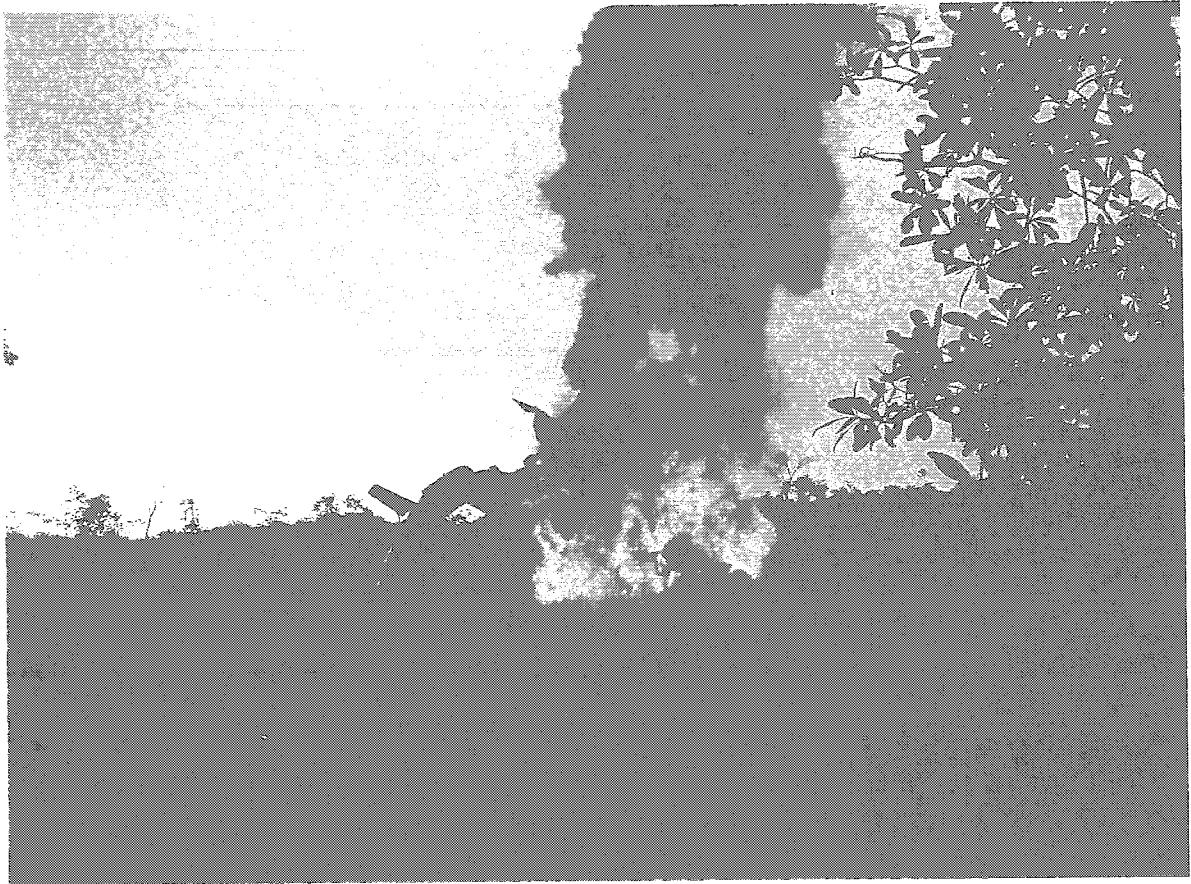
metre from their respective root ends and detach from the aircraft. The aircraft was on fire in the area around the both main engines and the front of the main rotor gearbox. This fire spread rapidly and consumed most of the aircraft apart from the tail pylon.

Photograph 2 – Hind Mi24V SL202 shortly after impact.

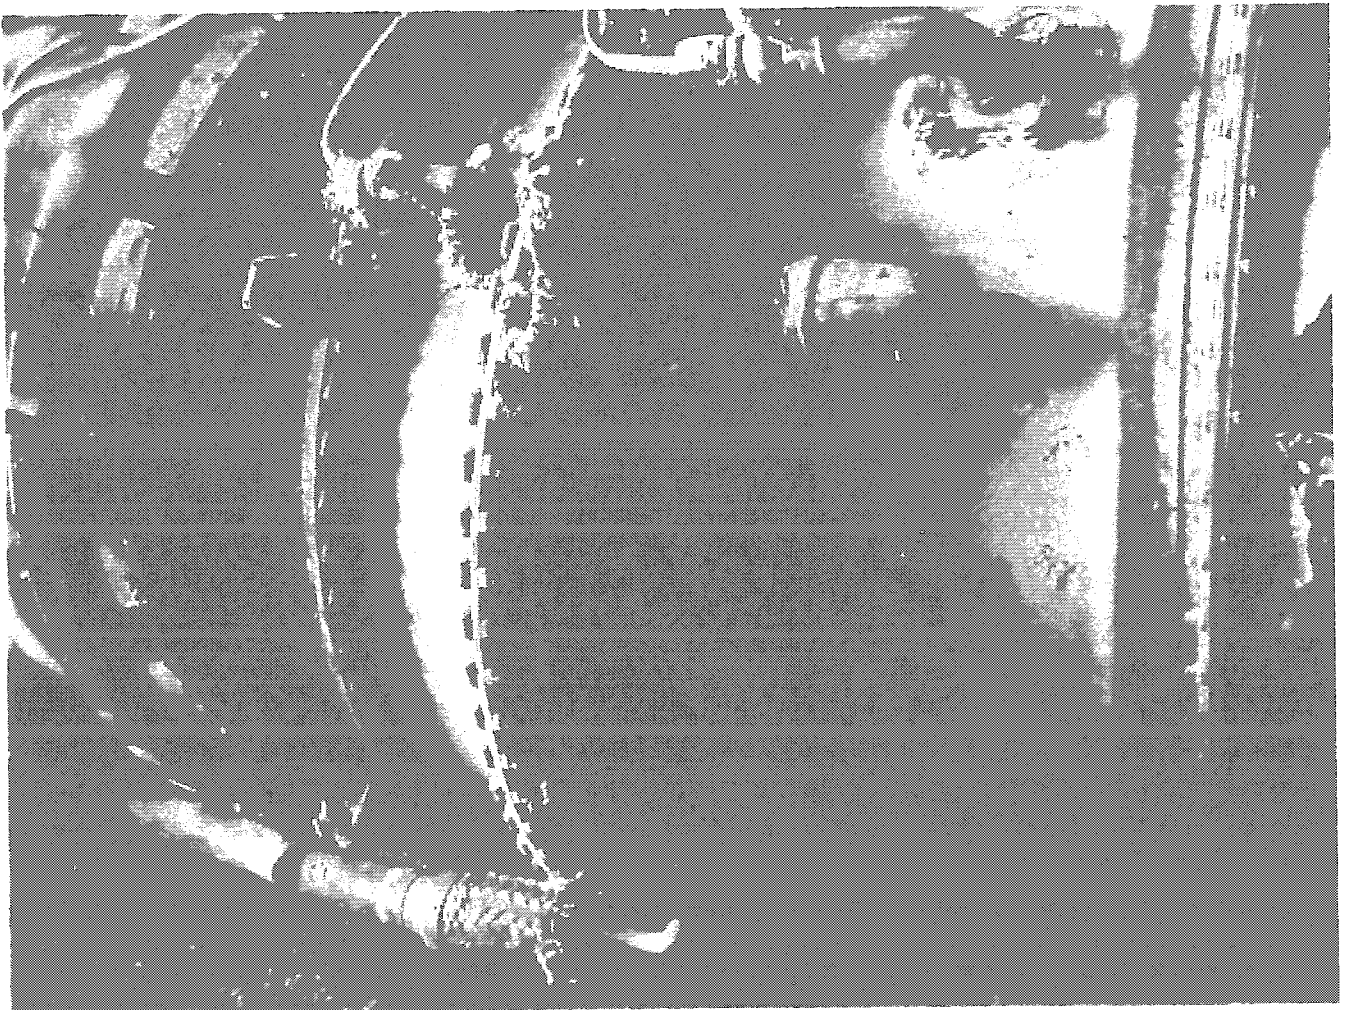
- e. The VIGV external linkages were intact.
- f. The free power turbine casing was fractured and holed on the engine's left-hand side. The casing was missing on the right-hand side of engine. The damage was consistent with objects passing through the casing from within. (See photographs 3 and 4).

Photograph 3 - Rear of No 1 engine showing left-hand side of free power turbine casing fractured and holed.

76. The physical examination of the No 1 engine revealed that there had been a break-out of the stage 1 free power turbine as the sections of the free power turbine casing were either missing or showing outward deflection marks and rubbing where it had been holed. Supporting this evidence, some of the external dressings and pipelines had been severed at the same axial location as the stage 1 free power turbine rotor. Approximately 50% of the free power turbine casing was missing and the fractured edges revealed no signs of burning or melting. The complete support assembly for the free power turbine bearing housing was missing as was the free power turbine assembly itself. Although the reason for the No1 engine's stage 1 free power turbine to have suffered an uncontained failure cannot be positively determined, the possibility that the engine could have ingested something can be discounted as the inspection of the No1 engine's compressor and compressor turbine revealed that these forward parts of the engine had not been affected by FOD. It is therefore considered probable that the bearing assembly supporting the No1 engine free power turbine assembly had failed, leading to an initial vibration followed by an imbalance of the free power turbine, bearing break up and subsequent catastrophic failure of the free power turbine. Although it was the No 2 engine's vibration warning that was the initial cockpit indication that something was wrong, it is possible that the vibration from the failing No 1 engine free power turbine support bearing was initially so high

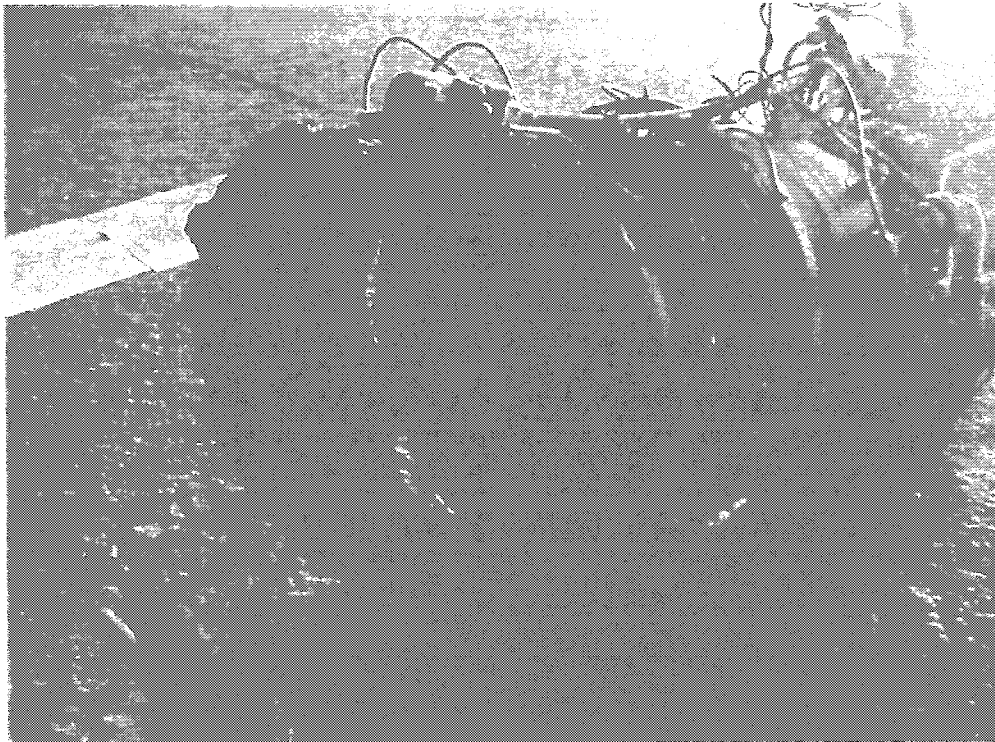
Photograph 4 - Rear of No 1 engine showing left-hand side of free power turbine casing fractured and holed and right-hand side consumed by fire.

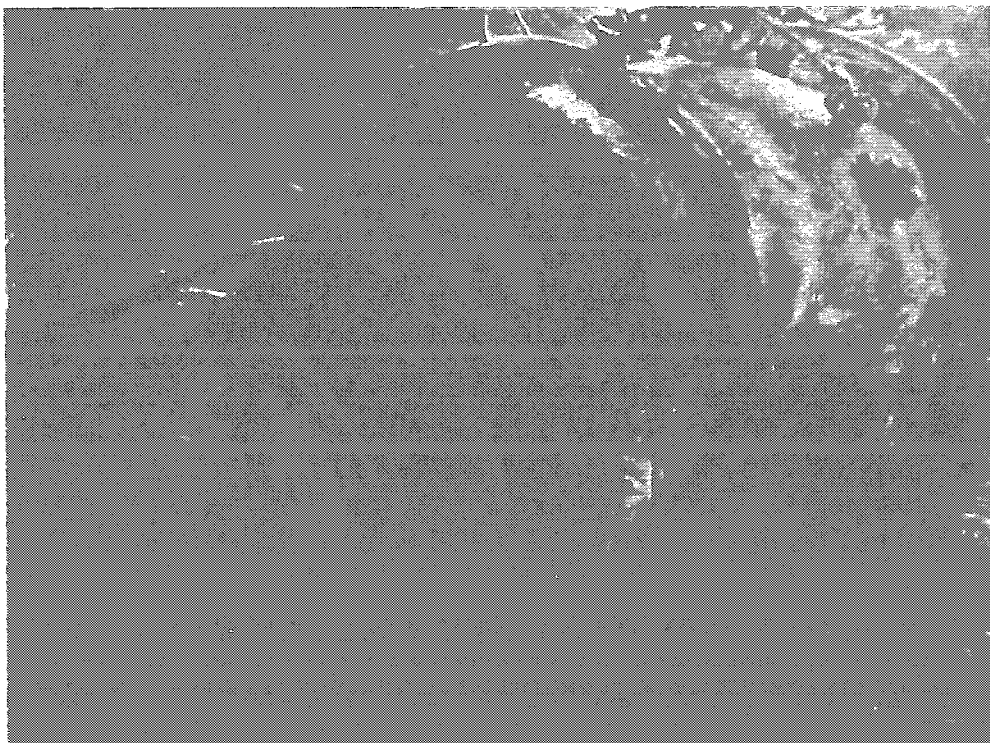
- f. All the casings aft of the combustion chamber had been completely consumed by fire and exposed the compressor turbine and stator blades beneath. These blades were partially consumed by fire. (See photograph 5).
- g. The right-hand side of combustion chamber had been consumed by fire where the engine had rolled over.
- h. The compressor turbine rear stator blade assembly was detached from the engine. One third had been consumed by fire. The remainder had small areas of impact damage on the aft surfaces. The impact damage appeared to have come from the free power turbine side of the stator blades. (See photograph 6).
- i. One-third segment of the free power turbine, including the complete hub, was detached from the engine. All the securing bolts were missing. The missing segments had been consumed by fire. (See photograph 7).

Photograph 5 – Rear of No 2 engine showing damage to compressor turbine and stators.

77. The physical examination of the No 2 engine also revealed that the free power turbine area of the engine was missing with no indications of FOD to the compressor. It is considered most likely that the one-third segment of a stage 2 free power turbine that was recovered originated from this engine as the No 1 free power turbine had suffered an uncontained catastrophic failure and there was no melting of the turbine's casing. The No 2 engine's free power turbine, compressor turbine and combustion chamber casings and the compressor turbine rear stator assembly however, all showed signs of melting as did the segment of stage 2 free power turbine itself (the free power turbine blades are made of a nickel based nimonic ATA alloy that melts at 1400°C and the compressor turbine rear stator assembly is made from an austenitic heat resisting stainless steel that melts between 1400°C and 1500°C).

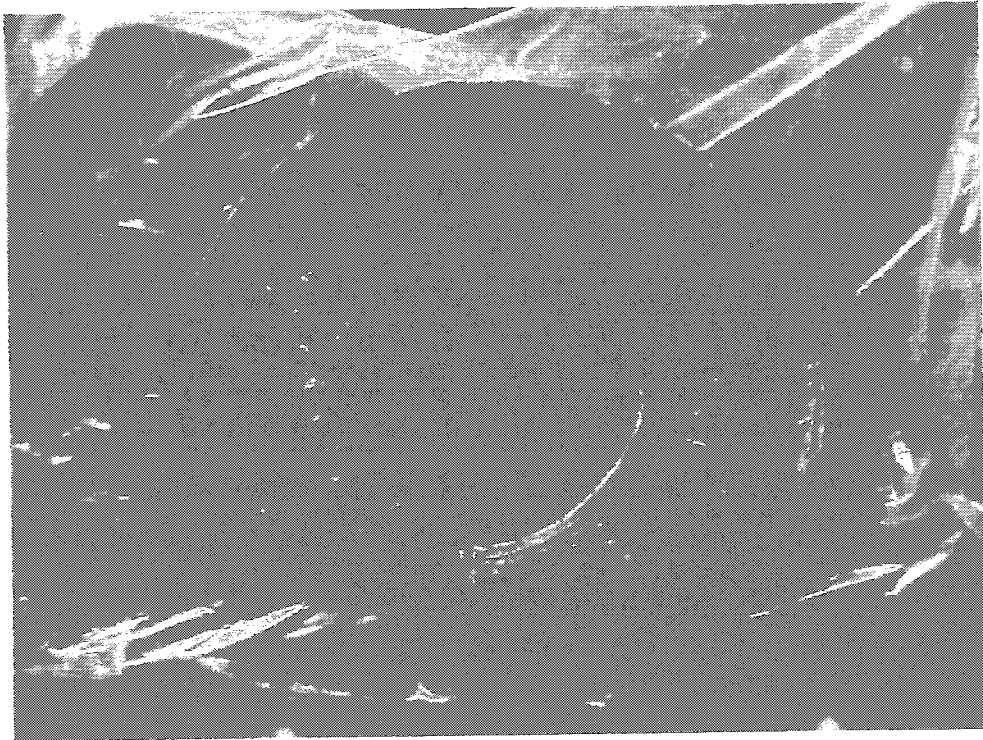
Photograph 6 - Compressor turbine rear stator blade assembly from No 2 engine.

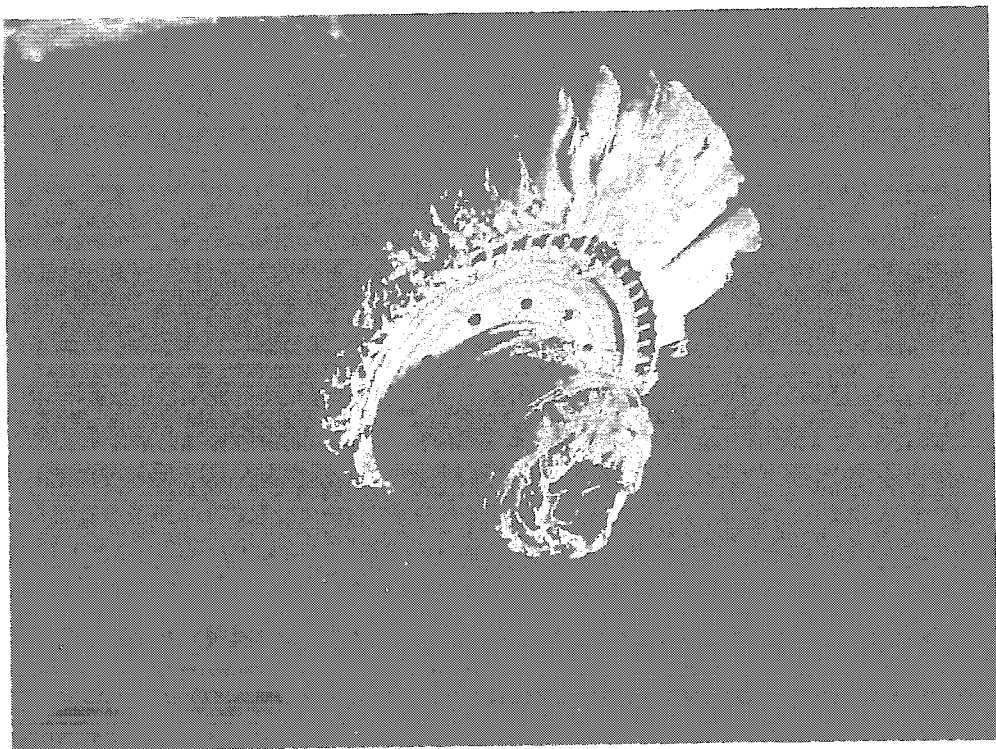
Photograph 7 - Segment of free power turbine including hub.
Believed to have come from No 2 engine.

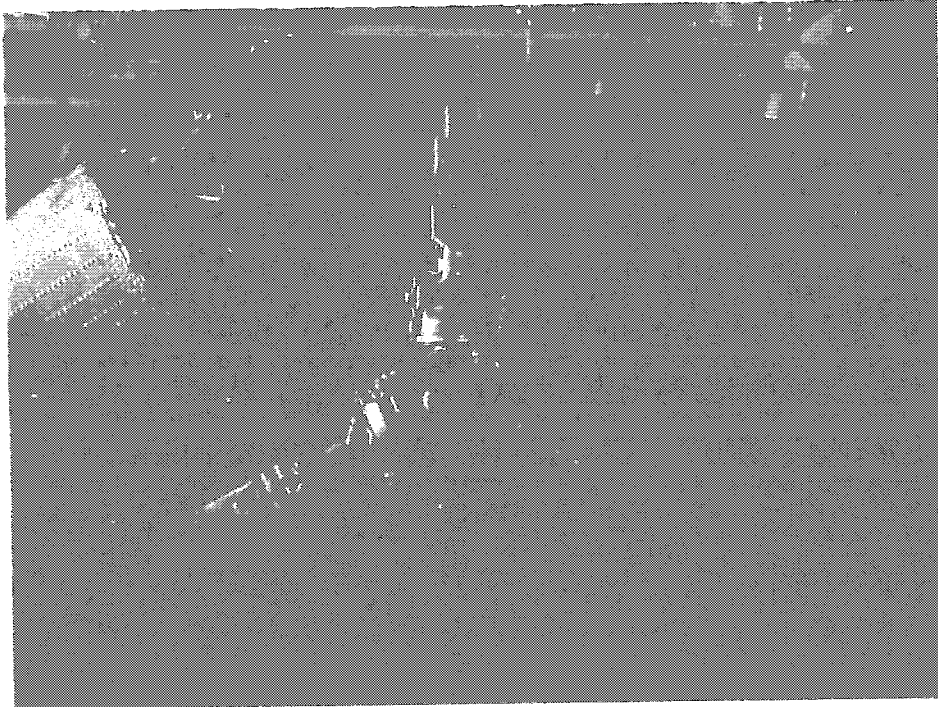
- b. The upper section of tail pylon was complete with tail rotor gearbox, tail rotor hub and tail rotor root sections.
- c. Outer sections of all 3 tail rotor blades were missing with evidence of a low speed impact. One tail rotor blade had evidence of an overload fracture of its leading edge spar 460mm from the root end. (See photographs 8 and 9). The remaining 2 blade root ends had crude cut marks where they had been hacked off by wreckage plunderers. Photographic evidence taken shortly after the accident showed that these blades were slightly distorted but intact after the crash. (See photograph 10). The fractured blade was later recovered approximately 1 km from the crash site and examination confirmed an overload fracture of its leading edge spar.

Photograph 8 – Tail rotor assembly showing tail rotor blade fractures.
Upper blade has overload fracture of leading edge spar.

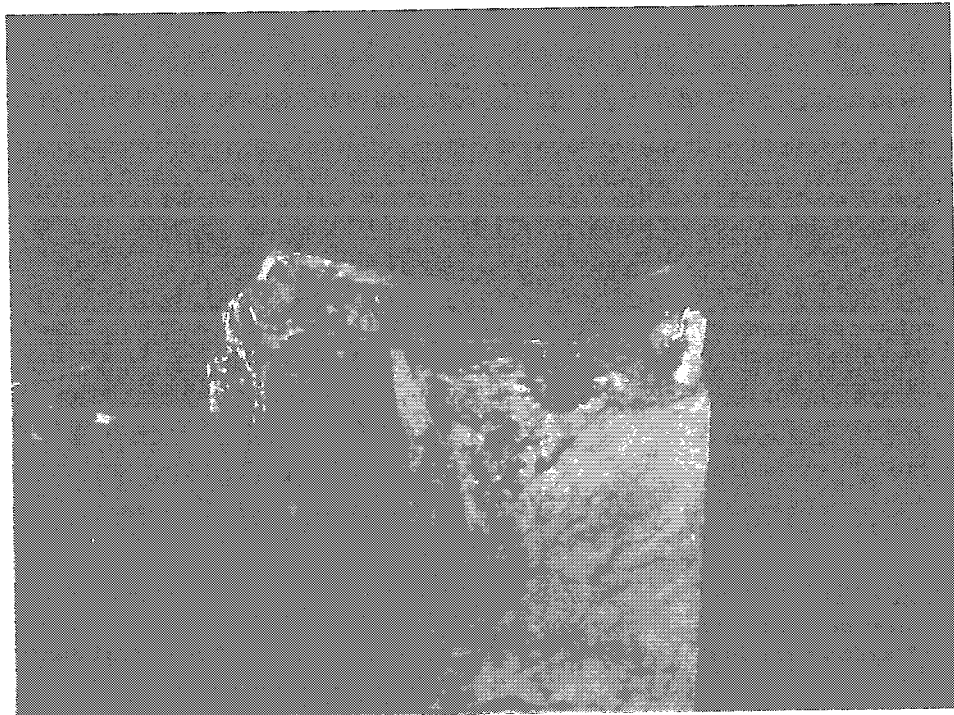
Photograph 9 – Overload fracture surface on tail rotor leading edge spar.

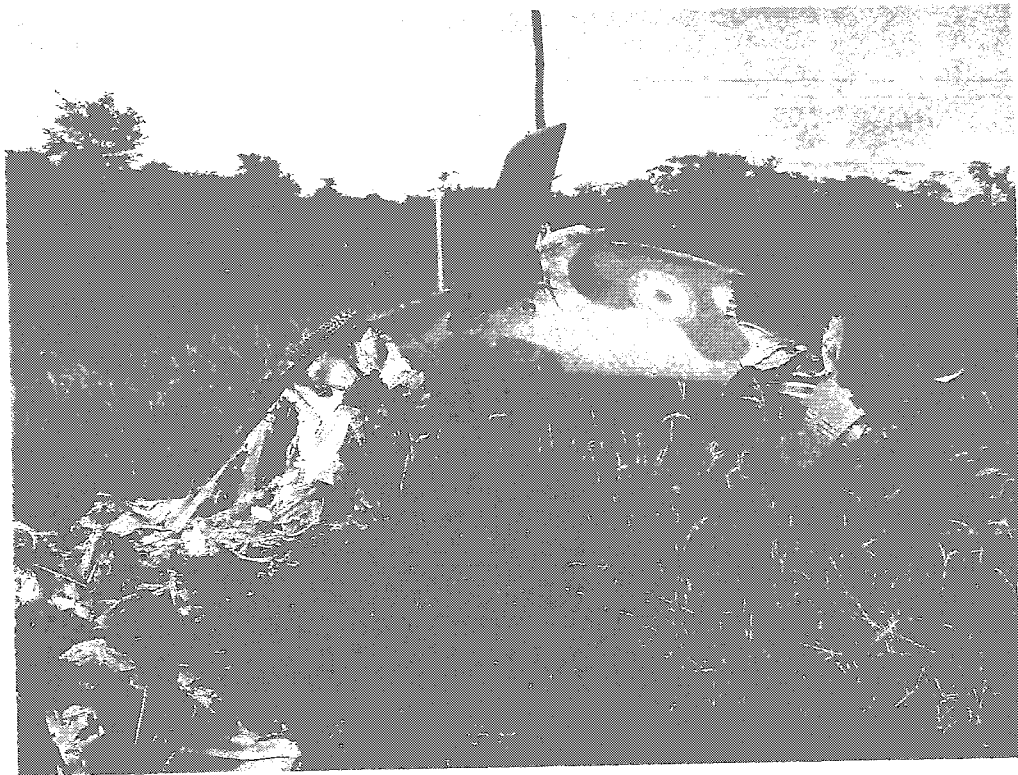
Photograph 10 – Tail pylon showing tail rotor blade with low speed impact damage.

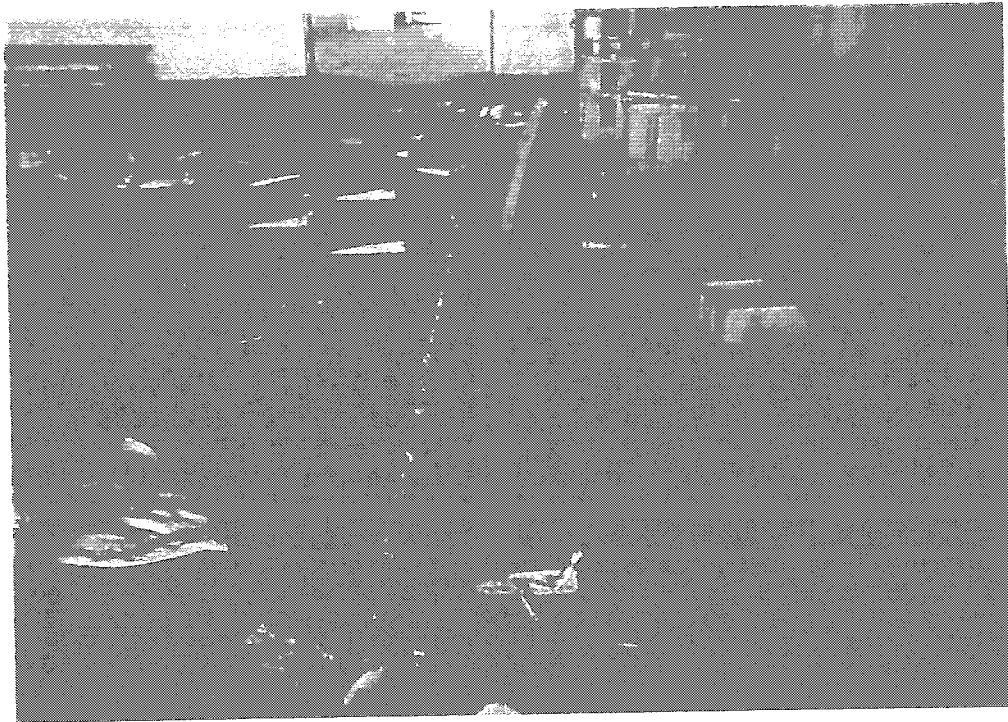
- a. Three main rotor blade leading edge spars were recovered. These were slightly bent along their span length and had overload fractures at the root ends.
- b. Twenty two separate main rotor blade trailing edge pockets were recovered. These pockets had crude cut marks where they had been hacked off by wreckage plunderers. (See photograph 11).

Photograph 11 – Main rotor blade leading edge spars and trailing edge pockets.

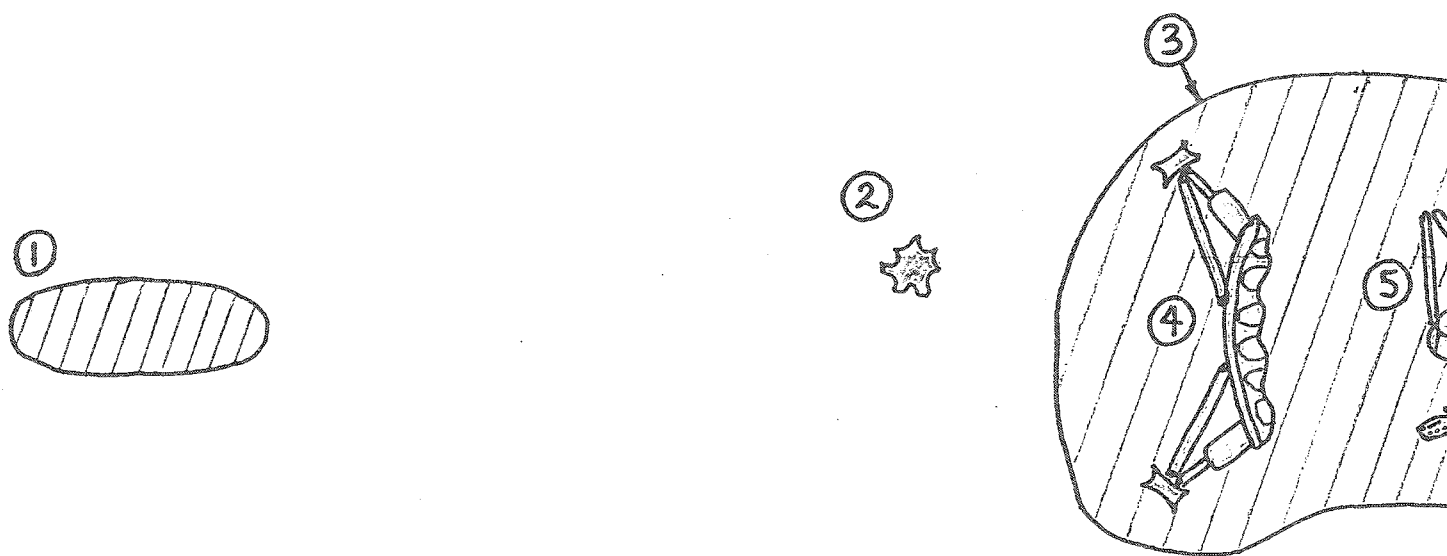
Figure 3

- ① - INITIAL BOUNCE GROUND MARK.
- ② - TREE STUMP (POSSIBLE TAIL ROTOR STRIKE MARK).
- ③ - AREA OF SCORCHED GROUND AND MINOR DEBRIS.
- ④ - MAIN UNDERCARRIAGE.
- ⑤ - MAIN ROTOR HEAD AND GEARBOX.
- ⑥ - COCKPIT RIGHT HAND SIDE PANEL, NOSE UNDERCARRIAGE AND NOSE GUN TURRET.
- ⑦ - BURNT TREE STUMP.
- ⑧ - GROUND MARKS FROM MAIN ROTOR BLADE STRIKES.
