# **Service Inquiry**

Puma XW229 11 Oct 15

SI/18/15/XW229

# SERVICE INQUIRY INVESTIGATION INTO ACCIDENT INVOLVING A PUMA HC MK 2 XW229 AT HEADQUARTERS RESOLUTE SUPPORT, KABUL, AFGHANISTAN ON 11 OCT 15

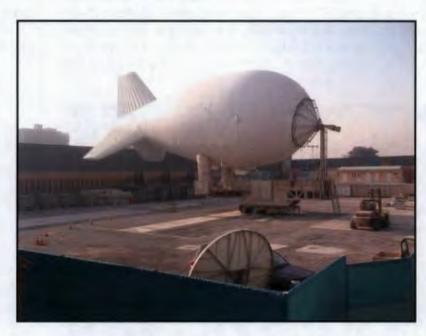
Figure 1.3.2 - HQRS PTDS in the 'down' position

1.3.11 After overflying SOC and routing to the north-east, both aircraft climbed to 500 ft AGL and turned to follow a track similar to the previous downwind leg with A22 remaining in trail formation. During their transit south for a further approach, it became apparent that the HLS was still occupied and A21 conducted a right-hand orbit at 500 ft AGL to the south-east of the HQRS compound. The south eastern corner of the HQRS compound housed the PTDS and associated infrastructure; on 11 Oct 15, the PTDS aerostat, Figure 1.3.2, was operating at a height of 2200 ft AGL.

- 1.3.12 As the formation passed to the south of the HQRS compound, and as A21 turned through north into a holding orbit, A22 lost sight of the lead aircraft. Shortly afterwards A22 increased its Angle of Bank during a right hand turn and was seen by observers on the ground to impact the PTDS tether.

1.3.15 A22 was observed from the ground to have struck the PTDS tether midway along the Main Rotor Blades (MRBs) on the right hand side of the aircraft. The tether parted and the PTDS aerostat drifted to the North West; the lower section of tether fell into the PTDS operating site. Eye witnesses reported that immediately prior to the impact with the ground, A22's MRBs were rotating but the Tail Rotor was stationary.

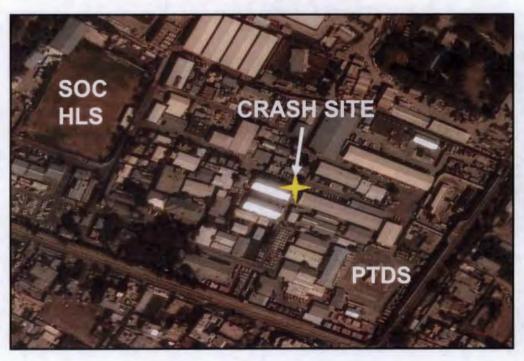
Figure 1.3.3 - Location of A22 crash site

1.3.16 A22 impacted the ground between buildings within the HQRS compound. The location within HQRS is shown in Figure 1.3.3; the aircraft is pictured in Figure 1.3.4. There was no immediate post-crash fire and a considerable number of personnel on the ground assisted in the rescue of the crew and passengers, the first of which was on scene within 15 seconds. As rescue activity progressed the initial responders were joined by the HQRS Fire Service and medical personnel. Numerous hand held fire extinguishers were discharged to mitigate the risk of fire due to leaking fuel; A22 had approximately 350 kg of fuel on board at the time of the accident. Rescue activities continued for approximately 1.5 hours until all crew and passengers were extracted from the aircraft.

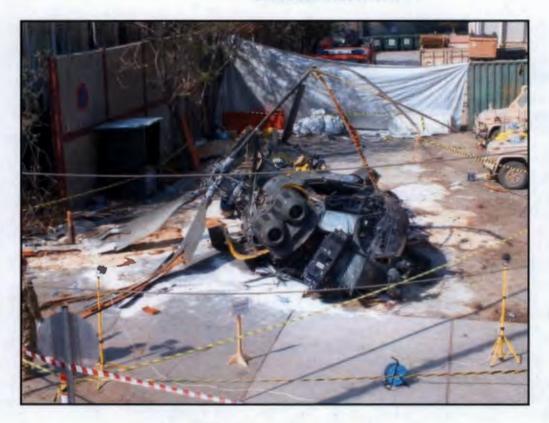
Figure 1.3.4 - Aircraft post-accident

1.3.24 On impact with the ground the aircraft suffered extensive damage. Further significant damage occurred during the rescue response as elements of the airframe were cut away to facilitate the extraction of casualties; this secondary damage was caused by individual actions to manually move airframe structure or by HQRS Fire Service personnel using specialist cutting equipment.
