Rail Accident Investigation Branch

# Rail Accident Report

## **Derailment of a freight train at Brentingby Junction, near Melton Mowbray 9 February 2006**

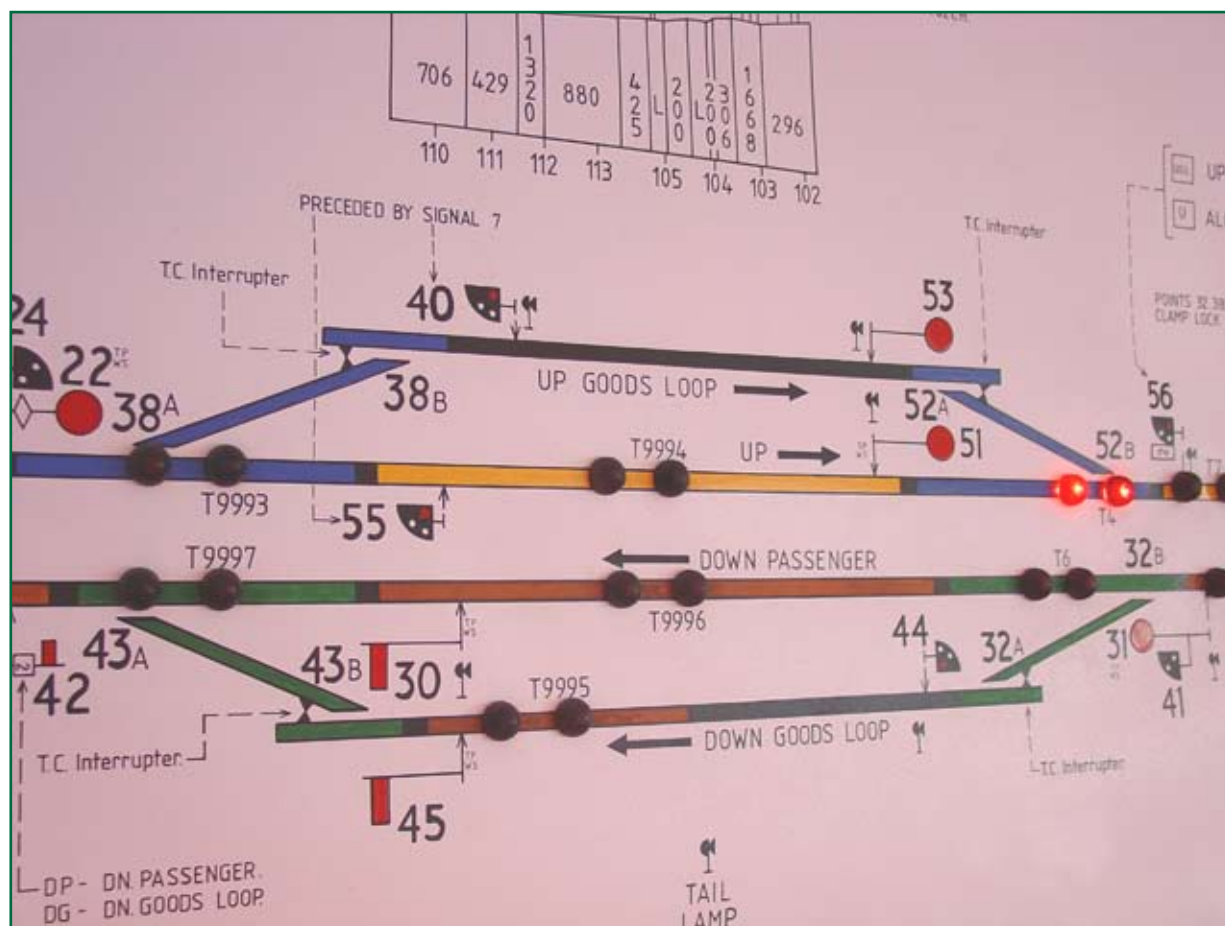
Figure 3: Extract of Melton Mowbray signal box diagram showing the Brentingby goods loops

- 27 Trap points designated 52A are located 43 m beyond signal 53. The points where the Up Goods Loop rejoins the Up Main line are designated 52B. These are shown diagrammatically on the extract from the signal box diagram shown in Figure 3.

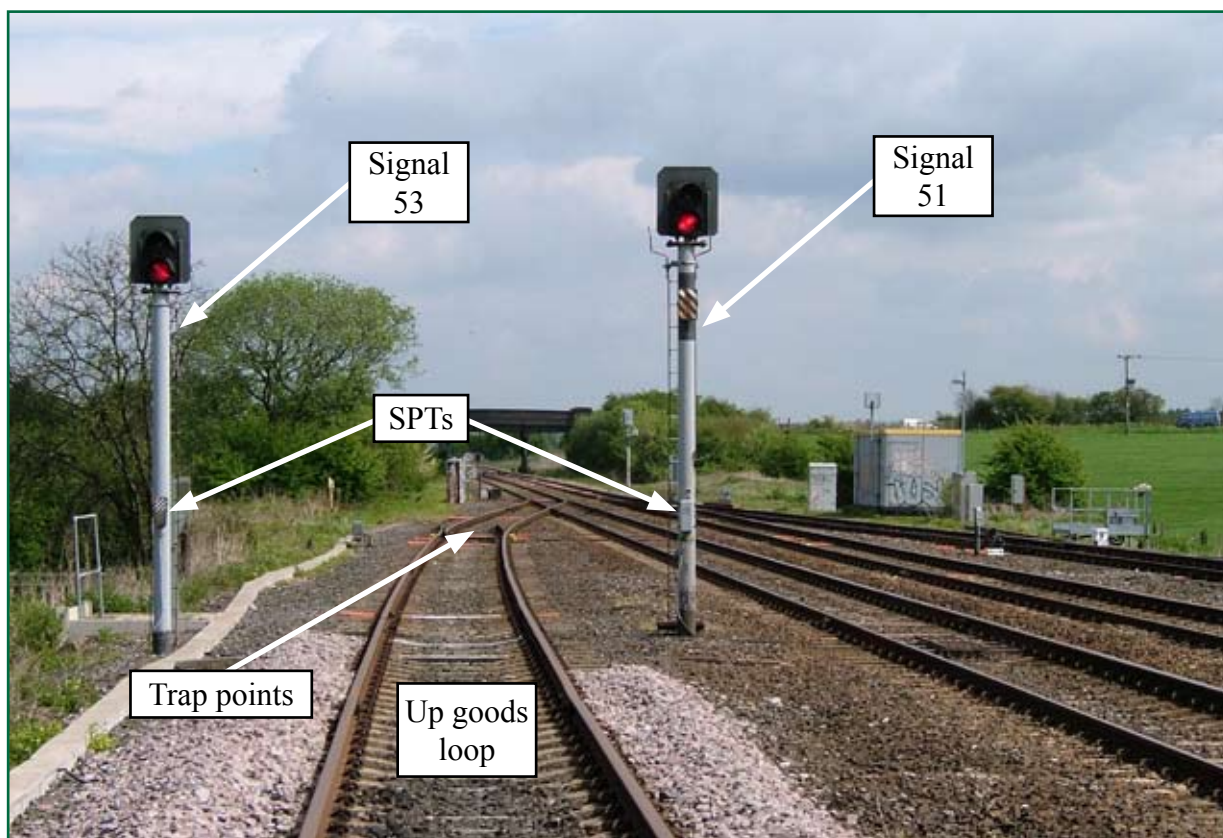
Figure 4: Signals 53 and 51 (by courtesy of Network Rail)

28 The signalling at Brentingby Junction is controlled by Melton Station signal box at Melton Mowbray located at 105 miles 27 chains. Signal 53 is a *two-aspect colour light signal*, and signal 51 (adjacent to signal 53) on the Up Main line is also a two-aspect colour light signal. The signals, which do not carry identification plates, and the trap points beyond signal 53 are shown in Figure 4.

- 33 A track circuit interrupter is fitted to the trap points beyond signal 53 so that any train that passes signal 53 at danger and subsequently derails at the trap points will break the track circuit interrupter and cause signals 51 and 22 if they have been cleared to go back to danger.
- 34 Both signal 51 and signal 53 are fitted with SPTs mounted on their respective posts. These are shown in Figure 4.

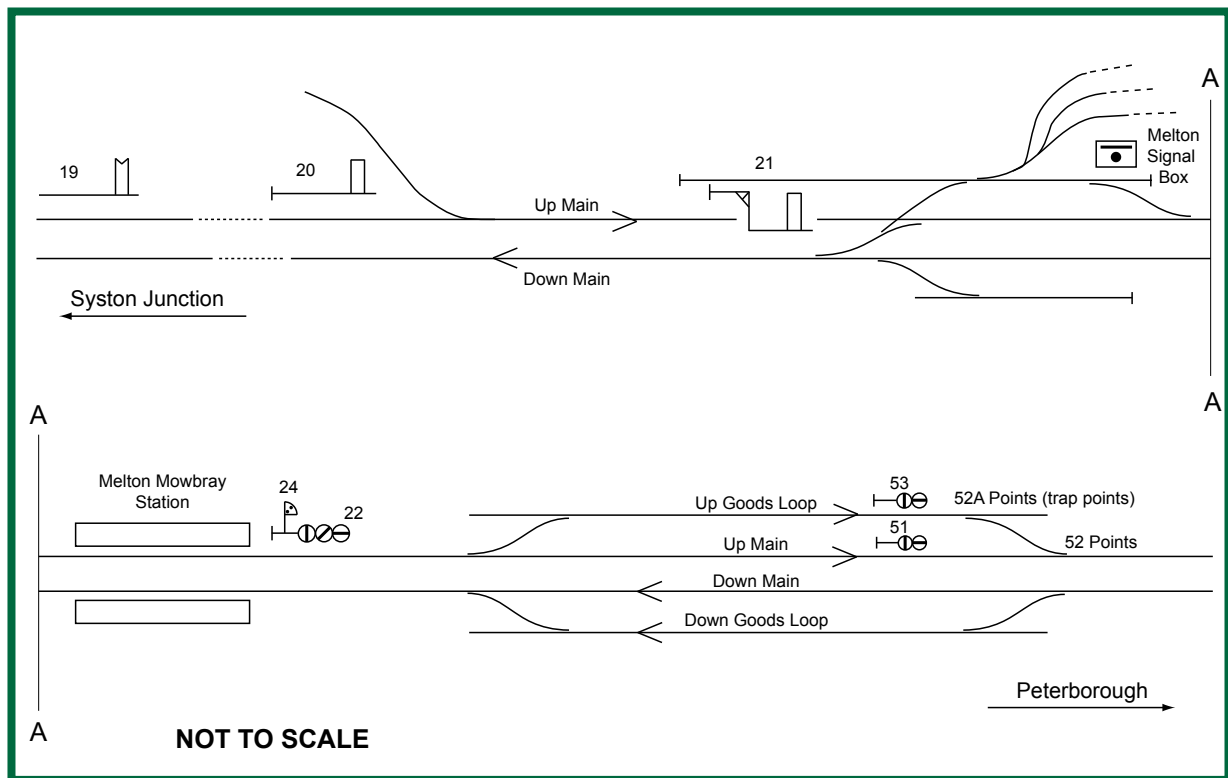
Figure 5: Location of relevant signals and points, Melton Mowbray

- 29 The method of signalling is *absolute block* with the block section east of Melton extending to Whissendine and the block section west of Melton extending to Frisby. The layout of the signalling at Melton Mowbray in the Up direction is shown in Figure 5.

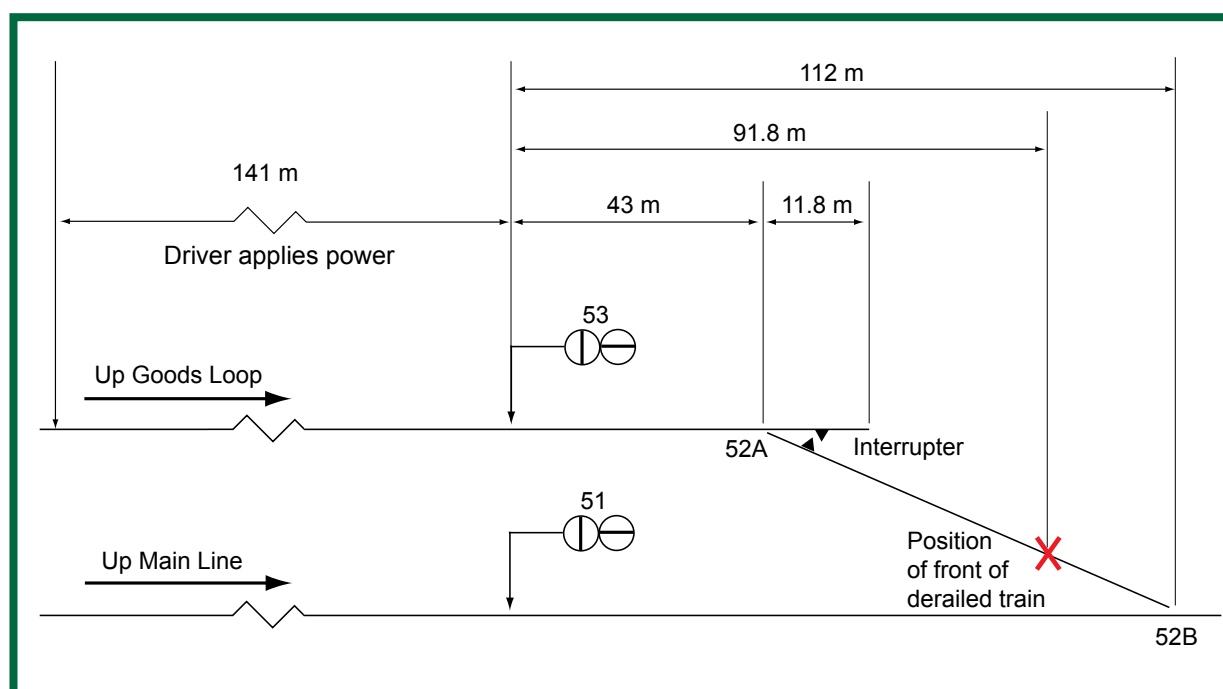
Figure 9: Critical measurements - Brentingby Junction

- distance from signal 53 to the *switch toes* of the trap points (52A): 43 m;
- length of *switch blades*: 11.8 m;
- distance travelled by the locomotive beyond the trap point switch blades: 37 m;
- the train therefore travelled 91.8 m beyond signal 53 before it came to rest;
- distance from signal 53 to the switch toes of 52B points: 112 m.

73 The critical measurements in paragraph 73 above are shown in Figure 9.
