Rail Accident Report

Derailments at London Waterloo 11 September and 24 October 2006

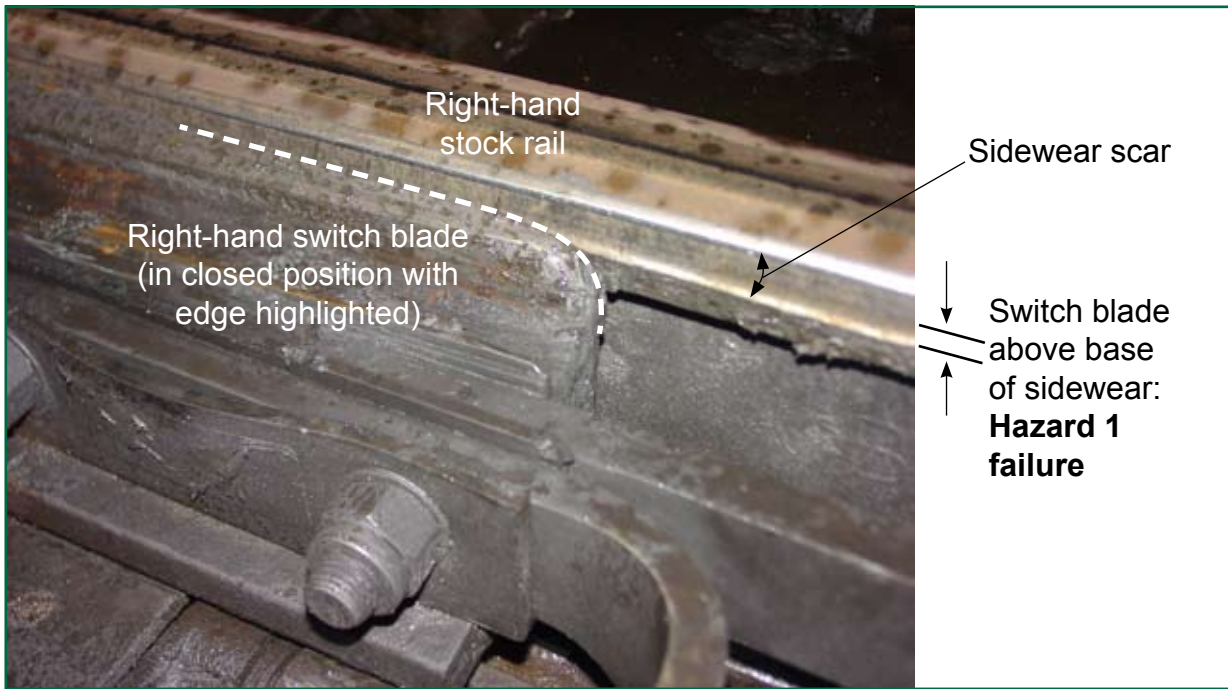
150 Following the derailment, the switches were examined and rail head profiles were taken at intervals along the right-hand switch and stock rails. A sidewear reading of step seven was obtained at the right-hand switch tips, reducing to a value of step five on the right-hand stock rail at a position 760 mm from the switch toes. Had this been recorded prior to the derailment, standard 053 would have required the prohibition of train movements in the facing direction involving the affected switch blade (ie into the south sidings).

151 Grease was observed on the switch toes, suggesting that grinding had not extended to the tip of the switch blade. However, other areas were effectively unlubricated.

Figure 9: 1565 points: View of right-hand switch rail in reverse (closed) position

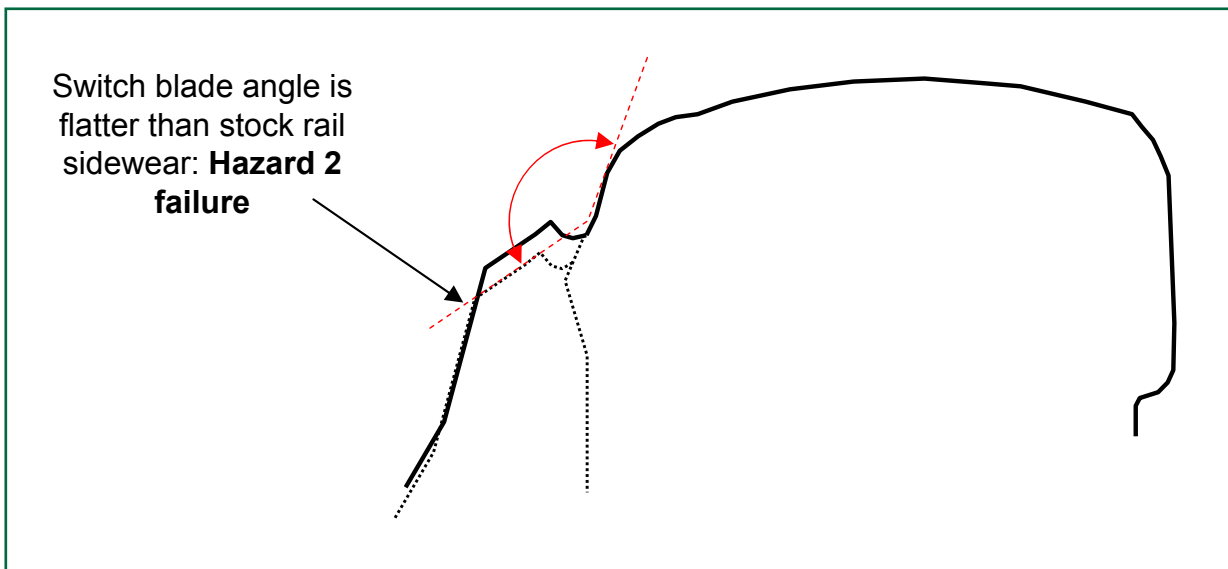
152 The right-hand switch blade of 1565 points was to be found non-compliant with standard 053 (Figure 10) in terms of the height of the switch blade when compared with the sidewear on the stock rail (hazard 1). In addition, the angle of the switch blade face was measured as being less than 40° to the horizontal at a position 100 mm from the switch tips, which was significantly shallower than the stock rail and less than the 60° requirement following reprofiling (hazard 2). This did not reflect the Waterloo GSM's findings.

Figure 10: 1565 points: Profile of switch and stock rail, 40mm from switch tip, after correction for hogging (corrected profile is shown by dotted line)

- 153 As a consequence of the switch and stock rail profiles, the right-hand wheel flanges of each train entering the south sidings, already in contact with the stock rail due to the track geometry, were presented with a ramp. Marks on the switches showed that several wheelsets had attempted to climb this ramp without leading to derailment.

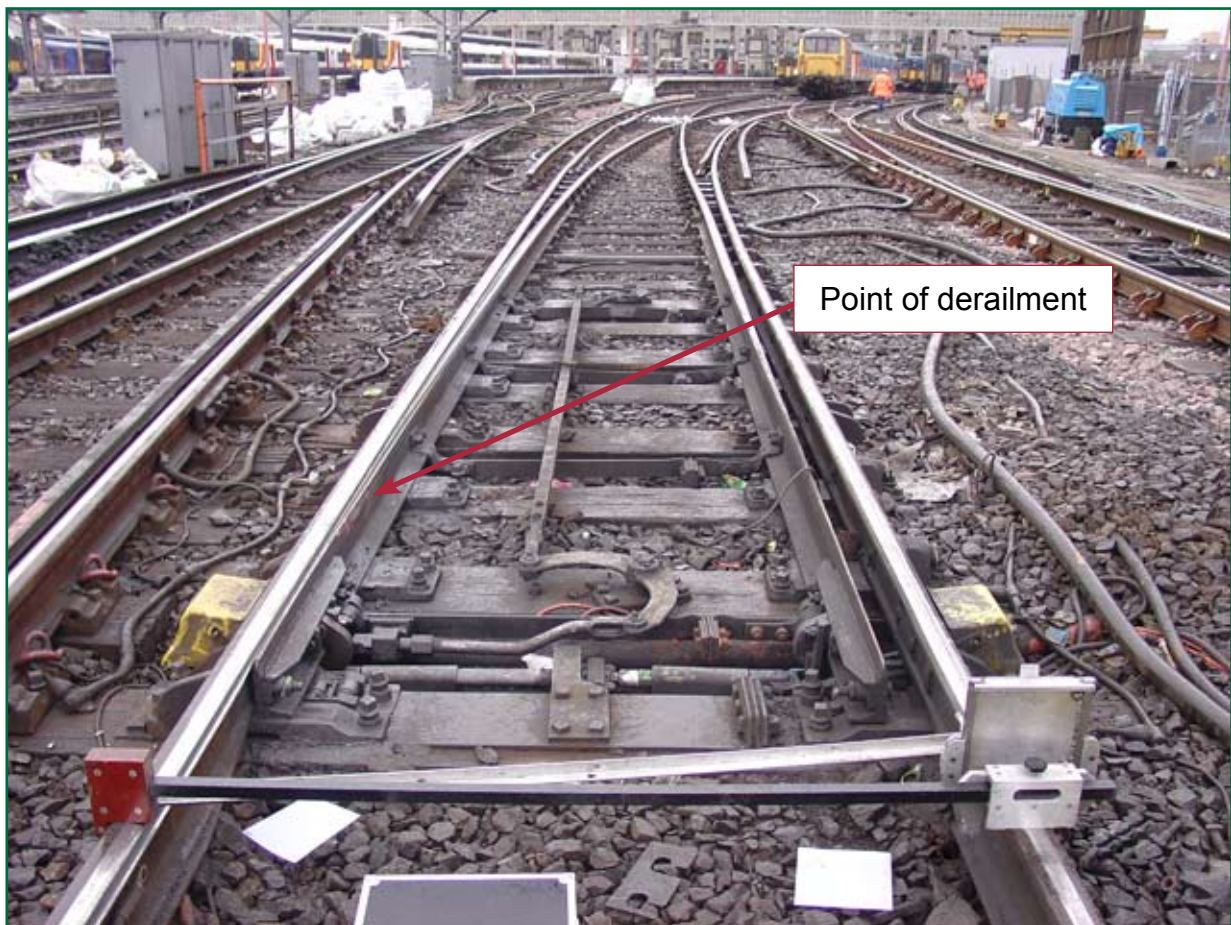
Figure 11: 1507 points viewed towards Waterloo station in the direction of travel. Train 1D54 is visible in the right background, with carriages 7 and 8 behind a Class 37 locomotive being used for recovery

186 Inspection of the site confirmed that the leading wheelset on the 7th vehicle had been first to derail close to the toes of 1507 points, with the following bogies being derailed as a result of the diverging movement. The first bogie to be derailed continued towards platform 2, while the remaining three bogies took a separate route towards platform 3/4.

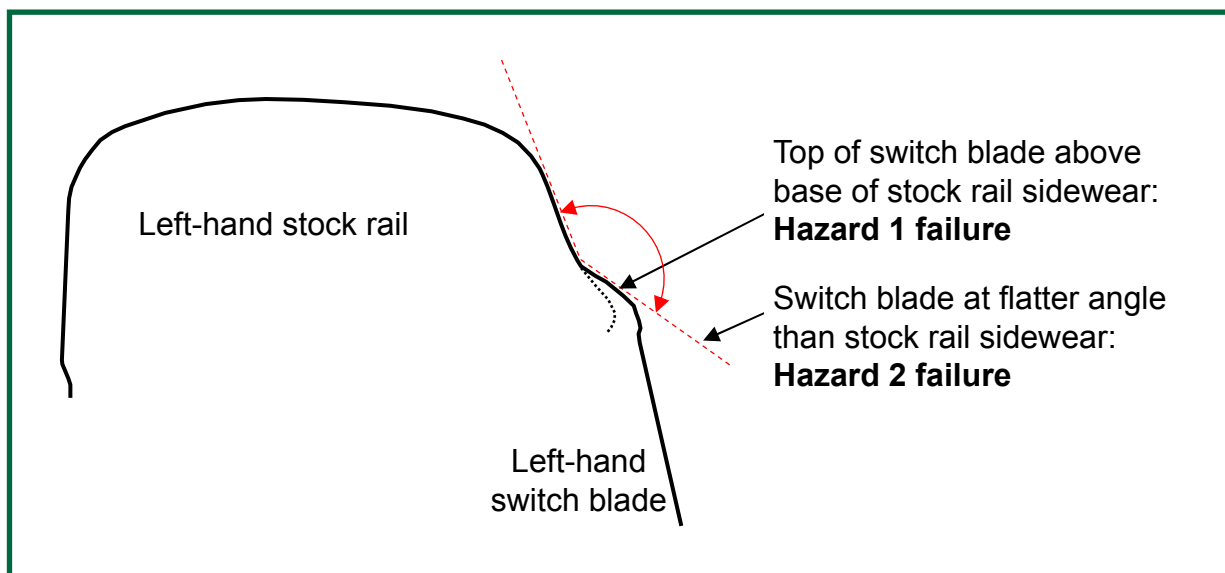
- a. the switch blade height was above the base of the sidewear on the stock rail, resulting in a derailment hazard 1 failure;
- b. the switch blade profile was flatter than the stock rail's sidewear resulting in a derailment hazard 2 failure;
- c. a sharp edge was apparent along the upper edge of the switch blade resulting in a derailment hazard 5 failure; and
- d. sidewear on the left-hand stock rail was at step 9 (there is no record of sidewear in the July FPI and an increased-frequency inspection regime had not been instigated).

Figure 12: Profile of left-hand switch half set of 1507 points, 100 mm beyond switch toe (from data recorded by Delta Rail)

185 Following the derailment, facing moves were prohibited until the switch blade was reground to comply with the requirements of a standard 053 detailed inspection.

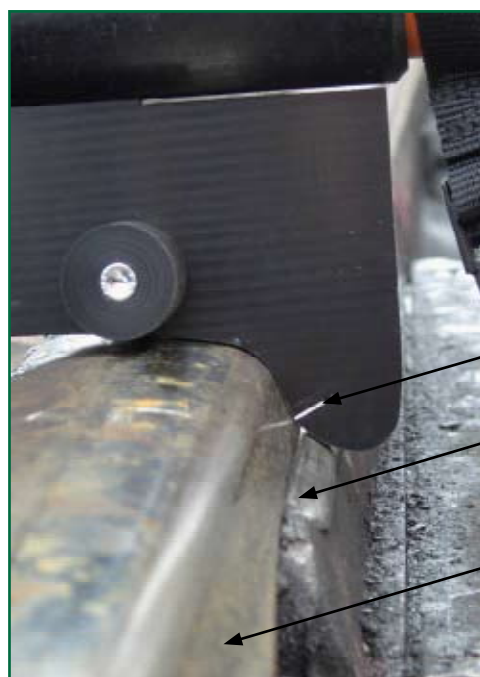
60° line marked on wheel profile gauge. Gauge should not make contact with rail below this marker

Switch blade angle visibly flatter than sidewear on stock rail

Figure 13: Image of wheel profile gauge on 1507 points (left-hand switch half-set). Photograph courtesy of Network Rail

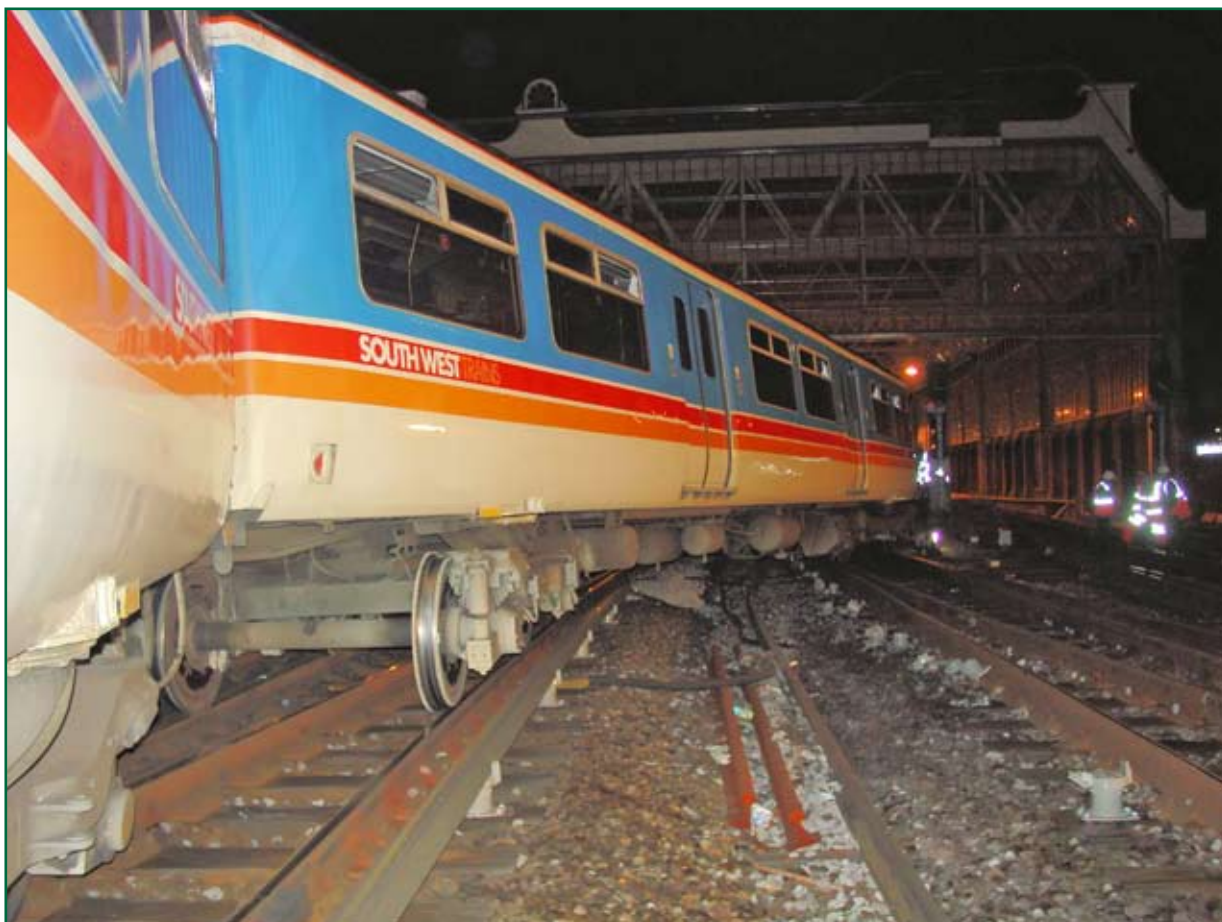
Figure 15: View of rear two carriages of train 1D54 in direction of travel following derailment
