# ***AAIB Bulletin***

***6/2015***

## **AAIB Correspondence Reports**

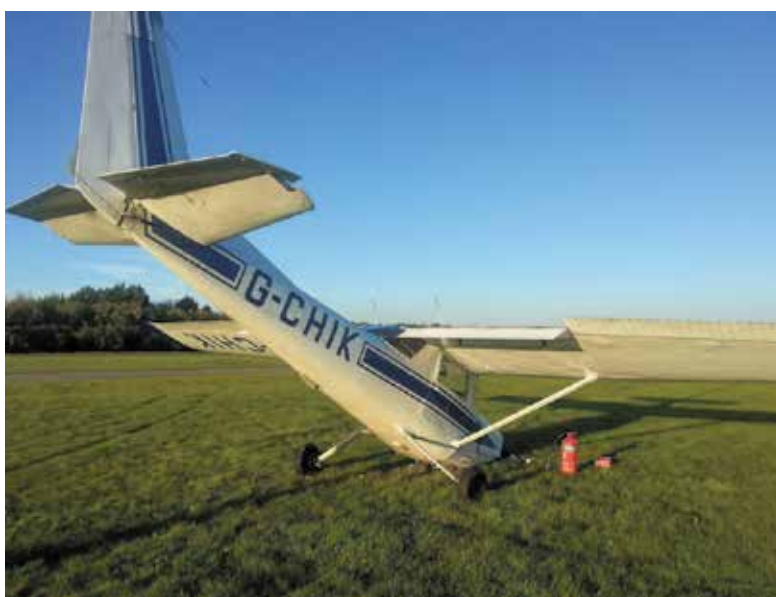
**Figure 1**

The first approach to Runway 24 was slightly high and fast and resulted in a go-around. On the second approach, a gust of wind caused the aircraft to roll to the right close to the ground.

This precipitated a loss of control, and the aircraft impacted hard on the nose landing gear, which collapsed (Figure 1). Airfield staff, observing the windsock, estimated the wind was from 190° at 12 kt.
