Foss Barrier and Pumping Station

FACTUAL REPORT ON FLOODING ON 26TH DECEMBER
2015

Environment Agency

5th May 2016

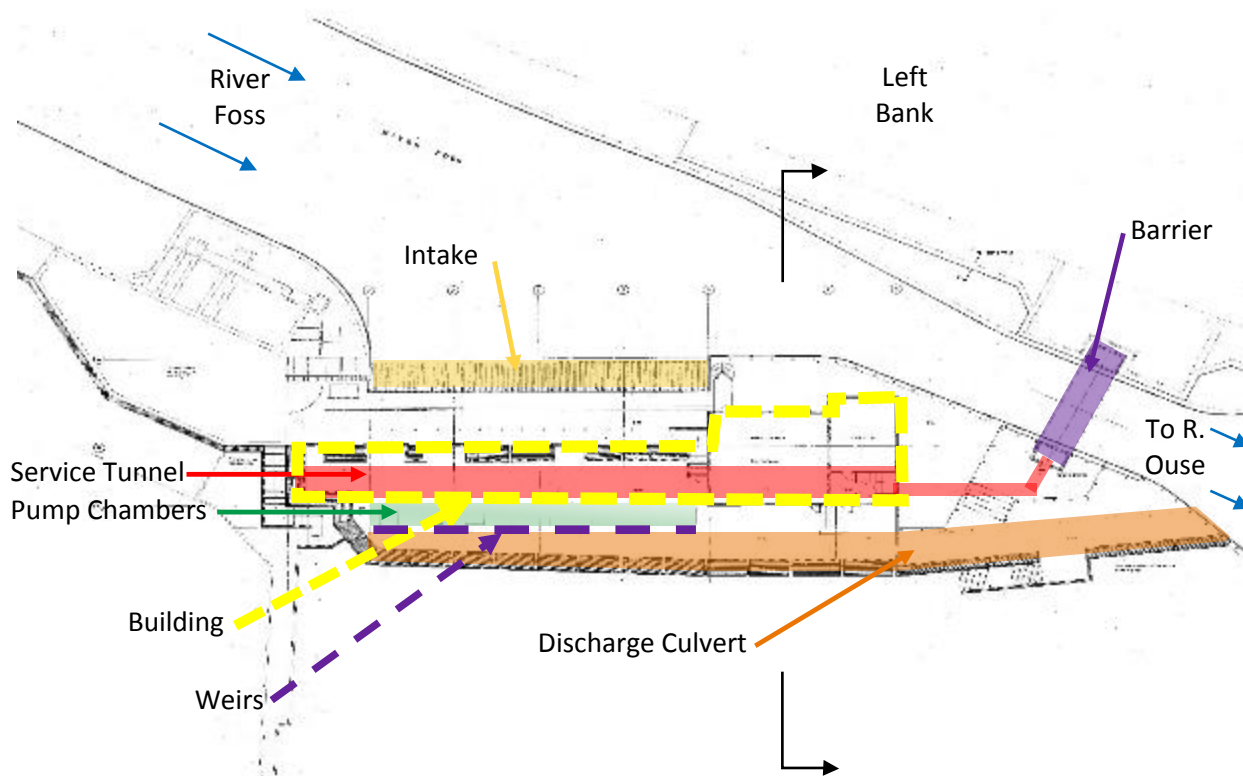
Figure 1. General layout

With reference to Figure 1 and 2, when the barrier is lowered to prevent water from the River Ouse entering the River Foss, up to eight pumps draw water through the intake. The water passes through the lowest part of the facility at a level of 3.2mAOD, beneath the service tunnel that is at 6.2mAOD and the ground floor at 8mAOD. The water is lifted through pump chambers, over individual weirs into the discharge culvert through which it flows before discharging downstream of the barrier. The weir crests are at a level of 10.5mAOD. Backup generators and a control room are located on the first floor level. A selection of construction photographs are appended to this report.

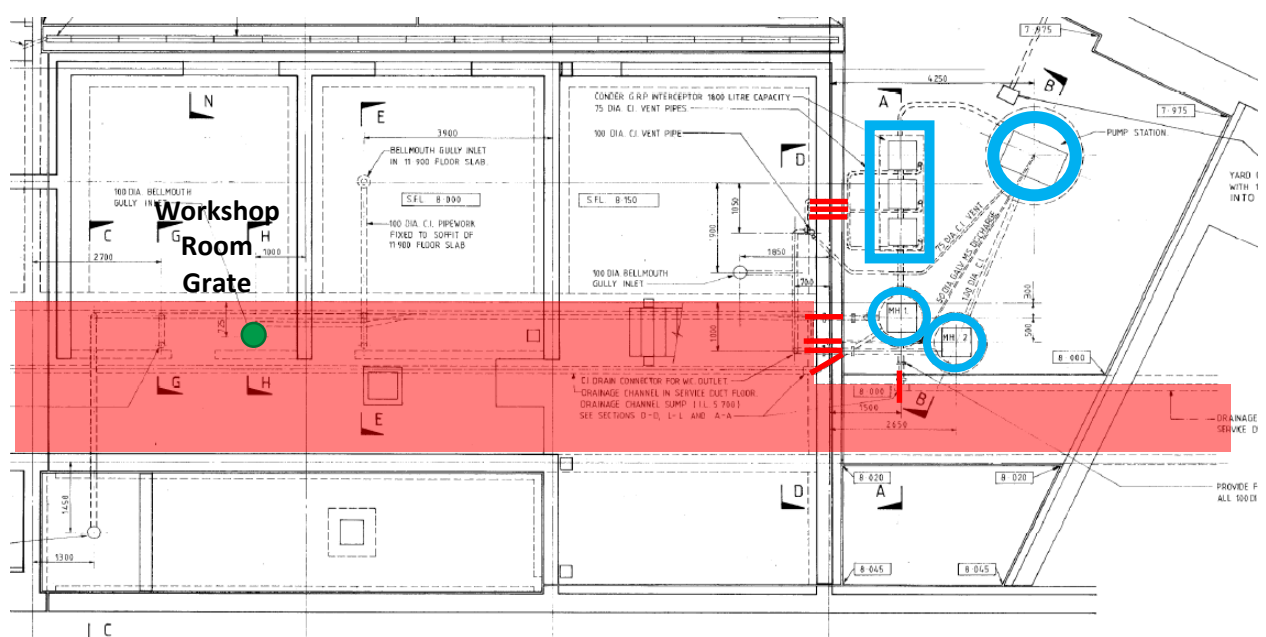
Figure 3. Drainage Plan

Drainage from the ground floor and first floor level of the facility is routed via a sealed cast iron pipe network. Pipes pass through the service tunnel and the wall of the building before connecting to the external drainage. The external drainage consists of chambers, an interceptor (for oil and diesel spills) and a drainage pump station from which the waste water is pumped. Figure 3 shows the southern end of the building where elements of the drainage pass through the perimeter of the building. The green circle is the location of the floor grate through which water was observed flowing into the building during the event. The red lines on Figure 3 show locations where drainage infrastructure pass through the perimeter of the building and the blue shapes are the external drainage chambers. On both Figures 1 and 3 the service tunnel is shaded in transparent red.

Water entering the building via the ground floor drainage is believed to originate from a leaking seal on a flapped discharge, see Figure 3. However, the water exerting pressure on the valve originated from the service tunnel leakage and service tunnel drainage, as explained in section 3.2.4.2.

Waste water from the facility is small in quantity and arises from spills, cleaning and domestic facilities. The drainage could be configured in a way which eliminated the need to pass through the perimeter of the building below flood level ie by having a small pumping system to pump it up and over the defence height. If this measure is adopted, all existing drainage routes which pass through the wall of the building would be sealed.

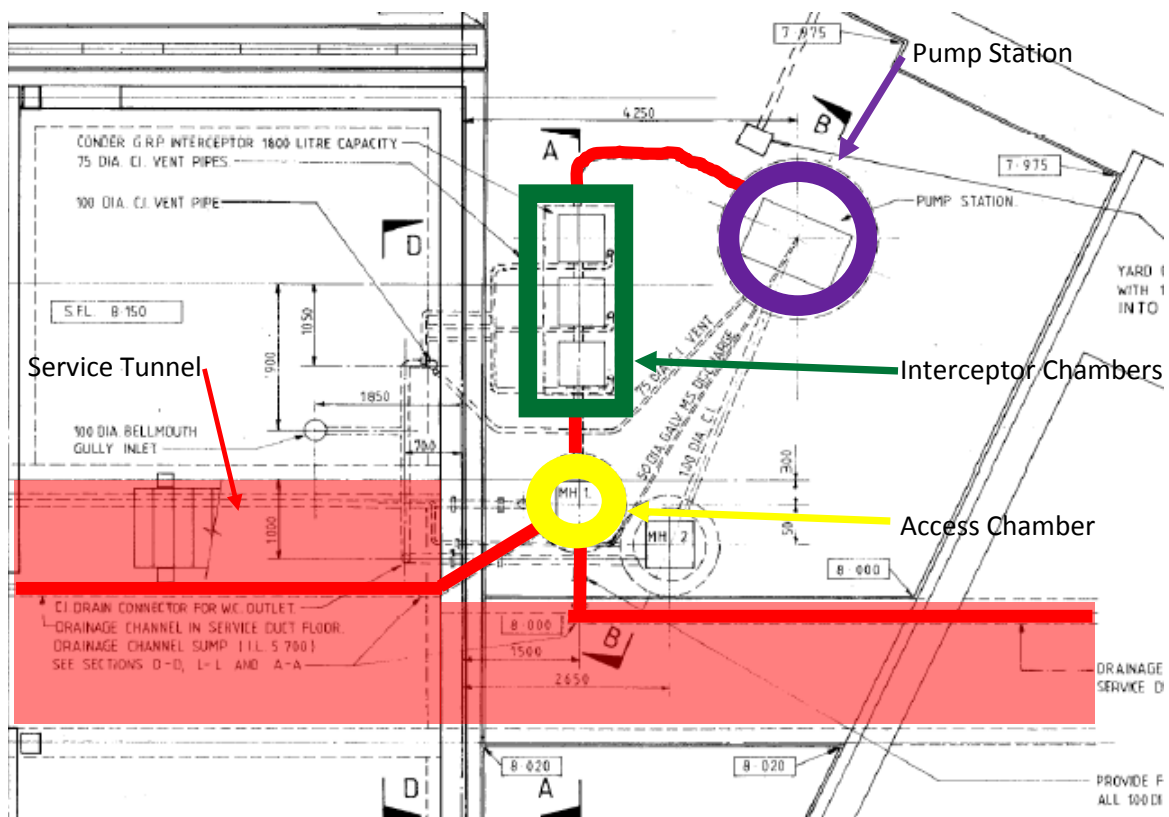
Figure 4. Service Tunnel Drainage Plan

Water is known to enter the facility's service tunnel. A degree of leakage into the service tunnel is accommodated in the design of the facility with the provision of channel drains in the base of the service tunnel. With reference to Figure 4, the channel drains convey water to an access chamber (yellow) outside of the building and onward to interceptor chambers (green) before discharging to the waste water pump station (purple). Water is pumped from the waste water pump station away from the facility. The access chamber (yellow) and interceptor chambers (green) have sealed covers so that water cannot enter them from above. Waste water discharges into the pump station through a flapped outfall.

On occasions, the rate of leakage exceeds the capacity of the pump station. In this situation water backs up the drainage system and the water level in the service tunnel rises. If left unchecked the water would rise and enter the building at ground floor level through access openings in the floor. Site operatives draw this water level down by pumping the excess water from the interceptor. This procedure necessitates removal of a sealed cover and lowering of a submersible pump into the interceptor. The electric pump used for this operation has a maximum capacity of 240 litres per minute reducing to 130 litres per minute at 7m head. The actual head during this operation is approximately 3.3 metres, but may be less depending on the water level in the interceptor.

Access openings between the building and the service tunnel should be sealed so that when water enters the service tunnel it cannot rise and flood the building. Permanent, immovable physical seals will eliminate operational risks associated with the existing moveable covers.

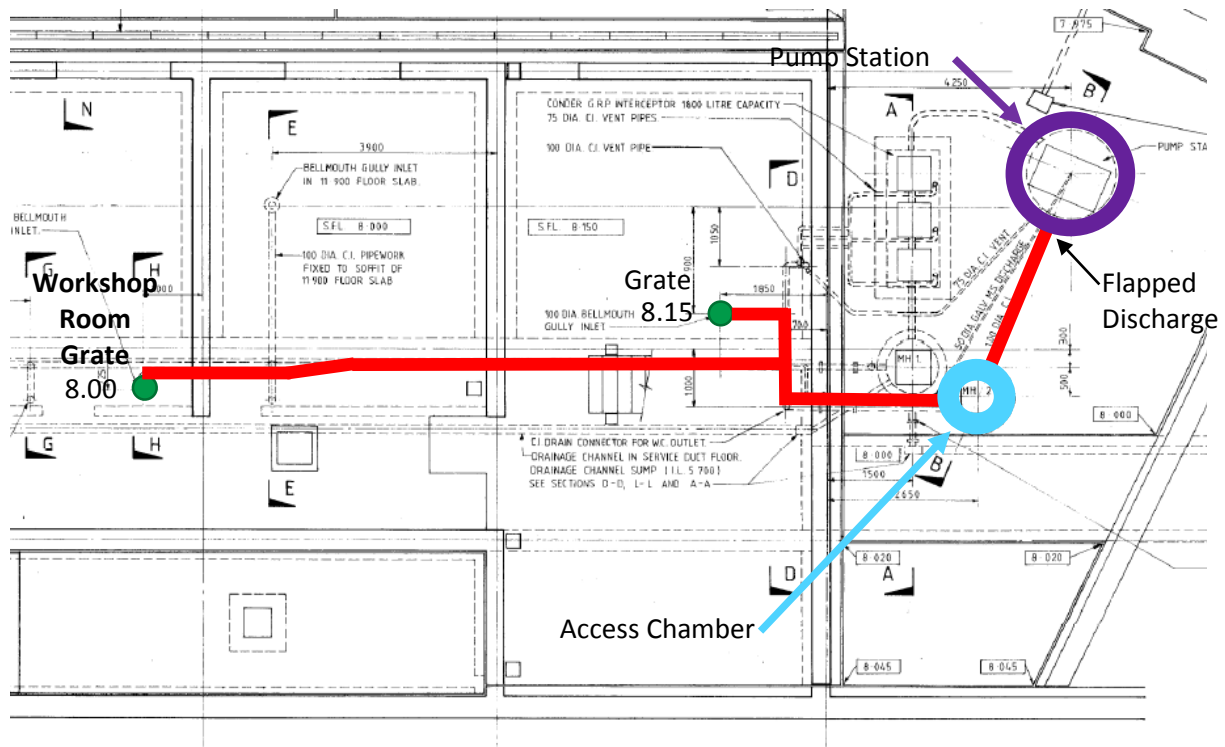
Figure 5. Ground Floor Drainage

This section relates to the grates located in the southern end of the building. The workshop room grate is located at a level of approximately 8.0m AOD and the other at 8.15m AOD. With reference to Figure 5, these floor grates are connected to the foul drain and convey waste water outside of the building to an access chamber (turquoise) before discharging to the waste water pump station (purple) through a flapped outfall.

Waste water was observed arising from the workshop room floor grate located at a level of 8mAOD at approximately 13:30. The most probable cause of this is the water that entered the interceptor flowed into the waste water pump station. Referring to Figure 5, the flapped discharge between the access chamber (blue) and the pump station (purple) has failed to completely close.

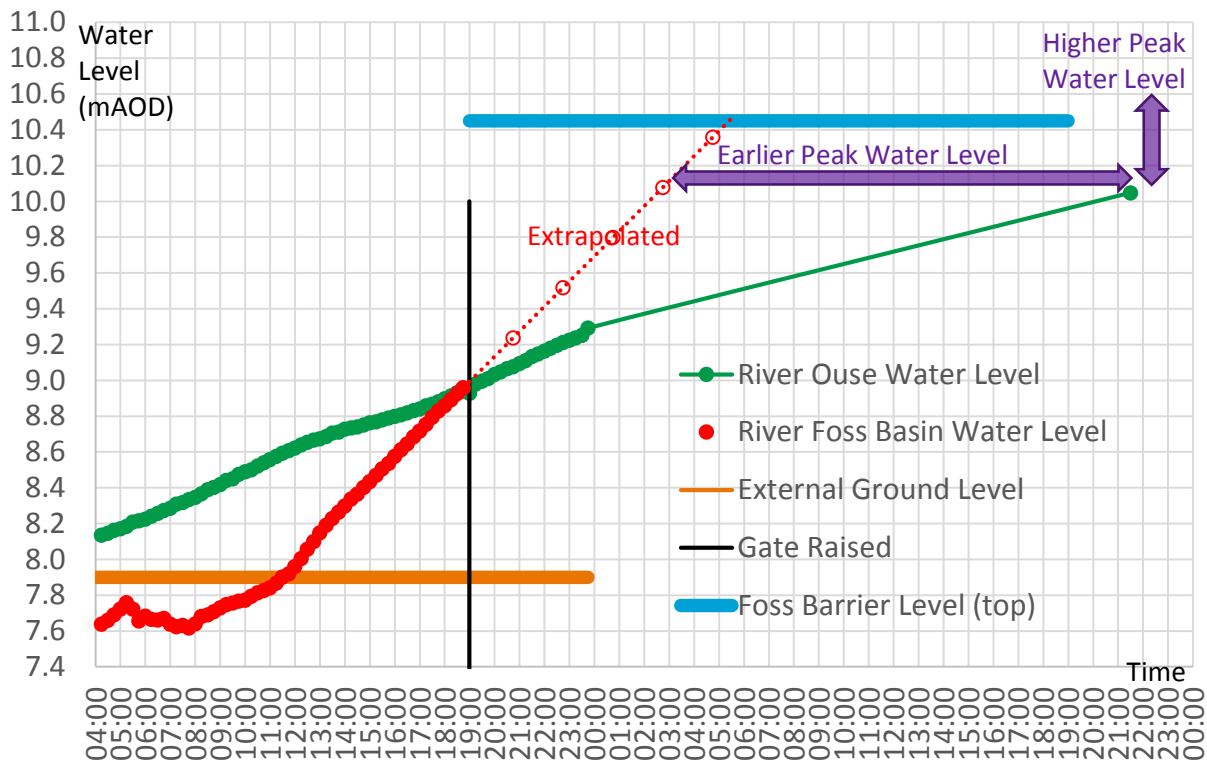
Figure 6. Operational Response in the Event (26/12/2015 – 27/12/2015)

On the 26th December 2015 during the event all eight pumps at the facility were operating until immediately before the barrier was raised at approximately 19:00 when they were turned off. Figure 6 shows the water levels at the River Foss Basin and the River Ouse (either side of the Foss Barrier). Water levels were being maintained at a level of around 6mAOD until 07:45. After this time the level in the River Foss Basin rose at a rate of approximately 70mm per hour to a level of 7.84mAOD at 11:00. From 11:00 to the time just before the gate was raised at approximately 19:00 the rate of water level increase in the River Foss Basin was approximately 140mm per hour. The peak flow in the River Foss on 26th December 2015 was extreme and equates to an annual exceedance probability of 0.5% (1 in 200 year).

Figure 6 shows the water level upstream and downstream of the barrier during the event, along with an approximation of water levels in the River Foss Basin if the barrier had not been raised. With all

eight pumps in operation the water level in the River Foss Basin was rising. Extrapolating the observed water level data it can be seen that if the barrier had not been raised the level in the River Foss Basin would have continued to rise until it spilled over the barrier into the River Ouse. The attenuated water level in the River Foss Basin would have been higher if the barrier had remained in the lowered position. Furthermore, the peak water level would have occurred some eighteen hours earlier. Both the possible higher water level and the timing of the peak water level are identified on Figure 6 by the purple arrows.
