SAFETY ALERT

Subject: Disruptive Failure of Radio Filter (RF) Power Filter

Number: SA 2015/07

Date of issue: 23 July 2015

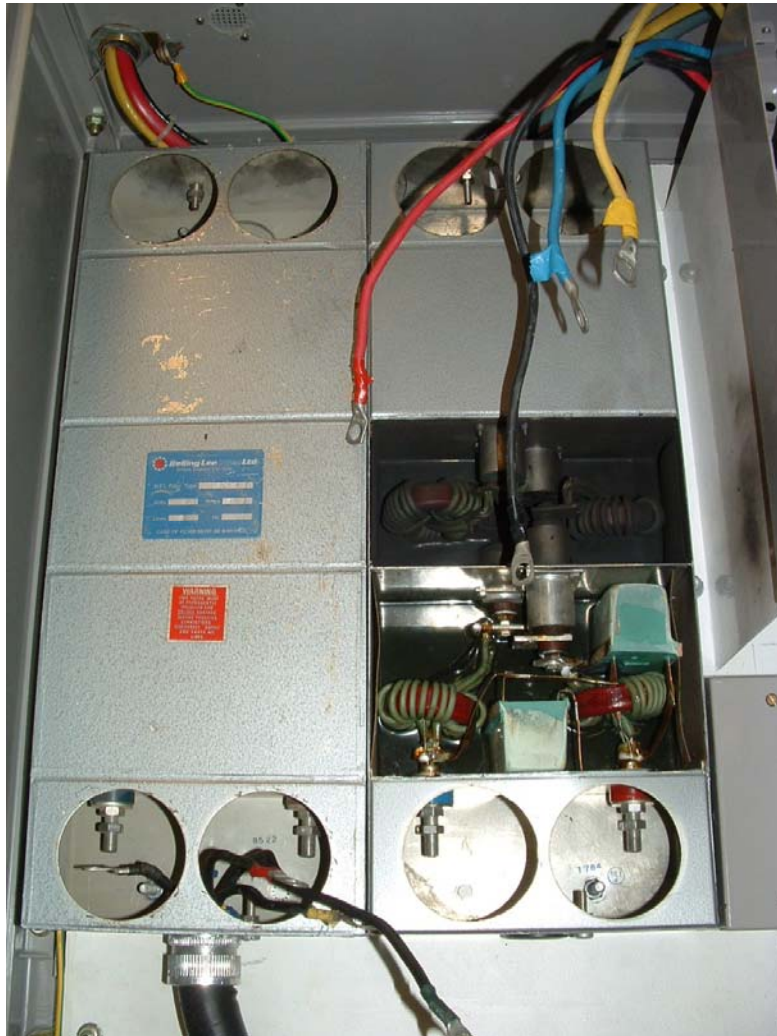
14. A disruptive failure of a mains RF filter type L2424 (250v 2 Line 60 Amp filter) manufactured by Belling Lee, and now supported by ETS-Kindgren, occurred within an MOD office location. The mains RF filter was housed in a GRP enclosure, for reasons unknown at present, and the overpressure damaged the GRP enclosure, including its door locking mechanism, and expelled debris into the room with one of the metal door locking interconnecting bars travelling approximately 20 feet across the office. Fortunately, the room was not occupied at the time of the failure.

15. ETS-Kindgren has recovered and inspected the mains RF filters and provided a 'Filter Field Failure Report'. The Report has identified two potential contributory factors to the failure: the age of the mains RF filters, and their use on a 3 phase 400v circuit. Early indications suggest that the failure was propagated by using two single phase filters in a 3 phase system but an age related failure cannot be discounted at this time.

Figure 1: Damaged mains RF Filter in GRP Enclosure (note: cables have been disconnected).

9. Responsible persons are to arrange for Competent Persons to inspect and confirm that the mains RF filters are operating within the manufacturer's design parameters. Where the mains RF filters are found to be operating outside of their design parameters arrangements are to be made to replace the filter with an appropriate mains RF filter.

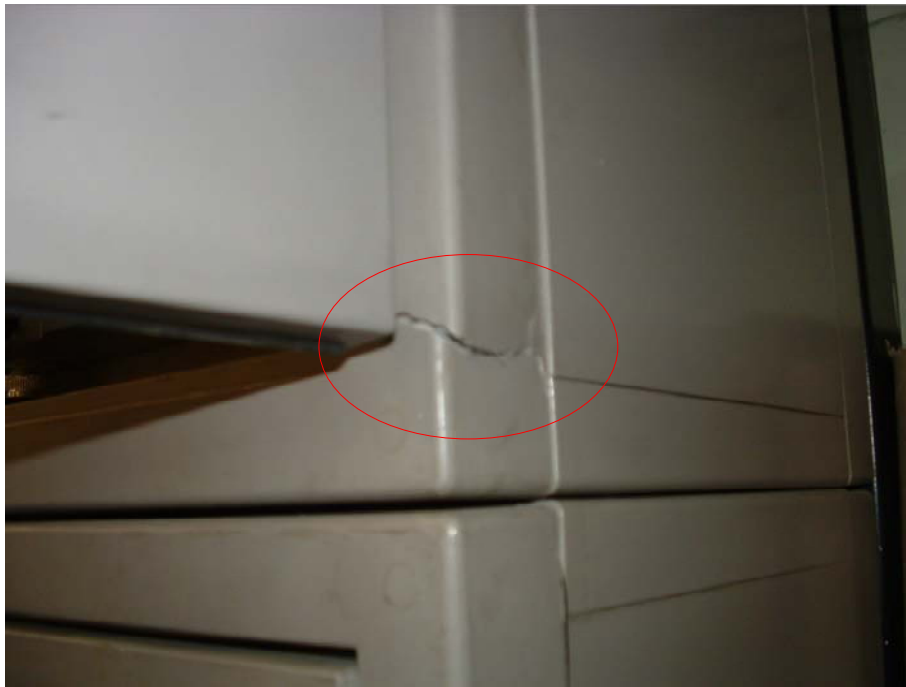
Figure 2: Damage to GRP enclosure.

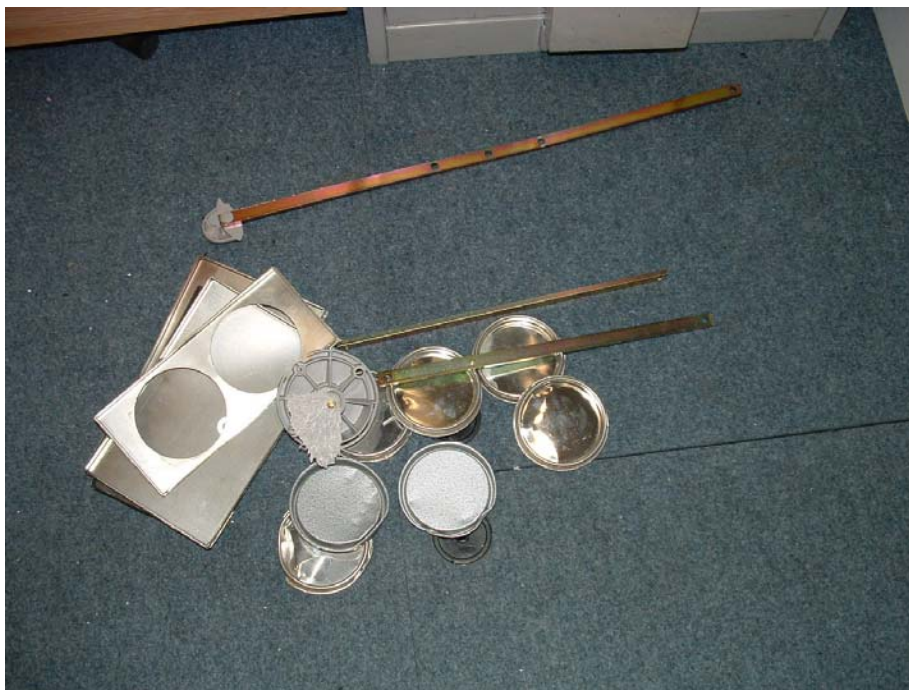
Figure 3: Debris ejected from GPR enclosure including interconnecting bar.

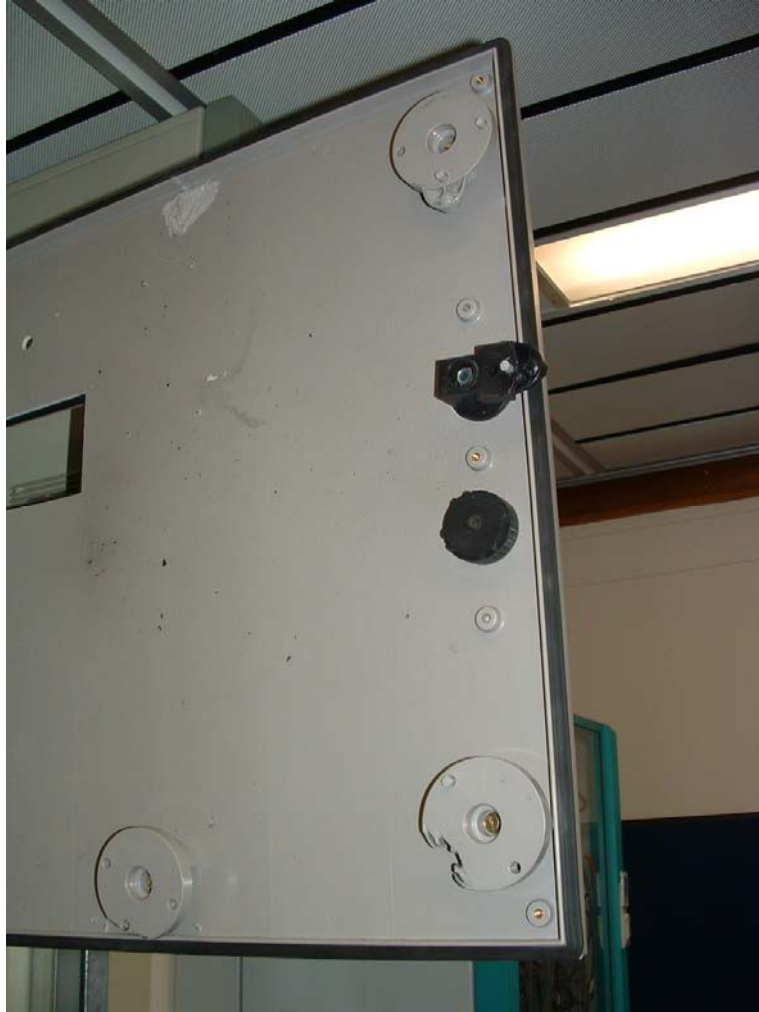
Figure 4: GRP enclosure door following the incident, note the interconnecting/latching bars were detached in the incident
