Rail Accident Report

Derailment of a freight train near Moor Street station, Birmingham 25 March 2008

Report 07/2009
March 2009

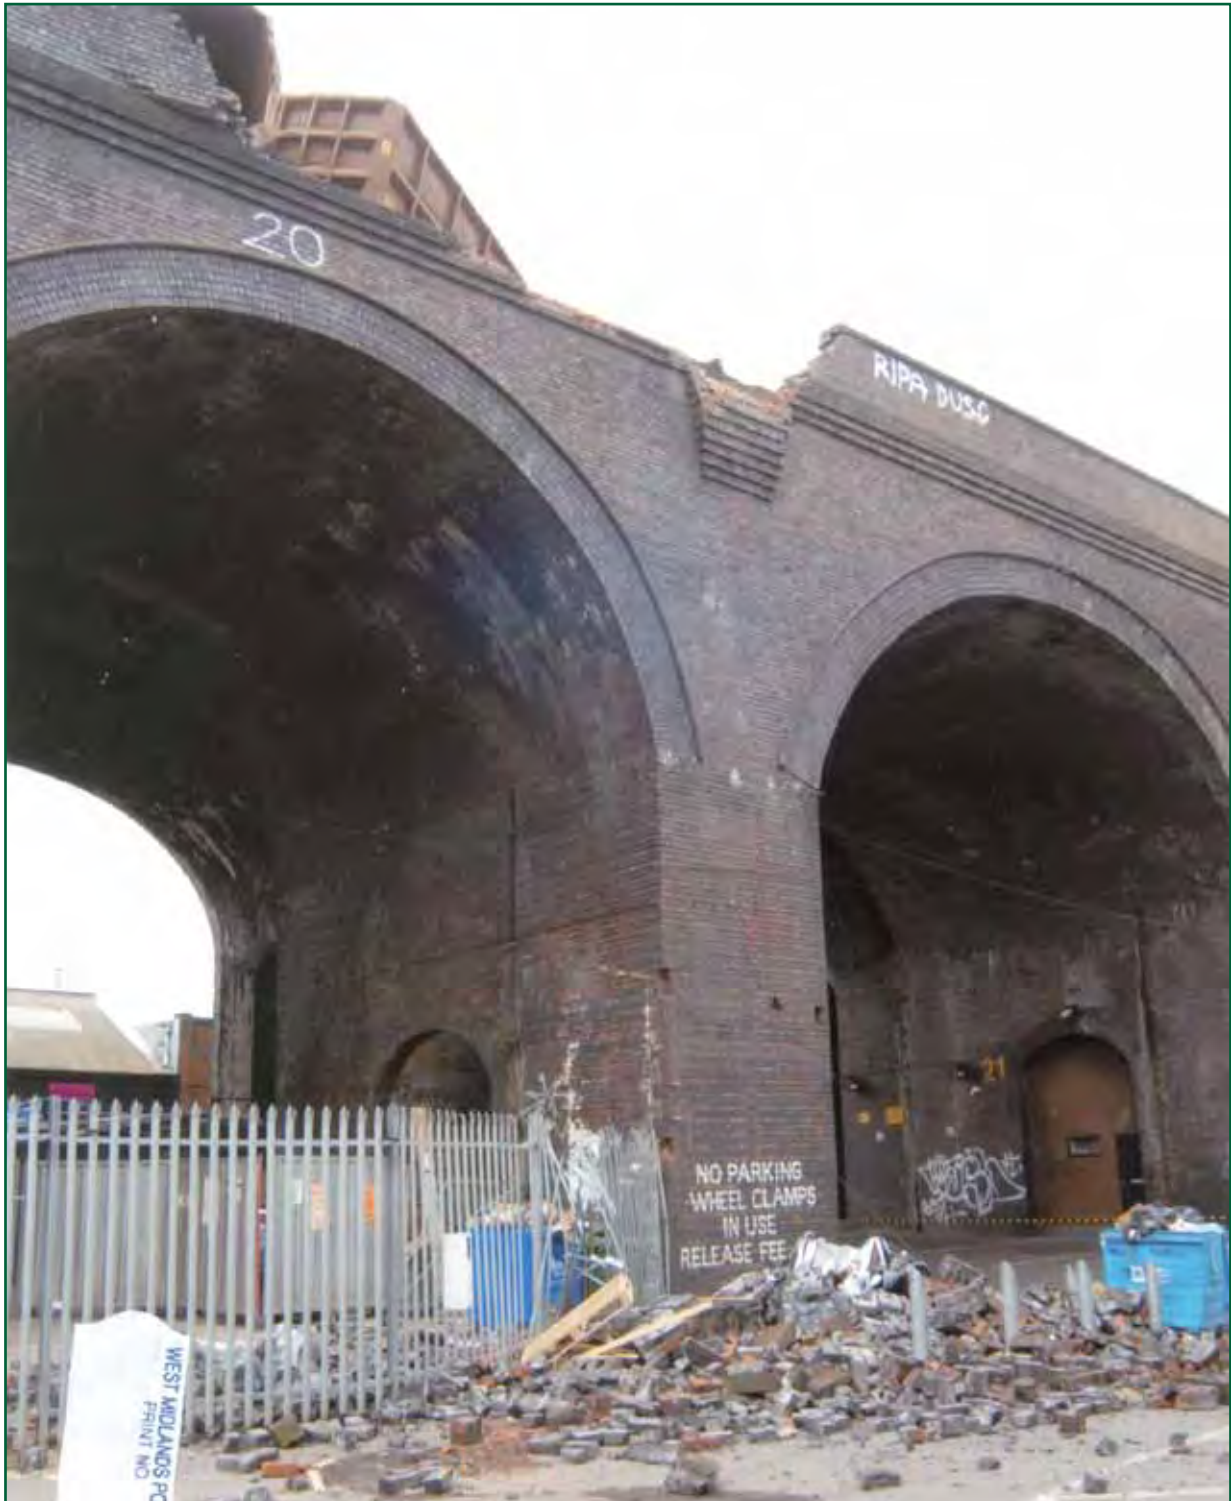
Figure 10: Fallen debris and damage to the parked car (image courtesy of West Midlands Police)

- 36 Just as the train stopped the upper trailing edge of the body of the 16th wagon, 470152, now lying and travelling on its left side, struck and displaced a 10 metre section of the brick parapet of the viaduct, which fell approximately 20 metres onto private ground below, severely damaging a parked car (Figure 10).

- 40 An unoccupied parked car was severely damaged by falling brickwork. The accident had potential for a more serious outcome, had there been any persons below the parapet.
