## Application SCR evaluation template

Name of activity, address and NGR	<p>Evonik Goldschmidt UK Ltd (formerly Goldschmidt UK Ltd): BM4198IC</p> <p>Main Road Flimby Maryport Cumbria CA15 8RP</p> <p>National Grid Reference – NY 0163 3306</p>
Document reference of application SCR, date and version of SCRs	<p>Application Site Report, reference DEG01, July 2003 prepared by E4environmental Ltd.</p> <p>PPC Permit No. BM4198IC (decision document dated 13<sup>th</sup> January 2004 and Application Site Report Evaluation Checklist dated 14<sup>th</sup> January 2004)</p> <p>Design Site Protection and Monitoring Programme, dated 27<sup>th</sup> March 2004 prepared by Goldschmidt.</p> <p>Updated Design Site Protection and Monitoring Programme, dated 4<sup>th</sup> April 2006 prepared by Goldschmidt.</p>
Document references relevant to SCRs	<p>The following documents were submitted on 29<sup>th</sup> September 2015 in support of the application to surrender the permit:</p> <ul style="list-style-type: none"> <li>• Site Condition Report Template: not dated;</li> <li>• Operational Description Report, prepared by Brian McAvoy, not dated;</li> <li>• Site Closure Plan, reference EV SCP 2015, dated 2

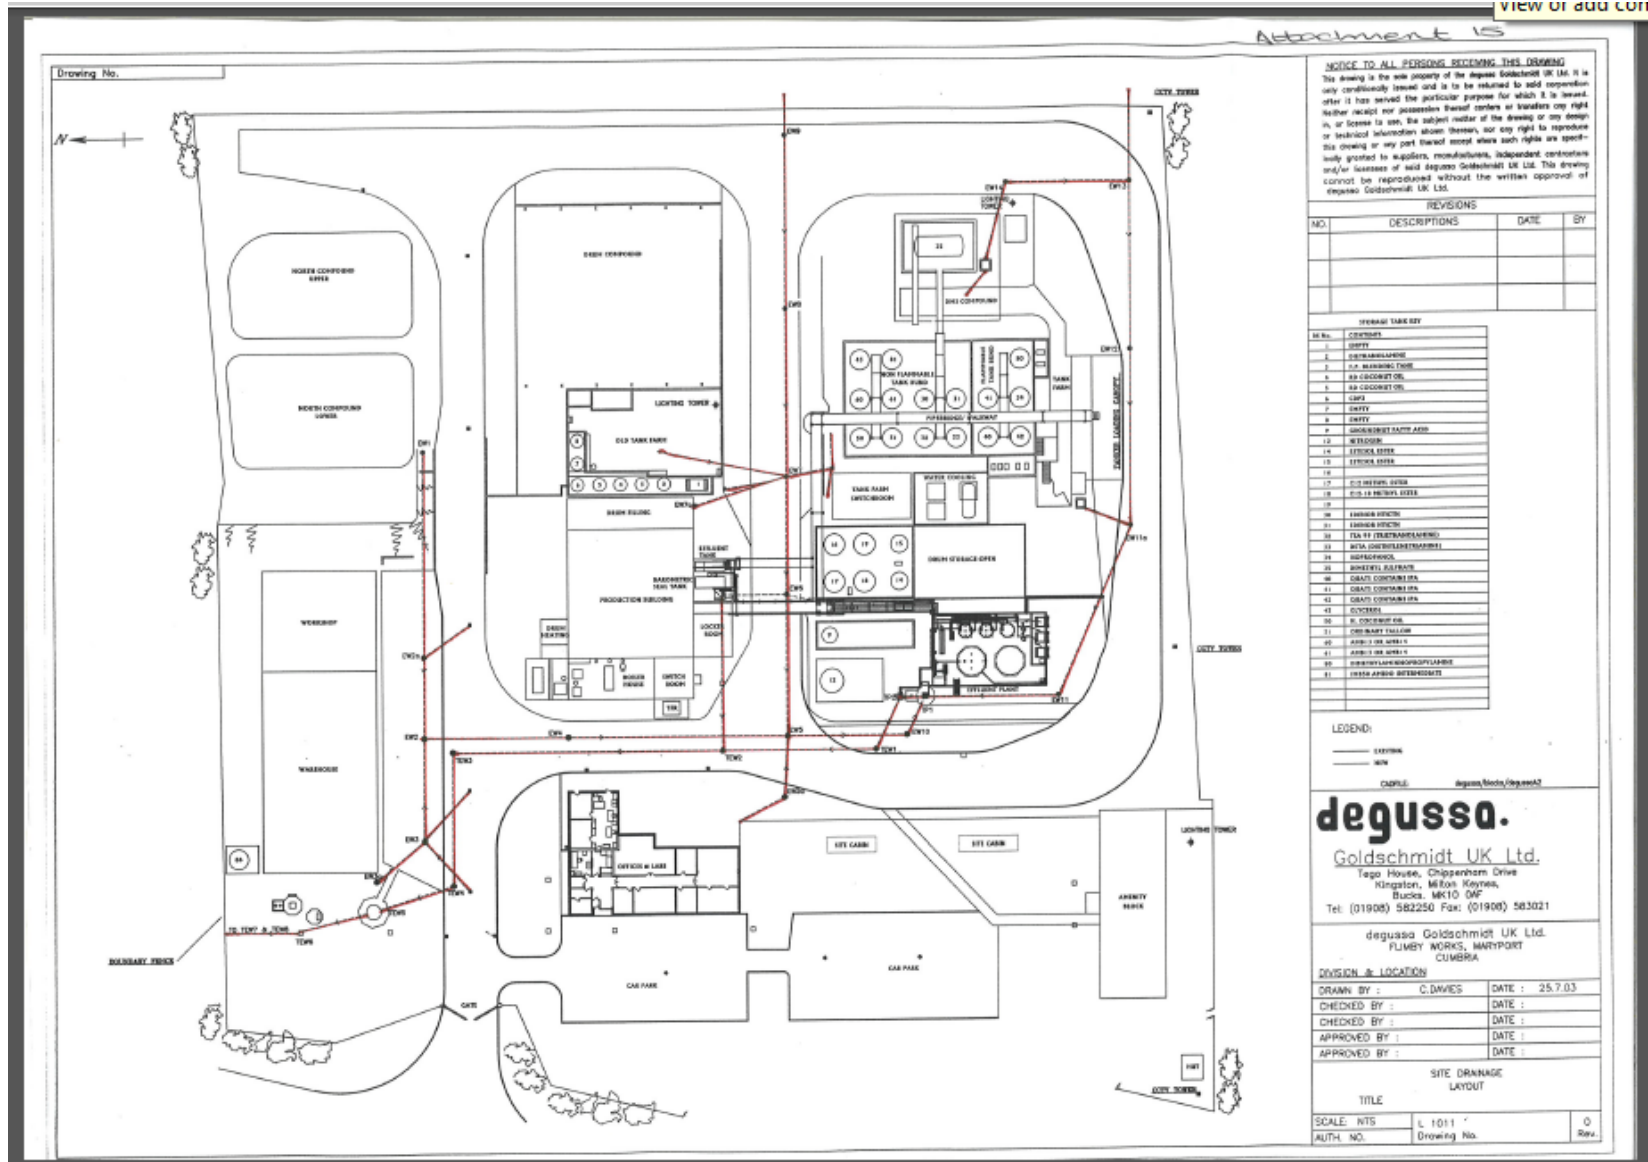
Drainage plan:

- Holes in the effluent line between manhole EW2a to manhole EW1 (01 to 04 o'clock and 09 to 02 o'clock);
- Infiltration gushing into the pipe between manhole EW6 to manhole EW5 (04 o'clock); and
- Displaced joints identified between manholes EW5 to EW9, EW13 to EW11a and EW2a to EW1.

- Infiltration seeping between manhole EW12 to manhole EW11a: (02 to 06 o'clock);
- Infiltration dripping between manhole TEW7 to manhole TEW5a: (12 o'clock);
- Broken pipe located between manhole EW2a to manhole EW1 (01 to 06 o'clock);
- Hole in pipe located between manhole EW4 to manhole EW5 (10 to 01 o'clock);
- Infiltration gushing between manhole EW6 to manhole EW5: (05 o'clock);
- Cracks identified between manholes EW8 to EW7 (08 o'clock), EW14 to EW13 (03 o'clock) and TEW9 to TEW8 (02 to 05 o'clock); and
- Displaced joint between manholes EW13 to EW12 and open joint between manholes TEW2 to TEW3.

- Holes in pipe between manhole EW1 and manhole EW2a (02 to 05 o'clock);
- Gushing infiltration between manhole EW6 and manhole EW5 (05 o'clock);
- Infiltration between manhole EW12 and manhole EW11a (no information on location);
- Longitudinal crack between manhole EW8 and manhole EW7; (07 o'clock) and
- Displaced joint between manholes EW13 to EW12 and open joint between manholes TEW2 to TEW3.

- Holes/broken pipe and a displaced joint between manholes EW1 and EW2a: this line drains a roadway at the site, the north compound and the area outside the workshop;
- Infiltration gushing in between manholes EW5 and EW6: this line is down gradient of manholes EW1 and EW2a and also carries effluent collected from the warehouse area, offices

- Displaced joints between manholes EW5 and EW9: this line collects effluent collected from the road way and the two tank farm areas;
- Cracks between manholes EW7 and EW8: this section of the line collects effluent from the road way;
- Infiltration seeping in between manholes EW11a and EW12, displaced joints between manholes EW11a and EW13 and cracks between manholes EW13 and EW14: this line is located in the tanker off loading area; and
- Cracks between manholes TEW2 and TEW3, infiltration seeping in between manholes TEW5a and TEW7 and cracks between manholes TEW8 and TEW9: this line carries treated effluent off site to connect in to the main sewer.

In addition, the letter indicates that the infiltration between manhole EW5 and manhole EW6 could be due to a fire hydrant leaking in this area or groundwater. The company recommends that this area merits further investigation to determine if this is the case.

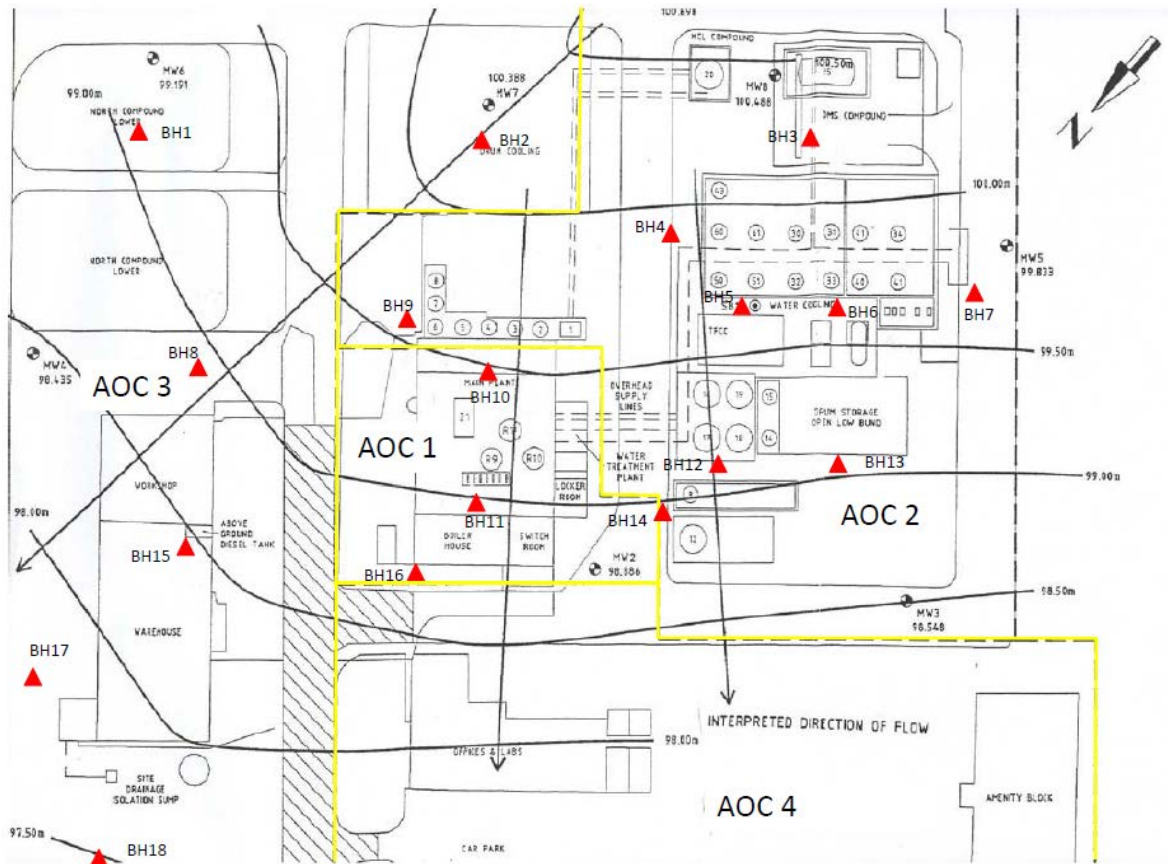
# Location of sampling points

The site investigation followed the proposals detailed in the letter of 30<sup>th</sup> April 2015. A number of the boreholes encountered refusals due to cobbles in the natural ground and had to be terminated early and BH15 was abandoned due to a concrete slab (see plan below for sampling locations).

In addition, groundwater samples were collected from BH10 as black staining was identified on the soils at 3mbgl and BH12 where a slight iridescence was observed on the water during the site works and analysed for VOCs.
