AAIB Bulletin

9/2016

Aircraft Type and Registration:	BAe ATP, G-BUUR
No & Type of Engines:	2 Pratt & Whitney Canada PW126 turboprop engines
Year of Manufacture:	1990 (Serial no: 2024)
Date & Time (UTC):	26 January 2016 at 1950 hrs
Location:	On approach to Guernsey Airport
Type of Flight:	Commercial Air Transport (Cargo)
Persons on Board:	Crew - 2 Passengers - None
Injuries:	Crew - None Passengers - N/A
Nature of Damage:	None
Commander's Licence:	Airline Transport Pilot's Licence
Commander's Age:	60 years
Commander's Flying Experience:	6,843 hours (of which 1,512 were on type) Last 90 days - 74 hours Last 28 days - 23 hours
Information Source:	AAIB Field Investigation

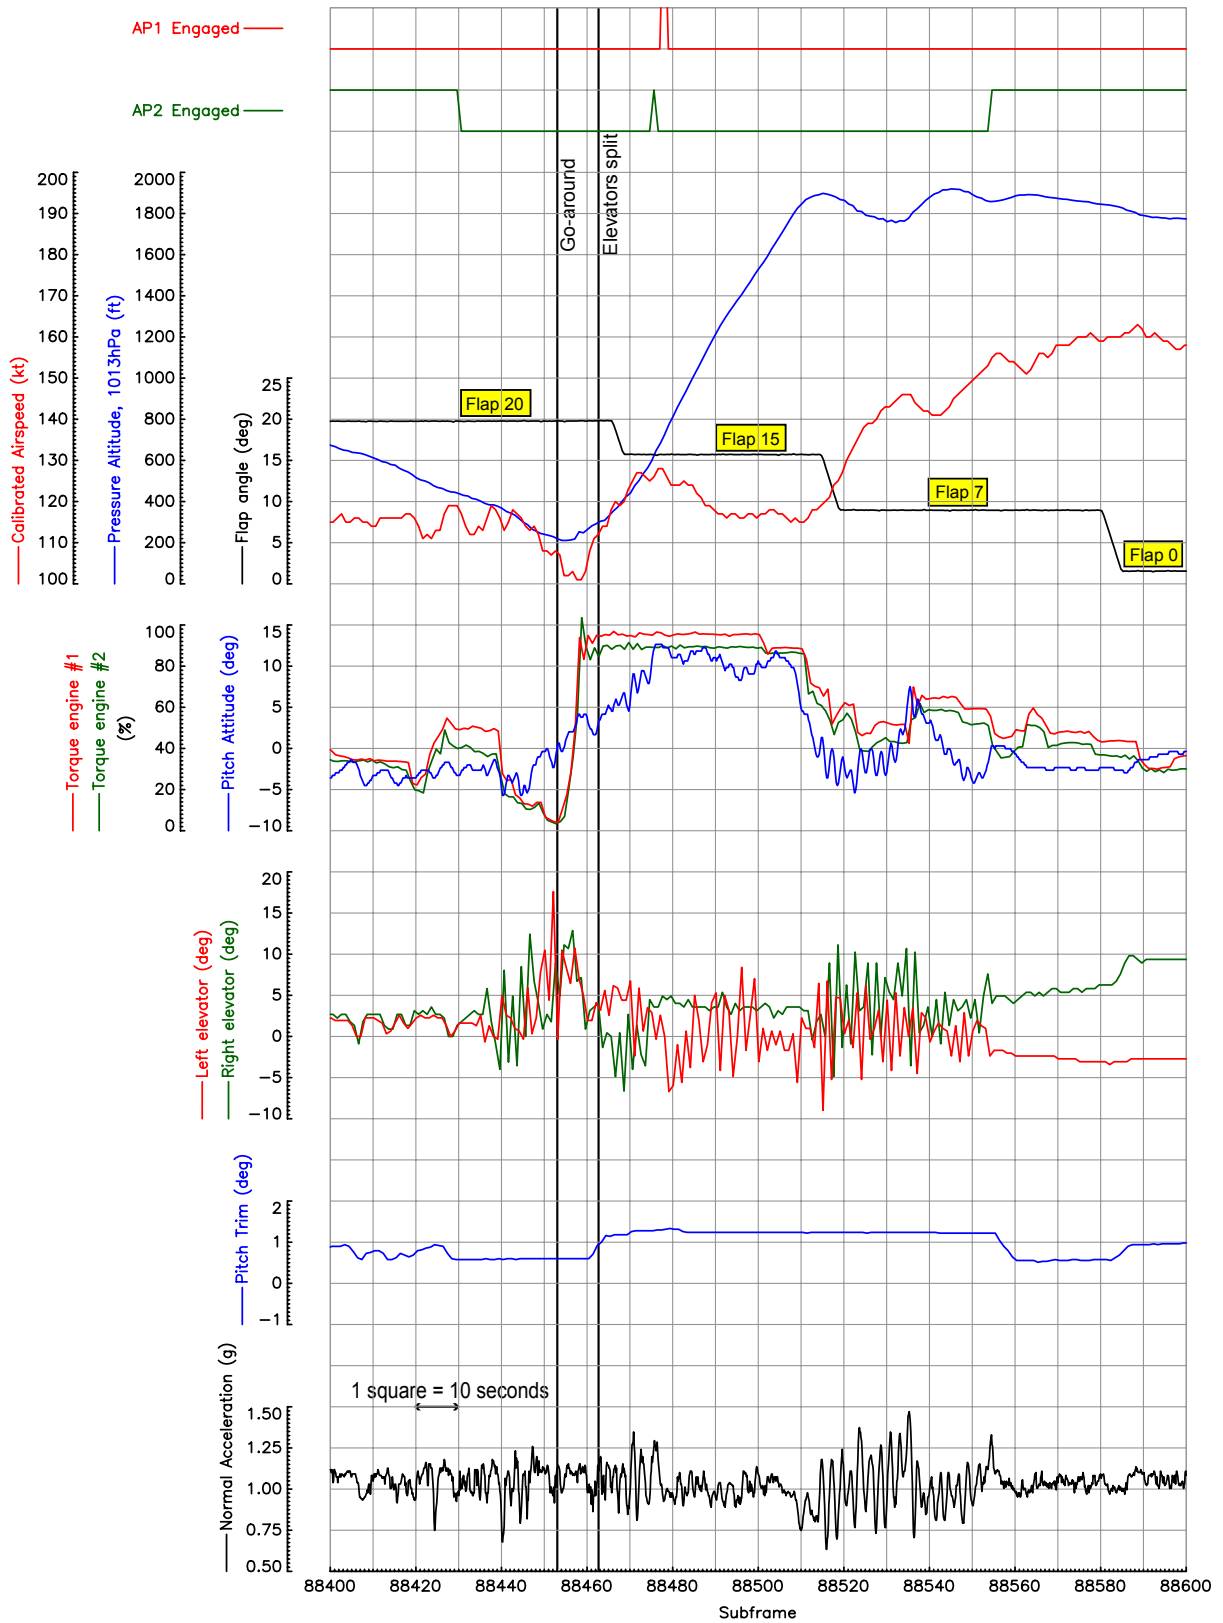
Figure 1

QAR data showing the approach and go-around at Guernsey

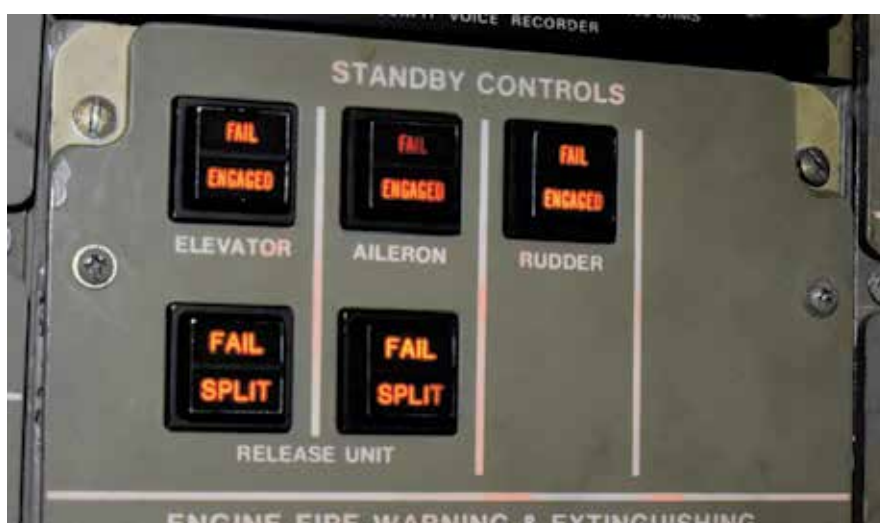
Figure 7

Continued operation of the elevators is dependent on the location of the jam. If the jam is forward of the elevator release unit and the difference between the two synchro transmitters exceeds 25%, the SCS will engage and the right elevator will be controlled by the right control column through the elevator servomotor. The amber **ENGAGED** caption will illuminate on the overhead panel (Figure 7).

STANDBY CONTROLS panel

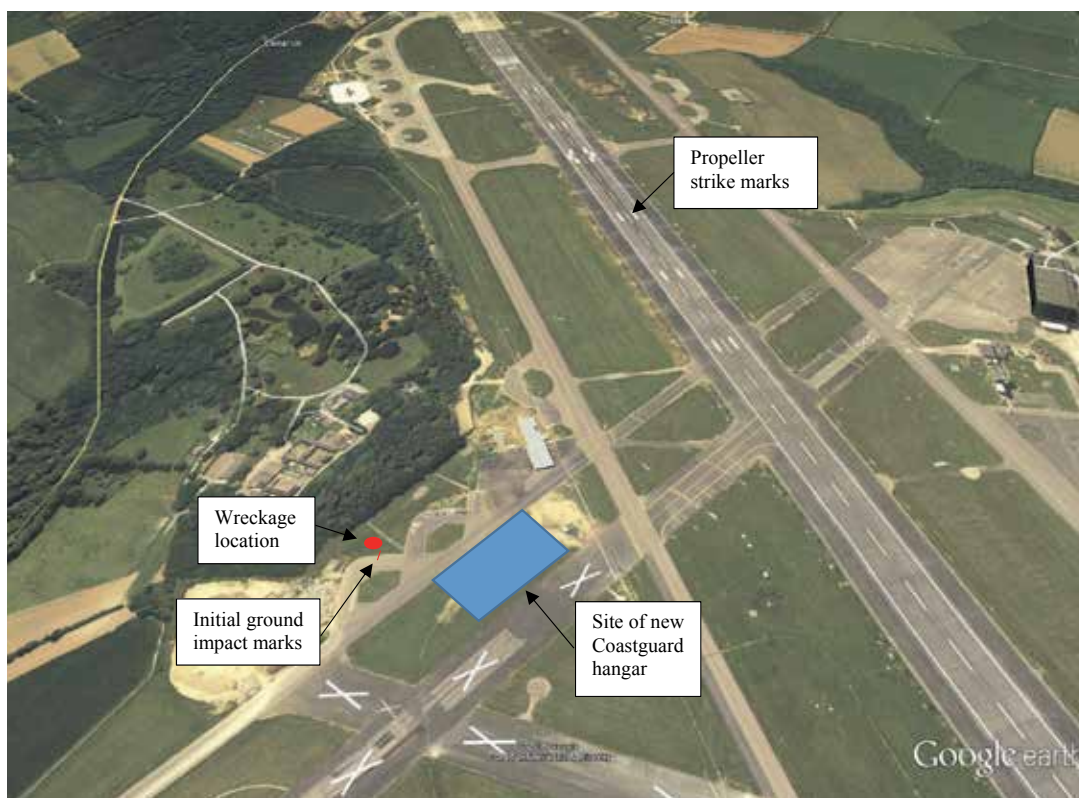
Figure 2

Accident site relative to the runway, looking back down Runway 30 from the direction of the Control Tower

The aircraft fuselage was significantly disrupted by the impact with the ground. The nose section was completely removed, with small pieces of the structure scattered around the debris field. The cockpit bulkhead was compressed as a result of the impact with the ground. All six propeller blades had been liberated from their hubs, which were also disrupted. The blades were distributed around the accident site but within close proximity to the main fuselage. Both engines had broken from their mounts and only remained attached by wiring and ancillary pipework. The right wingtip leading edge was damaged by the impact with the ground and the left wing tip had been destroyed by a small post-impact fire. The landing gear was down and locked, but the nose gear supporting framework had become detached. The main fuselage was compressed and bent upwards (relative to its normal attitude) at a point just aft of the rear passenger door. The vertical fin had also become partially detached at the forward attachment points. The flaps were in the stowed position, with the flap select lever in the zero flap position. Both wing fuel tanks had been disrupted and significant amounts of fuel had been released onto the grass.

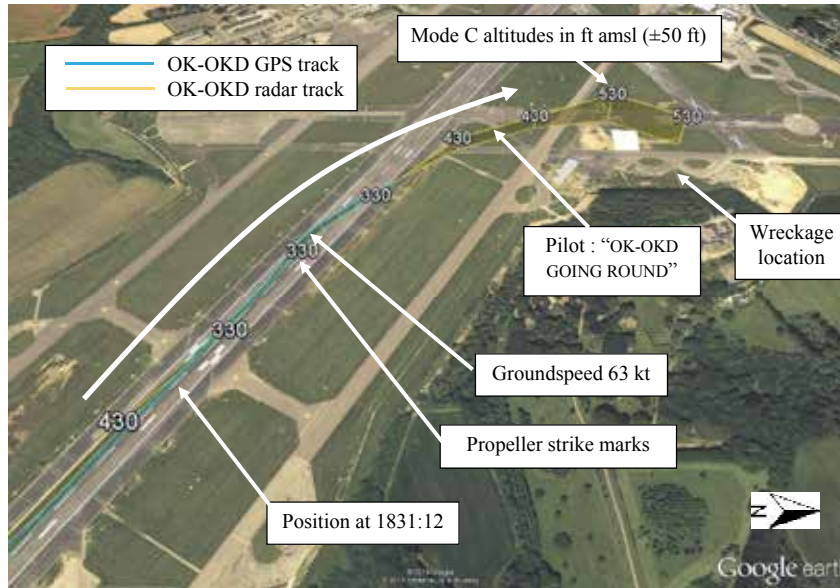
Figure 4

OK-OKD GPS and radar tracks showing corrected Mode C altitudes in ft amsl

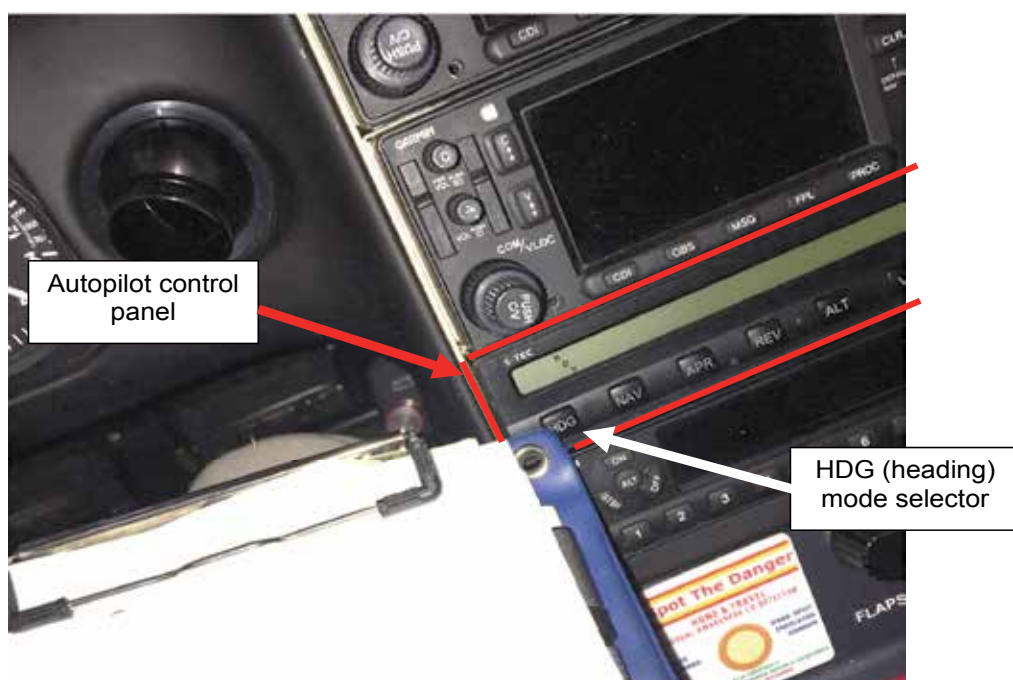
Figure 1

During troubleshooting, the pilot pressed the autopilot disconnect button and the disconnection warning sounded. Further investigation revealed that the pilot's kneeboard, which was strapped to his right leg, had inadvertently nudged the autopilot control panel and engaged the autopilot HDG (heading) mode (see Figure 1). This came as a surprise to the pilot as it was the first time he had experienced this issue with his kneeboard after "dozens of flights in this aircraft". He repeated the action and demonstrated it to his passengers on three further occasions.

G-GCDC pilot's kneeboard showing proximity to autopilot control panel

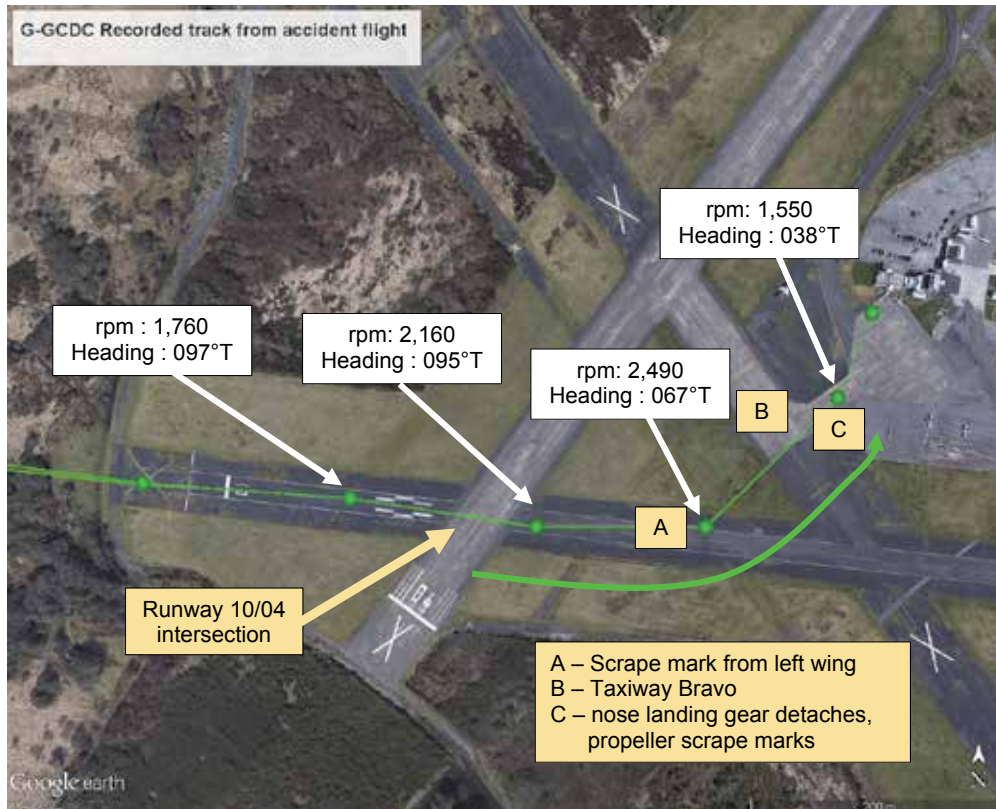
Figure 2

Engine rpm increased from 2,160 rpm to 2,460 during the touch-and-go (maximum recorded for this flight was 2,660 rpm) but then reduced to 1,550 rpm as the aircraft departed to the left of the runway. Due to the position and sampling rate resolution, it could not be established whether this reduction in rpm was prior to, or as a consequence of, the propeller strikes on the paved surface. The last recorded position corresponded with that indicated by the pilot.

Salient recorded parameters

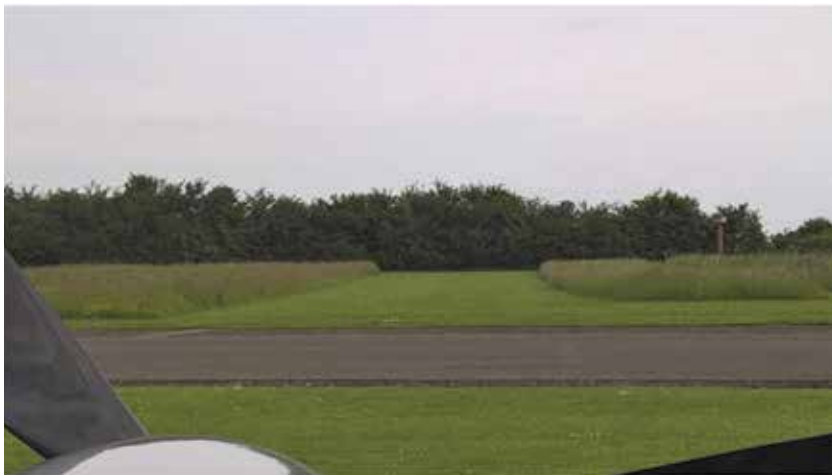
Figure 1

The pilot was attempting to take off from a mown strip of grass perpendicular to, and north of the asphalt runway at Strubby Airfield (Figure 1). When he realised he would not clear the hedge at the end, he turned to avoid it and the aircraft impacted the ground. The pilot referred to the strip as Runway 36, but the airfield owner advised that it was not a designated runway.

Mowed strip in the direction of takeoff
