Rail Accident Investigation Branch

Rail Accident Report

Unsafe events at Heathrow Tunnel Junction 27 and 28 December 2014

Report 20/2015
December 2015

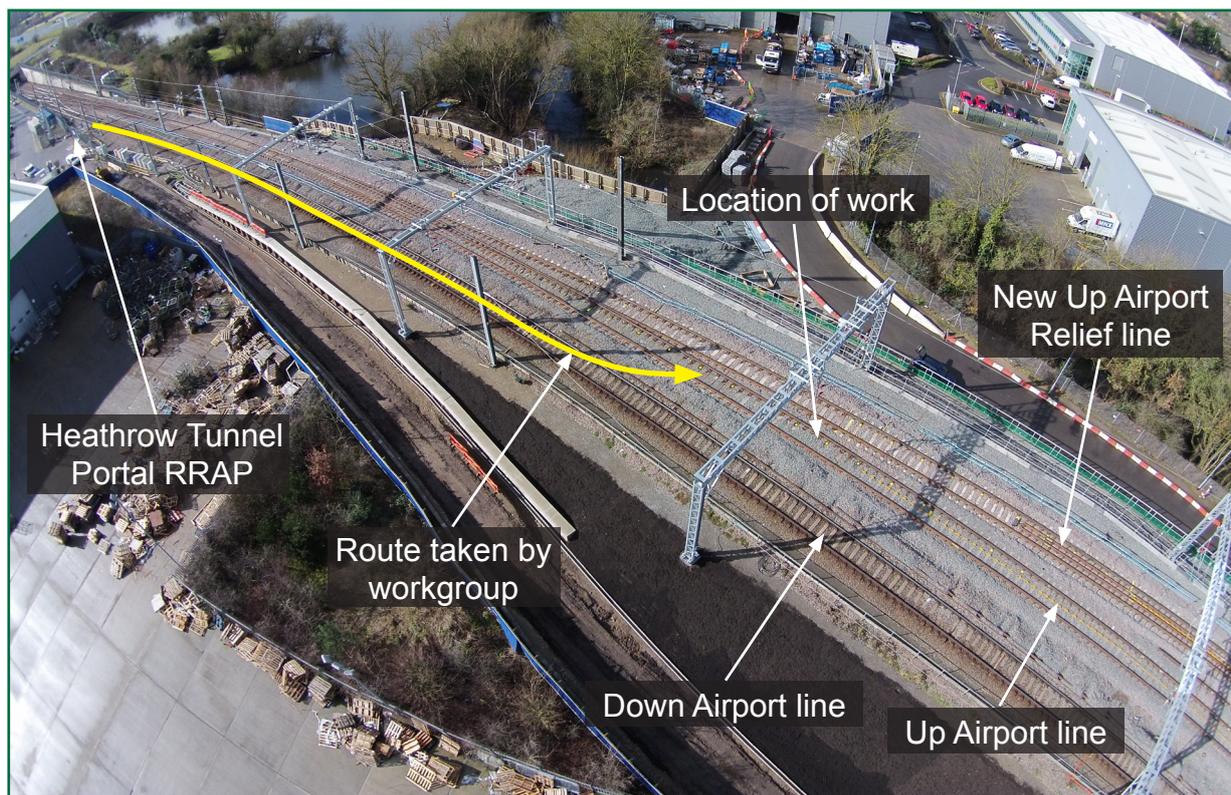
Figure 6: Route taken by workgroup on 27 December 2014

- 43 The workgroup walked from the access point towards the Great Western main line, pushing some equipment along the Down Airport line (figure 6) using a *rail skate* (a small trolley mounted on one rail, figure 7). They chose this line because it provided a *continuous rail* as they passed the *points* at Heathrow Tunnel Junction. COSS A intended the workgroup to cross to their working location on the Up Airport line after they had walked past Heathrow Tunnel Junction.

- 44 At about 15:00 hrs, as the group approached their working location, they were advised by staff working on the blocked Up Airport line that the Down Airport line was now open to traffic. COSS A still believed the Down Airport line to be blocked but, in response to the warning, moved his workgroup to the Up Airport line and they began their allocated tasks.

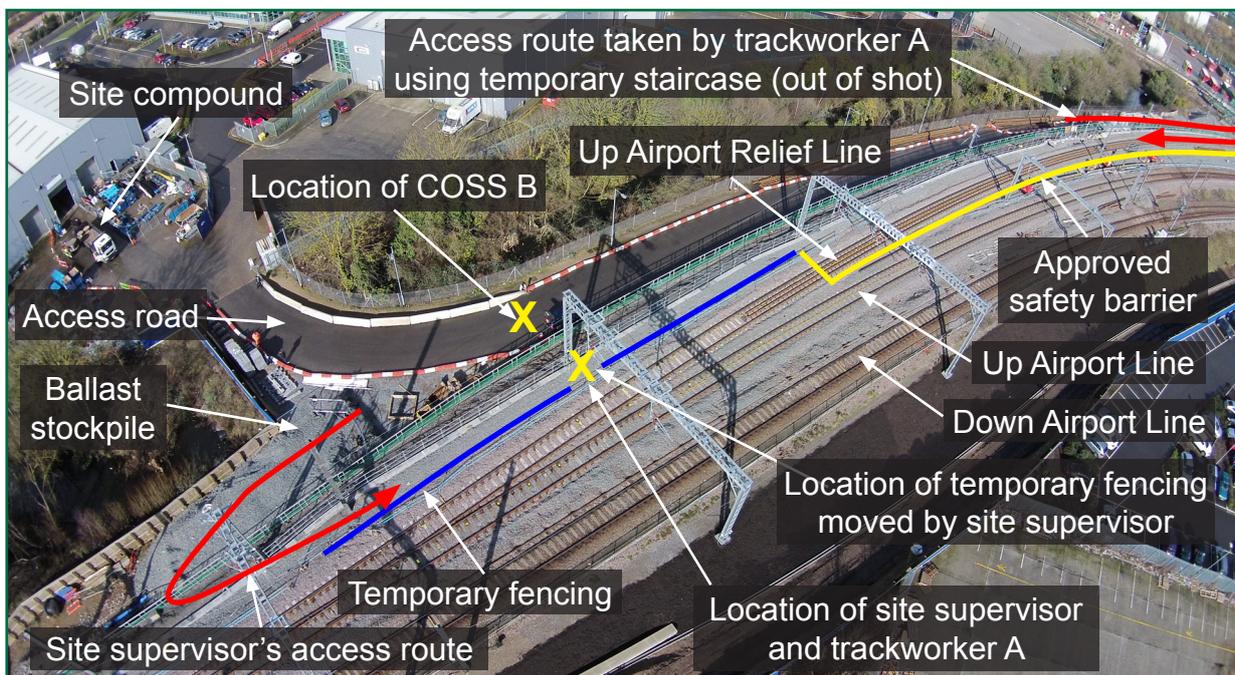
Figure 10: Location of access points and staff before incident

85 COSS B and the site supervisor left the site compound and met at a position on the access road near to the railway (figure 10) and were joined by the other members of the workgroup. COSS B then spoke to each member of the workgroup, although not all at the same time. COSS B stated that he did not consider he had given all members of the group a full briefing at that, or any other, time during the shift. Some members of the workgroup stated that, although they had received some information, they also did not consider this to be a full COSS briefing. However, all members of the workgroup did sign the RT9099 form (included in the SSoW pack) acknowledging that they had received a briefing from the COSS.

86 The site supervisor went ahead of COSS B to the intended location of work. This was near to COSS B but at the top of a retaining wall approximately 4 metres above the COSS's position. The site supervisor reached this location by walking up a large stockpile of *ballast*, a material needed for track installation and stored in a manner which created an unofficial access point (figure 10).

- 87 The last track worker to sign the acknowledgement form, trackworker A, left COSS B on the access road to join the site supervisor. Trackworker A stated that he accessed the location of work using the official access, a scaffold staircase (figure 10).
- 88 COSS B remained on the access road, near the foot of the ballast stockpile, to complete his SSoW paperwork and log his workgroup on with the site access control while the remaining members of the workgroup went to gather tools and equipment from the site compound (figure 10).

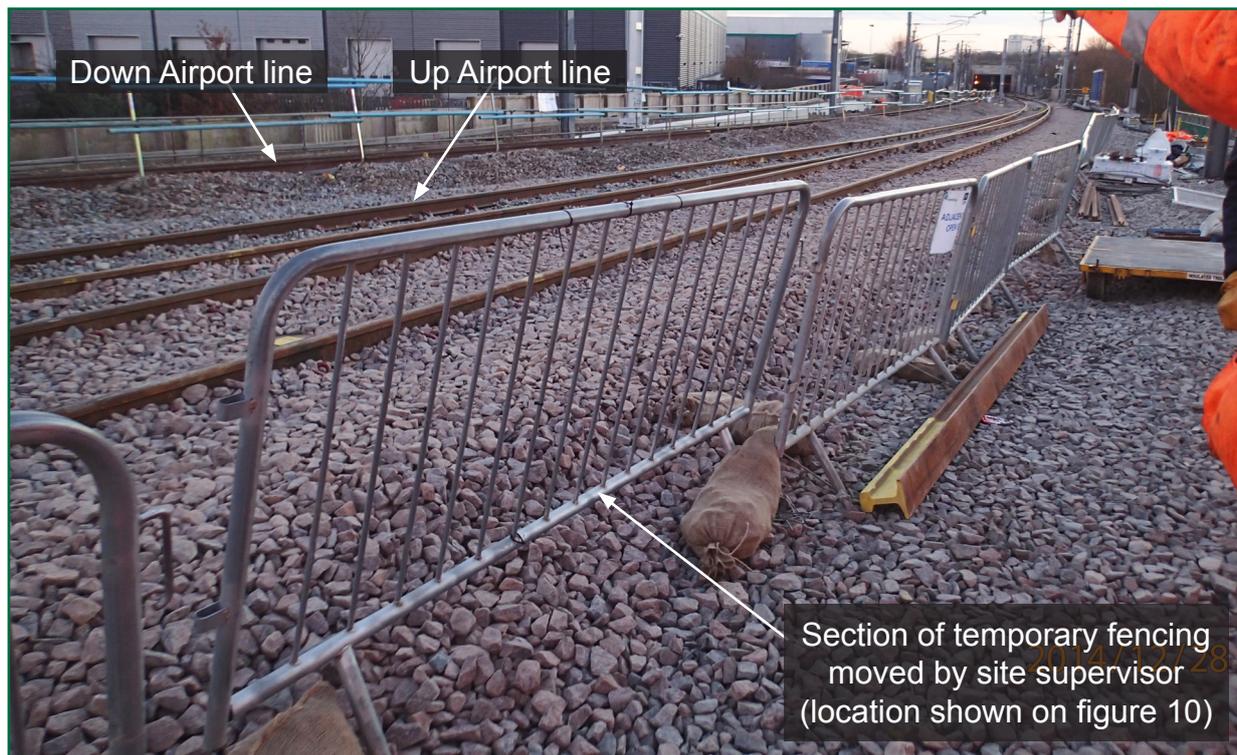
Figure 12: Section of temporary fencing moved to gain access to railway

- 91 After ending the telephone conversation with the engineering supervisor, COSS B called up to the site supervisor and gave permission to place the trolley on the track. The line name was not included in this communication; COSS B did not do so because he believed this had been established when the site supervisor requested consent to use the trolley (paragraph 89). The absence of a line name in this conversation meant that the site supervisor incorrectly believed he had permission to place the trolley on the Up Airport line which, unknown to him, was open to regular train services. The site supervisor and trackworker A then picked up the hand trolley from beside the Up Airport Relief line, carried it through a section of temporary fencing which had been moved aside by the site supervisor, and began to place it on the Up Airport line (figure 12).

- a. The information provided to the site supervisor did not prevent him from deciding it was safe to move the temporary fencing separating him from a line open to traffic and place the hand trolley on the open line (**paragraph 98, Recommendation 3**).

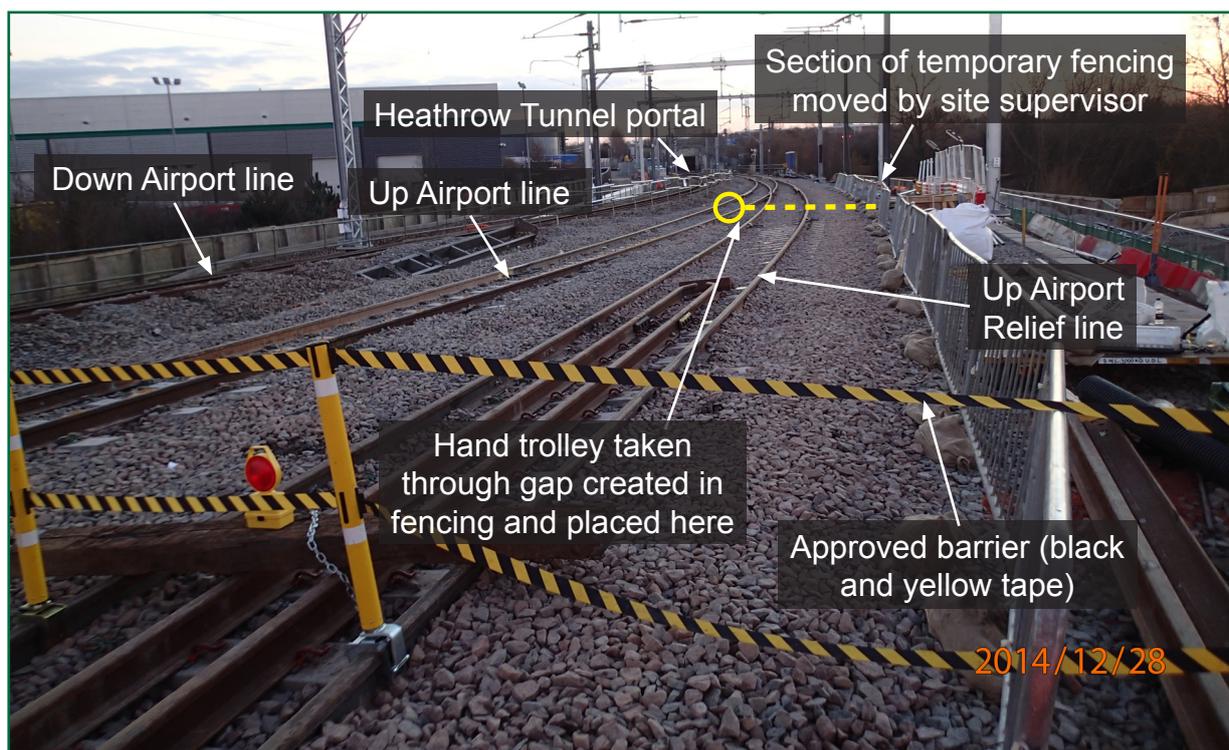
Figure 13: position of hand trolley relative to Heathrow Tunnel portal

- 92 At around 10:05 hrs, train 1Y40, the 09:48 hrs Heathrow Express passenger service from Heathrow Airport to London Paddington, emerged from Heathrow Tunnel travelling at approximately 45 mph (72 km/h) on the Up Airport line. As the train left the tunnel portal, approximately 300 metres from the site supervisor and trackworker A (figure 13), the driver realised there were people on the track on which he was travelling. He applied the *emergency brake* and started to repeatedly sound a warning using the train horn.

- 93 This warning was heard by the site supervisor and trackworker A while they were lining up the hand trolley with the rails. They both dropped the trolley with trackworker A moving aside and the site supervisor rolling clear of the train moments before it struck the trolley. At this point the train had slowed to approximately 36 mph (58 km/h). The train continued, with the trolley underneath the first *bogie*, until it stopped approximately 85 metres from the point of impact.
