RAIB Bulletin 01/2015

Derailment near Mitcham Junction 29 December 2014

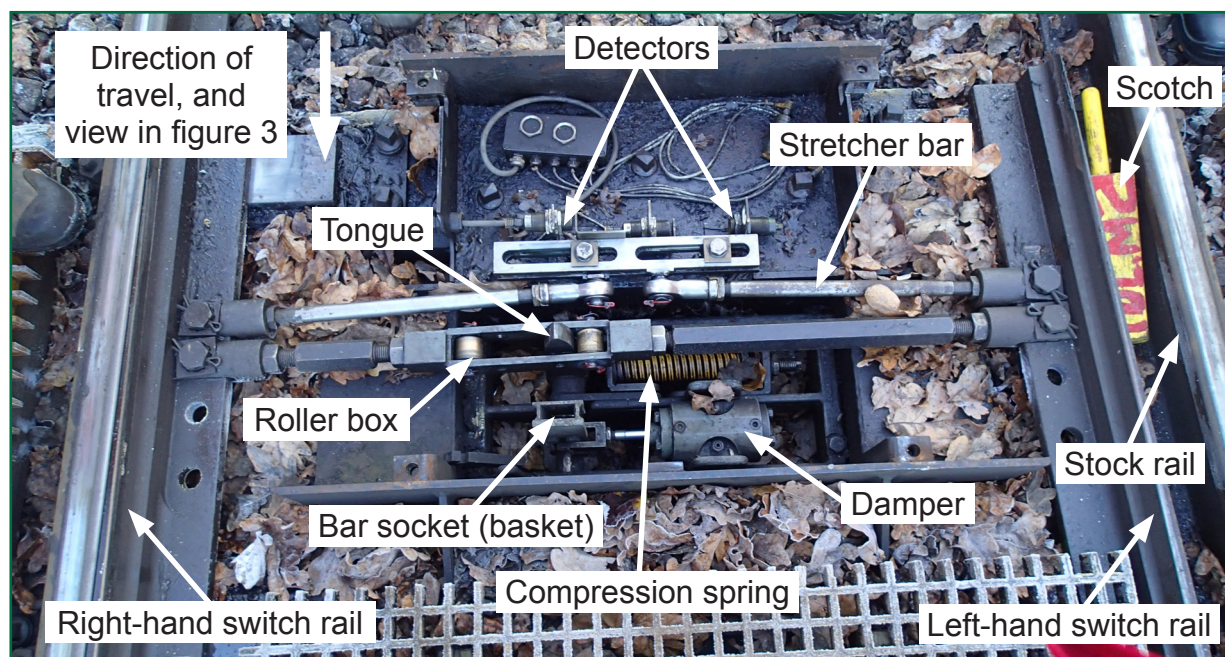
Figure 2: The switch mechanism of points MTJ09G (cover removed). The mechanism (the bar socket and tongue) is in the centre position where it was found after the derailment, and the roller box and switches are fully over to the right. A block of wood (known as a scotch) has been placed between the left-hand switch and stock rail, to prevent the points moving before a full examination had taken place.

- 10 The mechanism at points MTJ09G had previously been fitted to the points at Mitcham Station when the tramway was opened in 2000, and was moved to the new junction when the double track was extended in 2012.

- 20 The mechanism could not be moved to the right beyond the centre position, and there was a solid obstruction to any further movement. LT staff dismantled the mechanism under the supervision of the RAIB, and found that the source of the obstruction was the damper. Releasing the damper bleed screws caused the resistance to movement to disappear. The fluid in the damper appeared to be heavily contaminated, with evidence of small solid particles within the fluid (figure 5).

- 21 LT replaced the entire mechanism before the line was re-opened to traffic during the afternoon of 30 December. At the request of the RAIB, LT subsequently arranged for the damper from the mechanism of points MTJ09G to be examined by specialist consultants, with the aim of understanding the reasons for its failure and recommending any appropriate action.

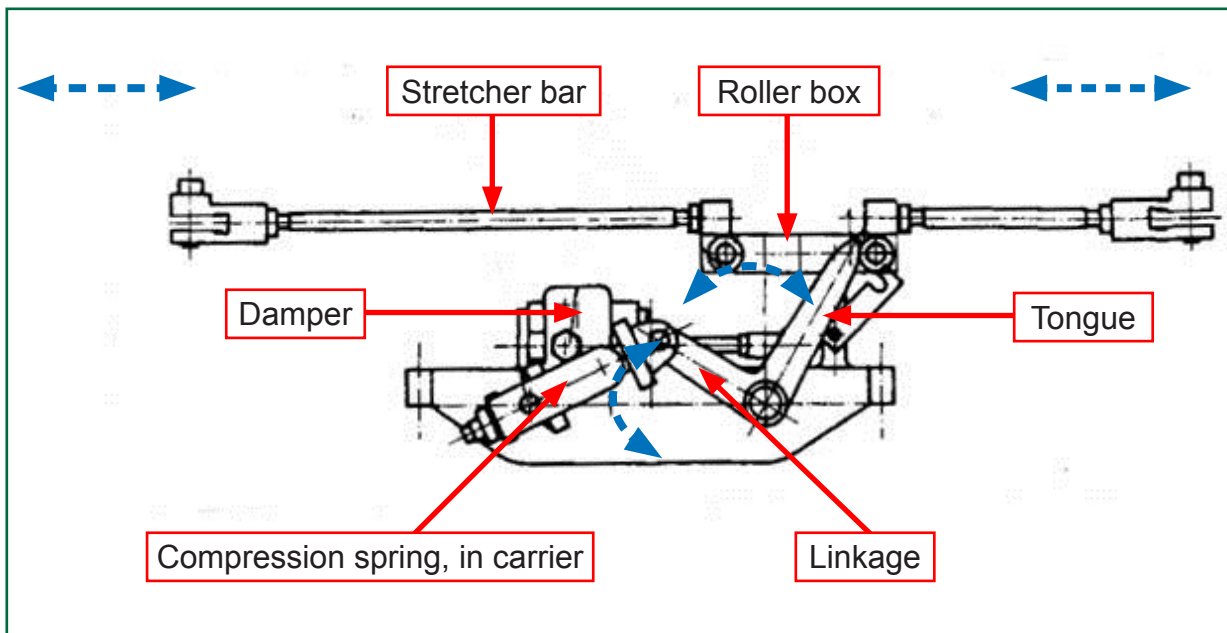
Figure 3: Diagram of switch mechanism, with tongue and roller box fully over to the right. The bar socket is hidden behind the tongue. The dashed arrows show the movement of the components of the mechanism when the points are moved to change the direction taken by rail vehicles passing over them.

- 7 The mechanism, shown in figures 2 and 3, drives the switches via a lever (known as the tongue) which acts through rollers that are contained within a roller box in the centre part of the stretcher bar. A compression spring acts through the linkage and the tongue to push the roller box in the stretcher bar, and thus the switches, over to the right-hand stock rail (the fixed rail, see figure 2), setting the points for the left-hand route. A damper is provided to reduce noise, and minimise shock loading to the mechanism, each time a tram trails through the switches.

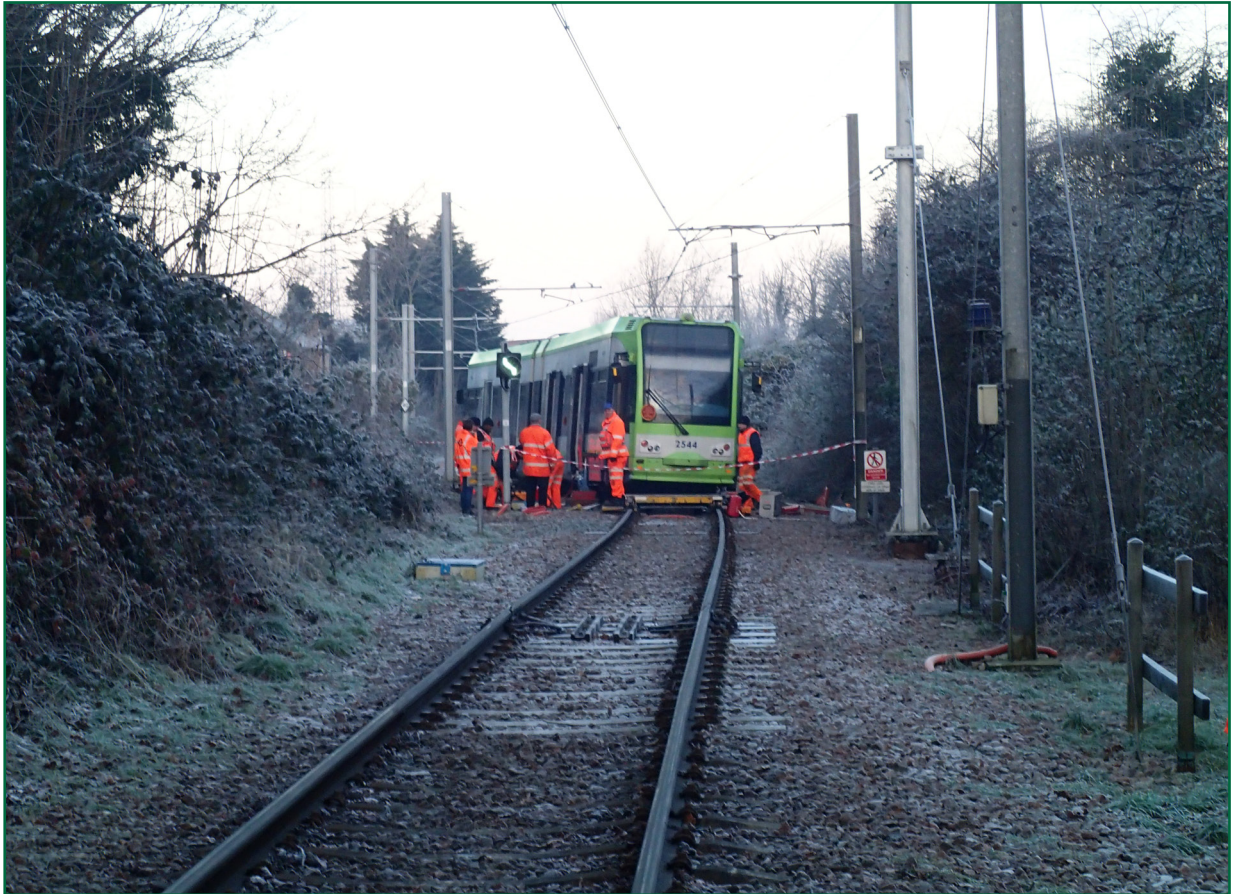
- 19 The switches were found hard over to the right, with the PPI indicating that detection was obtained for the route to the left (figure 4). However, in this state, the switches were free to move (for the reasons explained in paragraphs 8 and 13), and they could be pushed manually as far as their mid-position (where they came up against the tongue of the mechanism, which restrained them from moving any further).

Figure 4: The tram following the derailment, showing the PPI indicating that points MTJ09G are detected for the correct (left) route

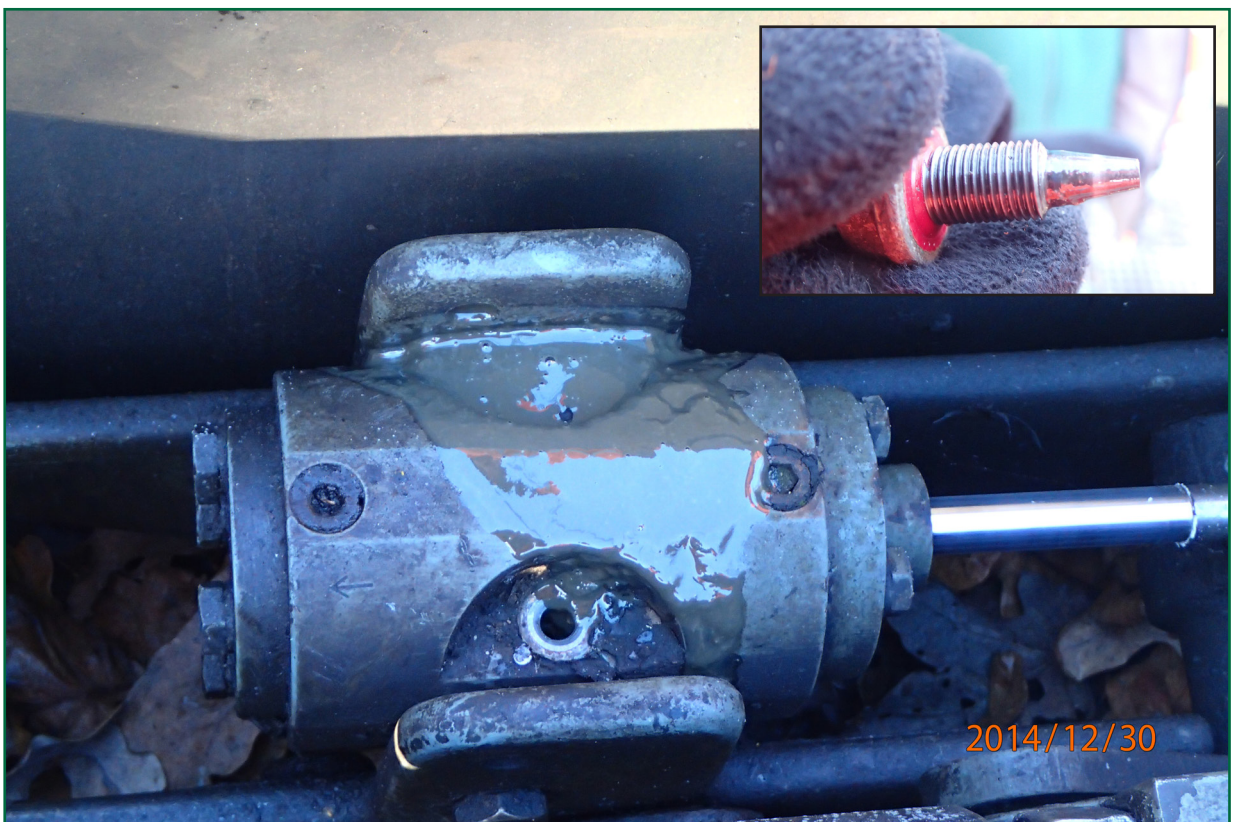
Figure 5: Damper after removal of bleed screws, showing contaminated fluid. **Inset:** bleed screw, with small particles of grit on the coned end

- 24 Following this derailment, LT replaced seven dampers on the tramway during January 2015 in a prioritised programme (based on the age of the dampers) as a precautionary measure, pending the results of the consultant's examination of the failed damper. The consultant's findings became available in March 2015. They concluded that the damper had become stuck in the middle position due to particle contamination and/or frozen water within the damper's hydraulic circuit. The fluid in the damper was found to be highly contaminated with iron, chromium and silicon, and contained more water than would normally be found in hydraulic oil. The consultant recommended that LT should replace dampers of similar age to the one that failed (15 years), and take action to prevent water from pooling around the restrictor valve tops on the dampers. It should also review the service life and maintenance regime of the dampers, in conjunction with the manufacturers of the points mechanism.
