Property Review

Damp and Mould Management Summary

11th December 2015

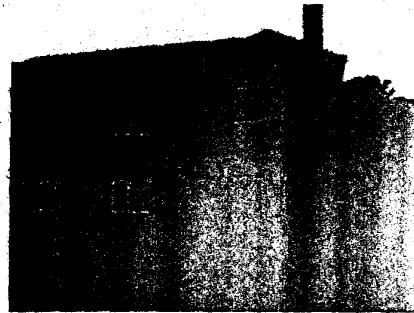
Front Elevation

In the lounge there was mould behind the sofa, the airspace between wall and sofa 150mm, the sofa is a large corner type which returns across the front bay, air movement is restricted but the table on the opposite wall has only legs and mould is still evident. On inspecting the walls externally the wall where the sofa is streaming with water, other external areas were not affected. There was only one low level vent in the bay area.

- There is a low level airbrick in the bay area of the front elevation lounge, as the fireplace has been sealed off an additional vent on the adjacent wall would help re-establish airflow in this area. The inner door area of the hall should be fitted with an air vent at low level.

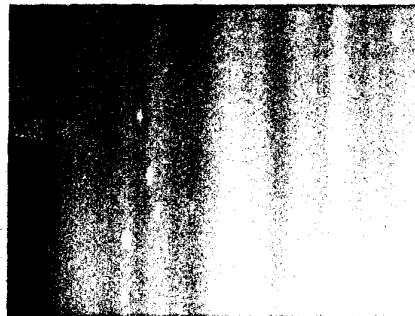
Front Bedroom

1. Mould growth evident above lintel reveal line to ceiling all 1st floor rooms external walls. The worst affected room is the main bedroom, the occupiers do not use the bedroom due to the mould and sleep in the ground floor lounge, the damage caused to possessions obvious, the room temperature at the time of visit was 15.9C the Relative Humidity 75.7, spot readings of the external wall were taken with a temperature probe at floor, mid height and ceiling levels. The ceiling level 14.1C mid 15.2C and floor 15.3C. The moisture content readings 18-23% There was mould also on the window reveals of both windows, the chimney passes through the room into the roof, heavy mould growth was evident on the ceiling at the intersection, the

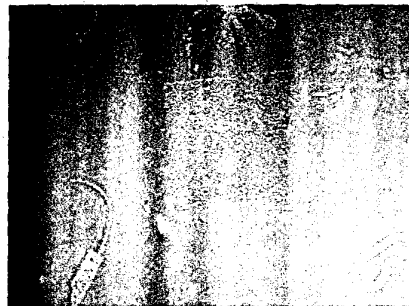
Mould
