Rail Accident Investigation Branch

Rail Accident Report

**Double fatality at Bayles & Wylies footpath
crossing, Bestwood, Nottingham
22 November 2008**

22 November 2008

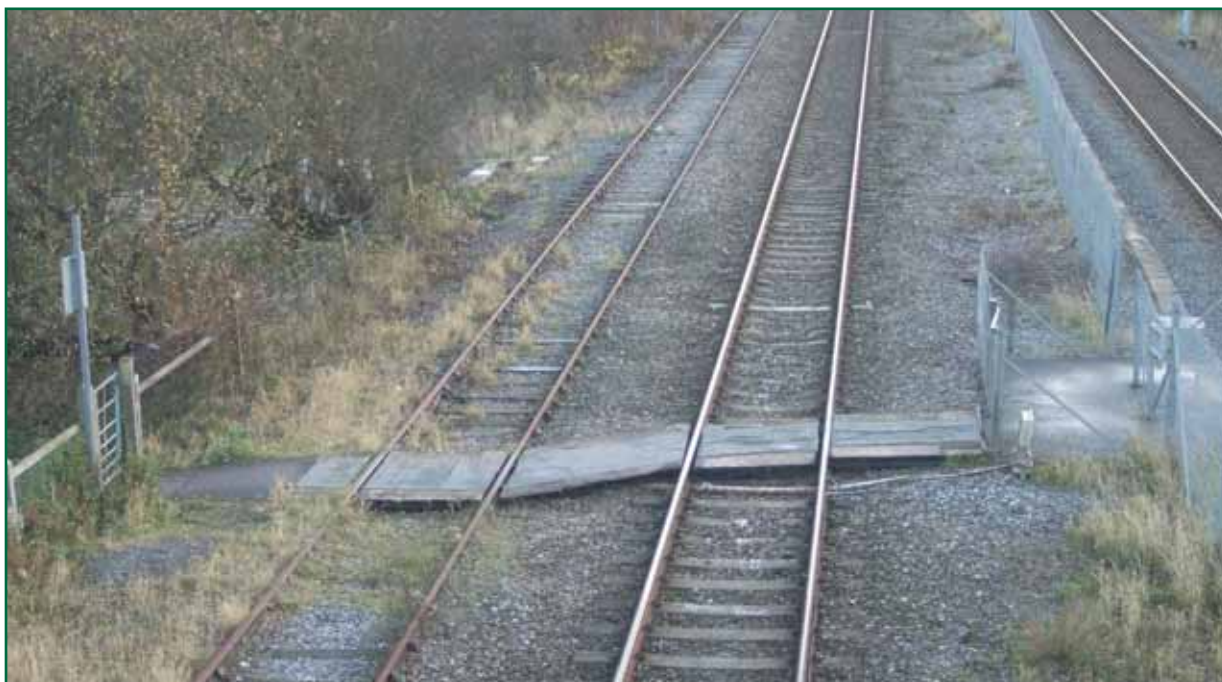
Figure 5: The crossing surfaces

- 25 Moving from east to west, the crossing surface initially consisted of a tarmac path 2.6 metres long. From this point to the central refuge, the surface consisted of a mixture of railway timbers (wooden *sleepers*) and plywood; forming a deck which was level with the top of the rails. The deck was 1.8 metres wide and its central 1 metre was covered with strips of roofing felt. The RSPG specify a minimum width of 1 metre (Appendix D). The edges of the plywood deck were showing signs of deterioration and some of the roofing felt strips were creased (Figure 5).
- 26 The service levels of trains and trams are independent, with both subject to variation. The concurrent arrival of a train and a tram from the same direction, together with a pedestrian approaching the crossing is a foreseeable, but uncommon event (paragraph 69).

109 The crossing surface, as described in paragraph 25, was somewhat uneven, and its edges were not defined by white lines.

174 In January 2009 Network Rail replaced the plywood deck with a construction made of railway sleepers and renewed all of the roofing felt covering.

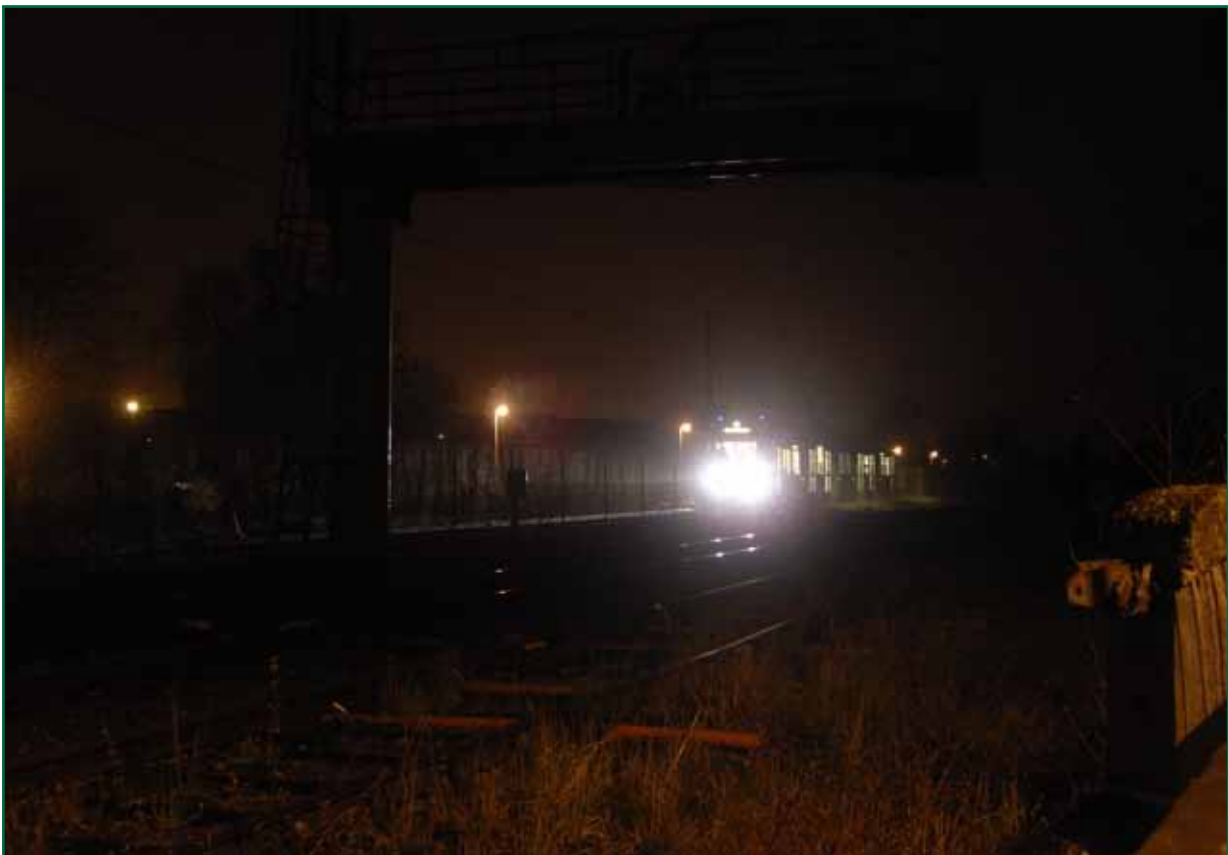
Figure 11: A tram 100 metres north of Bayles and Wylies crossing as seen from the gate in darkness

68 Nine seconds before the accident the RAIB's analysis indicates that the pedestrians were at the gate, and the tram was 100 metres to the north. The luminous intensity of the tram's headlights reduced as the effective angle between the tram and the pedestrians increased. However, the tram headlights still had a luminous intensity of 985 candelas when viewed from the gate. In addition, the saloon of the tram was illuminated, and would have been in the grandmother's line of vision (Figures 10 and 11).

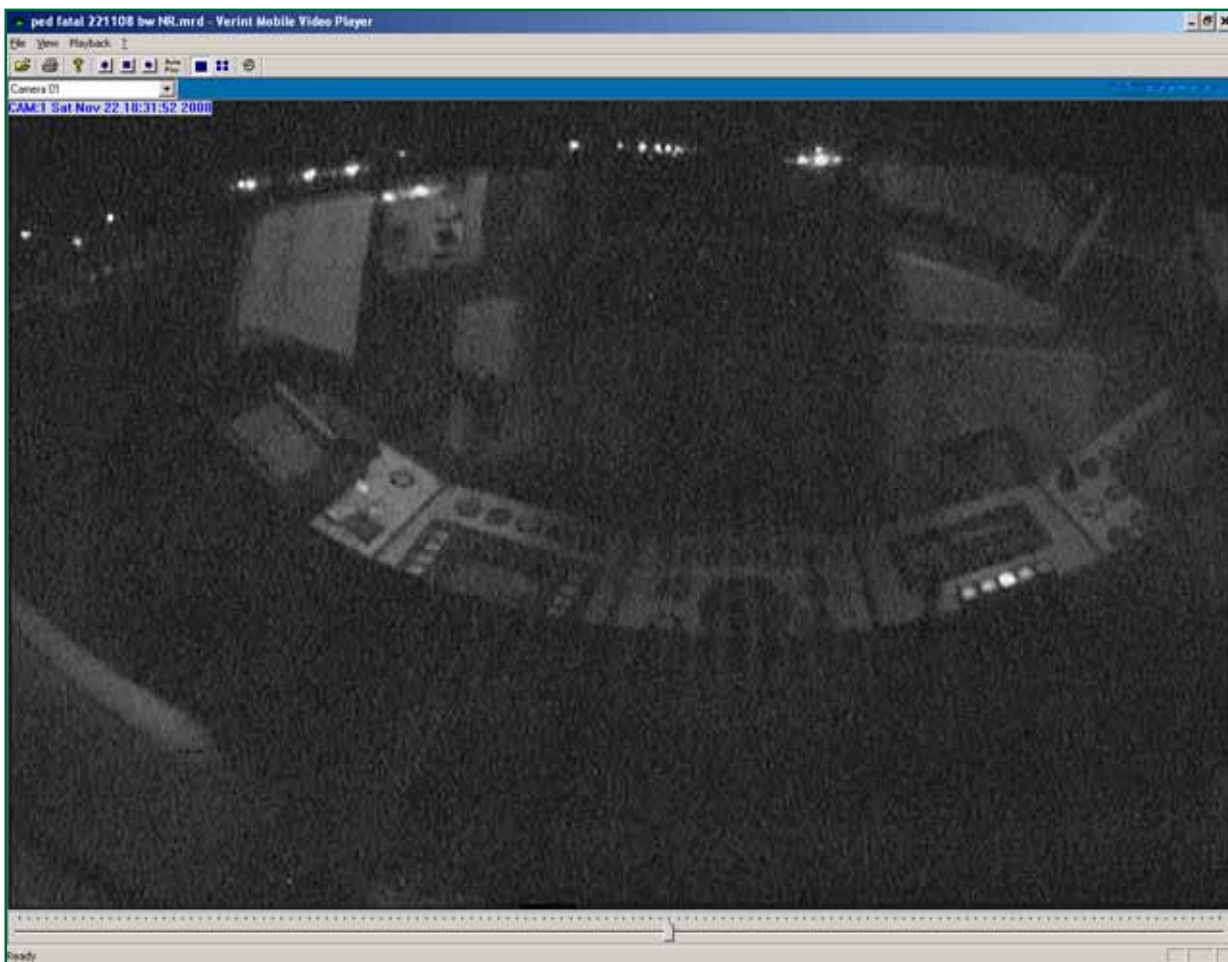
Figure 13: CCTV view from the rear of tram 205 as it crossed Bayles and Wylies crossing showing the lights of train 2D22

- 83 The luminous intensity of the train's headlights was below that required at the time of its construction, and there is no requirement to test or measure this value in service.

- 84 The rearward facing CCTV of the tram (Figure 13), and post-incident tests, both confirm that the night-time head light on train 2D22 was working at the time of the accident. However, the RAIB measured its luminous intensity when viewed from the east gate as 276 candelas when the train was 260 metres away, and 514 candelas when it was 180 metres away. At these distances the horizontal angle from the geometrical axis passing through the centre of the front of the train was between 1.3 and 2 degrees (Figure 14). This compares with a requirement in British Rail (BR) 'Technical specification for headlights for traction units' TEE/C/85/R/76, of March 1988, which was valid at the time that the Class 158 was designed in 1989, for a luminous intensity of 3500 (at 3 degrees) and 10000 candelas (at zero degrees). The current *railway group standard* for train headlight luminous intensity, GM/RT2483, 'Visibility requirements for trains', requires a luminous intensity of 32000 candelas at zero to 3 degrees, and 4500 candelas at 2 to 5 degrees.

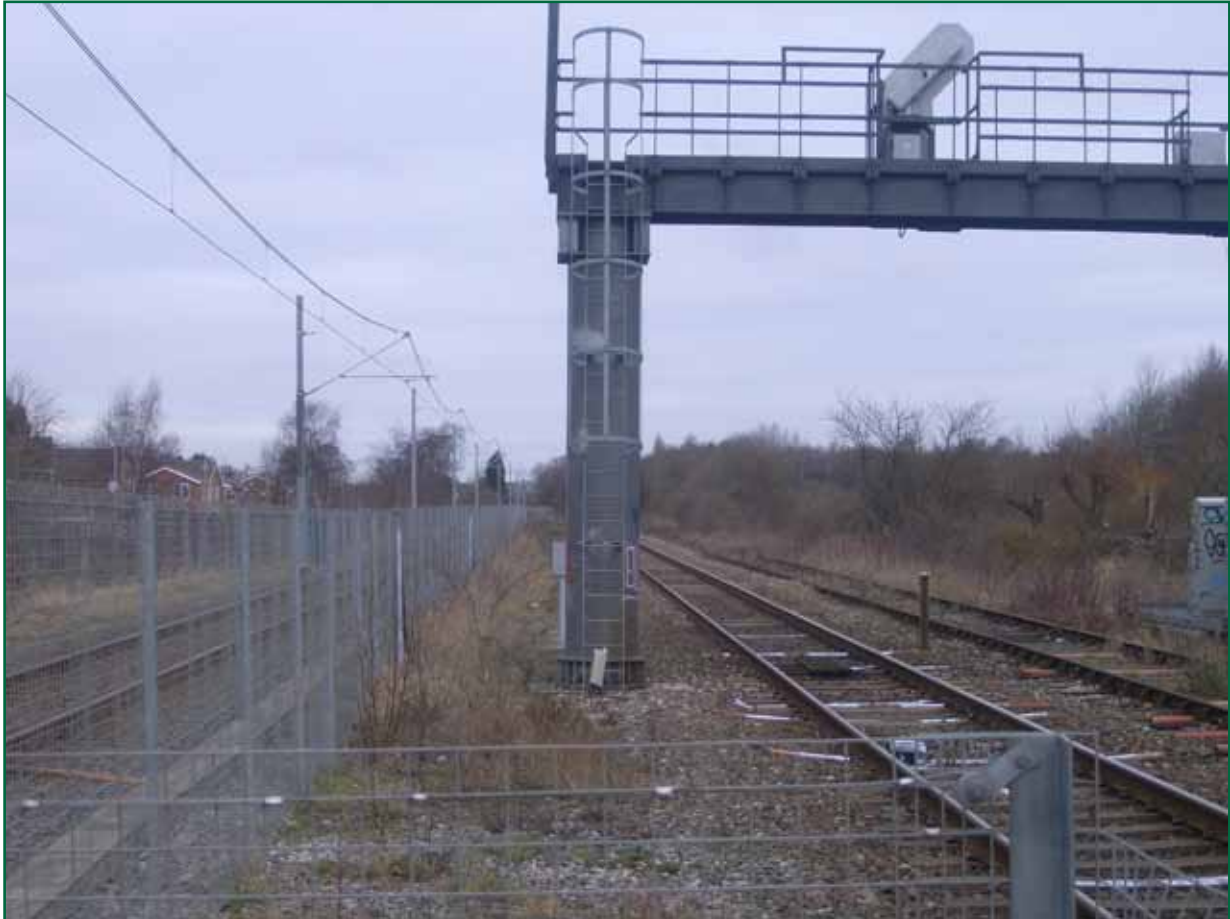
Figure 15: Signal gantry as seen from west-side gate

- 88 Whistle boards have been present at the crossing for many years and this particular board was retained because of a signal gantry which partially obstructs the visibility to the north for pedestrians entering the Network Rail crossing from the west (Figure 15).

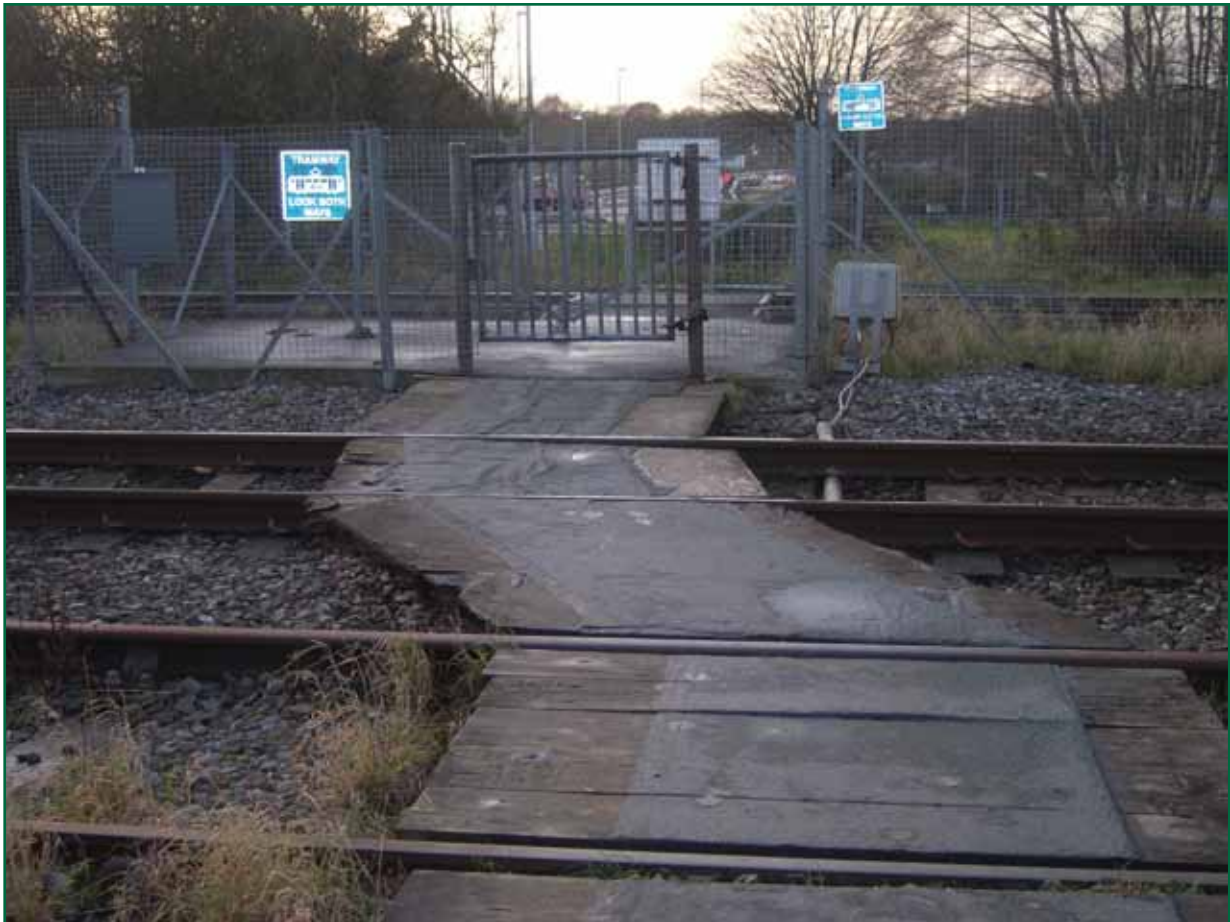
Figure 19: Bayles and Wylies footpath level crossing, showing offset to south

- going over the Calverton line at right angles, and then;
- diagonally at an angle of some thirty degrees across the interval between the lines, before;
- angling back to cross the Robin Hood line at a flatter angle, to;
- reach the refuge between the railway and the tramway (Figure 19).

The RSPG state that crossings should be perpendicular to the railway.

- 118 The crossing's variable angles introduced extra risk at the crossing.
- 119 The RSPG state that a crossing should be at right angles to the railway, and should be maintained in a good and even condition.
