Rail Accident Investigation Branch

Rail Accident Report

Trains struck platform at Moston, Manchester 28 January 2015

Report 17/2015
October 2015

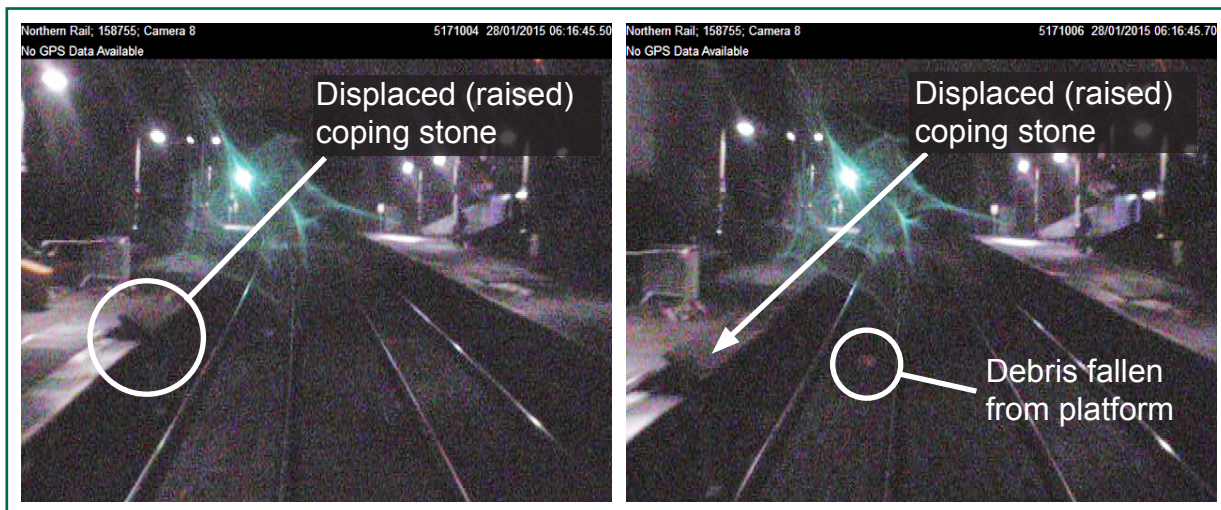
Figure 4: Images from CCTV fitted to front of passenger train (2E33)(courtesy Northern Trains)

- 13 Train 2E33 comprised a class 158 *diesel multiple unit* (158755) and left Manchester Victoria on time at 06:12 hrs. No-one was aware of the damage at Moston station until, at about 06:17 hrs, the driver of this train saw the displaced coping stones seconds before his train struck them (figure 4). The train suffered minor damage to the driver's cab step, suspension and other equipment (figure 5).

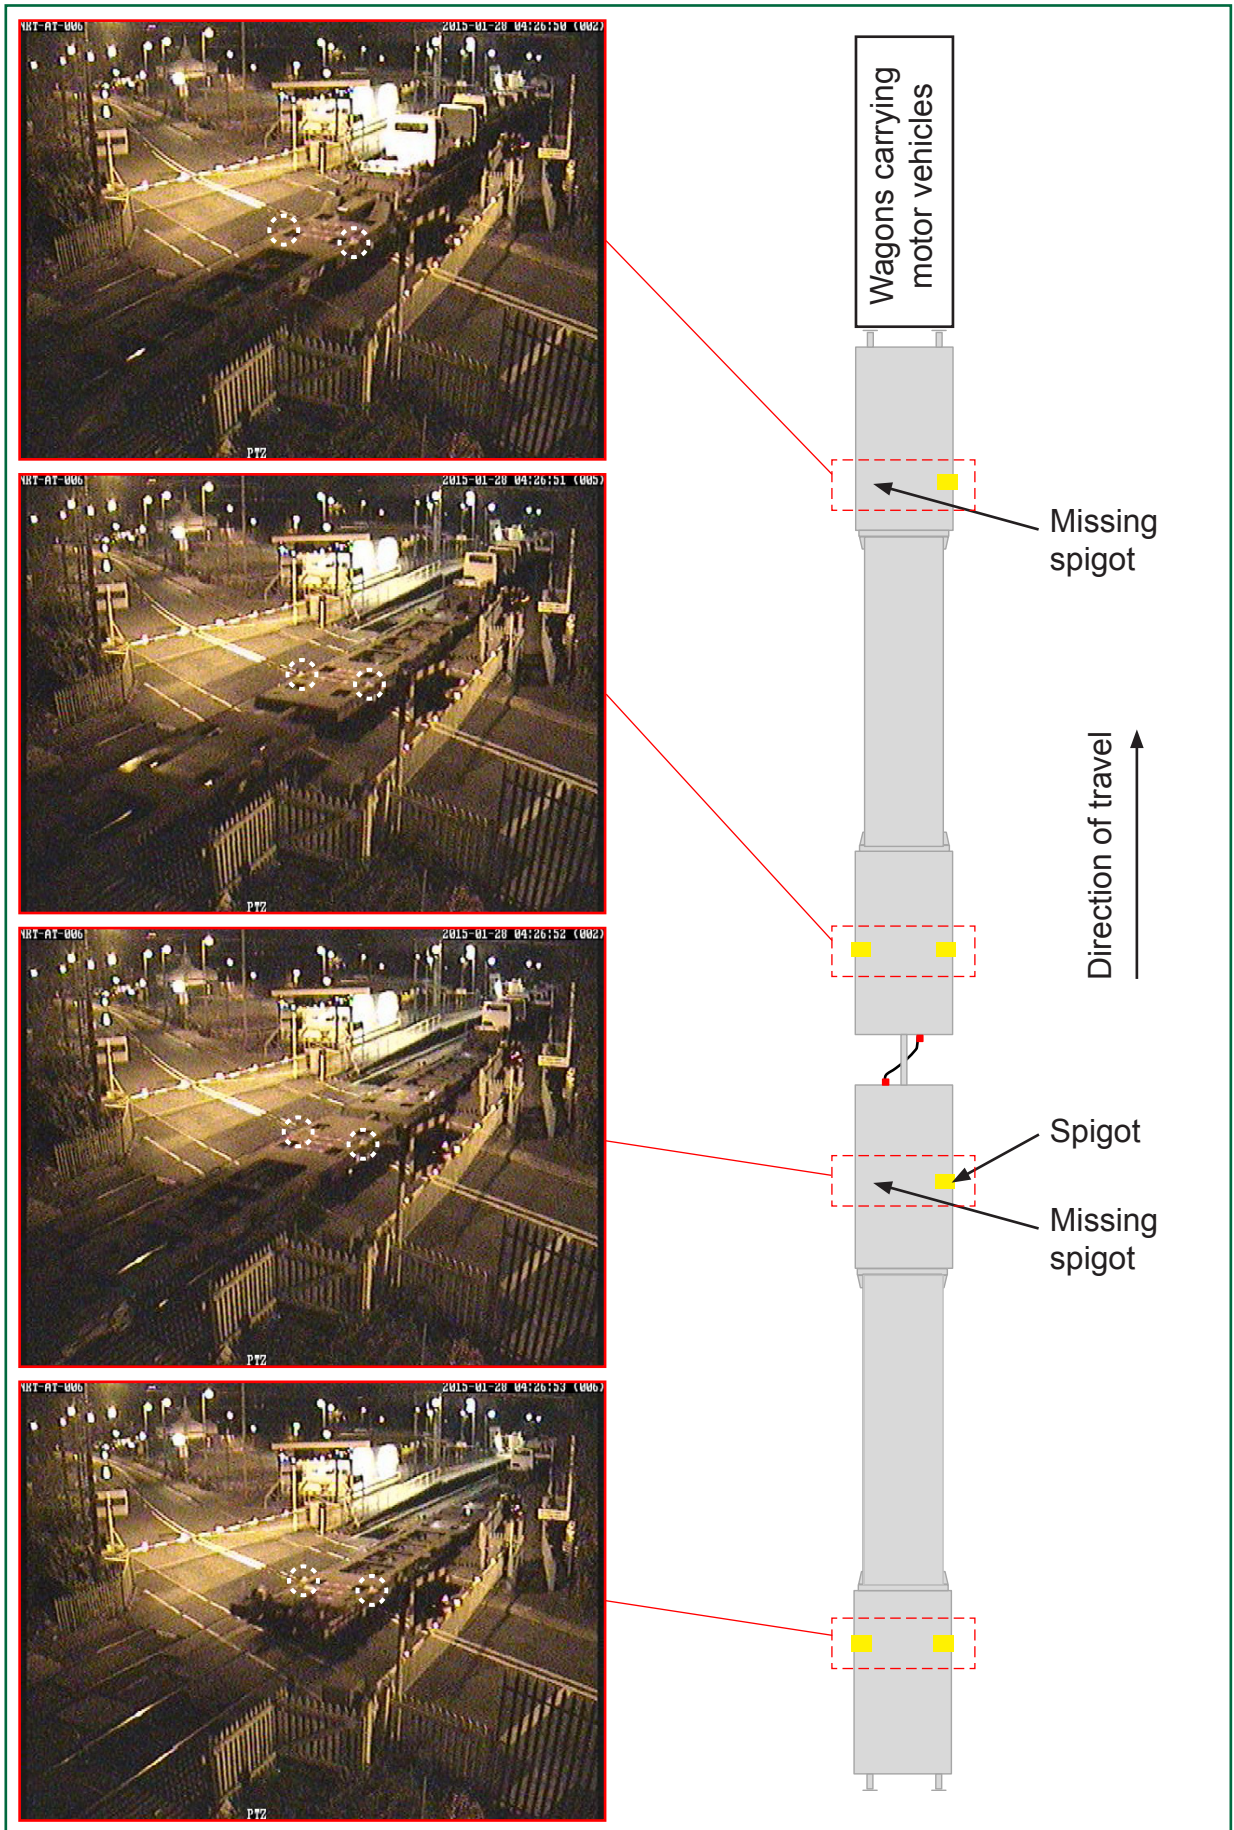
Figure 8: FKA wagon at Navigation Road

- 17 The FKA wagon passed Navigation Road level crossing before reaching Moston. Images obtained by a temporary closed circuit television (CCTV) system at this crossing show spigots located in six of the expected eight positions (figure 8). These correspond to locations where spigots were found in their correct positions when the wagon was inspected at Doncaster. The CCTV images show that spigots are absent from two expected positions, both on the wagon side furthest from the CCTV camera where an outward projecting spigot would be hidden by the wagon. These positions correspond to the locations where spigots were found to be missing at Doncaster and the RAIB has concluded that the two spigots found at Moston were attached at these positions, but projecting outwards, as the train passed Navigation Road level crossing.

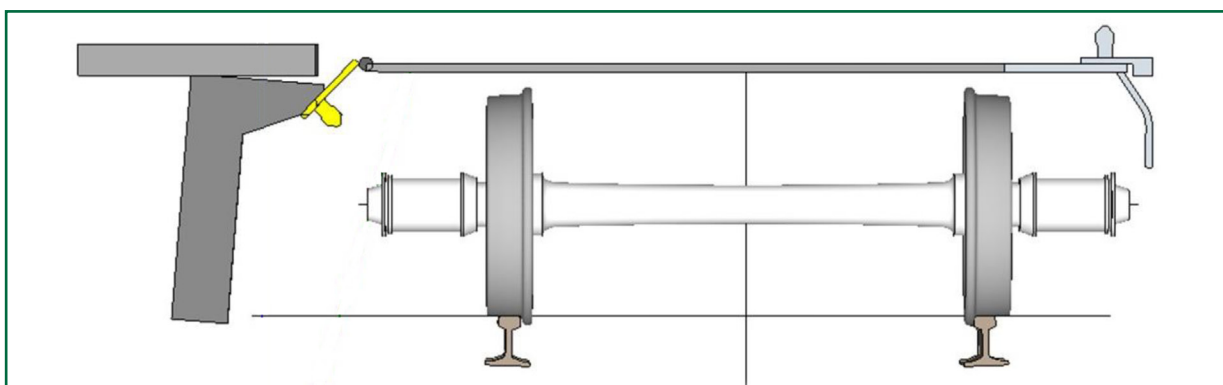
Figure 9: Outward projecting spigot position relative to platform

- 18 The outward projecting spigots struck the platform supports, causing coping stones to be displaced. This is evidenced by a comparison of the measured position of the spigot relative to the platform (illustrated in figure 9 using measurements described at paragraphs 20 and 34) and the following witness marks made as the train travelled northwards through the station:

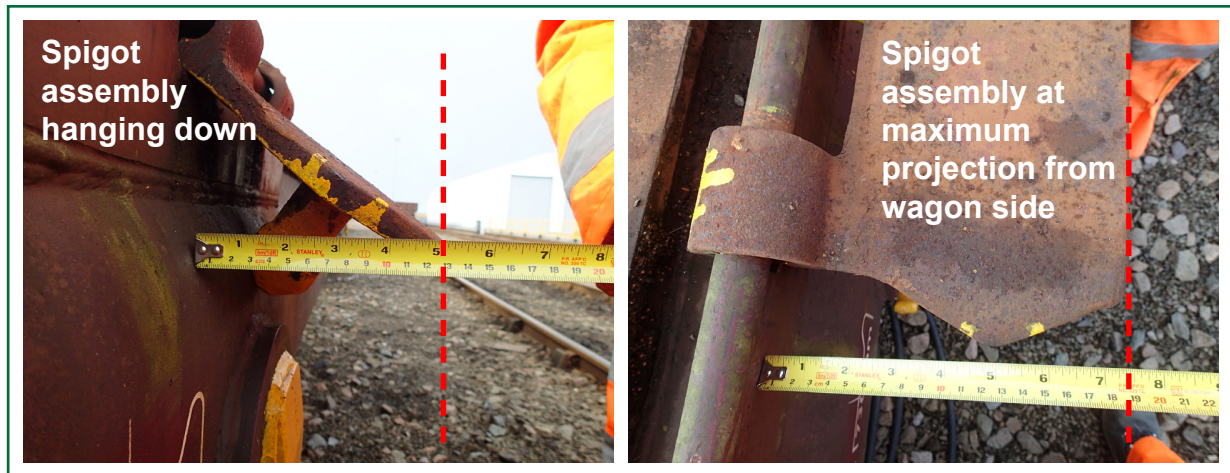
Figure 13: Outward projecting spigot assembly positions

- 23 The weight of the spigot assembly means that it would normally hang downwards and rest against the wagon body if left in an outward projecting position. It will extend further from the wagon body if raised upwards by impact with other objects, or while being deliberately lifted (figure 13).

- 24 Analyses based on data taken from wagon construction drawings and measurement of *spigot assemblies* recovered from Moston station show that an outward projecting spigot extends about 58 mm beyond W6a wagon gauge when resting against the wagon body. As W6a gauge projects 1350 mm beyond the track centre-line, the 58 millimetre projection beyond W6a gauge equates to 690 mm overhang beyond the rail⁴. The manufacturer's gauging drawings show that 12 mm of lateral movement should be considered when assessing wagon compliance with W6a wagon gauge and so a spigot hanging down projects 70 mm beyond this wagon gauge. The amount of projection increases by up to about 70 mm as the spigot is raised.

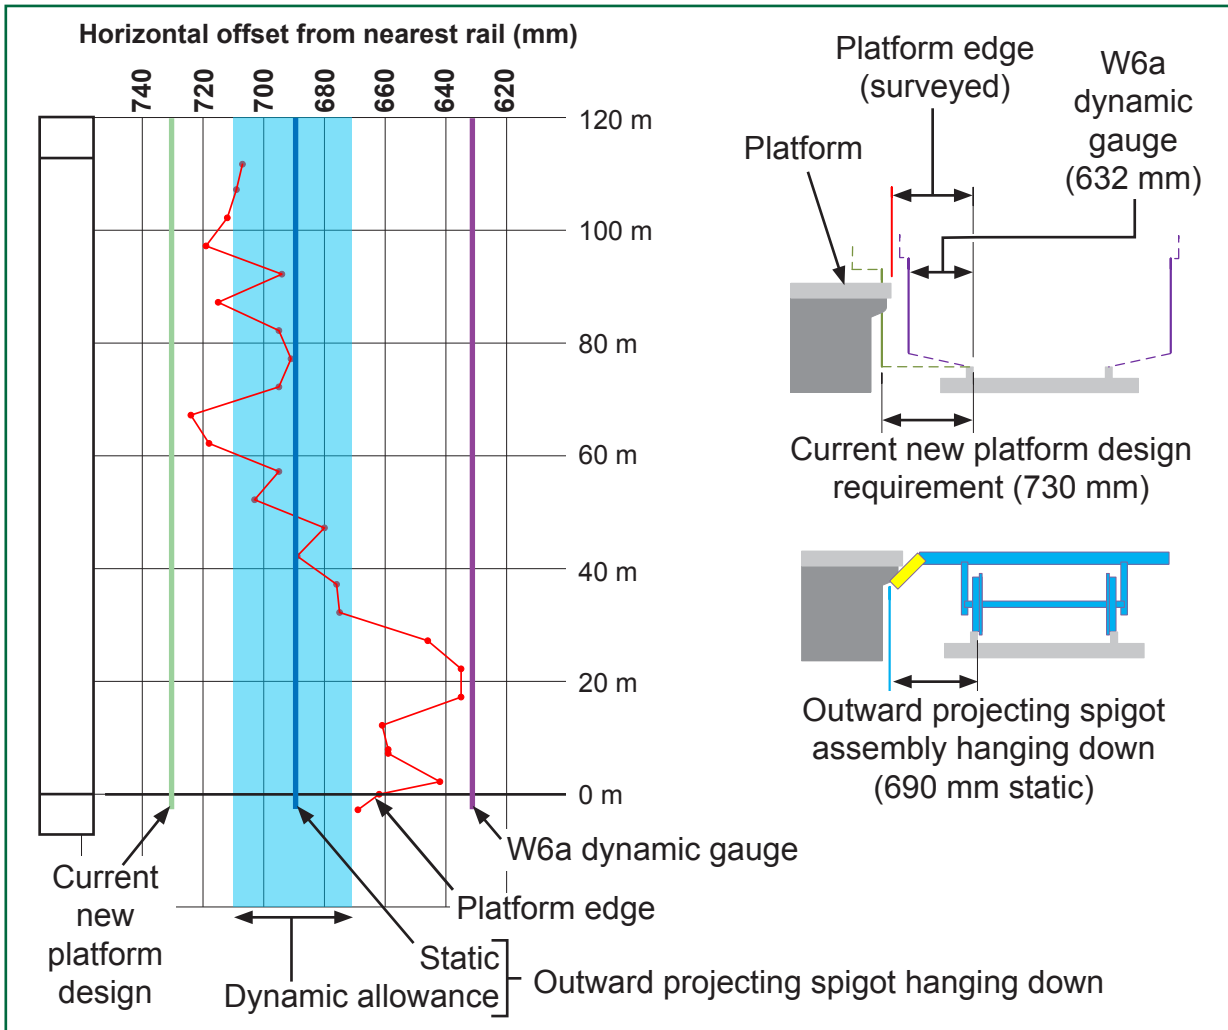
Figure 15: Platform edge distance from track (July 2014)

- 40 The outward projecting FKA spigot data plotted on figure 15 takes account of:
- the *static* offset of 690 mm beyond the nearest rail applicable to a spigot hanging downwards (paragraph 24);
 - lateral sway effects due to intended suspension movement and suspension wear;
 - lateral movement of wagon wheels between the rails due to wheel/rail clearances, flange wear and rail sidewear; and
 - measurement inaccuracies.

- 41 Figure 15 includes an allowance of +/-20 mm for the effects of sway, lateral wagon movement and measurement inaccuracies. This is considerably less than the +/- 35 mm included for the same effects in railway industry calculations of clearance between structures and trains⁸. The industry values are intended to model the extreme combination of conditions which must be considered in order to demonstrate a very low, and acceptable, risk of trains striking structures. The RAIB has applied a subjective reduction to these values in order to illustrate likely wagon behaviour. The reduction takes account of the FKA wagon passing through Moston station at a speed of 36 mph (58 km/hour), significantly less than both the 60 mph (96 km/hour) maximum speed applicable to FKA wagons, and the 70 mph (113 km/hour) maximum speed for all trains at this location.

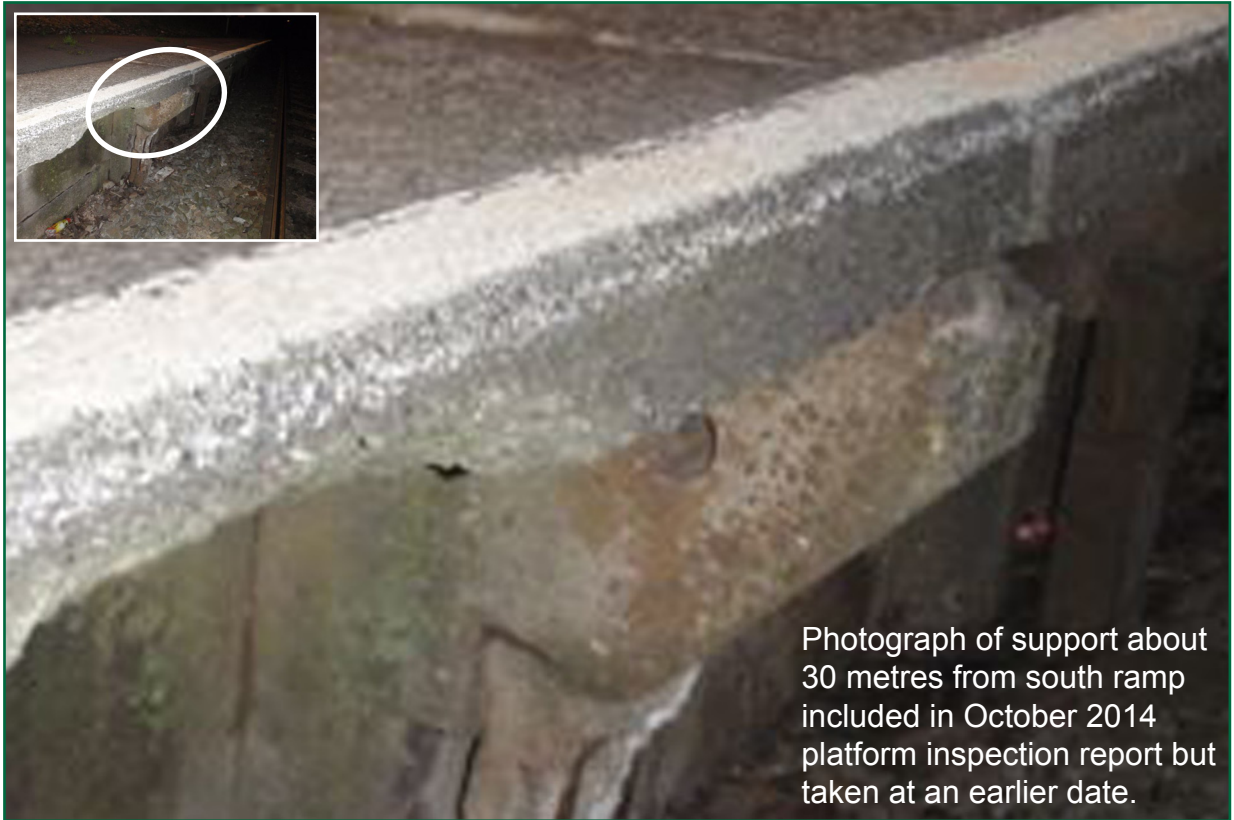
Figure 19: Platform support projecting beyond coping stone

Photograph of support about 30 metres from south ramp included in October 2014 platform inspection report but taken at an earlier date.

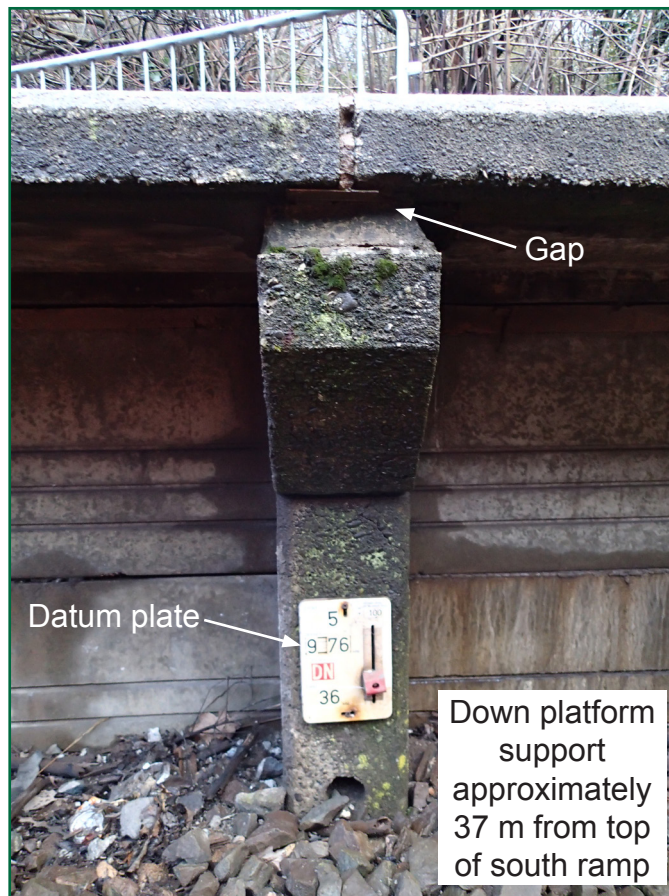
Figure 20: Gap between support and coping stone

- A gap between the coping stones and a platform support observed by the RAIB, outside the accident area, about 40 metres from the southern ramp (figure 20); and

- 53 The cause of these movements is uncertain, but is probably at least partly due to inadequate drainage to deal with water flowing down the cutting sides which rise up from the back of the platform¹¹.

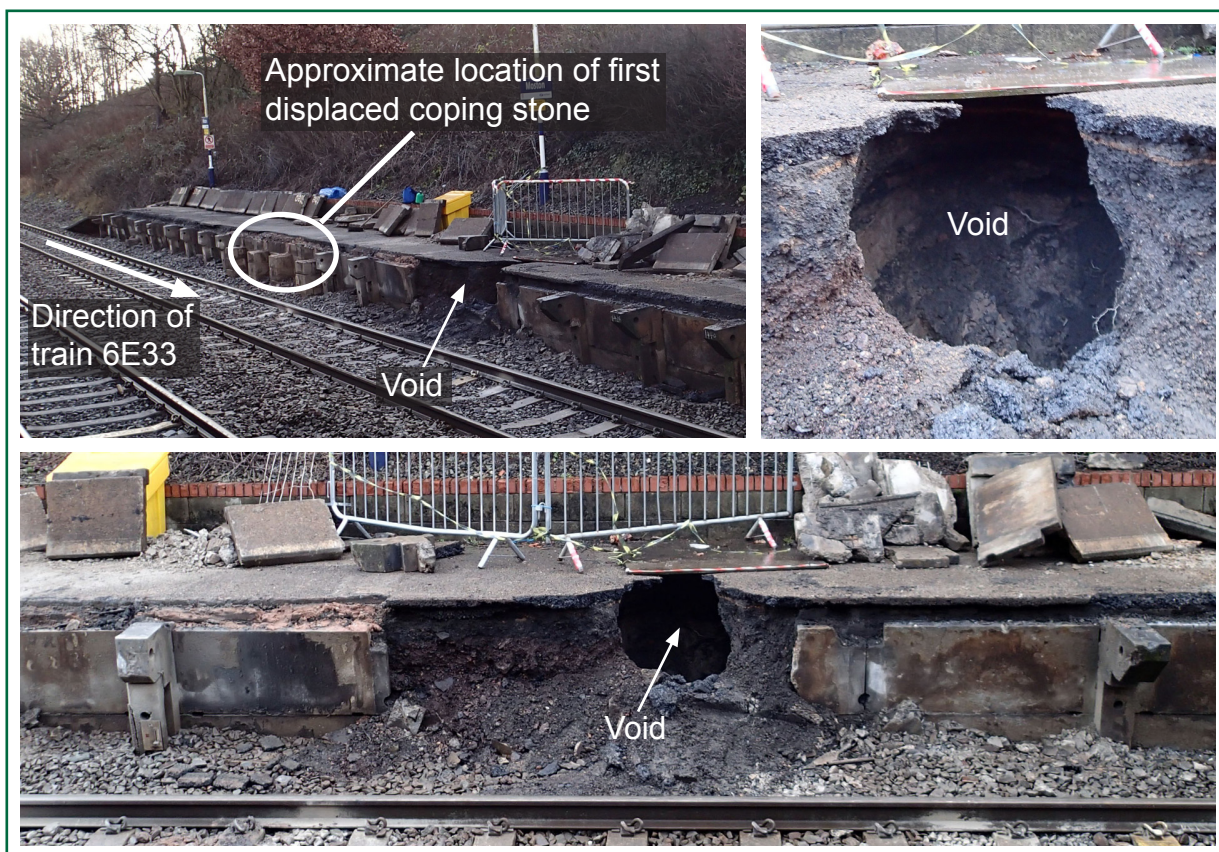
Figure 21: Void in fill beneath platform

- A void beneath the Down platform which had been recorded by Network Rail before the accident but, although near the accident area, is located after the area of impact and so is not considered to be related to the accident (figure 21).

¹¹ The cause of the void as suggested in Network Rail's London North Western Building Asset Management's 'Response to RAIB investigation' dated 20 March 2015.

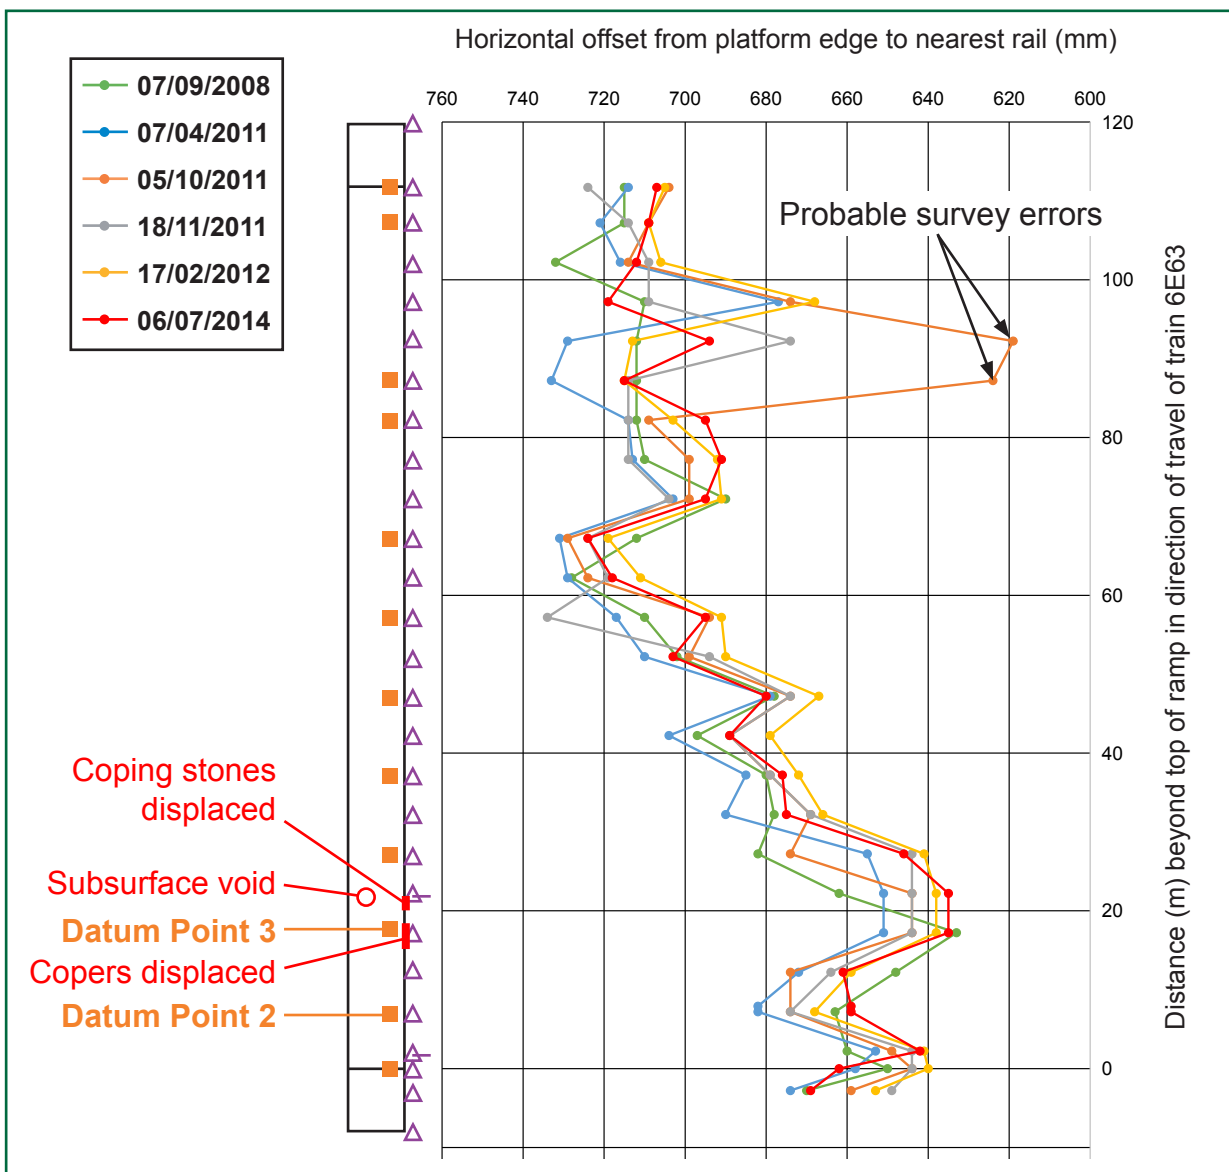
Figure 22: Platform edge positions 2008 to 2014

- 57 Platform edge survey data recorded by Network Rail since 2008 was analysed by the RAIB and shows no evidence of the platform-track spacing reducing significantly since January 2009 (figures 22 and 23). It is possible particularly tight offsets in the area of the accident (figure 22) are a consequence of historic platform movements, but it is also possible that they are a consequence of deliberately positioning the track to achieve a good track alignment.

- 2 *The intent of this recommendation is to provide Network Rail staff with clear guidance, and practical methodologies, for recognising long term reductions in clearances at platforms. Where clearances are managed by comparison to a reference datum (eg the position of a platform in January 2009), the process should facilitate this comparison. Documents referenced in Network Rail standard NR/L2/TRK/3201 should be checked to ensure that the current version does not have a potential to mislead staff involved in management of clearances at platforms.*
