Rail Accident Report

Derailment at Santon near Foreign Ore Branch Junction, Scunthorpe 25 January 2008

Report 10/2009
April 2009

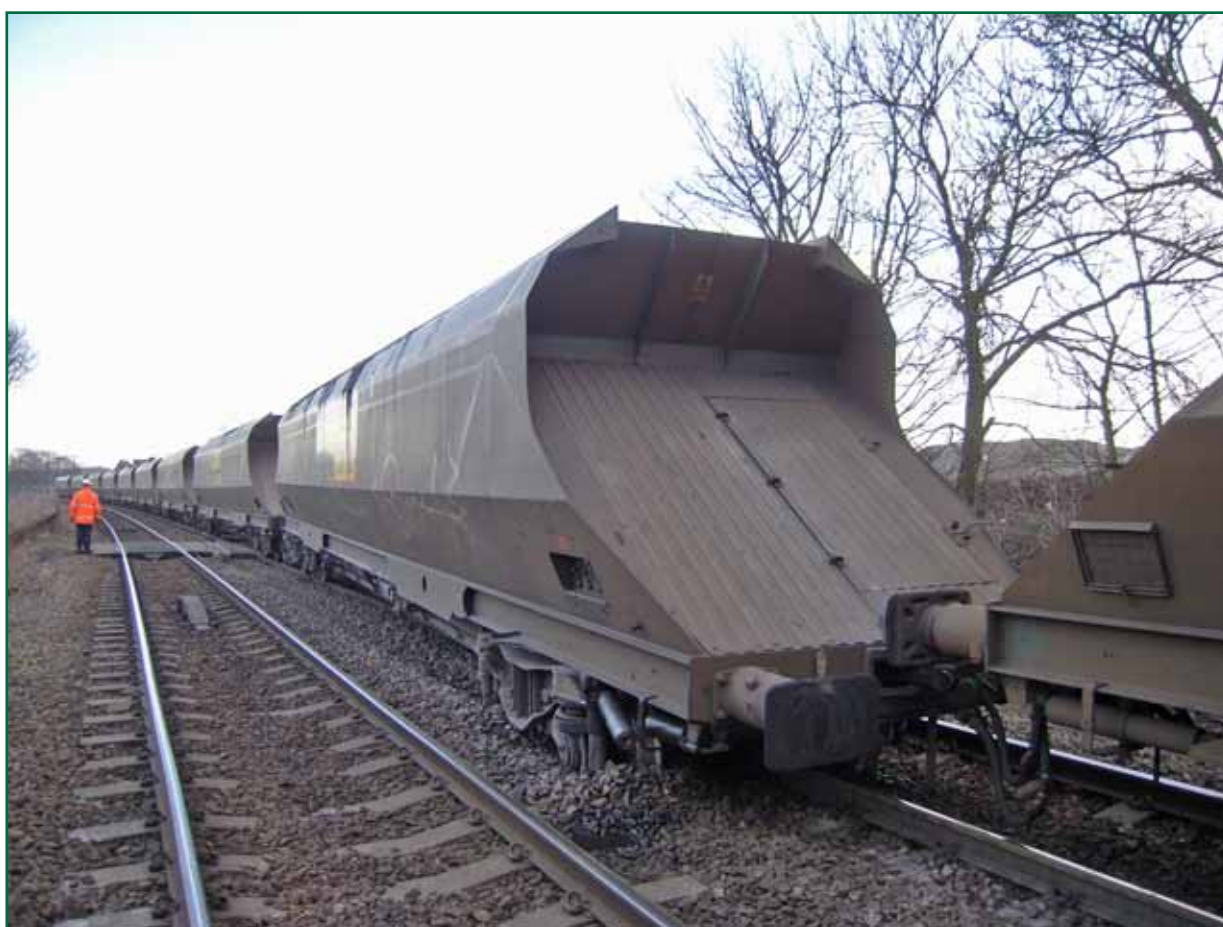
Figure 2: The tenth wagon of 6M49 derailed

- 19 No one was injured in this accident. The derailed wagon suffered damage to its leading bogie, and about 1400 metres of track, including two sets of switches, signalling equipment and a level crossing, required repair or replacement.
- 20 The derailed wagon deviated to the right and ran derailed foul of the *up* line. A train travelling in the opposite direction on the up line could have collided with this wagon, with the possibility of more severe consequences.

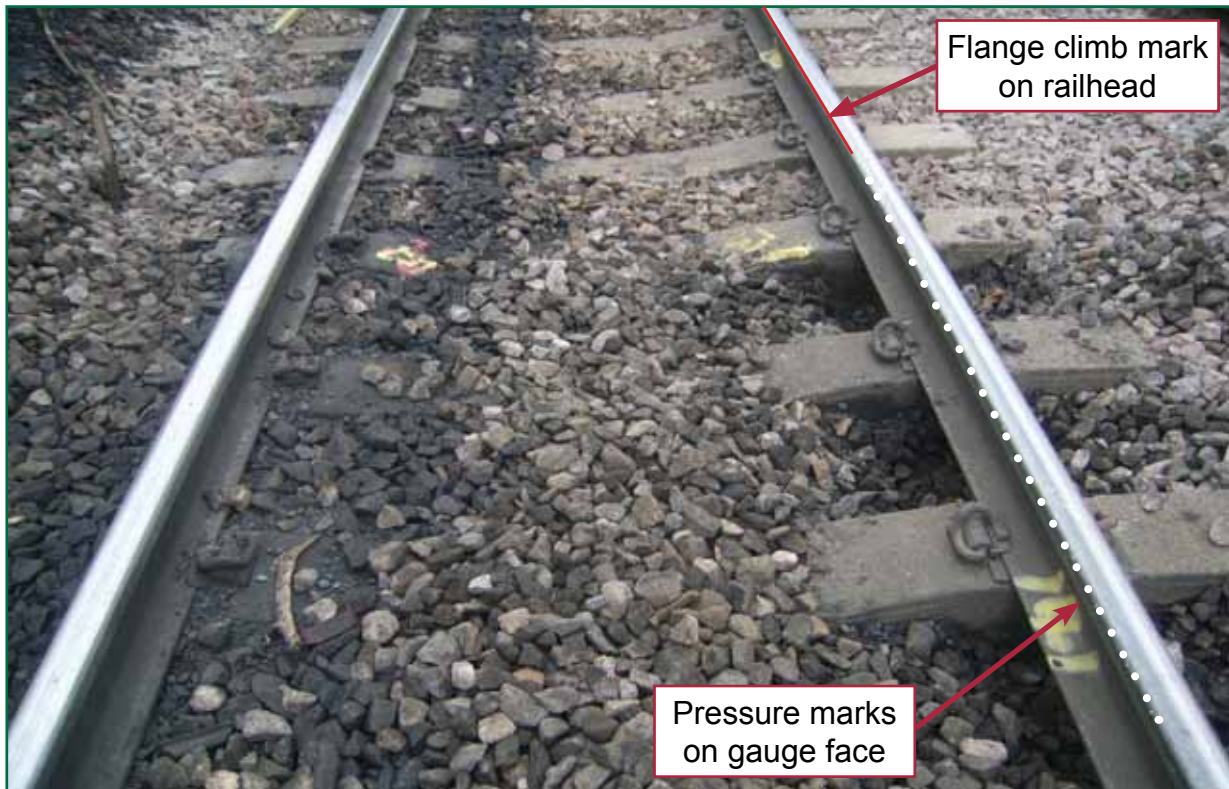
51 Marks on the railhead showed that a wheel flange had climbed onto the six-foot railhead at 26 miles 13 yards. The exact point where it started to climb was not clear, as over a distance of about 2 metres, there were many pressure marks on the gauge face, see Figure 6. These marks indicated that other wheels had begun to climb.

Figure 6: Pressure marks and flange climb mark on the railhead looking in the direction of travel

- 52 The flange mark showed the wheel ran on the railhead for approximately 6.8 metres, before dropping in to the six-foot and running on rail fastenings and sleepers. Corresponding *tread corner* marks on the *cess* rail showed the left-hand wheel derailing.

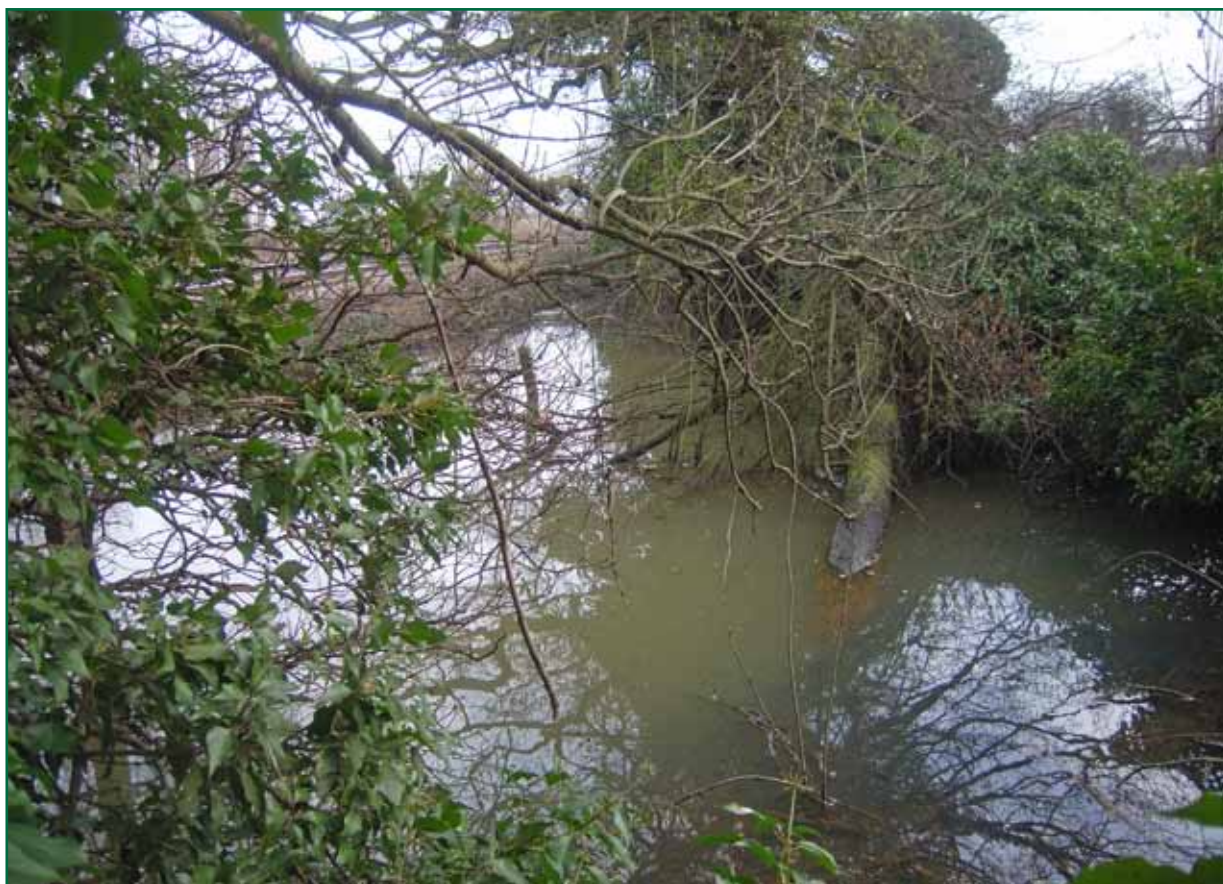
- 58 Further up the gradient towards Scunthorpe, at around 25 miles 78 chains, a large volume of water was pooled next to the down line cess, see Figure 7. The drains on the adjacent road were blocked and water had breached the side of the road and was collecting in this area.

Figure 7: Water pooled next to the down line's cess

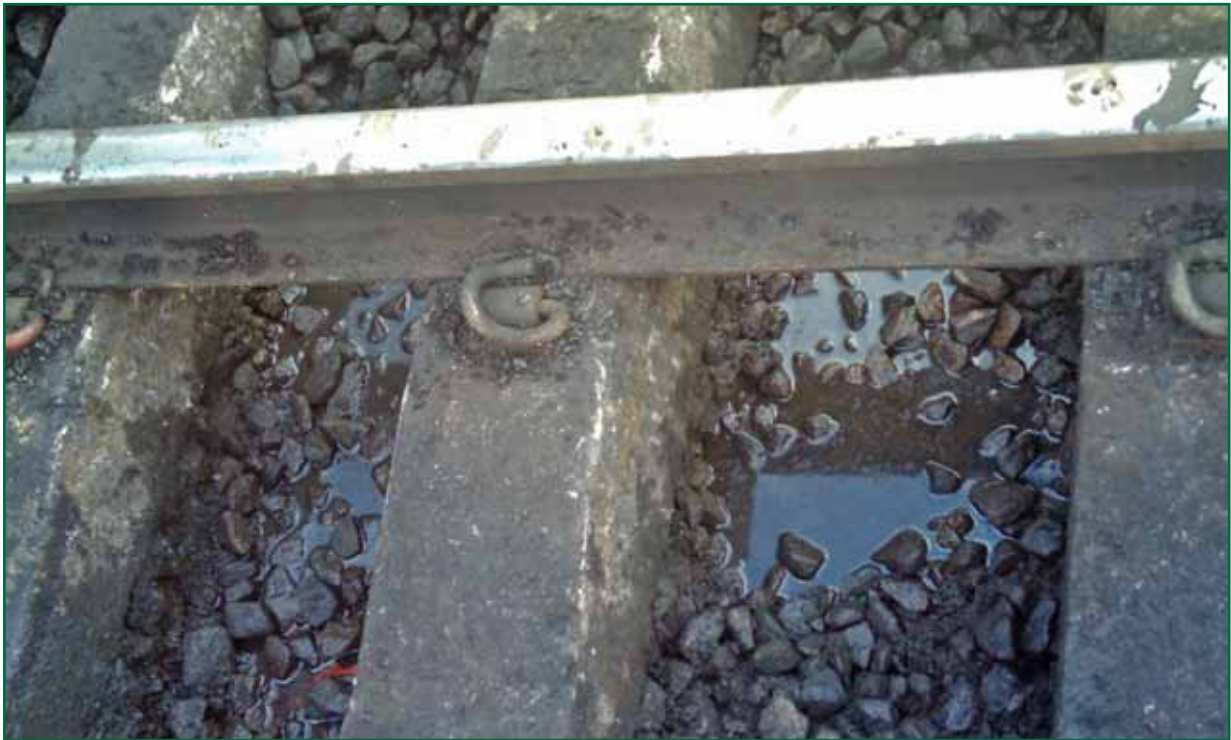
- 59 Although there were no signs of water on the surface, when Network Rail staff dug out some ballast in the *cribs* to install *void meters* as part of the post-accident track survey, they found water below sleeper bottoms, particularly towards the cess side. On the following day, Network Rail dug out all of the ballast in the cribs over the point of derailment. Water was again found under the cess side rail and in the four-foot towards the cess side, see Figure 8. They did not find any water on the six-foot side of the track.

Figure 8: Water under the cess rail (photograph courtesy of Network Rail)

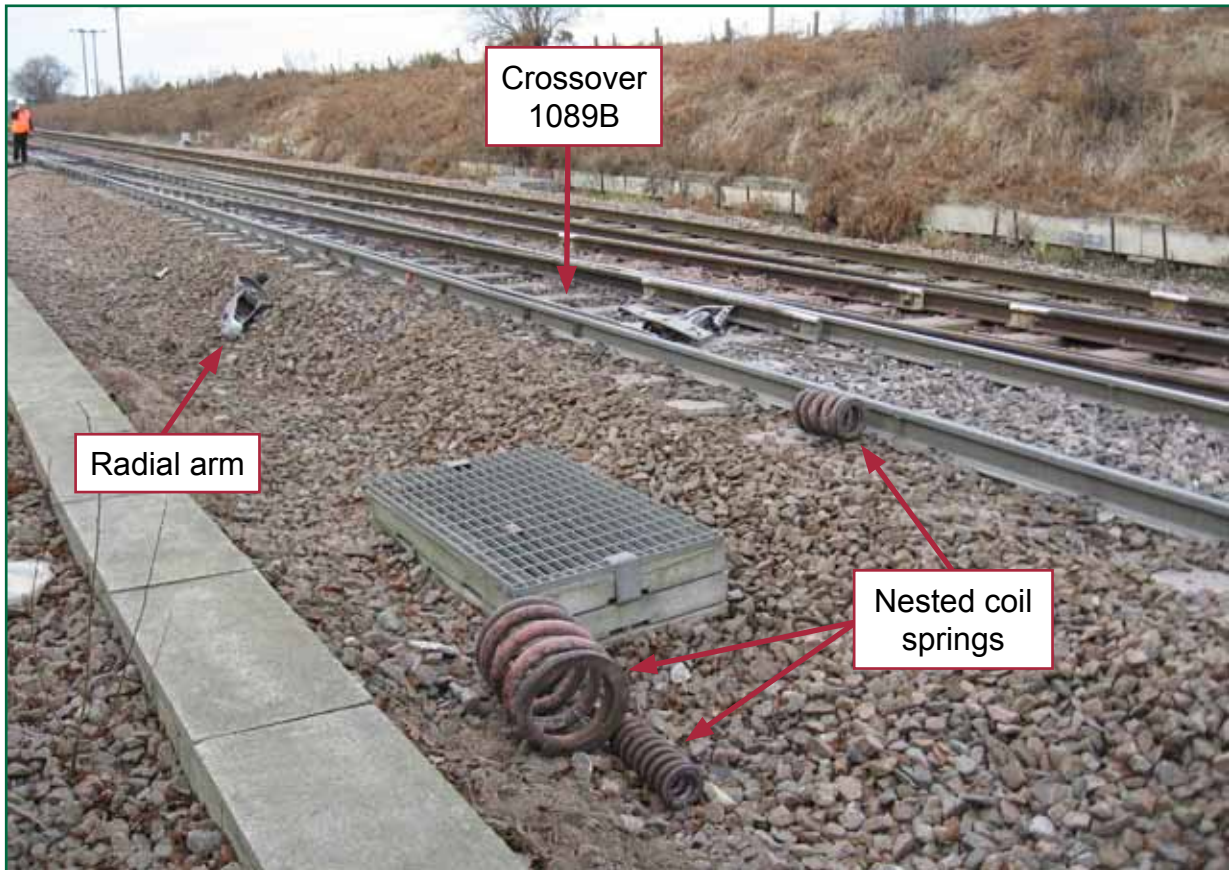
- 72 The *radial arm* for the trailing left-hand wheel was detached from the front bogie. On site, this radial arm and the *nested coil springs* for the trailing left-hand wheel were lying in the cess close to *trailing* crossover 1089B at Foreign Ore Branch Junction, see Figure 9. The two *huck bolts* that attach the radial arm to the bogie frame were found 176 metres and 232 metres after the crossover. There was no evidence on site or from the post-accident examinations of wagon 370 157 to suggest that there were any pre-existing suspension faults.

Figure 9: Detached wagon suspension components next to crossover 1089B

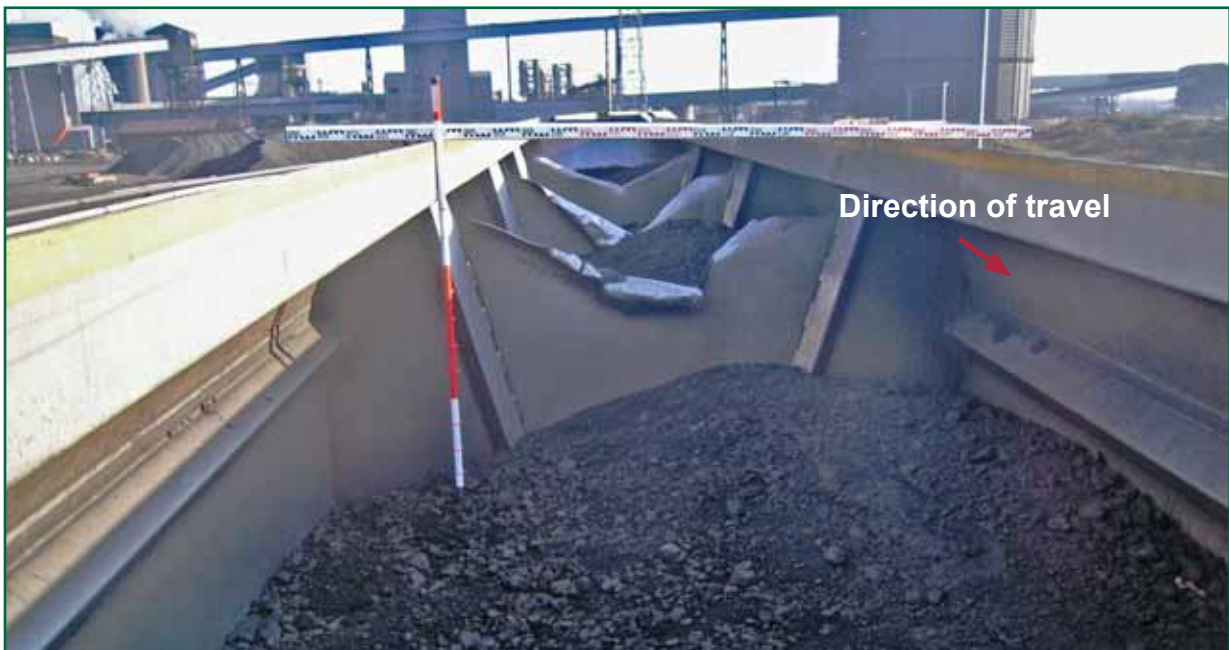
- 73 The load on each wheel of wagon 370 157 was measured at North Lincoln sidings in Scunthorpe on 8 February 2008; it had a gross laden weight of 84.1 tonnes. The wheel loads for wagon 370 110, which had been following wagon 370 157, were also measured; it had a gross laden weight of 85.5 tonnes.
- 74 Visual examination of the coal in wagon 370 157 indicated that the load was not evenly distributed. It was offset to the left-hand side (Figure 10).

Figure 10: Coal load in wagon 370 157 - the damage to the compartment partitions is most likely to have occurred during loading by bucket loaders and played no part in this accident.

75 The coal mostly consisted of very small pieces and dust. It was very wet and water was dripping out from underneath the wagon. Coal slurry was streaked down the right-hand side of the wagon.

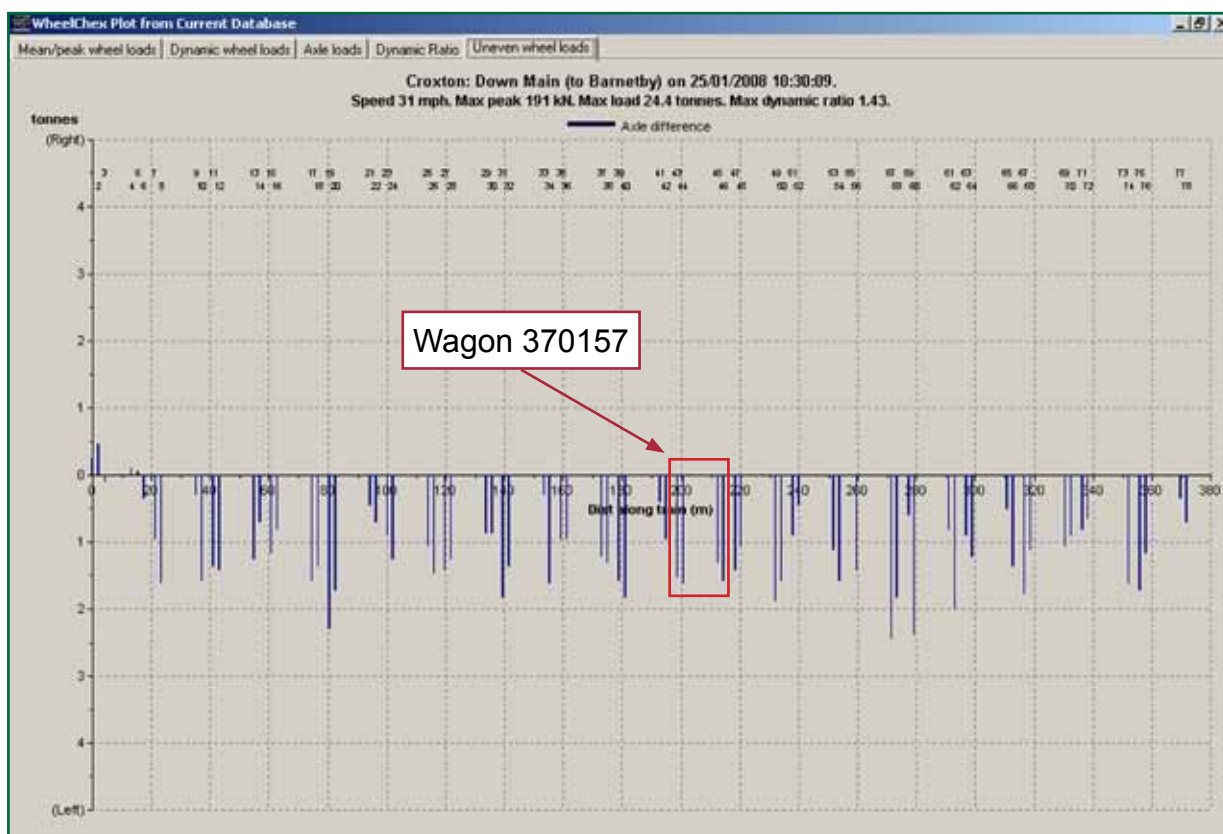
Figure 11: Wheelchex uneven wheel loads report for train 6M49

- 78 Wagon 370 157 (denoted as axles 43 to 46) is highlighted. All of the axles for the HHA wagons show an imbalance to the left-hand side of the train whereas the locomotive (denoted as axles 1 to 6) does not. The RAIB used the static wheel load measurements from undamaged wagon 370 110 (paragraph 73) to corroborate the dynamic weight measurements from WheelChex. The two sets of wheel load measurements were all within 6.5% of each other. The WheelChex measurements were further corroborated by comparing the gross laden weights of 15 other wagons from train 6M49 against those recorded at Rugeley Power Station before being discharged. The two set of measurements were all within 1% of each other.

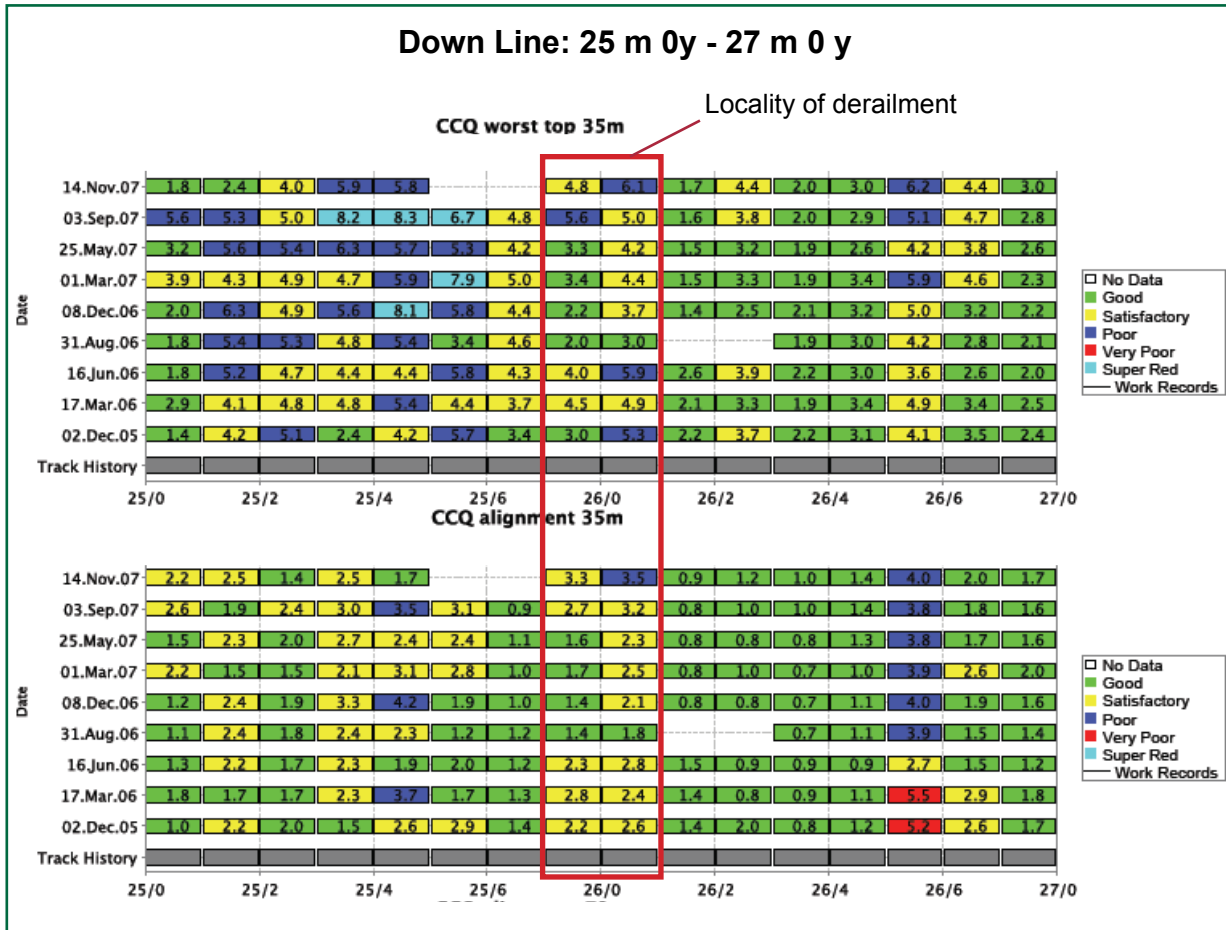
113 The point of derailment was close to the boundary between the two eighth mile sections at milepost 26. The vertical and lateral alignment standard deviation values for these sections had been steadily increasing since the track geometry recording run in May 2007, moving them from the good band to the satisfactory or poor bands. Neither eighth mile section had reached a target value which would have triggered the local maintenance team to carry out remedial actions to improve the track quality.

Figure 14: The standard deviation chart covering the point of derailment

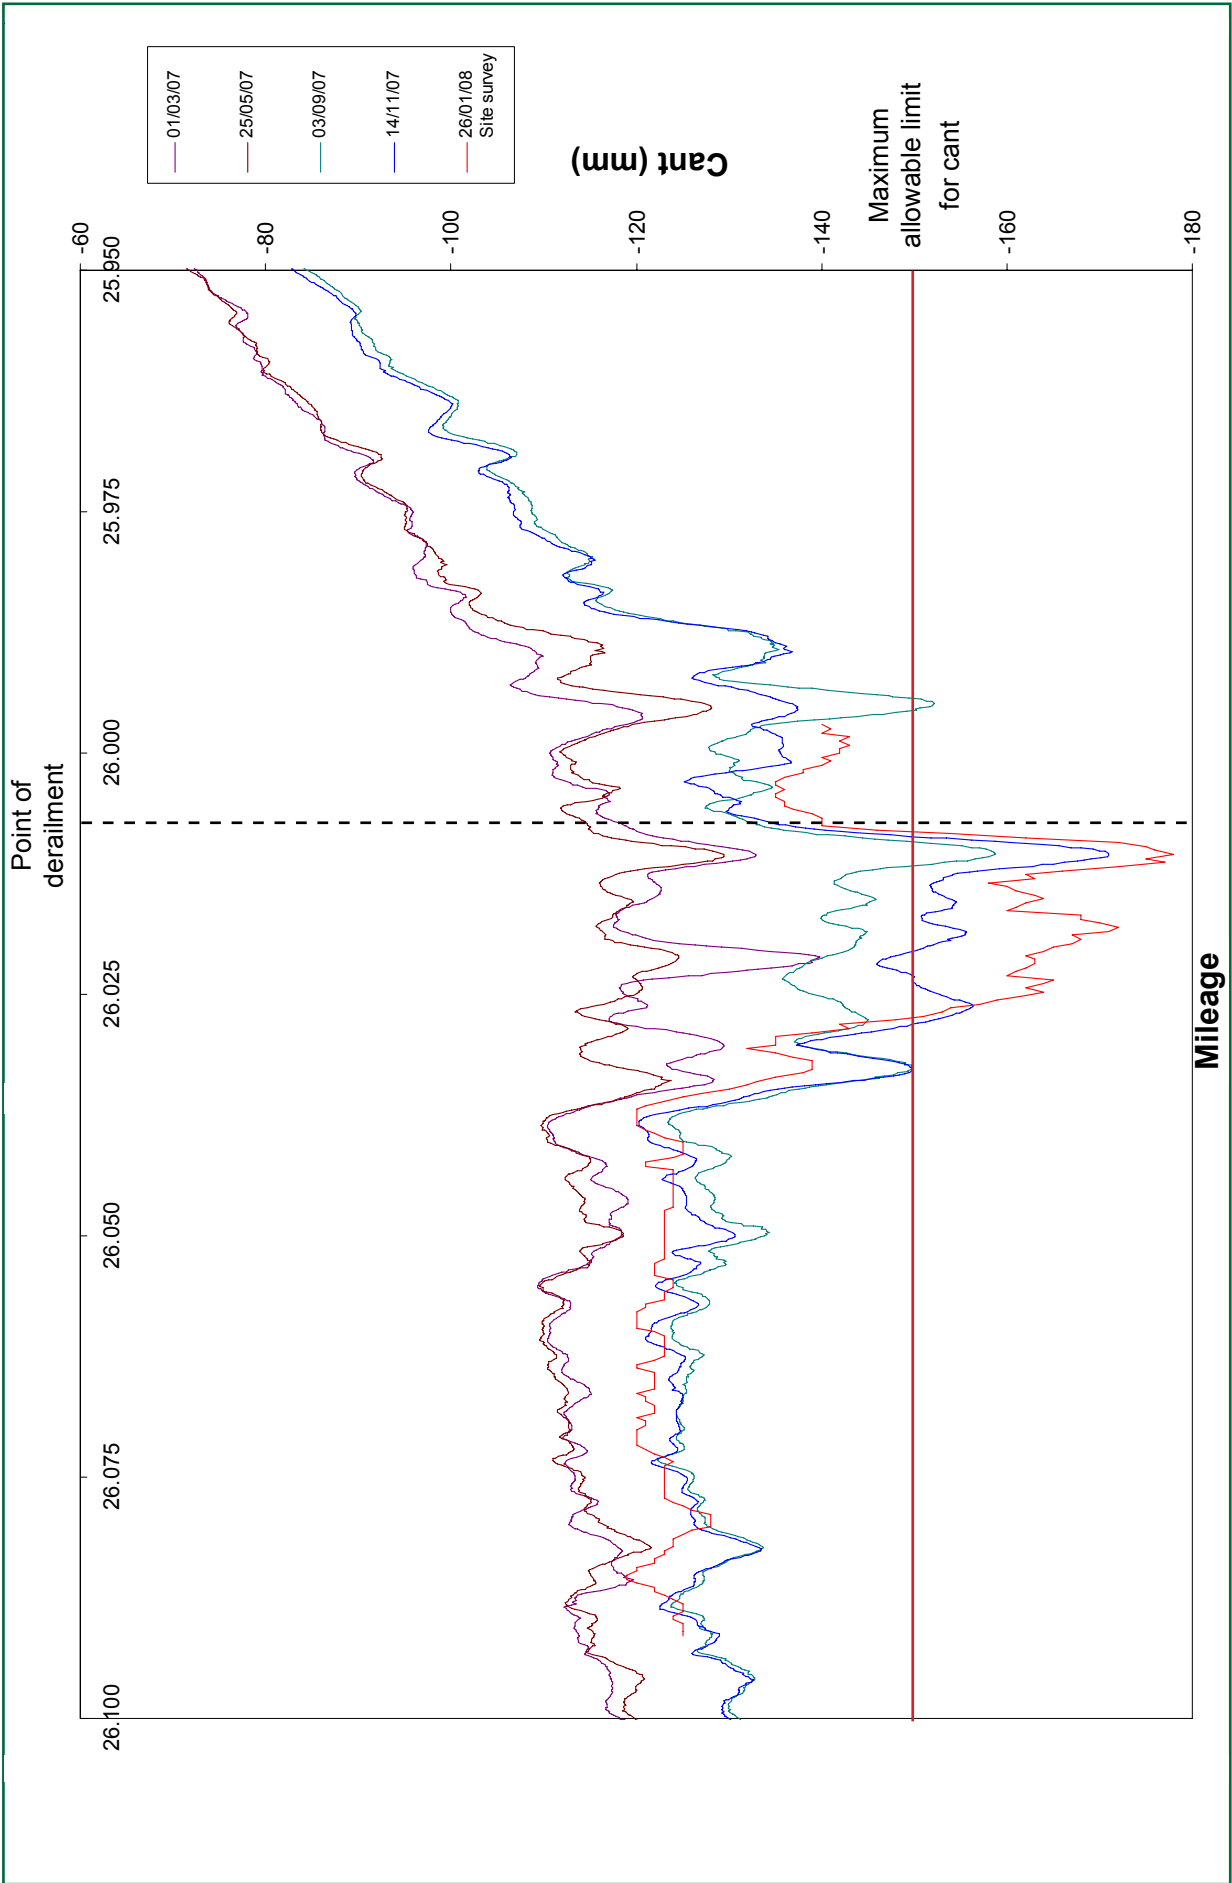
Figure 16: Change in cant on down line over time

196 The deterioration in cant indicates that the formation under the cess rail was deteriorating at a much greater rate than that of the six-foot rail. This is corroborated by the majority of track defects found during visual inspections being with the vertical alignment of the cess rail rather than the six-foot rail. Also, when the ballast was dug out from the cribs after the accident, water was found under the cess rail but not the six-foot rail (paragraph 59). The cant and the lack of a ballast shoulder on the cess side of the track provided a path for water to flow underneath the cess rail rather than the six-foot rail. The rapid deterioration of the track geometry due to water in the trackbed was a probable causal factor.

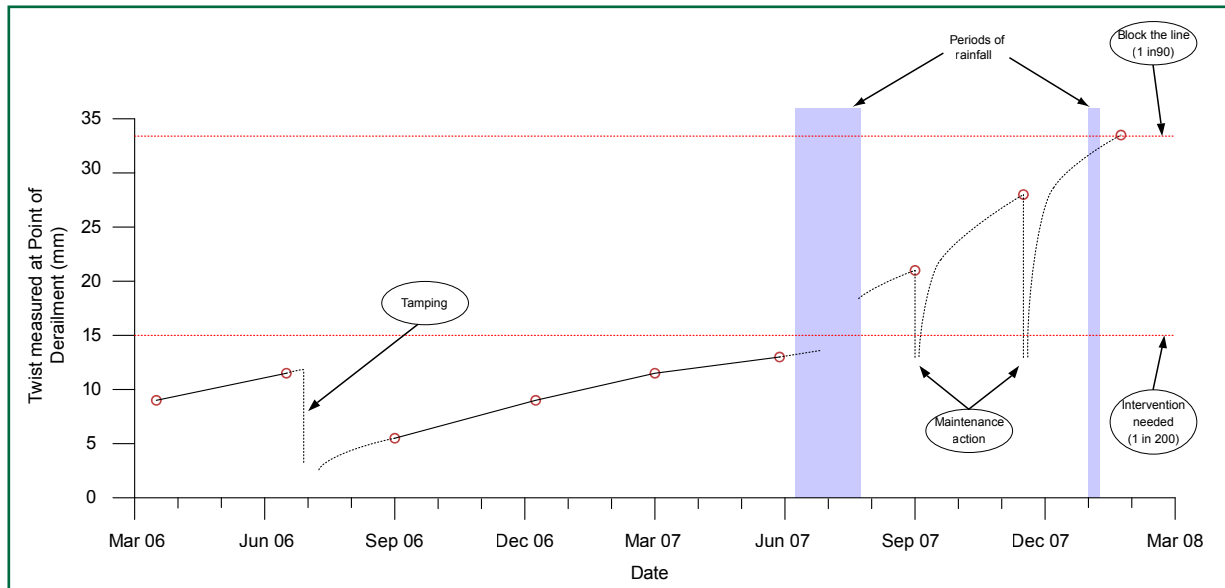
Figure 17: Change in track twist at point of derailment over time
