# ***AAIB Bulletin***

***5/2016***

S1/2016 Hawker Hunter T7	G-BXFI	22-Aug-15	3
--------------------------	--------	-----------	---

<b>Aircraft Type and Registration:</b>	Hawker Hunter T7, G-BXFI
<b>No &amp; Type of Engines:</b>	1 Rolls-Royce Avon Mk 122 turbojet engine
<b>Year of Manufacture:</b>	1959 (Serial no 41H-670815)
<b>Location:</b>	Near Shoreham Airport, West Sussex
<b>Date &amp; Time (UTC):</b>	22 August 2015 at 1222 hrs
<b>Type of Flight:</b>	Private
<b>Persons on Board:</b>	Crew - 1                      Passengers - None
<b>Injuries:</b>	Crew - 1 (Serious)      Passengers - N/A Others                      - 11 (Fatal)
<b>Nature of Damage:</b>	Aircraft destroyed
<b>Commander's Licence:</b>	Airline Transport Pilot's Licence
<b>Commander's Age:</b>	51 years
<b>Commander's Flying Experience:</b>	14,249 hours (of which 40 were on type) Last 90 days - 115 hours Last 28 days - 53 hours
<b>Information Source:</b>	AAIB Field Investigation

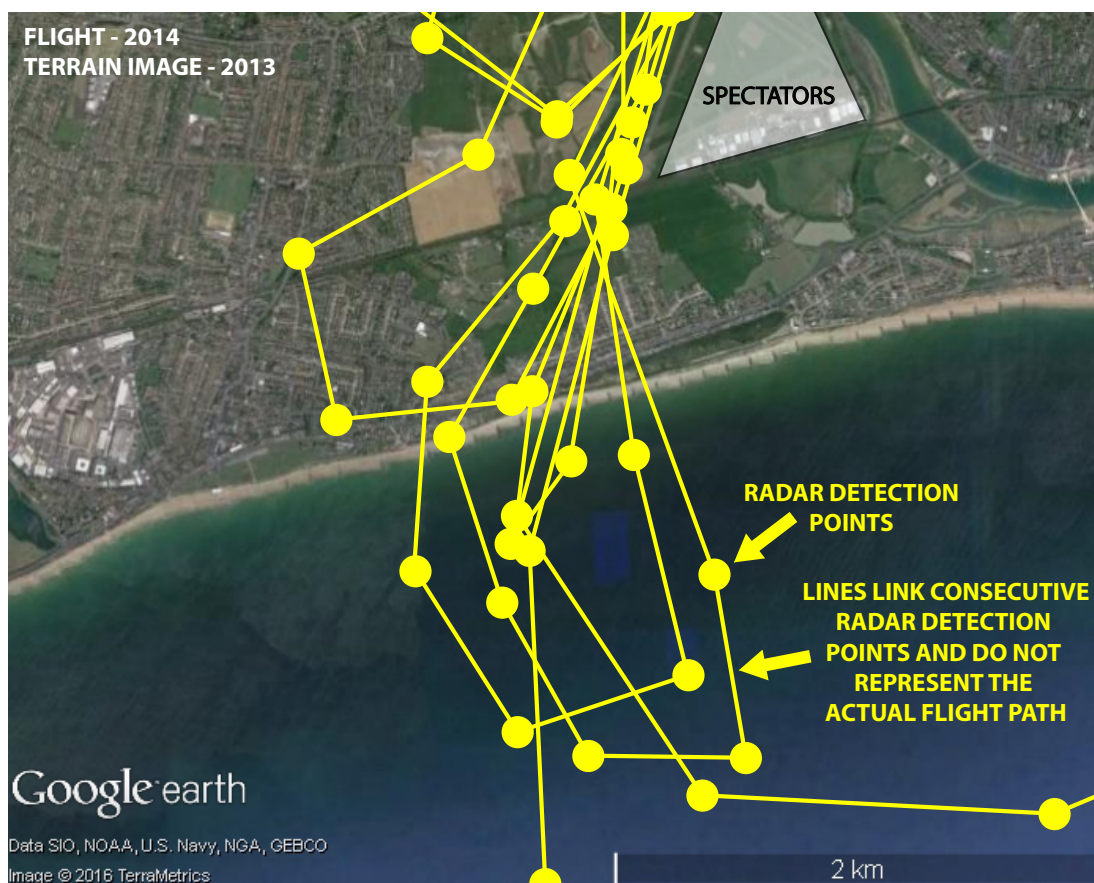
**Figure 1**

Video footage of a previous display of G-BXFI at the 2014 Shoreham Airshow indicated that the majority of the aerobatic manoeuvres (including steeply banked turns) were conducted away from the airfield, over areas accessible to the public and outside the control of the display organisers. Footage and tracks determined from radar data showed that the aircraft overflow residential areas along the A259 south of Shoreham Airport several times and in one manoeuvre overflow the central area of the town of Lancing at an angle of bank in excess of 90°. (Figure 1). The pilot was not instructed to stop this display. Either these regulatory infringements were not detected by the display organisers or were not understood.

Overflights of congested area by G-BXFI during 2014 Shoreham flying display

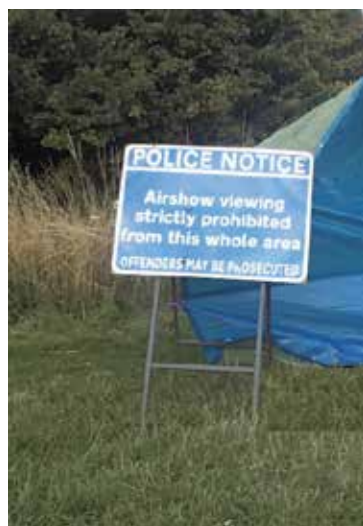
**Figure 4**

The same arrangements had been in place for several years and had restricted the view of the airfield, placed various signs in the area<sup>24</sup> (Figure 4) and used stewards to ask people to move on. However, neither the organisers nor the police had requested or been granted the legal power to prevent people from being in this area and their efforts did not prevent a gathering at the A27 junction.

Sign at A27 / Old Shoreham Road junction

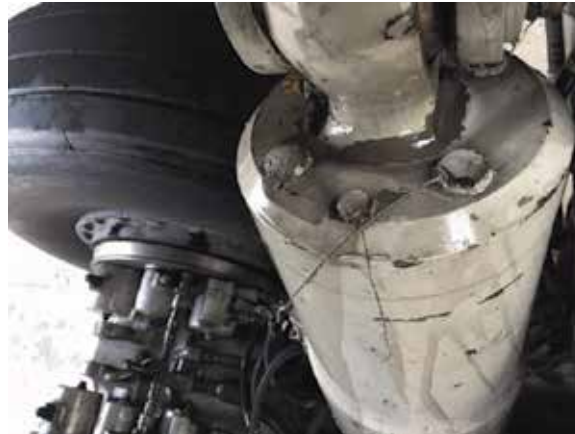
**Figure 1**

The images in Figures 1 and 2 were taken by the commander shortly after the aircraft had taxied to the stand and the passengers had disembarked. An oil stain was readily visible on the ground around the right main gear leg and there was a piece of broken locking wire (Figure 1) attached to the top of the shock-absorber. Bubbles of oil were coming from a hole where a bolt head was missing and oil was seeping from the base of the bubbles. Over the next 24 hours the rate of bubbles originating from the hole slowed significantly. The shock-absorber was removed and taken to the manufacturer for examination.

Image taken just after landing - shock-absorber on the right main gear leg

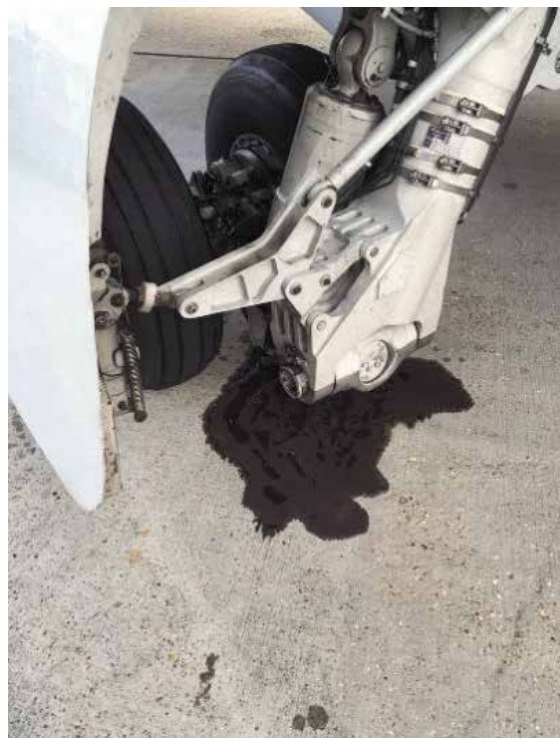
**Figure 2**

Image taken just after landing - right main gear

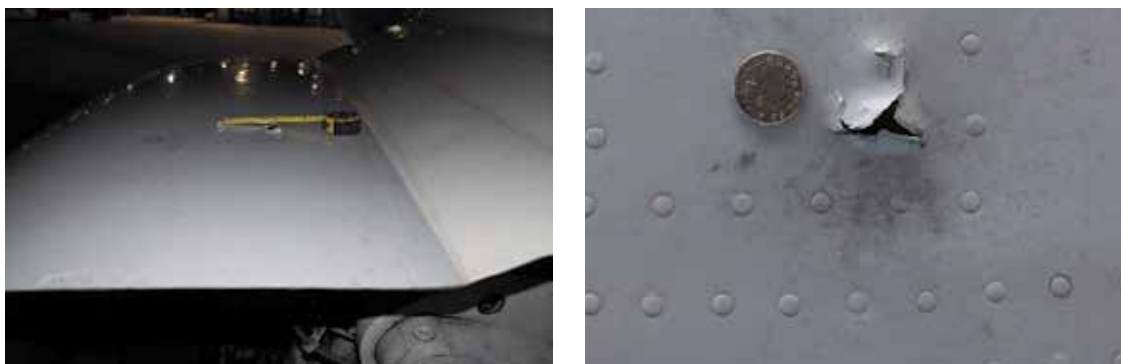
**Figures 3 and 4**

The landing gear door had been punctured from the inside – see Figures 3 and 4. The location and the size of the hole was consistent with the missing bolt head being forced against the inside of the door without the bolt head passing through the door structure.

Images of the hole in the right main landing gear door.  
Note: the coin and bolt head have approximately the same diameter

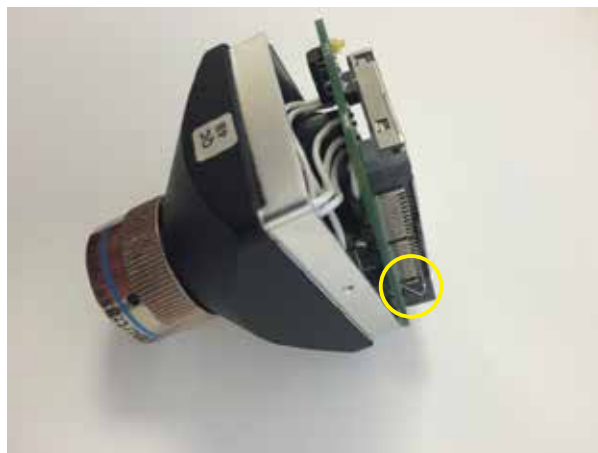
**Figure 6**

In addition to the FDR and CVR, the aircraft was also fitted with a Quick Access Recorder (QAR) which in this case was designed to record to a removable solid state CompactFlash (CF) card. The card was downloaded but found to be blank. On further investigation, the QAR was found to have damage to two pins that are part of the electrical interface from the unit to the CF card. Figure 6 shows the visible damage to one of these pins, highlighted in yellow.

Damage to one of the pins forming the QAR unit's CF card electrical interface

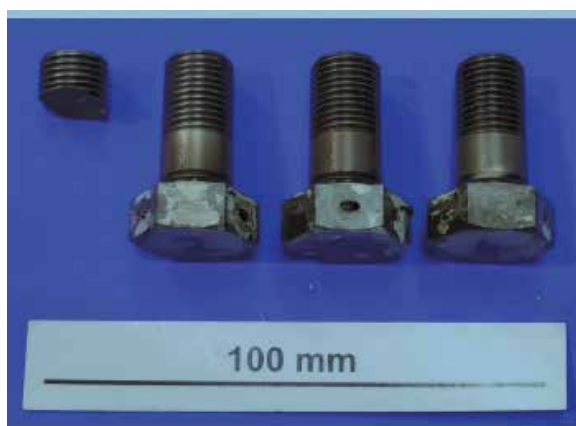
**Figure 8a**

The half of the fractured attachment bolt that had remained in the shock-absorber was removed and subjected to a metallurgical examination (Figure 8a). Three crescent-shaped fatigue cracks were observed on the outer edge of the fracture surface (Figure 8b). The conclusion of the metallurgical examination was that the bolt had fractured due to the initiation of multiple fatigue cracks from a number of locations. These locations were where the bolt interfaced with the outer cylinder, and no defects were observed at these initiation sites. No evidence of cracking was found in the other three bolts.

Image of fractured bolt compared with the three remaining complete bolts

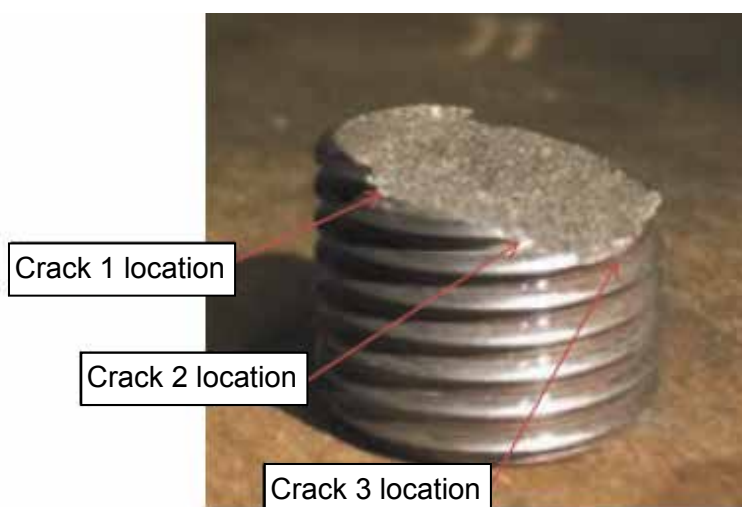
**Figure 8b**

Image of fractured bolt showing fatigue crack locations

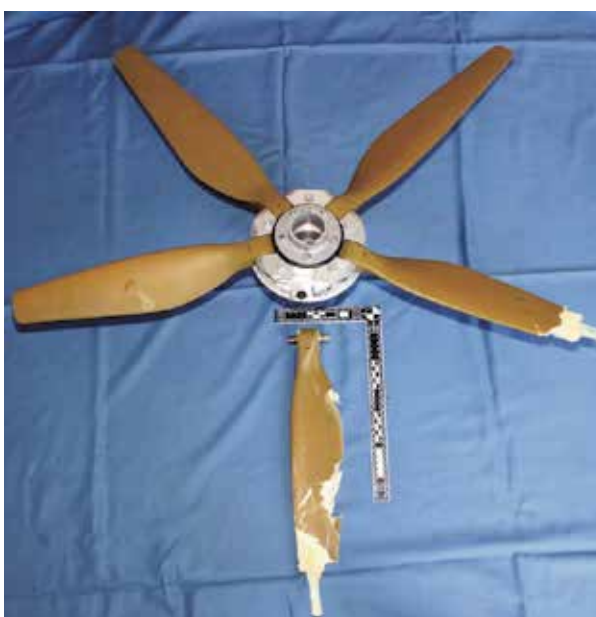
**Figure 1**

When examined by the AAIB, the detached blade had been removed from the fuselage/wing root, but there were also several small marks on the fuselage and wing where debris had impacted. There had also been damage caused by the engine moving on its flexible mounts under the severe out-of-balance forces which had been generated.

Photograph of propeller showing detached blade and damage to adjacent blade

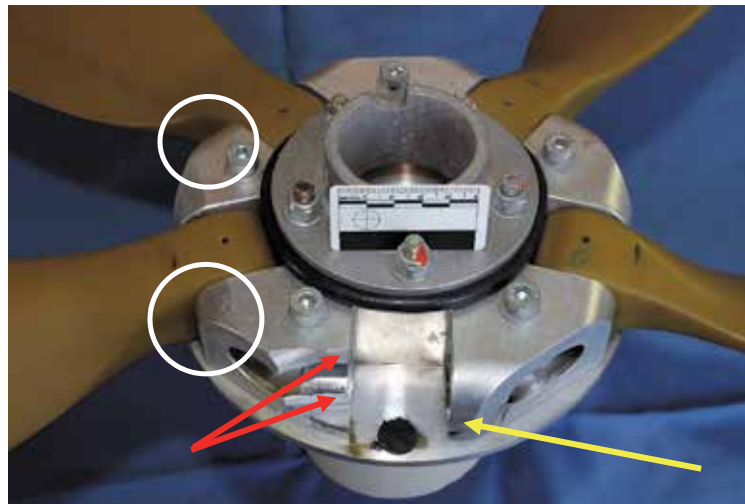
**Figure 2**

The propeller was removed and sent to a materials laboratory for detailed examination. The metallurgical report states that the blade had detached due to pre-existing fatigue cracking of the metal hub blocks which retain it (Figure 2).

Photograph showing fractured hub blocks. Yellow arrow points to the initial crack origin and double red arrows point to secondary cracking resulting from released section of right-hand block. Additional cracks were found at the locations circled

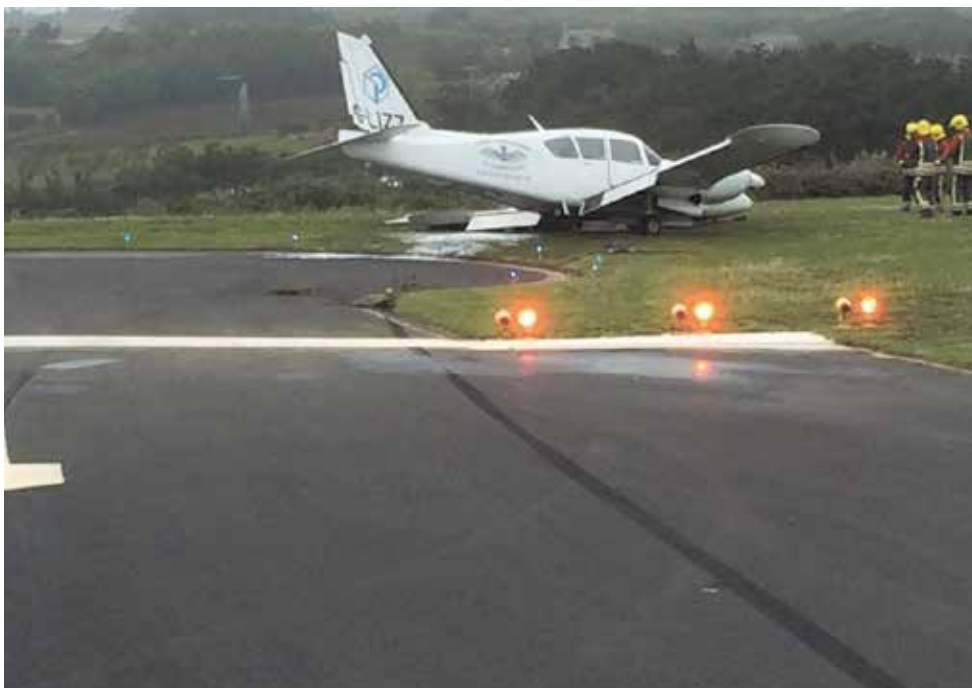
The aircraft landed approximately 200 m from the threshold, close to the top of the slope. As the aircraft reached the top, the pilot considered it was too fast to stop before the end of the runway. Aware of a precipice in the overshoot he steered the aircraft to the right. The aircraft departed the paved surface at the end of the runway and onto grass at its edge. As it did so, the nose and left main landing gear collapsed and the aircraft came to a halt. See Figure 1. The pilot secured the aircraft’s systems and the occupants vacated the aircraft uninjured. The RFFS were quickly in attendance.

**Figure 1**  
G-LIZZ after the accident
