BRE Global Client Report

BS 8414-1:2015 + A1:2017 test referred to as DCLG test 4.

Prepared for: DCLG
Date: 9th August 2017 (Issue 1.0)
30th August 2017 (Issue 1.2)
Report Number: B137611-1037 (DCLG test 4) **Issue: 1.2**

Prepared for:
Department for Communities and Local
Government
2 Marsham Street
London
SW1P 4DF

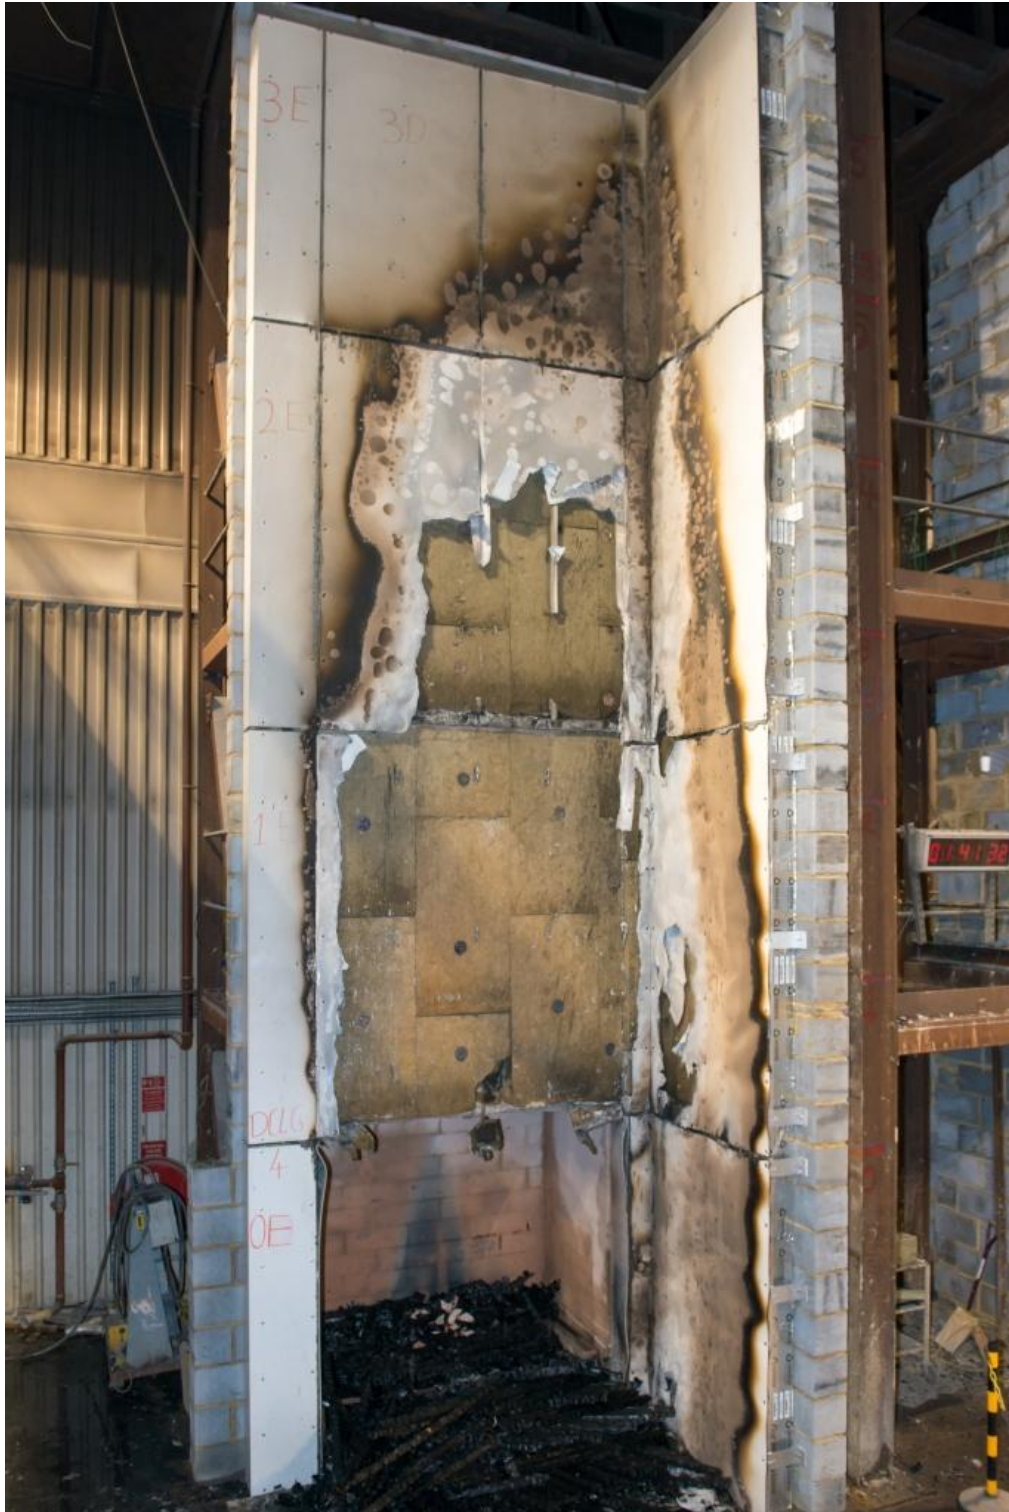
The cladding system was damaged across the full height – see *Figures 21-35*. The extent of the damage increased from black discolouration of the ACM panels at the edges of the flame damage zone to complete consumption of panels, rail substructure and substantial discolouration of the insulation directly above the combustion chamber opening up to a height of approximately 3600mm – see *Figures 21-35*. The wing wall was less severely damaged than the main wall with small areas of panel consumption (total area <0.6m²) up to the height of the first cavity barrier and significant ACM panel discolouration up to the height of the third cavity barrier, which reduced in severity towards the top of the cladding system – see *Figures 21-27*. Beneath the ACM panels on the wing wall, insulation discolouration (concentrated in the region of panel consumption) was limited to below the height of the third cavity barrier and, with the exception of the area between the second and third horizontal cavity barriers, on the main wall side of the central ‘L’ rail – see *Figures 31-35*.

Figure 21. Full height photograph of system post-test.

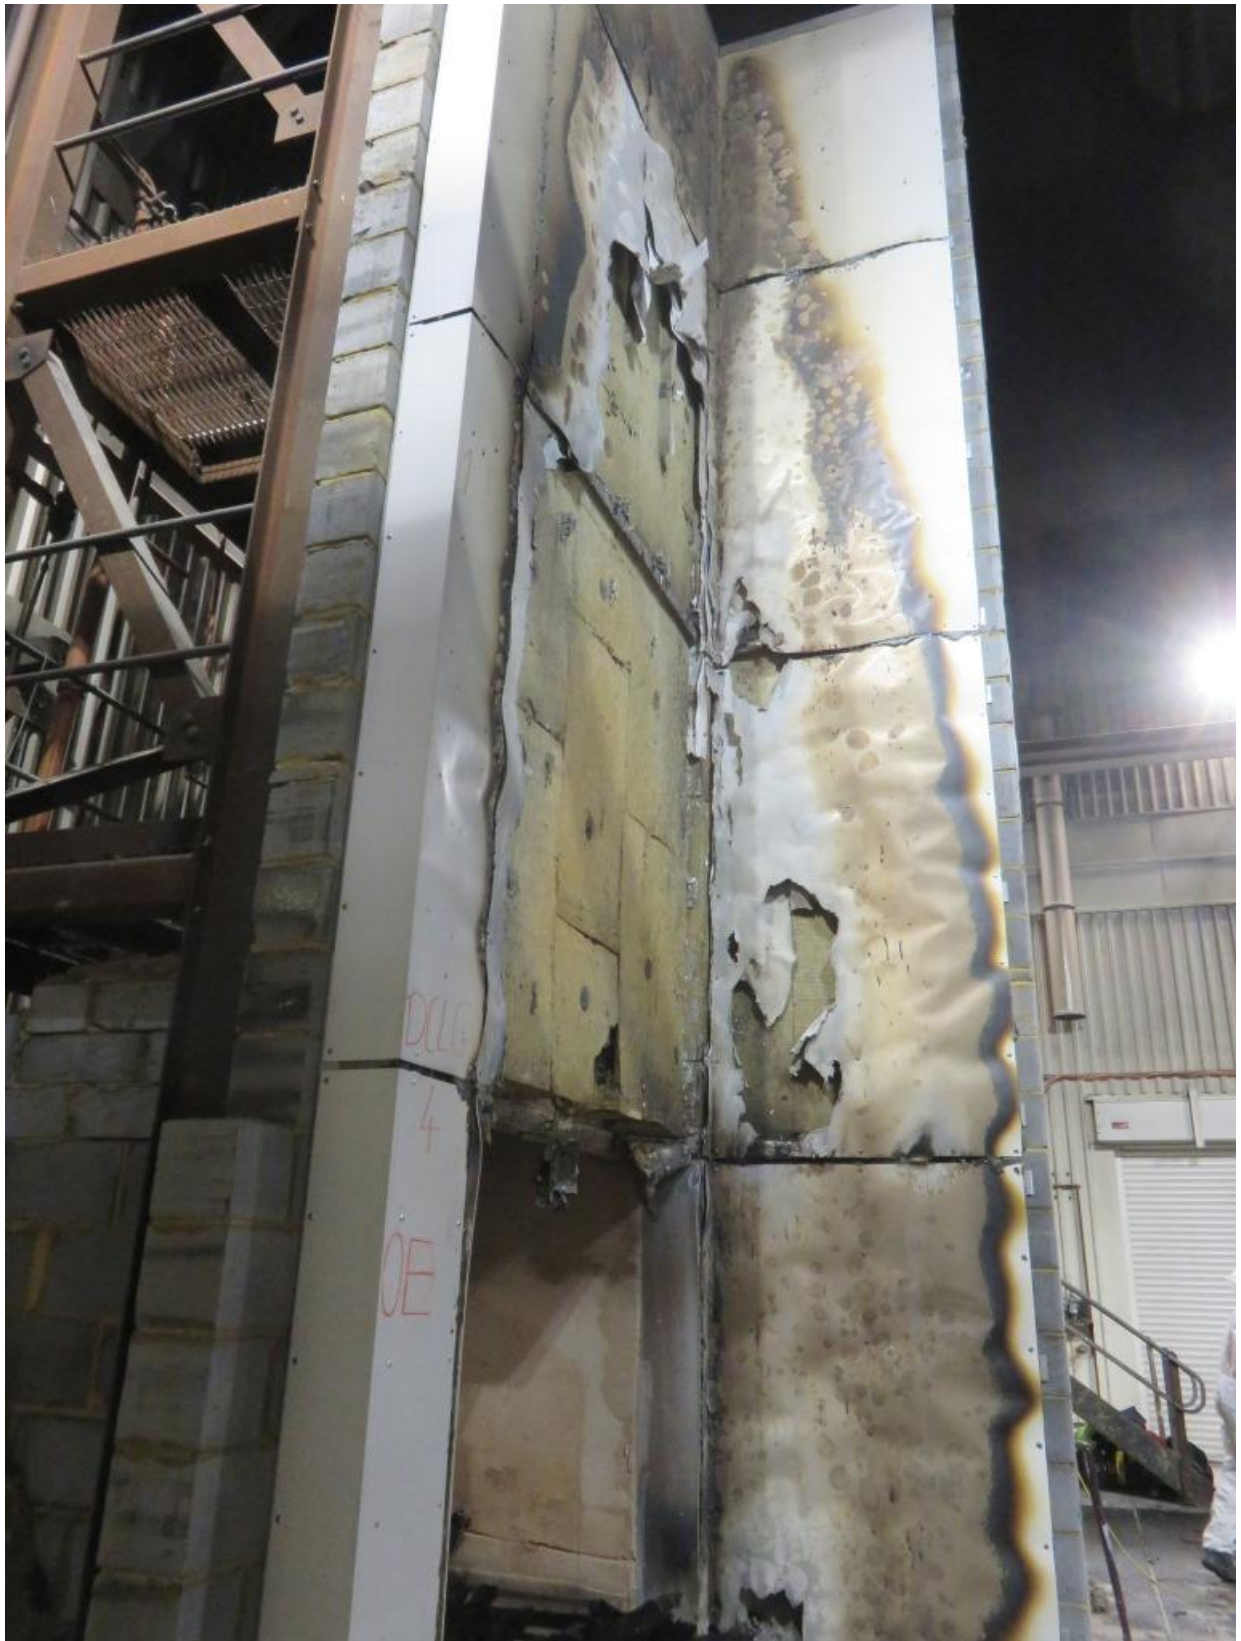
Significant discolouration and distortion was sustained by panels: 0A (90%), 1A (90%), 2A (70%) and 3A (30%) – see *Figures 21-25*. The damaged area tapered, in the direction of the main wall, from the outer edge of the wing wall (approximately 1.2m above the height of the combustion chamber) to the wing-main wall junction at the top of the cladding system – see *Figure 22*.

Figure 22. Full height photograph of wing wall post-test.

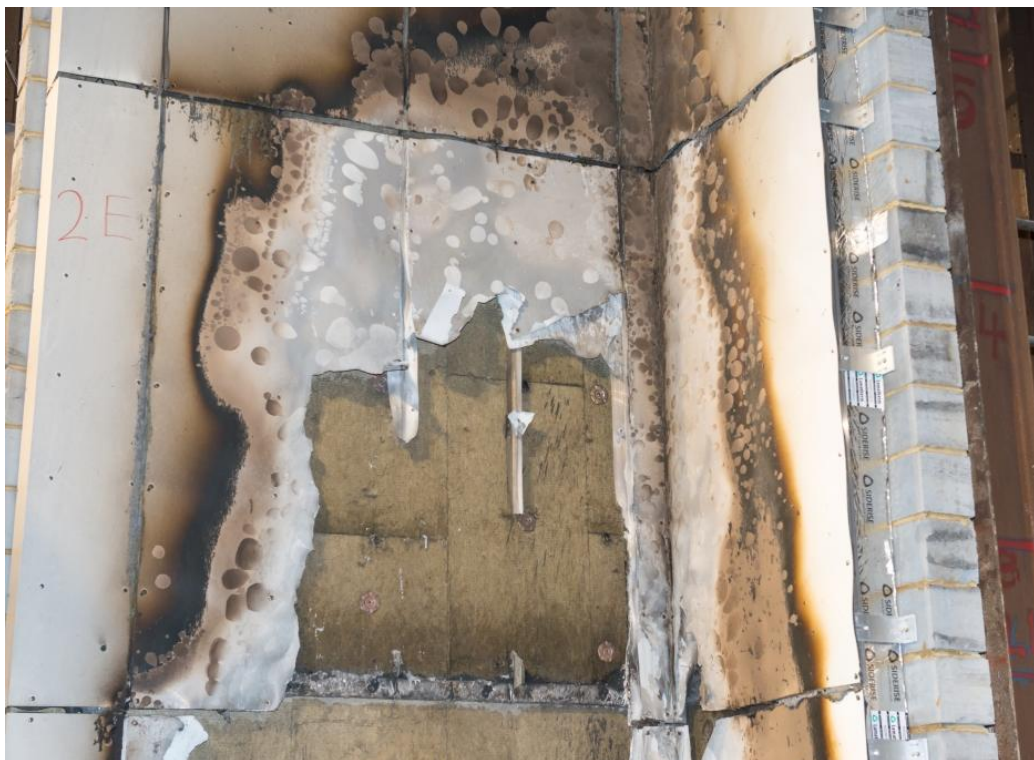
Figure 24. Second row ACM panels (approximately 2300mm-4600mm above combustion chamber).

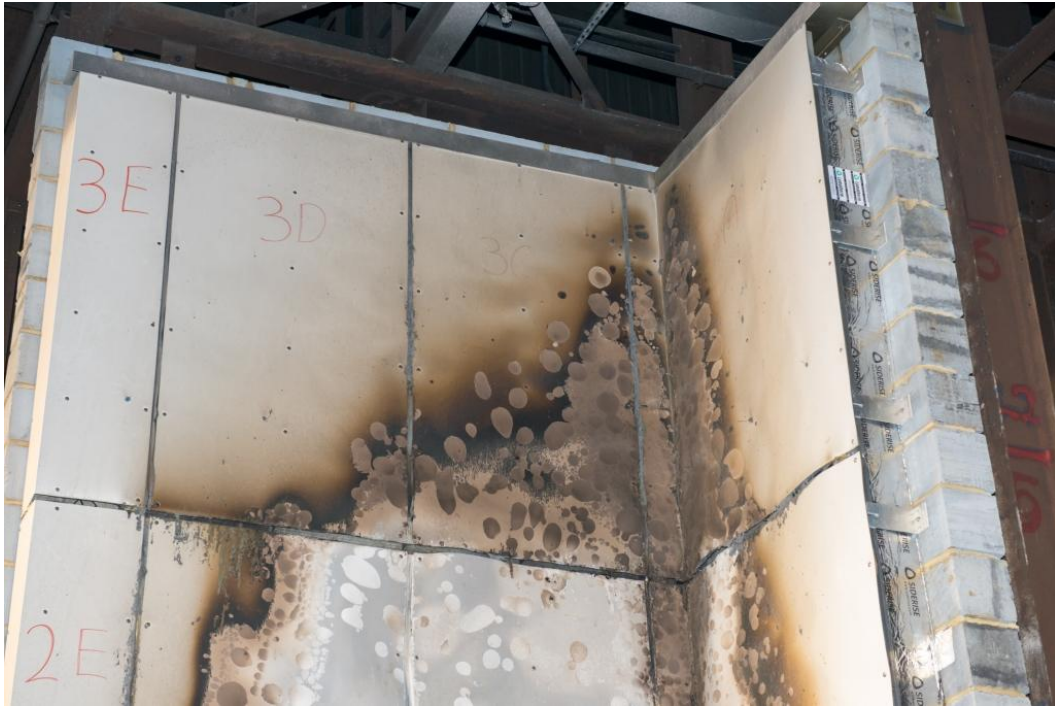
Figure 25. Third row ACM panels (approximately 4600mm-6500mm above combustion chamber).

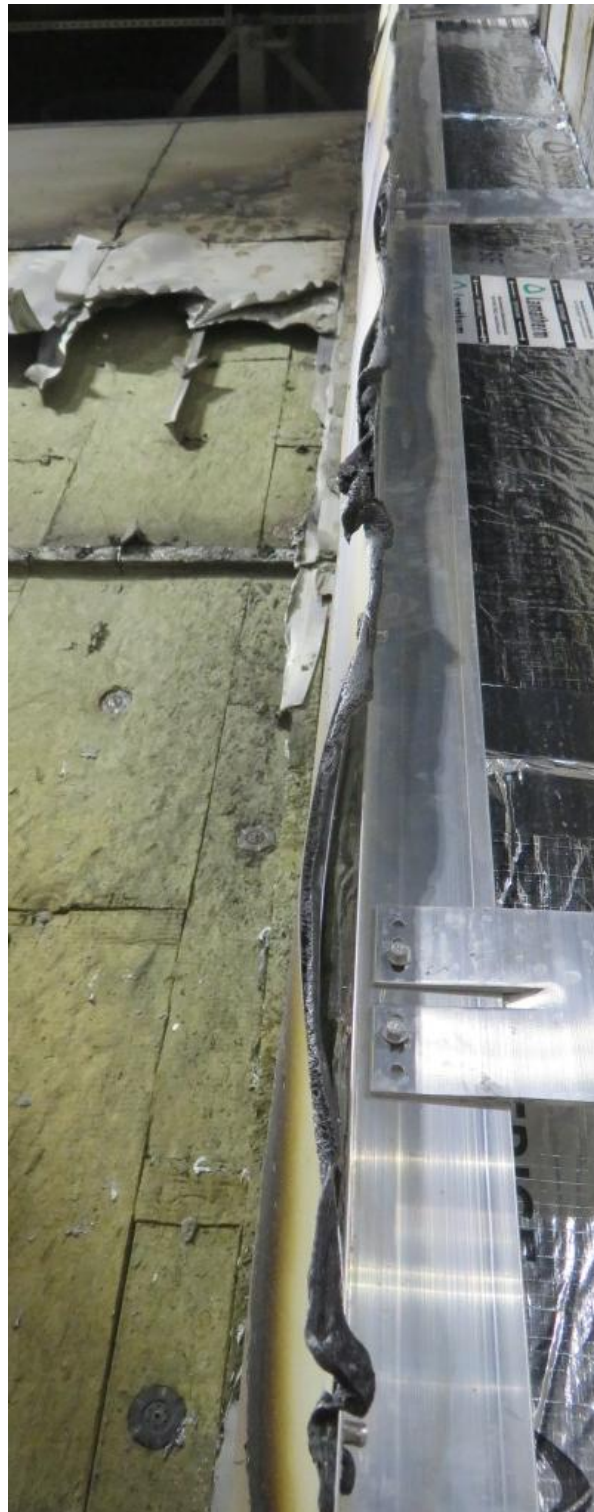
Figure 26. Close up of ACM panel edges showing melted core filler material.

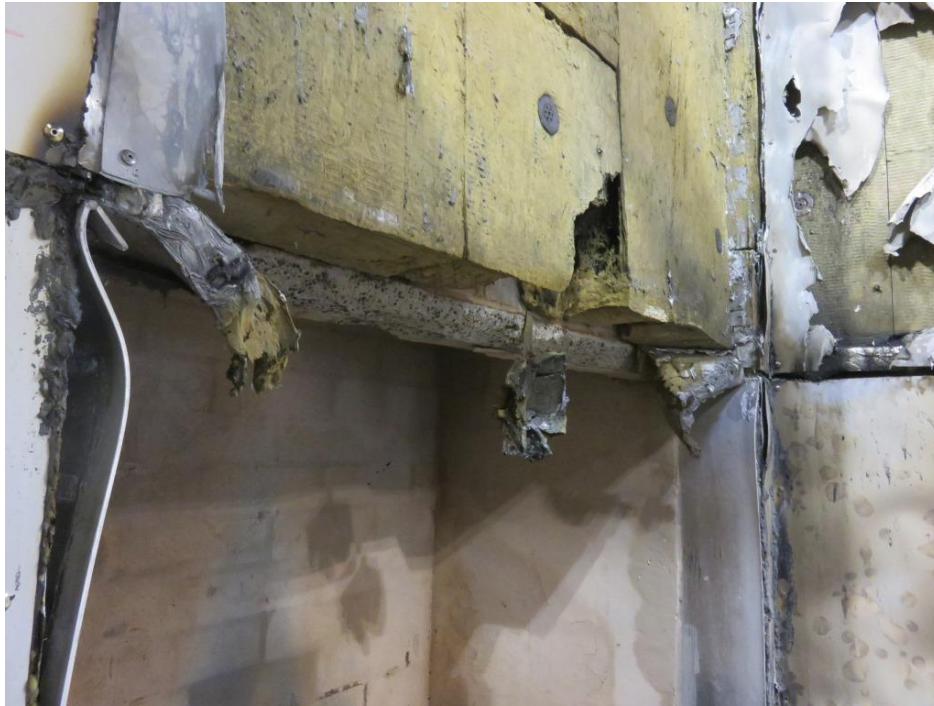
Figure 27. Close up of melted window pod and collapsed horizontal cavity barrier directly above the combustion chamber.

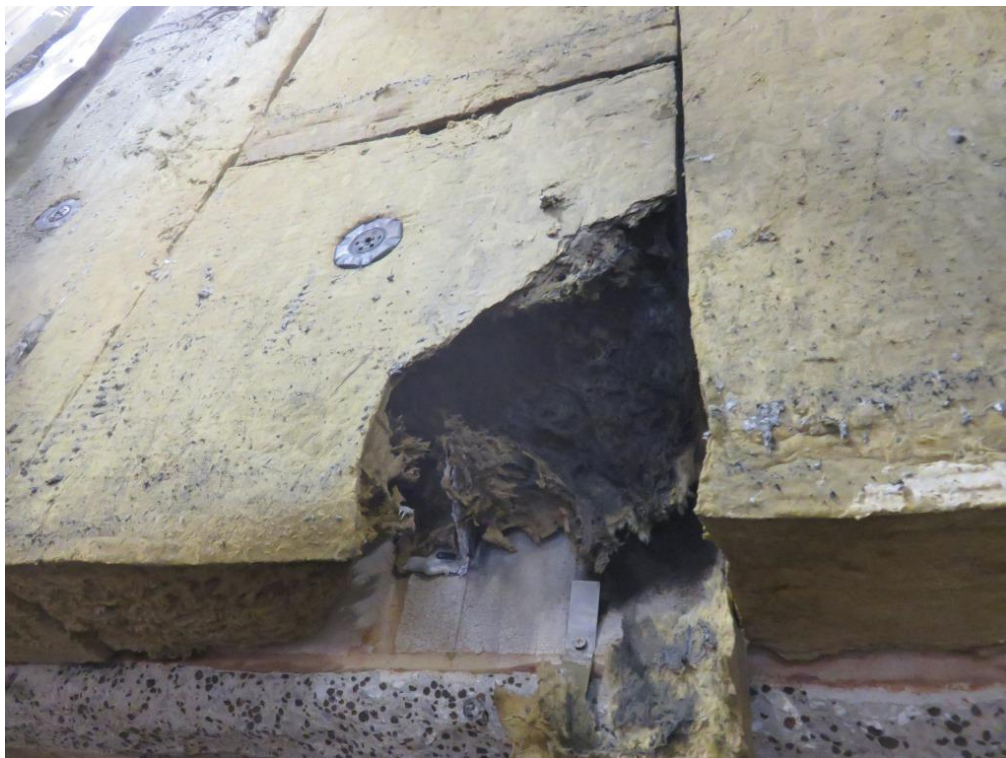
Figure 28. Close up of detached section of stone wool insulation directly above the combustion chamber.

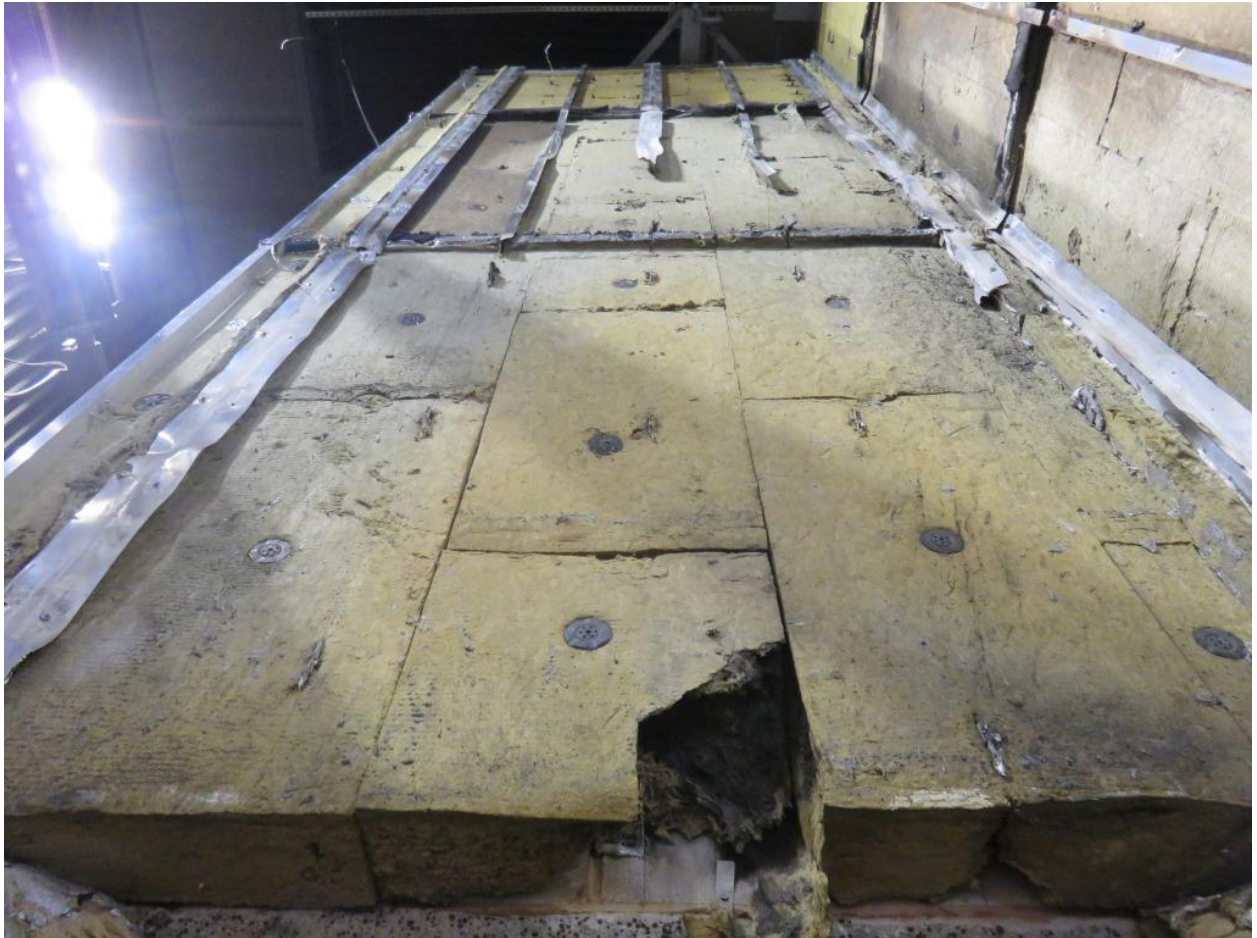
Damage to the rail substructure was most severe on the main wall with four of the five sections spaced evenly across the combustion chamber opening sustaining significant consumption – see *Figures 29-30*. At 500mm intervals from the edge of the combustion chamber adjacent to the wing wall the following damage occurred:

Figure 30. Damage to cladding system beneath ACM panels directly above the combustion chamber.

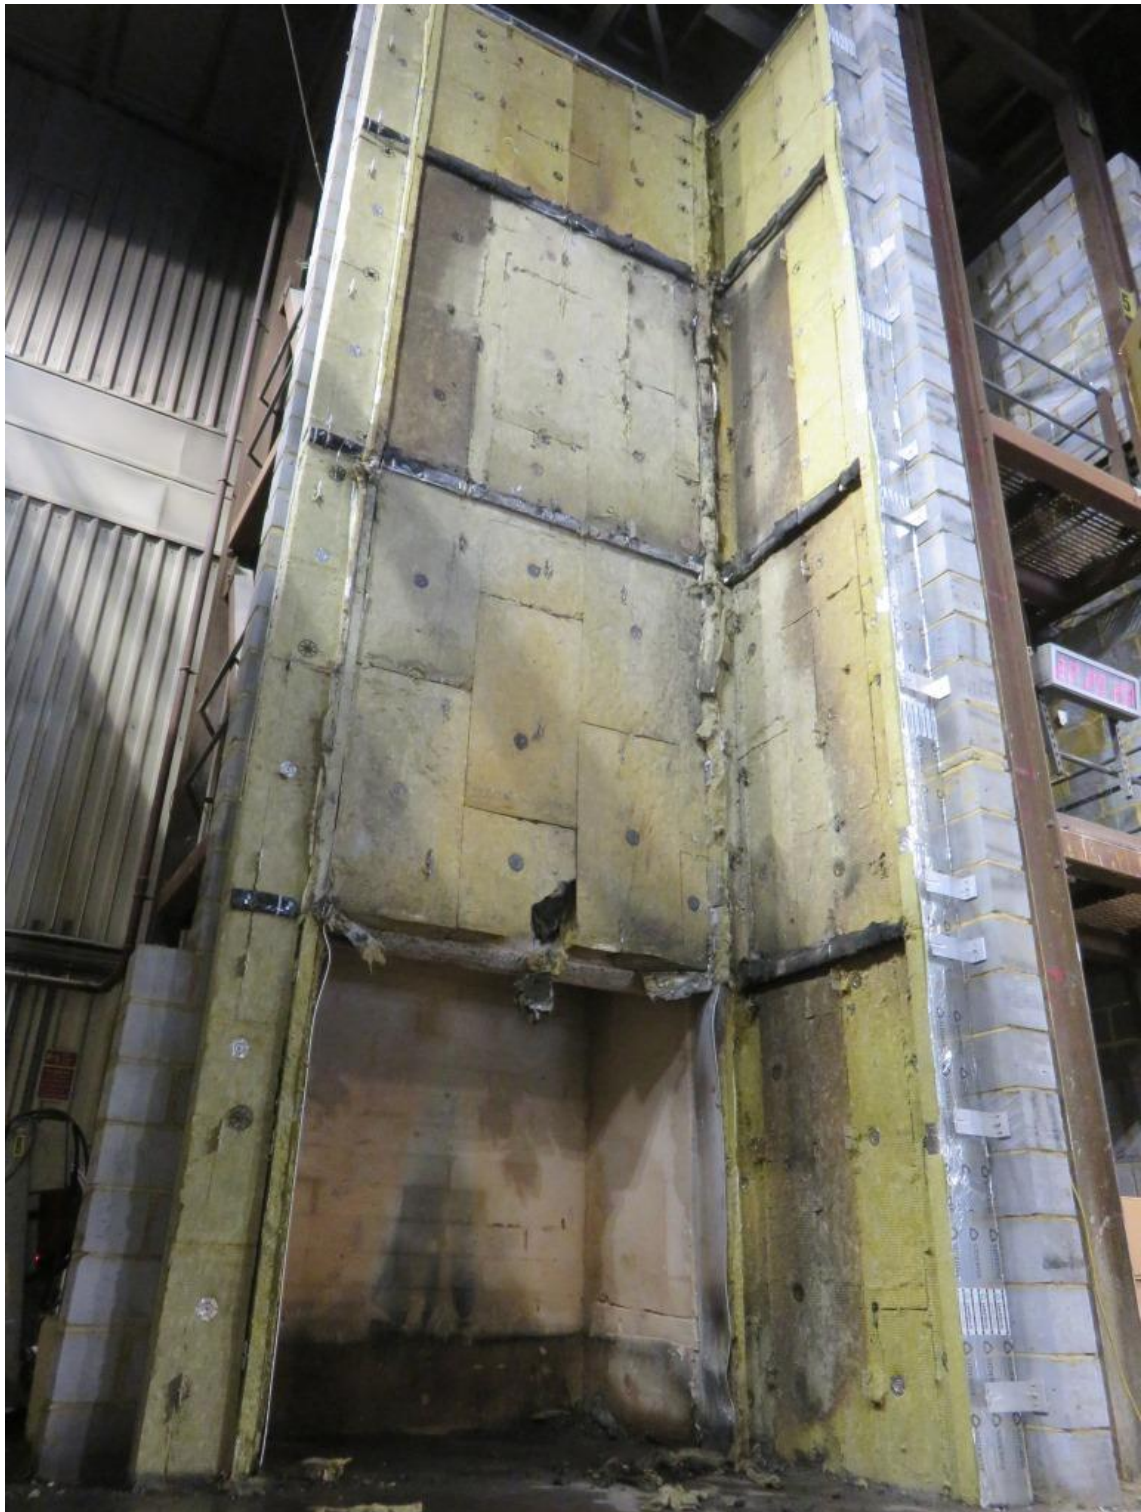
Full-width activation of the intumescent strip occurred on the wing wall with detachment of the expanded material observed between the main wall and the central 'L'-rail – see *Figures 31-33*.

Activation of the third row of horizontal intumescent cavity barriers occurred across the full width of the combustion chamber opening and the wing wall – see *Figures 31, 32, 34&35*. Detachment of the intumescent material was observed in line with the central 500mm of the combustion chamber opening and in a section 150mm-long approximately 100mm from the main wall. Partial activation occurred in the section of cavity barrier located at the outer edge of the main wall.

Figure 31. Full height photograph of cladding system following removal of ACM panels and rail substructure.

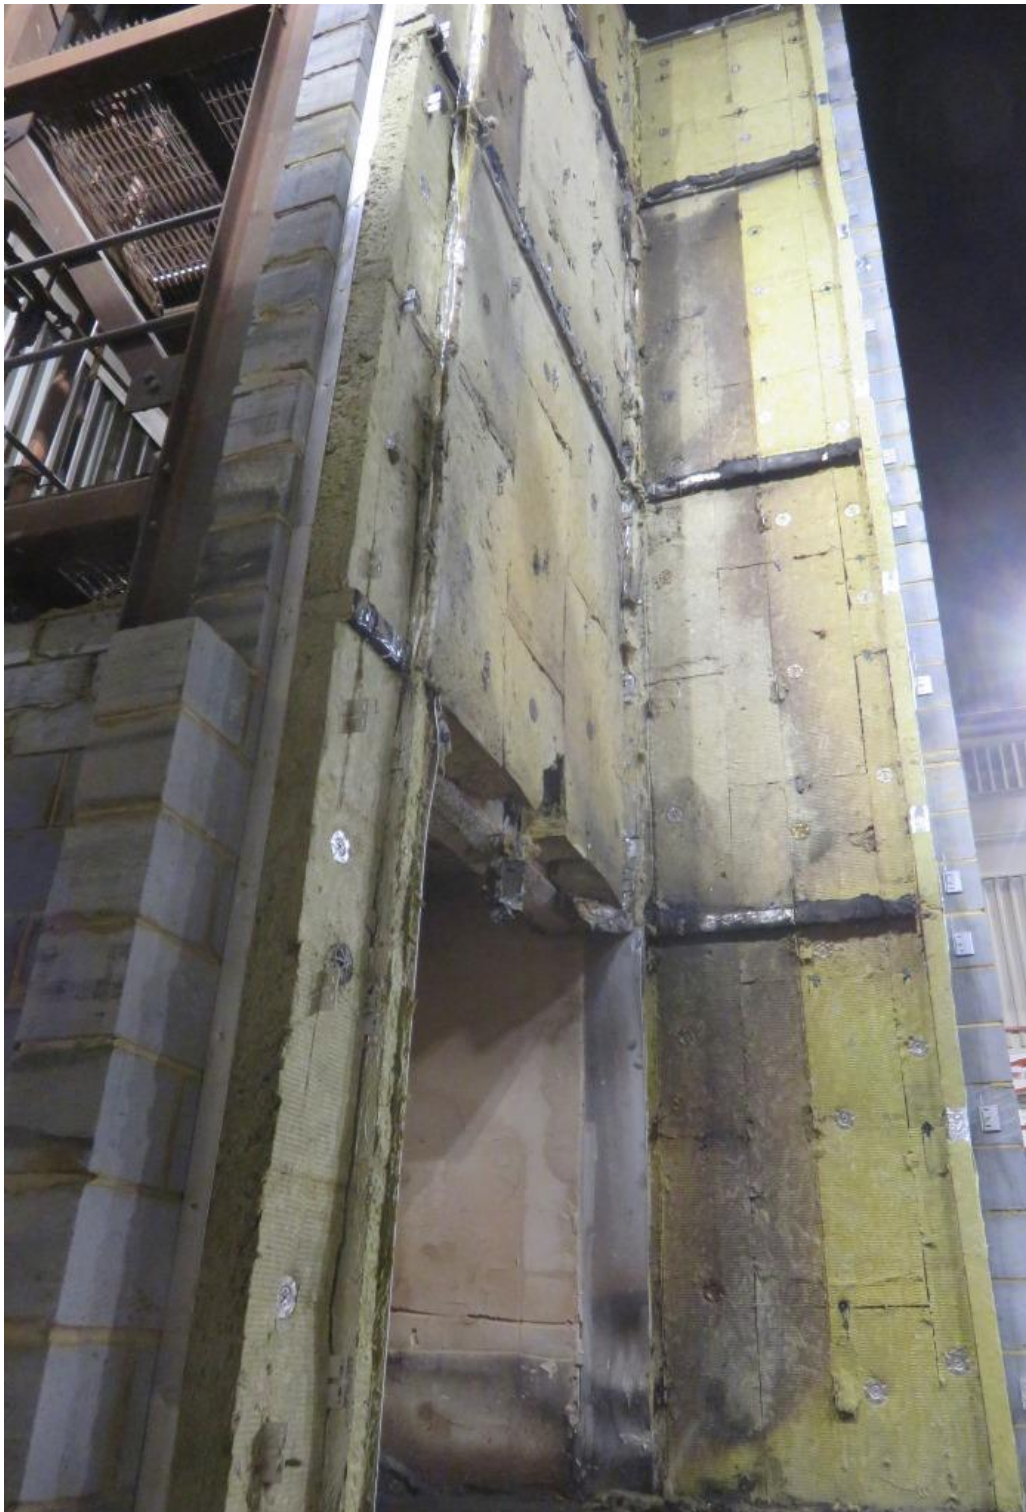
Between the second and third horizontal cavity barriers, the pale/bleached appearance of the stone wool insulation spanned the region, approximately 1500mm-wide, between the 'L'-rail (500mm from the outside edge of the combustion chamber opening) and the 'T'-rail (in line with the inside edge of the combustion chamber opening) – see *Figures 31&34*. Dark discolouration was observed on the remaining area in line with the combustion chamber opening and, on the wing wall, between the main wall and the central 'L'-rail – see *Figures 32&34*.

At ground level, dark discolouration was observed on the wing wall between the main wall junction and the central 'L'-rail – see *Figures 32*.

Figure 32. Full height photograph of wing wall following removal of ACM panels and rail substructure.

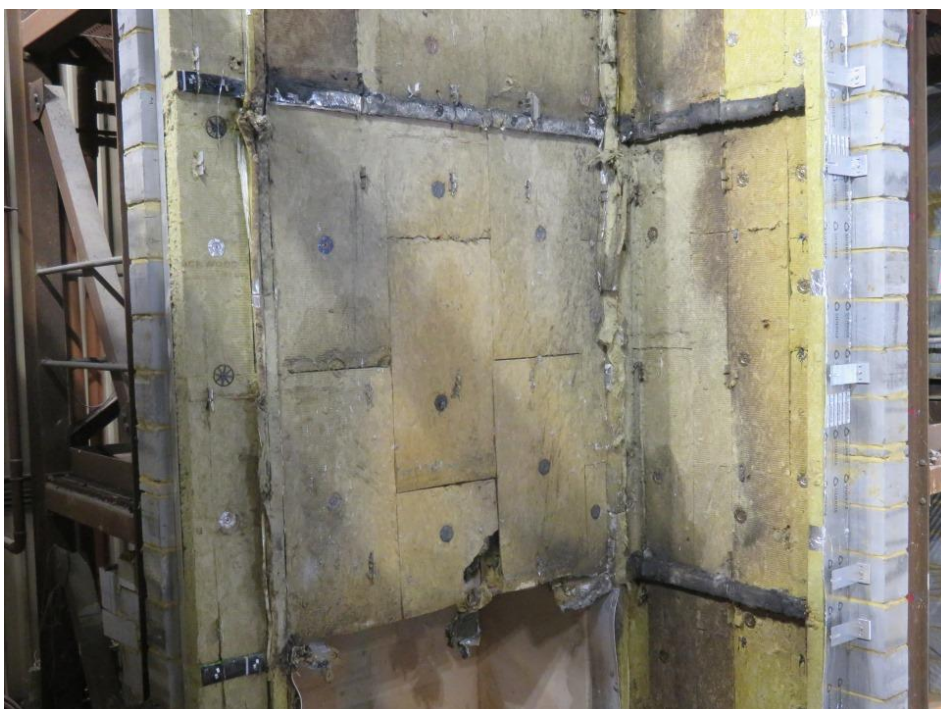
Figure 33. Cladding system beneath ACM panels and rail substructure between the first and second horizontal cavity barrier (approximately 0-2400mm above combustion chamber).

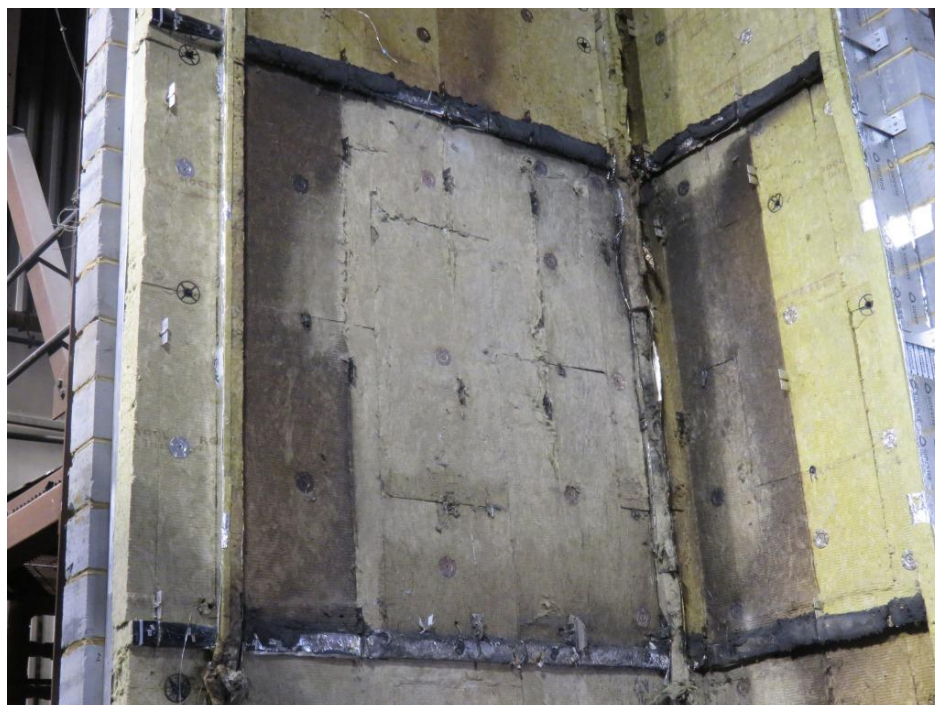
Figure 34. Cladding system beneath ACM panels between the second and third horizontal cavity barrier (approximately 2400-4700mm above combustion chamber).

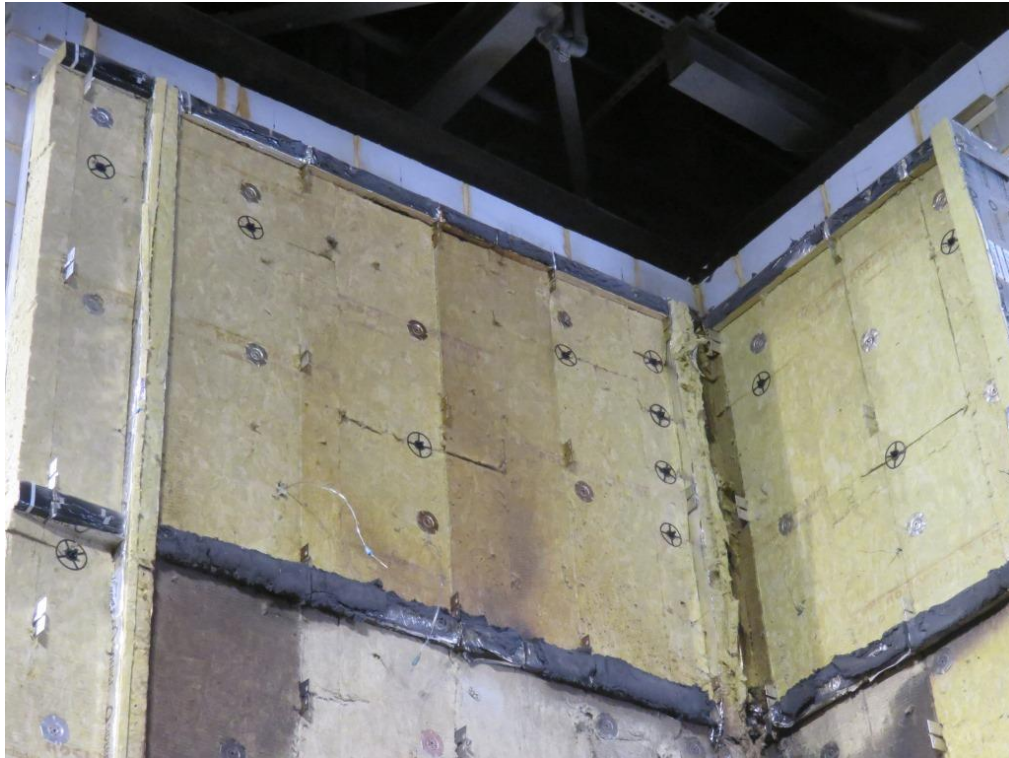
Figure 35. Cladding system beneath ACM panels between the third and fourth horizontal cavity barrier (approximately 4700-6400mm above the combustion chamber).
