Damp & Mould Issues

Surveyors Notes/Observations of occupation

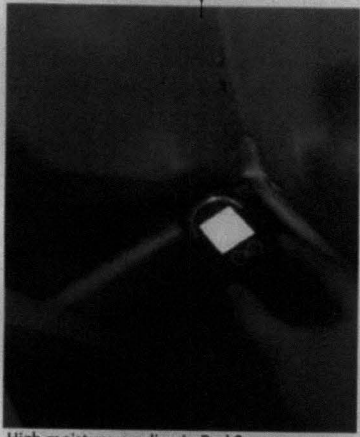
Moisture meter reading taken in corner of bed 3 where flashing & large weep hole are positioned externally confirms the existence of water penetration to the timber floorings, skirting & plasterwork.

High moisture reading in Bed 3

- Remove all moisture retaining cabinets, flooring, skirting & plasterwork within Kitchen/Diner, Hallway & Bed 3
- Install dehumidifiers, turn heating on to at least 22 degrees & ventilate property (open 1st floor windows).
- Monitor moisture meter readings within all areas affected by water penetration on a weekly basis, once normal readings are obtained re-install new cabinets, flooring & skirting etc.
- Secure flashing the side elevation & install weatherproof shield to large weep hole by flashing
- Mould growth is likely to build up in non-ventilated areas - all areas will require a thorougher cleandown with a Borate solution & repainting.
- Ensure roof void is adequately ventilated.
-
-
-
-
-

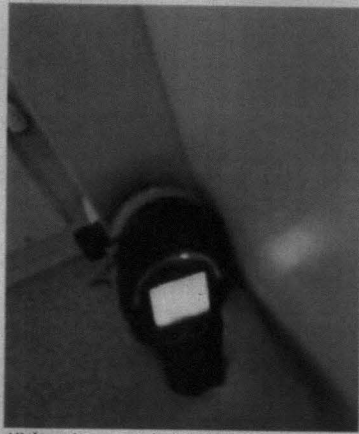
Random moisture meter readings taken throughout the Kitchen/diner confirms "high" or "at risk" levels of moisture within flooring, kitchen cabinets, skirting and low level plasterwork.

High moisture reading in Kitchen

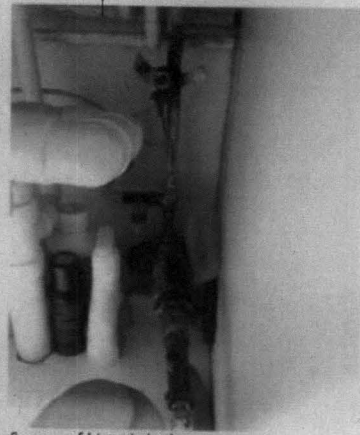
Occupant has lived at the property for just over 3 years during which they have had to complete a daily routine of cleaning down mould growth. Prior to move-in the property was subjected to a flood due to a damaged stop cock within the kitchen, the flood was not addressed until shortly before move-in. Affected areas (walls/skirting/doors/carpets/vinyl) were not replaced before occupancy, the new occupants were provided with dehumidifiers.

Source of historic leak

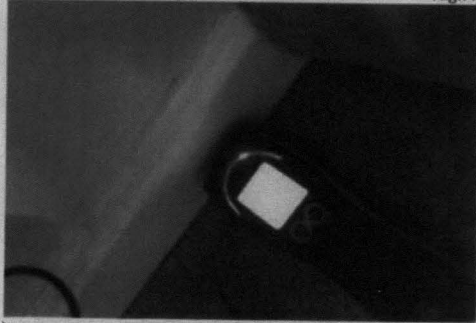
High moisture reading in kitchen

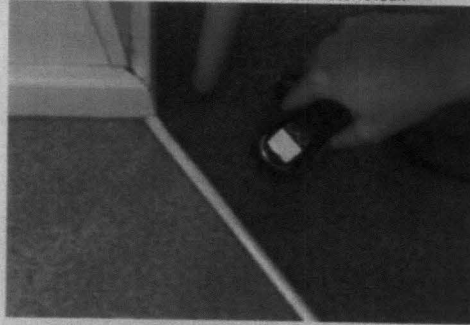
Wet carpet in kitchen

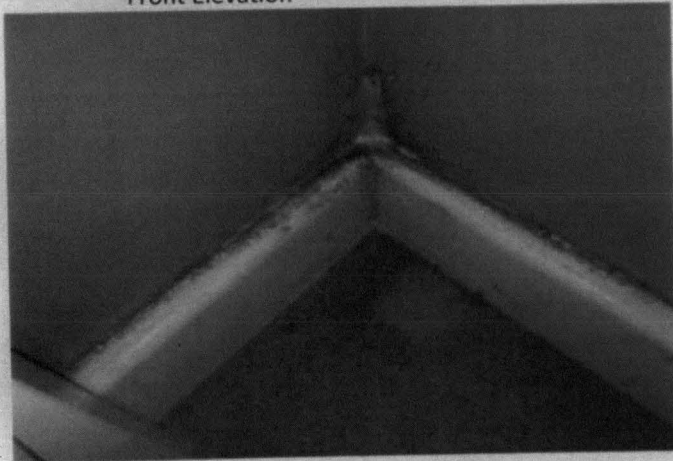
Rainwater is gaining access to bed 3 walls and flooring via the large weep hole & flashing.

Wet carpet & mould growth in Bed 3 adjacent
Flashing about garage

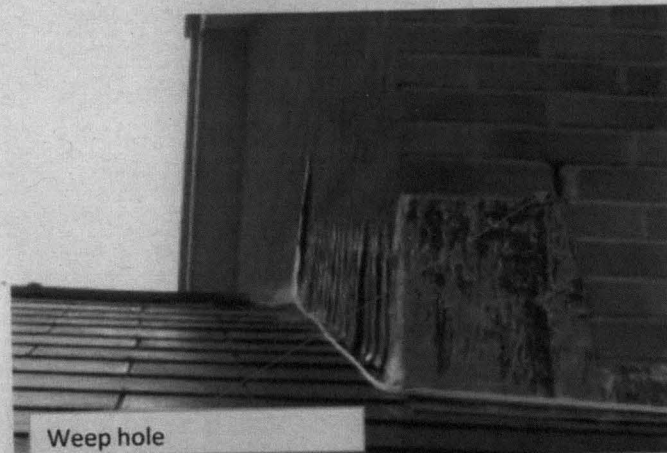
The flashing above the garage/ground floor wc is slightly displaced in places and the weep hole which the flashing is keyed into is very large. Ventilation grilles to roof soffits are discoloured and appear blocked.

Large weep hole & displaced flashing above garage

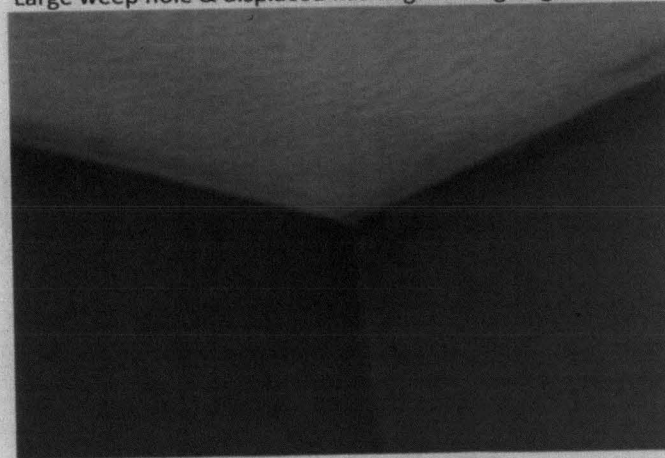
Mould growth in Bed 3 above wet carpet but no
indication of water penetration

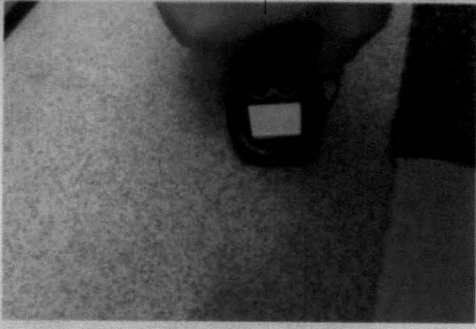
Wet vinyl flooring in kitchen

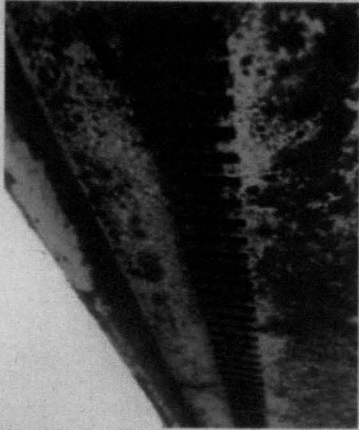
Blocked loft ventilation

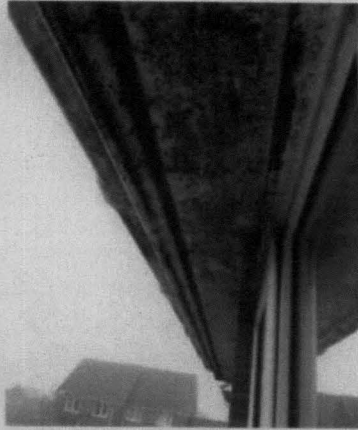
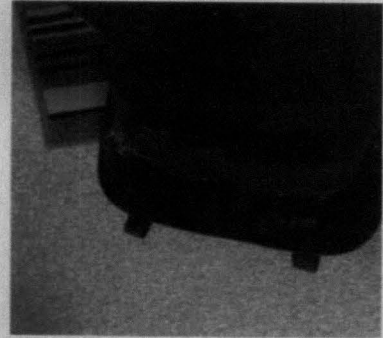
Sporadic mould growth noted elsewhere within the property especially in closed cupboards.

Typical mould growth on items stored within cupboards
