Rail Accident Investigation Branch

Rail Accident Report

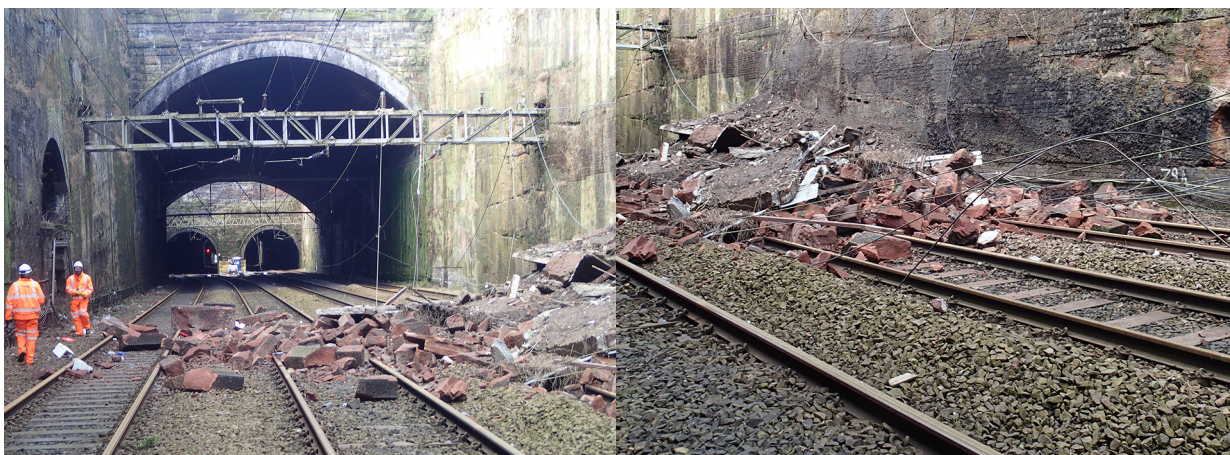
Figure 3: The debris on the track following the wall collapse

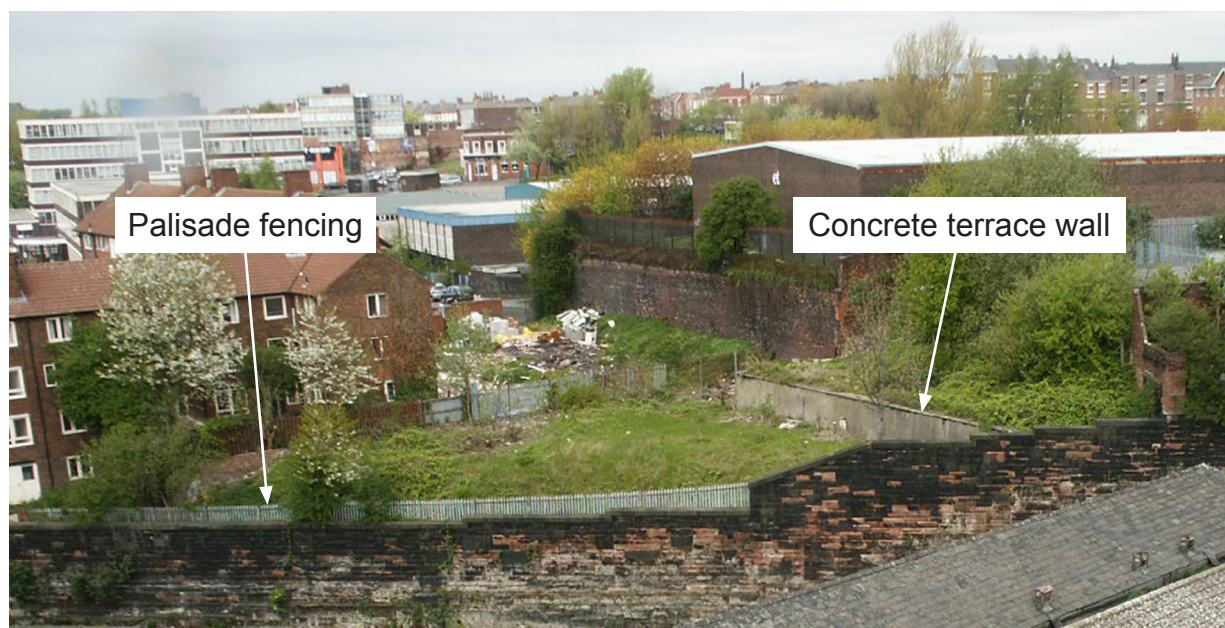
Figure 5: The land adjacent to the wall prior to development in 2004 (photograph courtesy of Williamson Tunnels Heritage Centre)

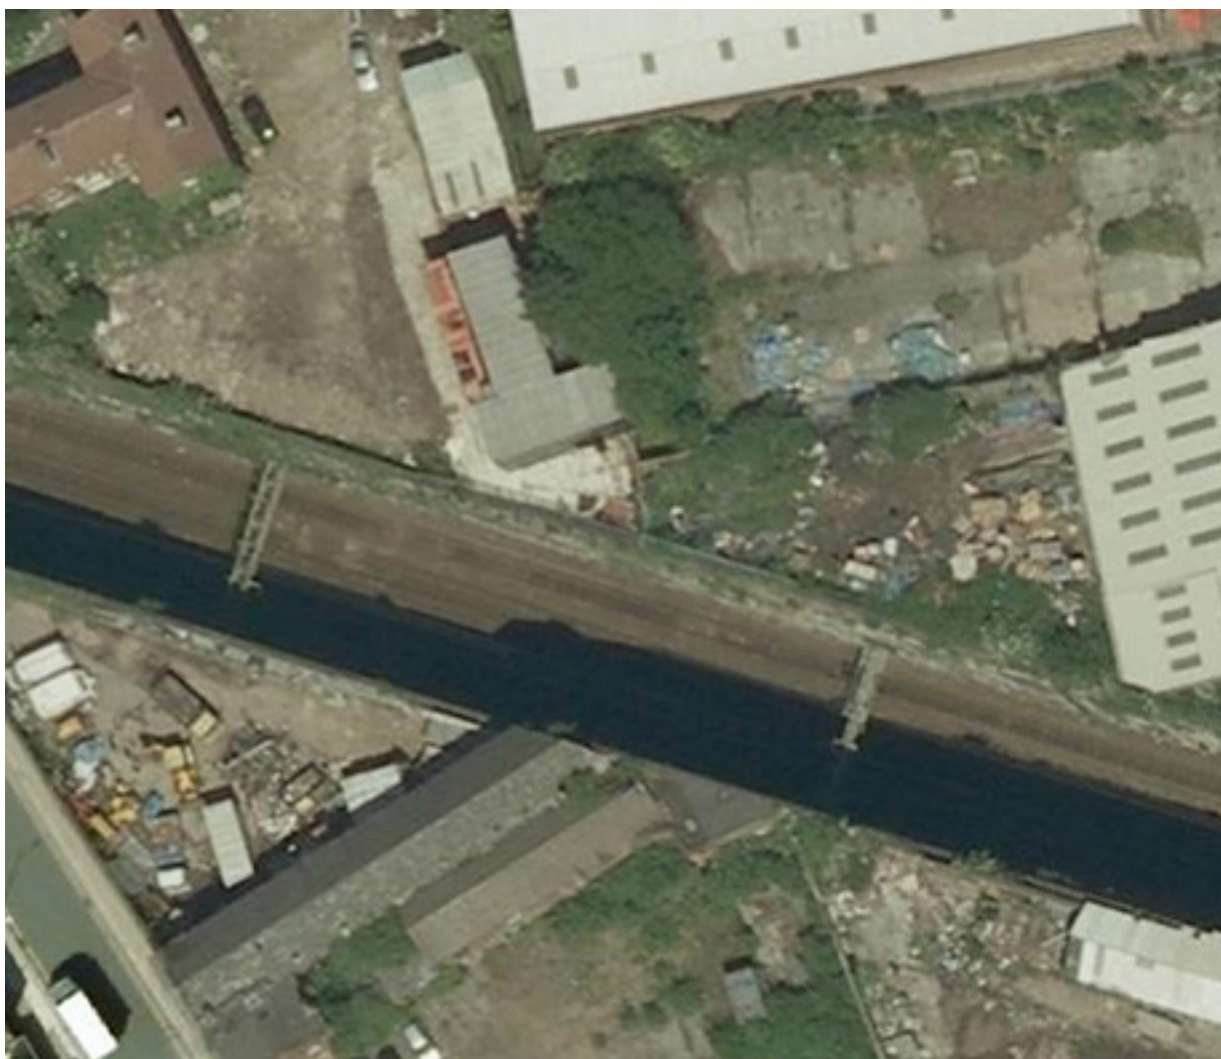
Figure 11: Aerial image of the site taken on 24 June 2009 showing the concrete slab meeting the railway wall (courtesy of Getmapping PLC)

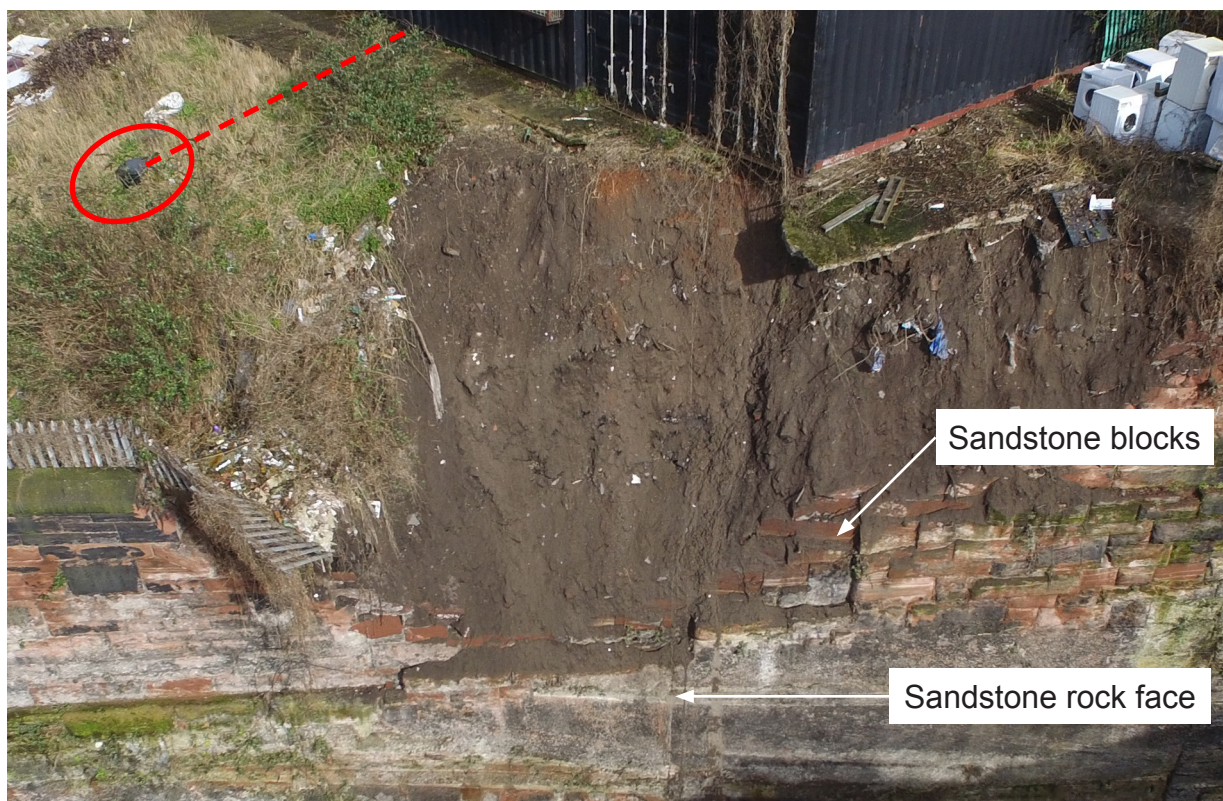
Figure 12: The upper part of the cutting wall following the collapse (red circle indicates a drain chamber - see paragraph 39)

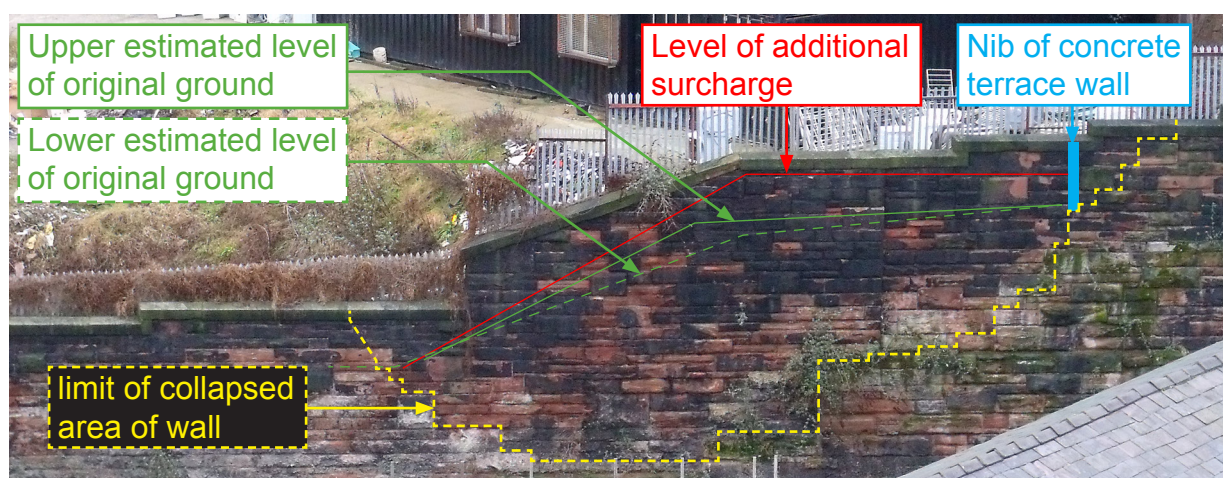
Figure 13: Photograph of the wall taken around 2011 overlaid with estimated change to the wall surcharge and the area of wall that collapsed (photograph courtesy of Williamson Tunnels Heritage Centre)

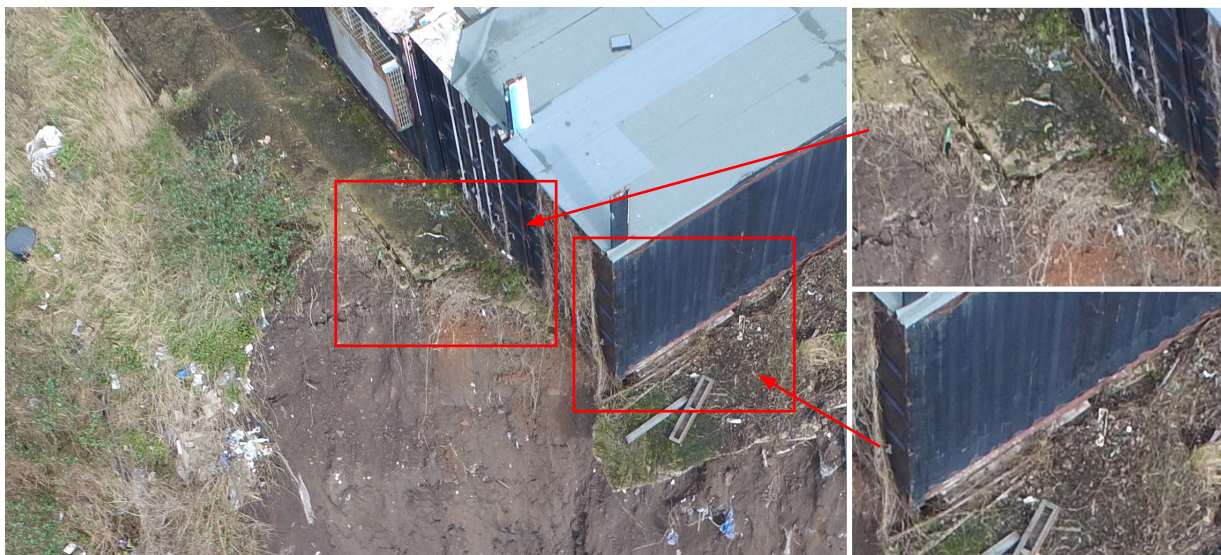
Figure 14: The soil embankment following the collapse showing pre-existing cracks in the concrete slab

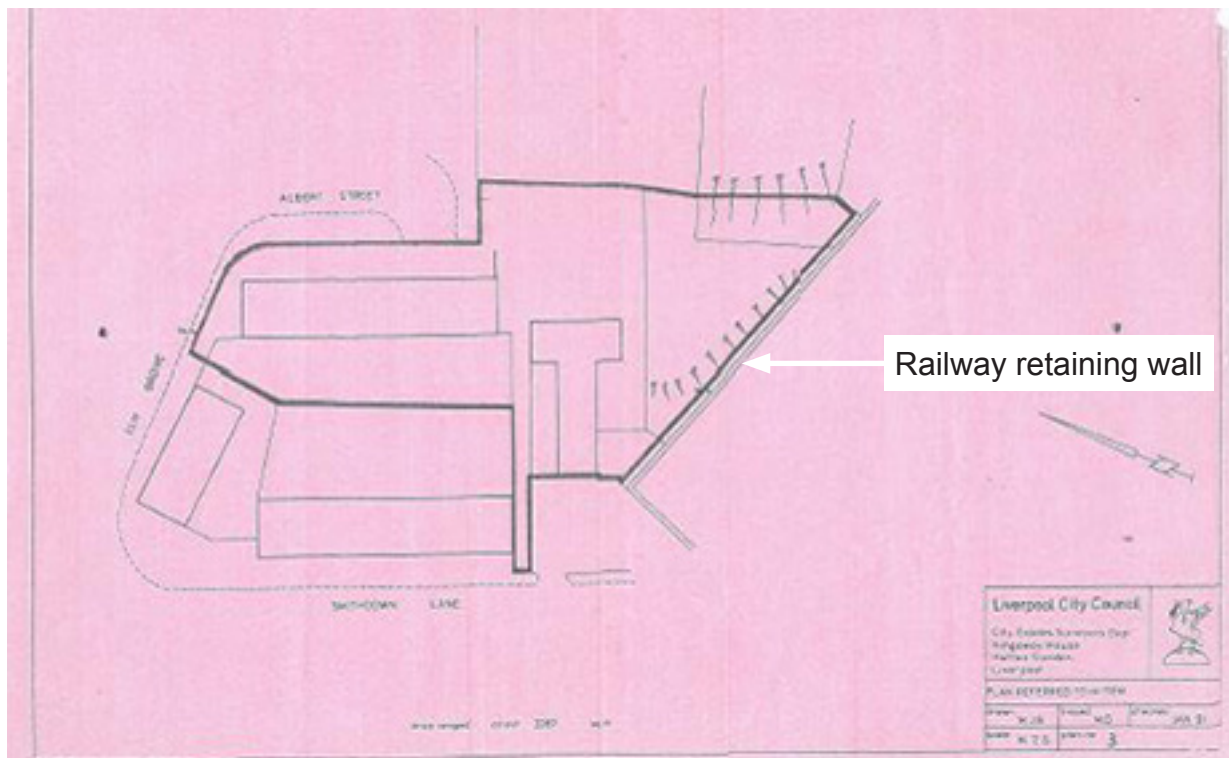
Figure 15: The land plan associated with the lease showing a space between the property boundary and the railway wall
