# BRE Global Client Report

**BS 8414-1:2015 + A1:2017 test referred to as DCLG test 2.**

**Report Number:** B137611-1037 (DCLG test 2) **Issue: 1.2**

Prepared for:  
Department for Communities and Local  
Government  
2 Marsham Street  
London  
SW1P 4DF

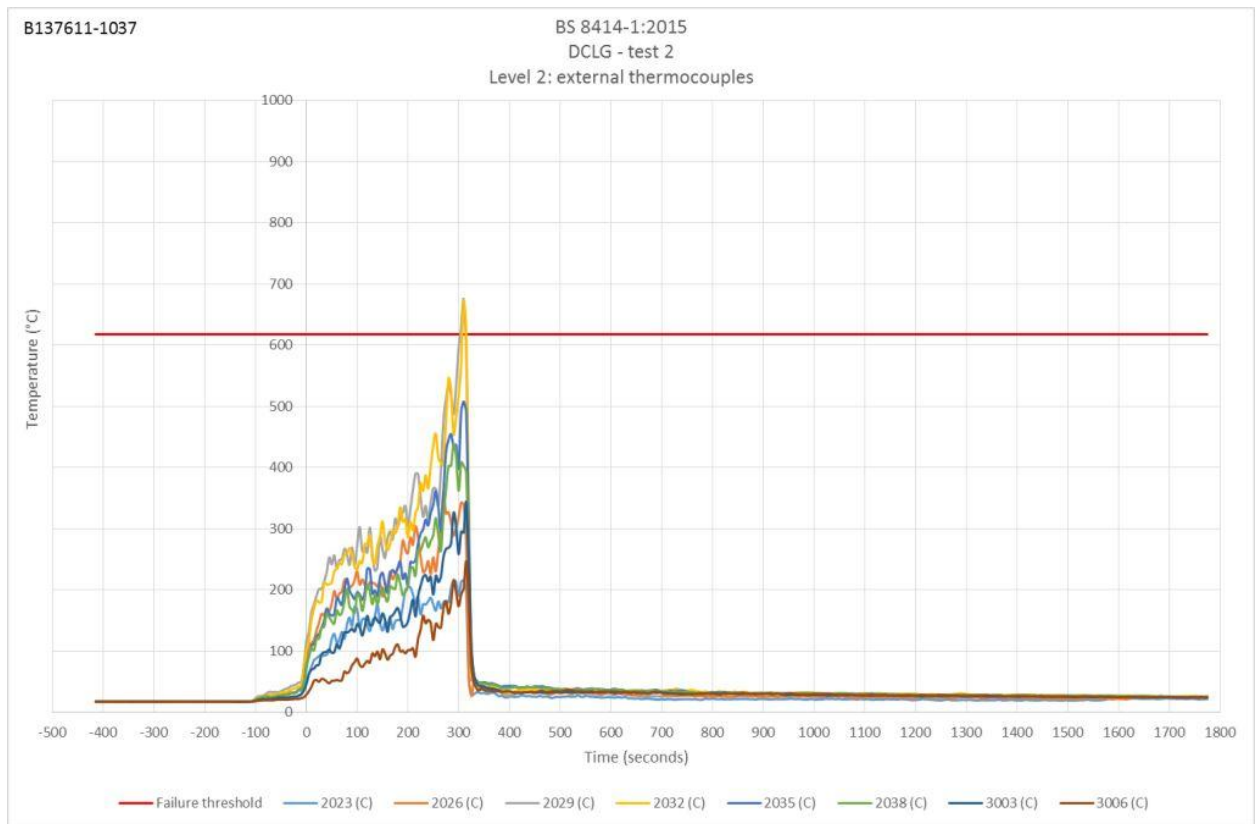
Figure 18. Level 2 external thermocouples.

In addition, *Figure 18* shows that the level 2 external thermocouples having exceeded a 600°C temperature rise above  $T_s$  after 305s, would have sustained this temperature rise, for a minimum of 30s, within 15mins from test start time ( $t_s$ ) had the test not been terminated early due to flame spread off the top of the cladding system.

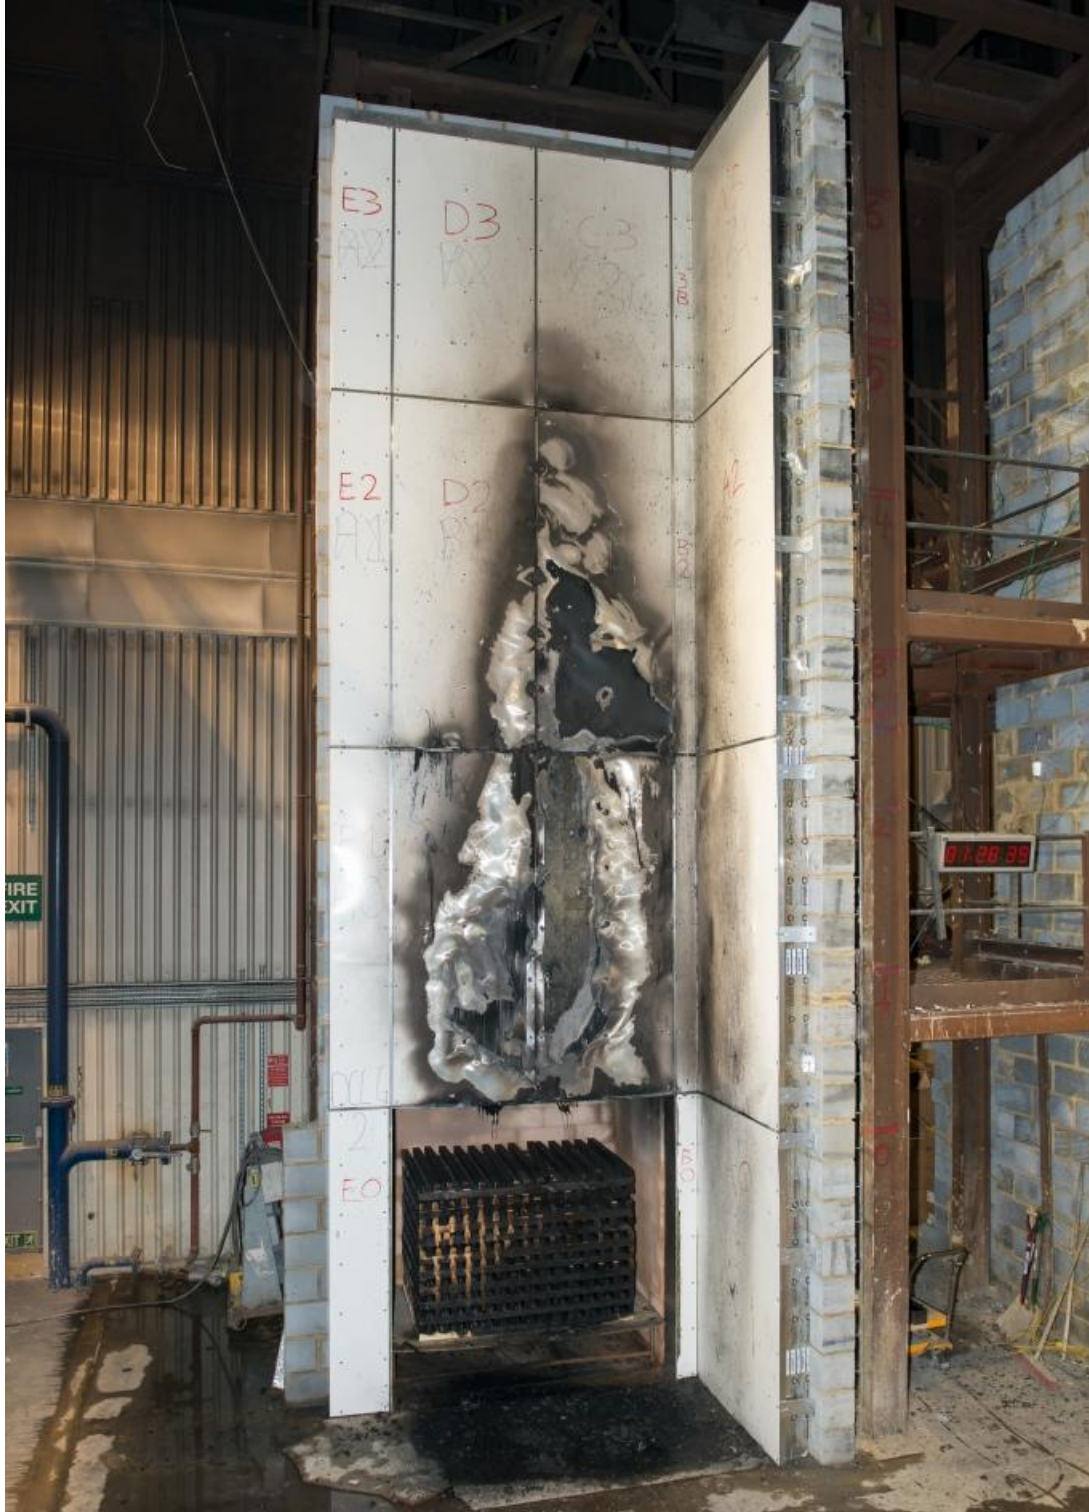
Figure 21. Full height photograph of system soon after test termination.

*Figures 21-23* show that the main damage areas spanned the majority of the combustion chamber opening (2000mm-width) tapering to a point approximately 5000mm above, leaning slightly (approximately 300mm at the top) in the direction of the wing wall. The extent of the damage increased from black discolouration at the edges of the damage zone to complete consumption of sections of the ACM panels, a small amount of distortion to the rail substructure and some discolouration of the insulation at the centre of the main wall – see *Figures 21-31*. On the wing wall, slight distortion to ACM panels 1A&2A, either side of the panel joint and immediately adjacent to the main wall, was the only visible external damage on this face of the cladding - see *Figures 21-23*.

The surface finish of the panel was burnt away revealing a shiny metallic surface in a typically 300mm-wide strip adjacent to the consumed areas of the ACM panel which increased to approximately 1000mm at the tip of the flame impingement zone. Adjacent to the ‘metallic’ strip, a strip of dark discolouration, approximately 100mm-wide, which increased to approximately 1000mm at the tip of the flame impingement zone, extended to a height of 5000mm above the combustion chamber – see *Figure 21*.

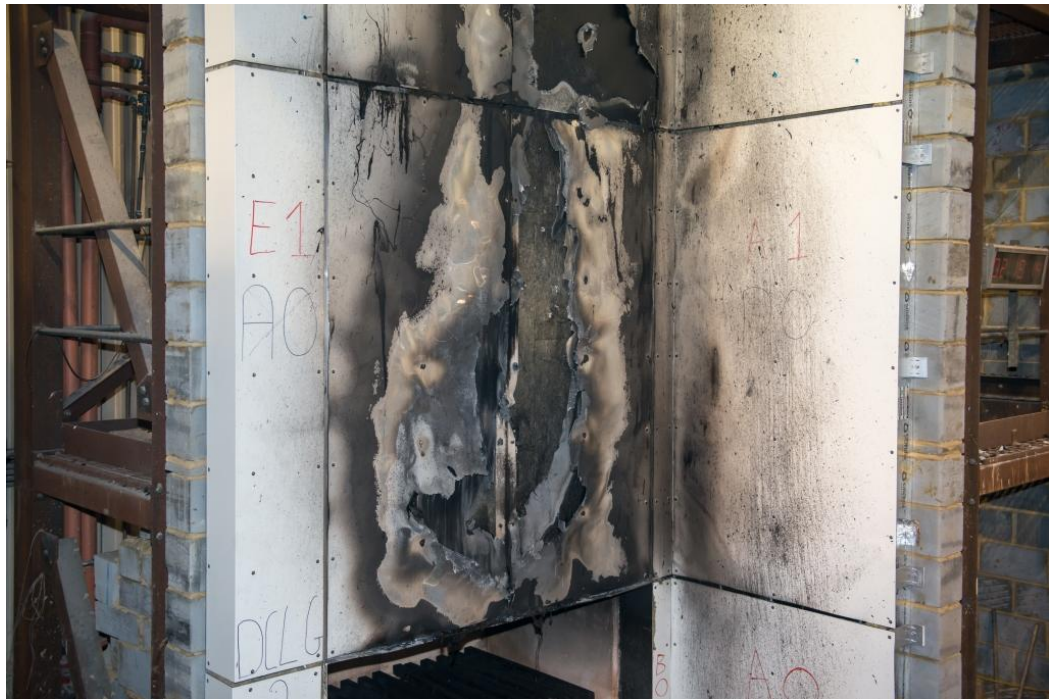
Figure 22. First row ACM panels (directly above combustion chamber).

On the main wall, approximately 20% of ACM panel 1C was consumed - see *Figures 1, 21&22*. This damage was sustained in a strip approximately 250mm-wide×1800mm-high positioned directly adjacent to the centre line of the combustion chamber, and extended from 500mm above the opening to the height of the second cavity barrier – see *Figures 21&22*. Partial consumption (inner aluminium layer of panel remained intact) affected a 200mm-high x 450mm-wide strip at the base of the fully consumed section of panel 1C.

Partial consumption (inner aluminium layer of panel remained intact) of panel 1D affected approximately 15% of the surface area. The PE core was completely lost from this area and, where visible, between the distorted aluminium layers directly adjacent –see *Figure 24*. A small section (<0.05m<sup>2</sup>) of panel 1D had been fully consumed approximately 450mm above the combustion chamber opening – see *Figure 22*.

Slight distortion of the ACM panels was sustained on the wing wall, directly adjacent to the main wall, in the region approximately 2000mm-2500mm above the height of the combustion chamber opening – see *Figures 22&23*.

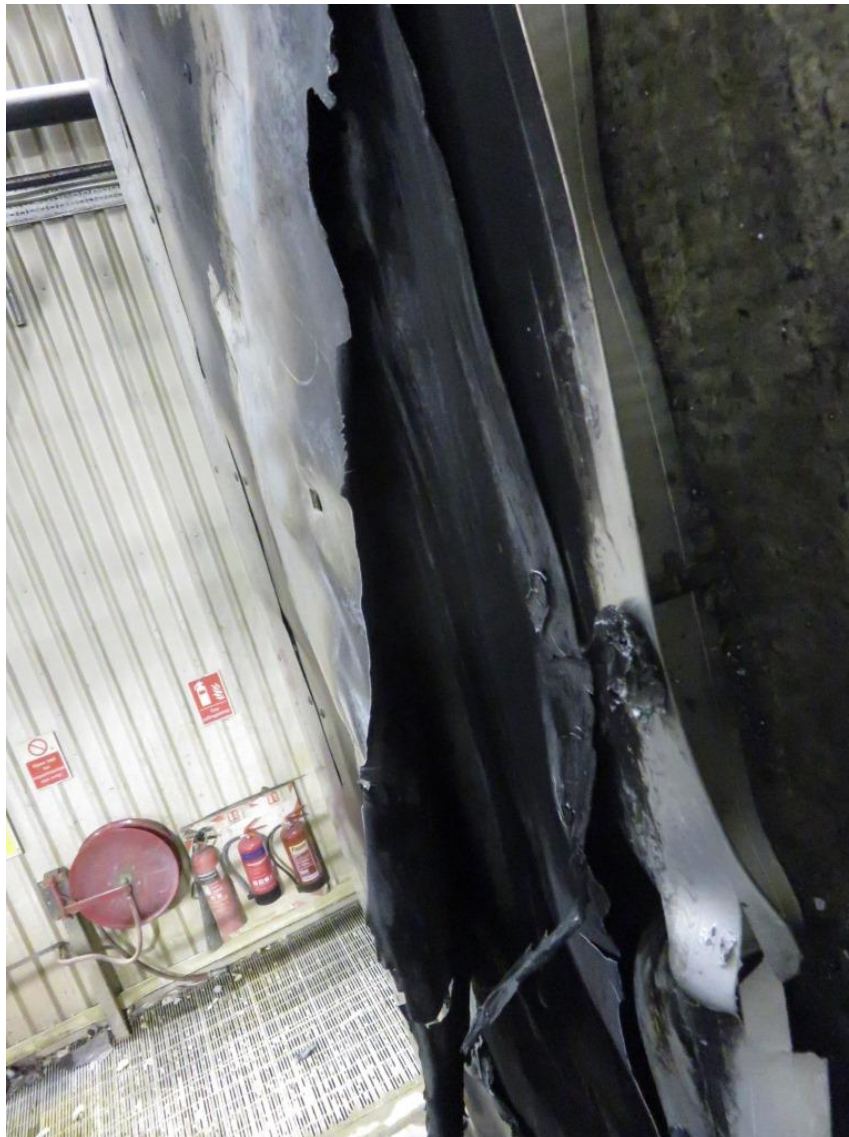
Figure 24. View between distorted aluminium layers of panel 1D (approximately 1000mm above the top of the combustion chamber) showing absence PE core material.

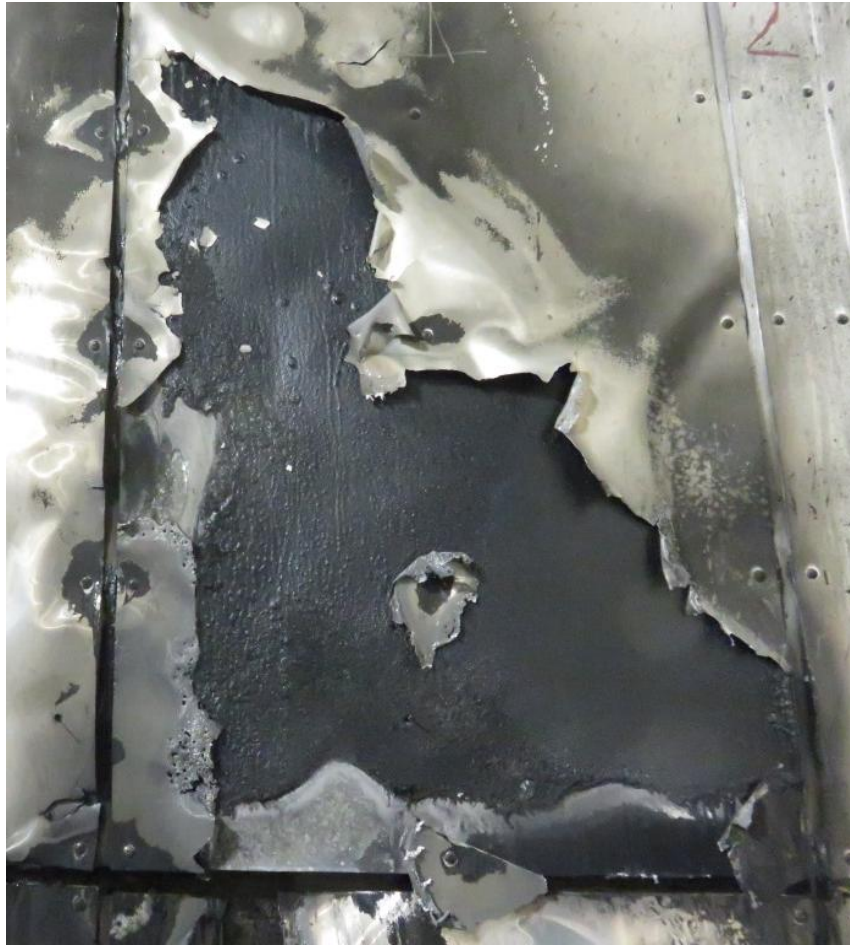
Partial consumption (inner aluminium layer of panel and some filler material remained intact) at the base of panel 2C affected approximately 30% of the surface area – see *Figure 23*. The PE core had been completely lost in a 100mm strip along the lower and central edges of this area but the majority, approximately 25% of the total panel surface area, remained intact and visible – see *Figure 25*.

Figure 25. Close up of panel 2C (approximately 4600mm above the top of the combustion chamber) showing melted aluminium outer face with intact PE core material.

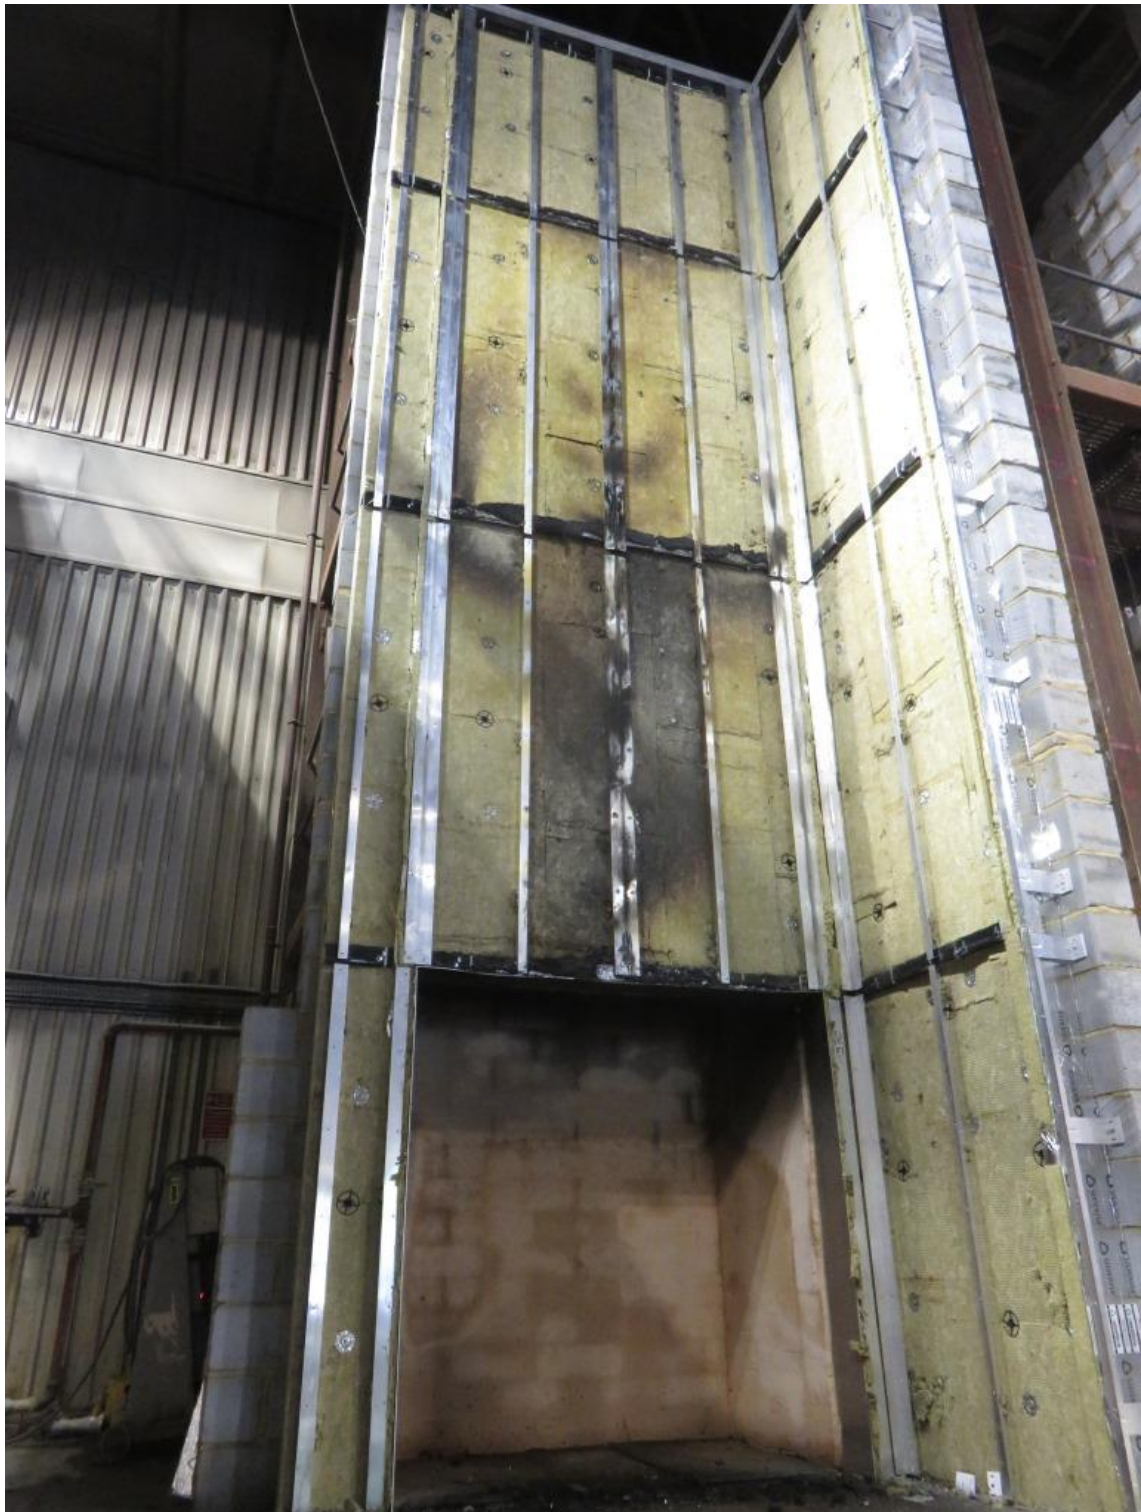
Figure 26. Full height photograph of cladding system following removal of ACM panels.

A 100mm-tall section of the central ‘T’ rail was distorted and partially melted at a height of 1000mm above the top of the combustion chamber – see *Figures 26&27*. This was the only structural damage observed to the rail substructure.

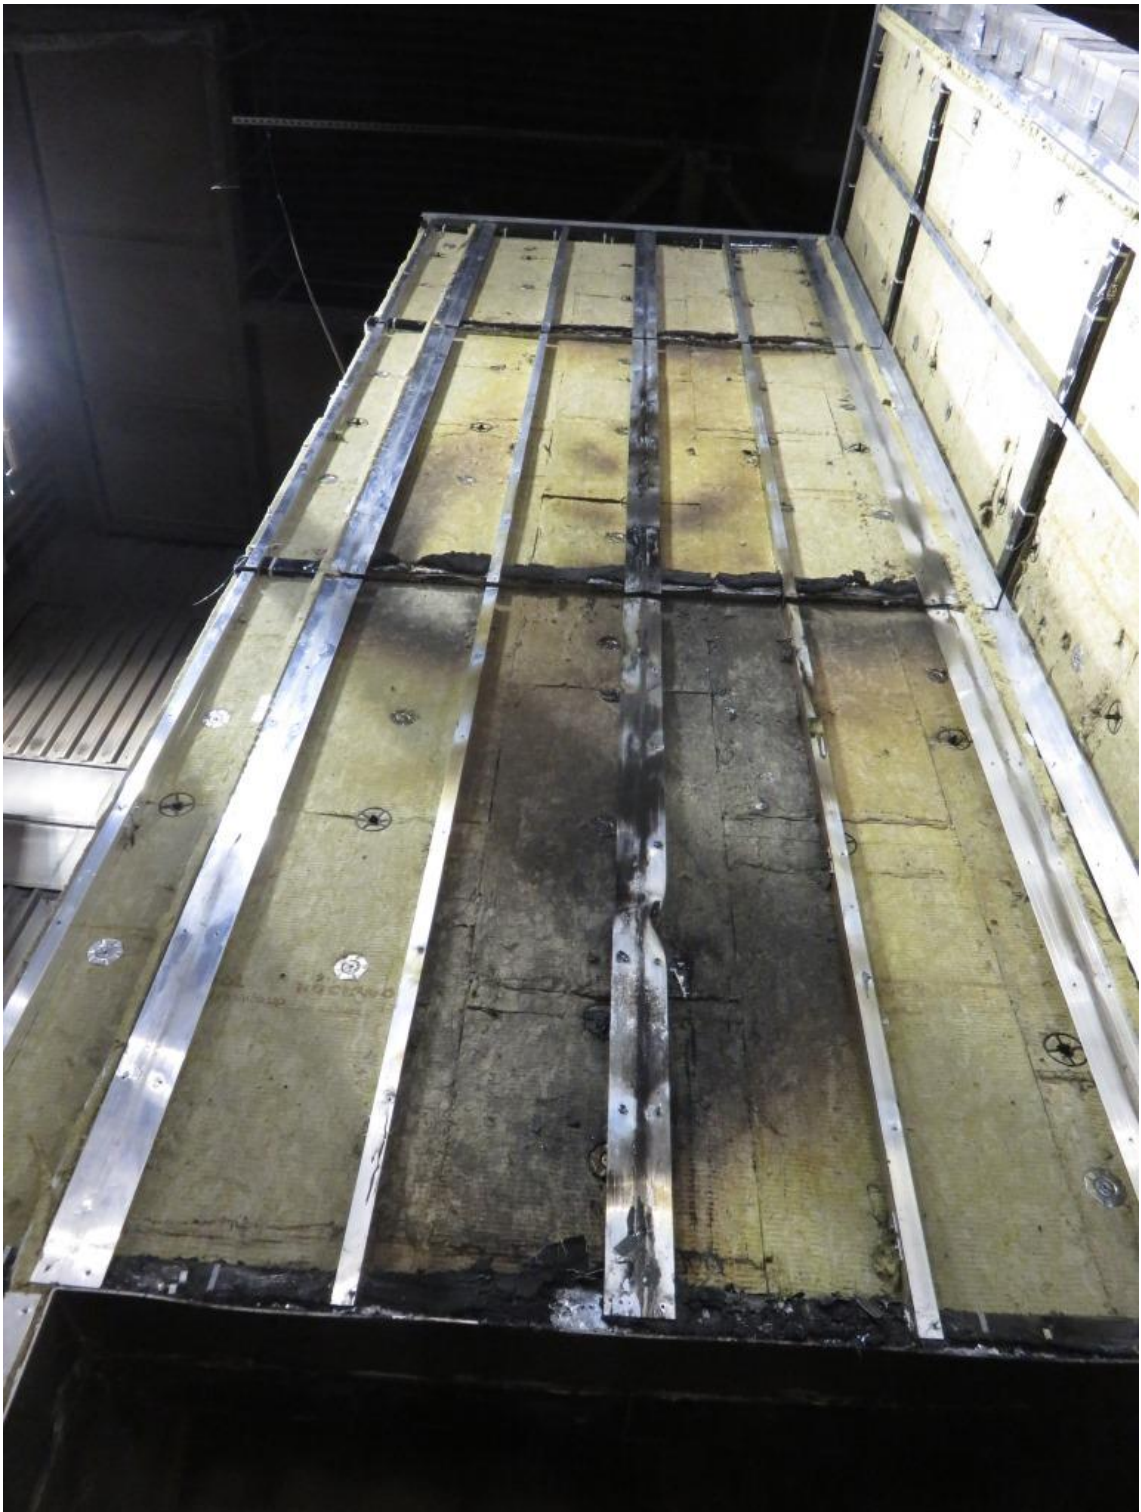
Figure 27. Damage to cladding system beneath ACM panels directly above the combustion chamber.

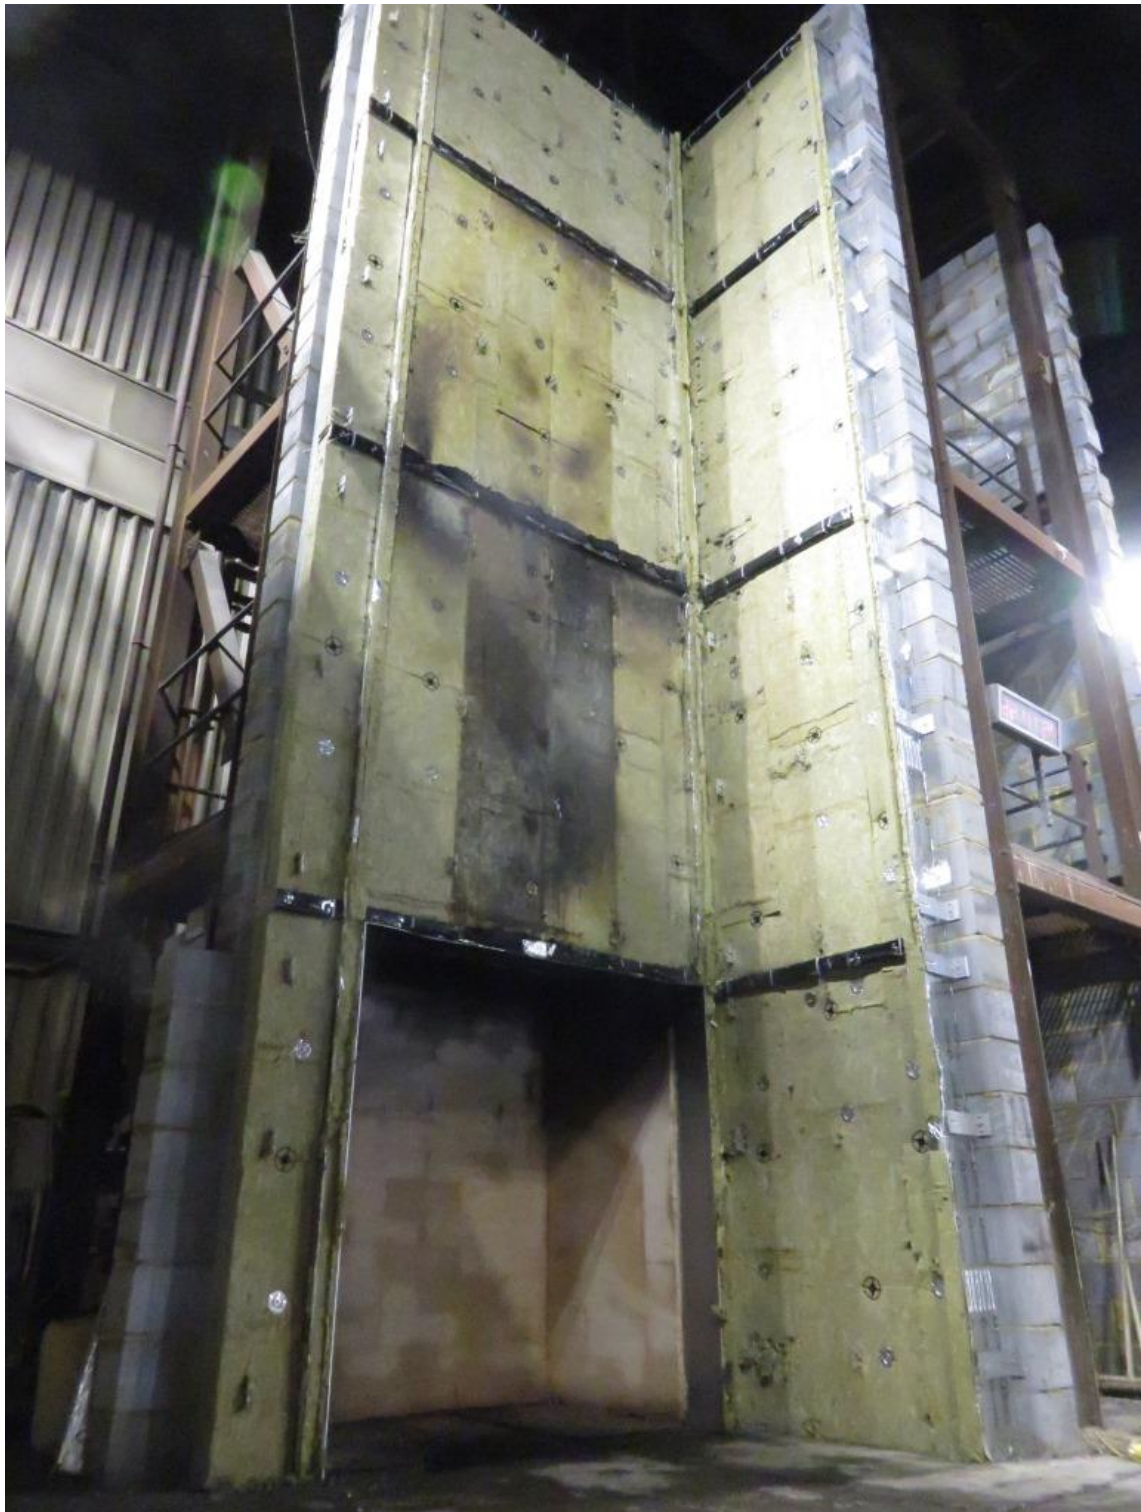
Figure 28. Full height photograph of cladding system following removal of ACM panels and rail substructure.

No damage was observed outside the bounds of the main wall vertical cavity barriers (including the full-height of the wing wall) or beyond the third row horizontal cavity barrier – see *Figure 28*.

The fire damage to the ACM panels and stone wool insulation was confined within the bounds of the vertical cavity barriers either side of the combustion chamber opening – see *Figure 28*. Minimal damage to the vertical cavity barriers was observed.

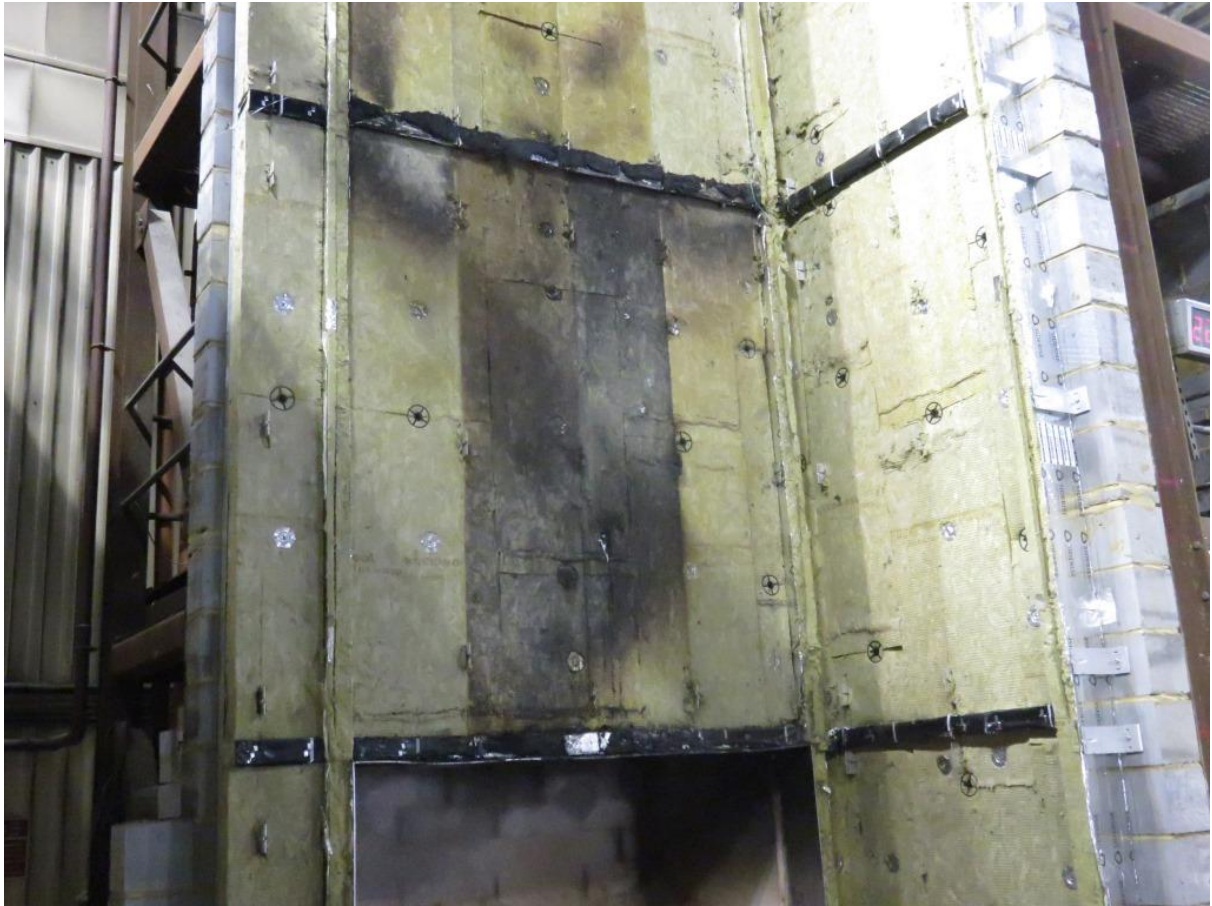
Discolouration of the stone wool insulation was observed in the central 1000mm-width above the combustion chamber which was contained by consecutive sections of ‘L’ rail, up to the height of the second row horizontal cavity barrier – see *Figure 29*. Lighter discolouration of the stone wool boards from

approximately 400mm below and up to the height of the second row horizontal cavity barrier between the 'L' rails and external 'T' rails on the main wall face was noted.

Figure 29. Cladding system beneath ACM panels and rail substructure between the first and second horizontal cavity barrier (approximately 0-2400mm above combustion chamber).

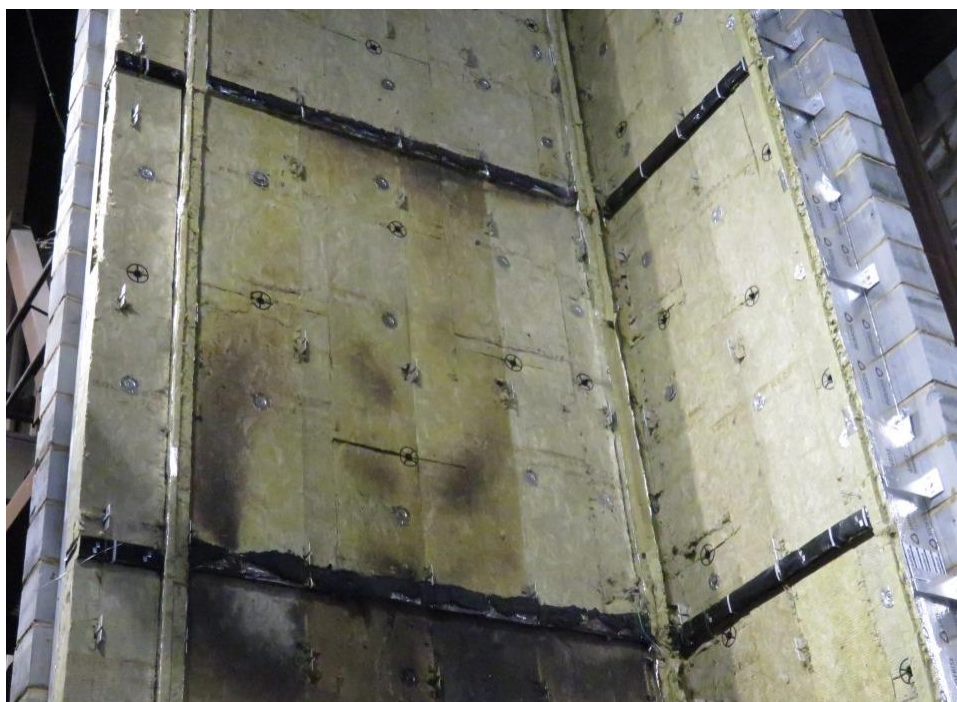
Discolouration of the stone wool insulation affected approximately 40% of the area contained between the second and third row horizontal cavity barriers and the vertical cavity barriers - see *Figure 30*. The areas of damage were concentrated:

Figure 30. Cladding system beneath ACM panels between the second and third horizontal cavity barrier (approximately 2400-4700mm above combustion chamber).
