# Rail Accident Report

## **Track worker near miss incidents at Camden Junction South, London 28 February 2017**

Report 16/2017  
November 2017

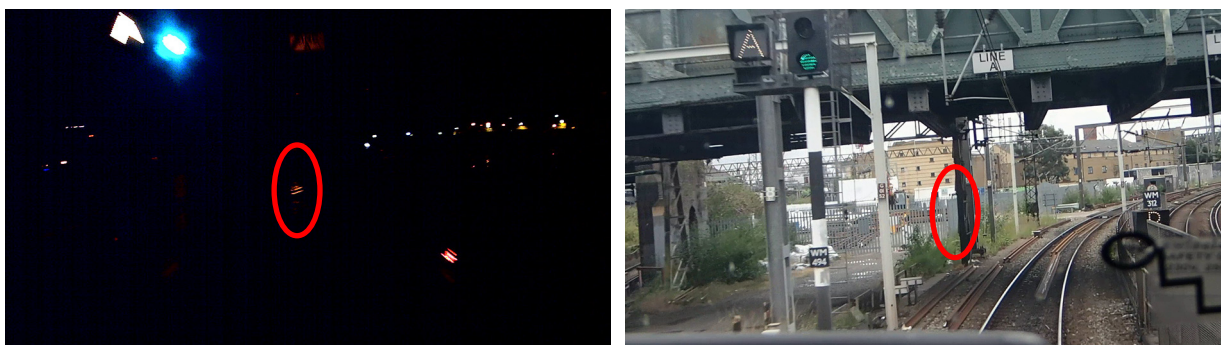
- 30 Just before 01:03 hrs, the train passed signal WM494 and, immediately afterwards, approached PS1, who had been in the process of placing a *possession limit board* on the track. PS1 heard and then saw the train approaching, and so took the possession limit board and walked off the track to a position of safety to the left of the track (in the direction of travel). The train driver saw PS1 walking off the track, sounded the train's horn and then started braking. PS1 reached the position of safety just before the train passed (figure 4). The train stopped about 25 seconds later, having travelled about 264 metres past the signal (ie all except the last carriage of the train had passed the point where PS1 had been standing). The train driver and PS1 did not have any further interaction.

Figure 4: Image of the first near miss from the train's forward-facing CCTV (left, courtesy Virgin Trains) and comparable daytime view (right) highlighting the approximate position of PS1

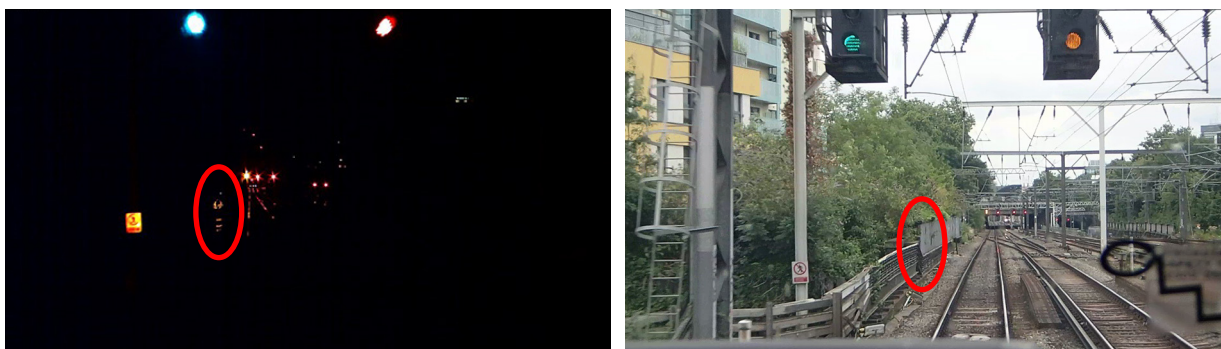
- 33 Meanwhile, at 01:07 hrs, the train passed signal WM492 and then stopped, a few metres before reaching PS2 (figure 5). The train had been moving for half a minute and had reached a speed of about 24 mph (39 km/h) when the driver saw someone on the line ahead, sounded the horn twice very briefly, and began braking. PS2 had been walking towards London (ie with his back to the train) from the access point, in the direction of his blocking point at signal WM490. PS2 had intended to place his protection between signals WM492 and WM490, but when he heard the train approaching and realised it was on Line A, he stepped off the track, about 40 metres past signal WM492. However, due to limited clearance at this point (PS2 was on a bridge), he was not in a position of safety. The driver spoke to PS2 through the cab window, and allowed PS2 to move past the train into a position of safety before moving off again. The driver did not report this second near miss to the signaller.

Figure 5: Image of the second near miss from the train's forward-facing CCTV (left, courtesy Virgin Trains) and comparable daytime view (right) highlighting the approximate position of PS2

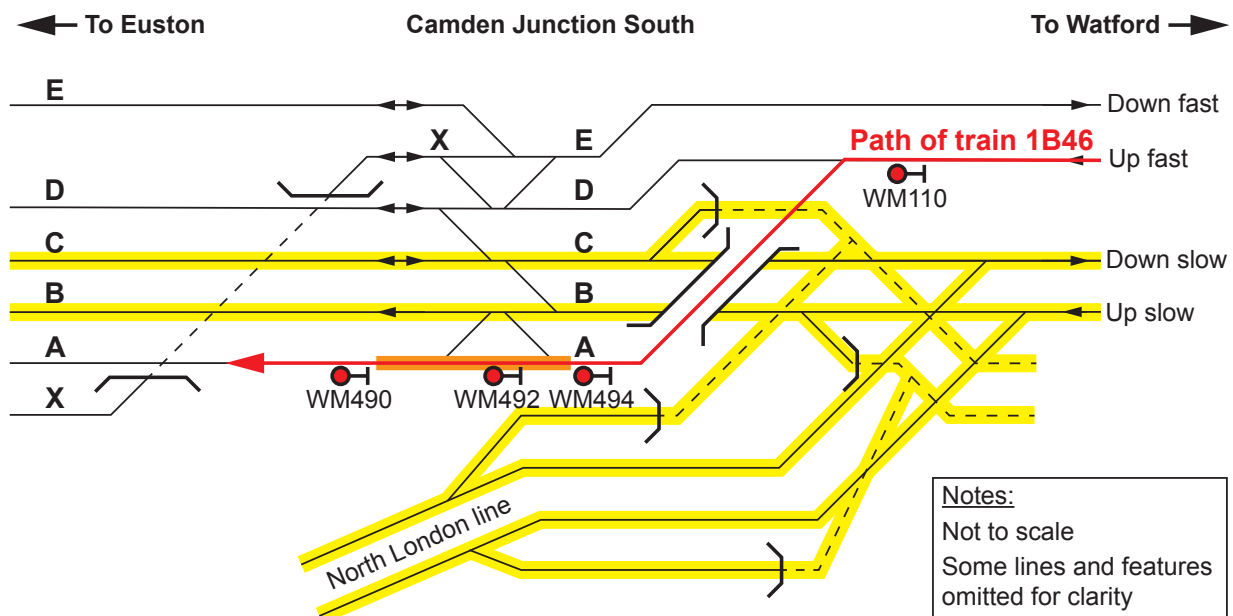
- 37 The engineering work taking place on the night of the incidents involved a possession of several lines in the area bounded by Euston, Wembley (on the main lines) and Watford Junction (on the local or 'DC' lines). The early part of the possession, beginning at 23:00 hrs, mainly affected the slow lines from Camden Junction to Wembley Central, and concerned panels B, C and D at Wembley MLSCC. The possession was due to be extended at 01:00 hrs to include several other lines and affecting all panels at Wembley (figure 6).

Figure 6: Schematic diagram of the track layout showing lines affected by the possession from 01:00 hrs, including the portion of Line A (shaded orange), and the route taken by train 1B46

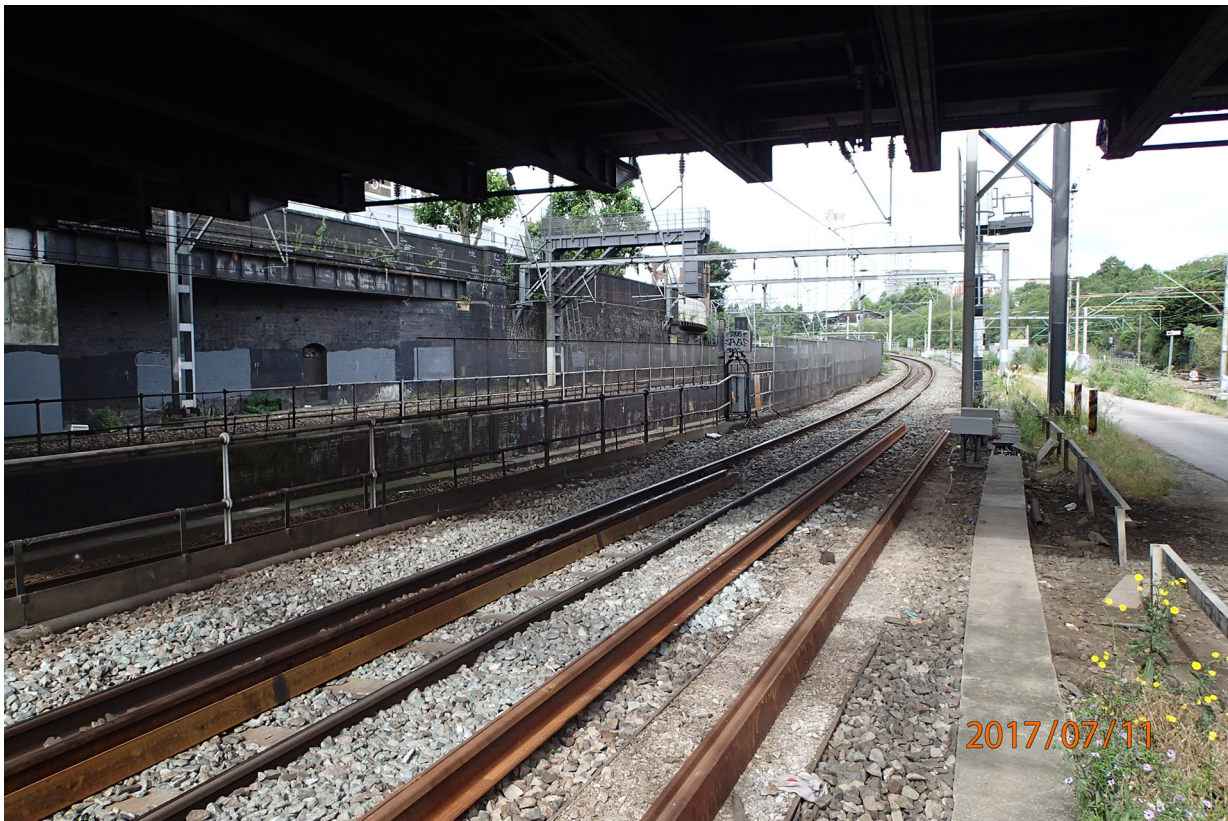
Figure 9: View of Line A towards approaching traffic from the approximate position of PS1

- 79 The RAIB's analysis found that PS1 became visible to the driver approximately five seconds before the train passed. The driver sounded his horn within one to two seconds of seeing PS1, and applied the brakes a further two seconds later. Research published by the Transport Research Laboratory<sup>9</sup> shows that most car drivers respond within about two seconds of becoming aware of an unexpected event. The train driver's initial reaction time to sounding the horn is therefore normal in these circumstances.

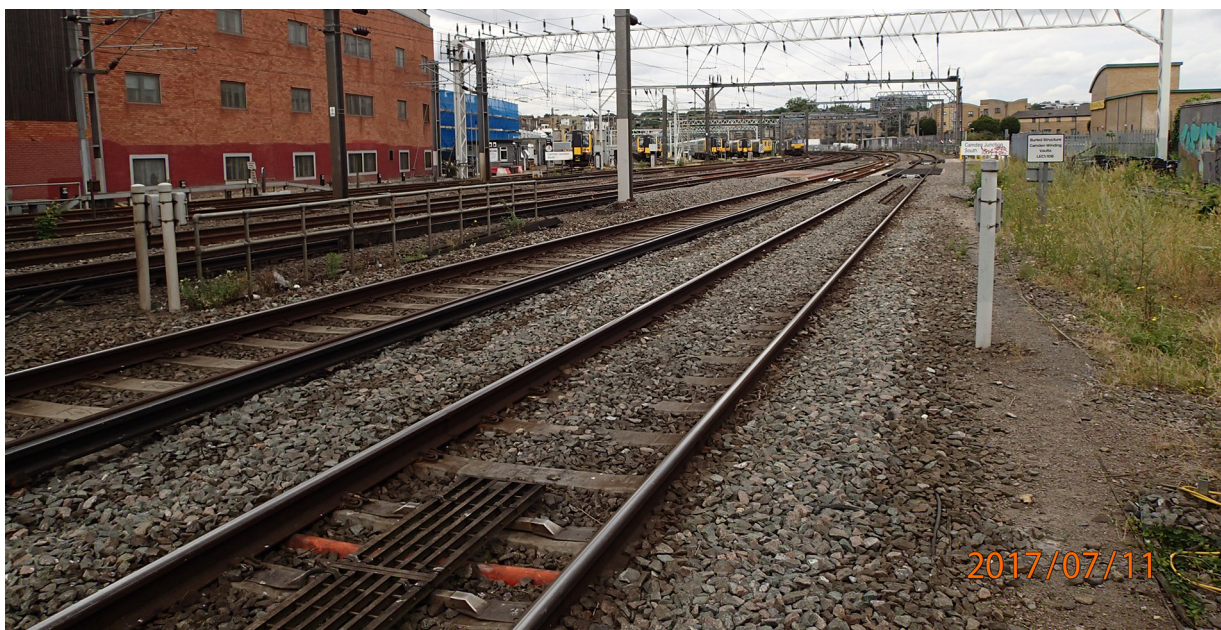
- 81 Compared with signal WM494, the area around signal WM492 affords better sighting as the track is straight at this point, although the layout presents the potential for confusion as all the lines now run parallel with each other (figure 10). Furthermore, PS2 was necessarily facing away from the oncoming train as his walking route from the access point to the blocking point took him in that direction. Nevertheless, PS2 heard the train coming and stepped off the track as far as he could; meanwhile the train had not gathered much speed following the near miss at signal WM494 and the driver was able to stop just before reaching PS2.

Figure 10: View of Line A towards approaching traffic from the approximate position of PS2 (note that this photograph was taken from a position of safety and therefore does not reflect the exact view of PS2)
