# SAFETY ALERT

## Subject: Type C(1938) Hangar Gutter Support Failure

Number: SA 2017/07  
Version 1.1

Date of issue: 8<sup>th</sup> August 2017

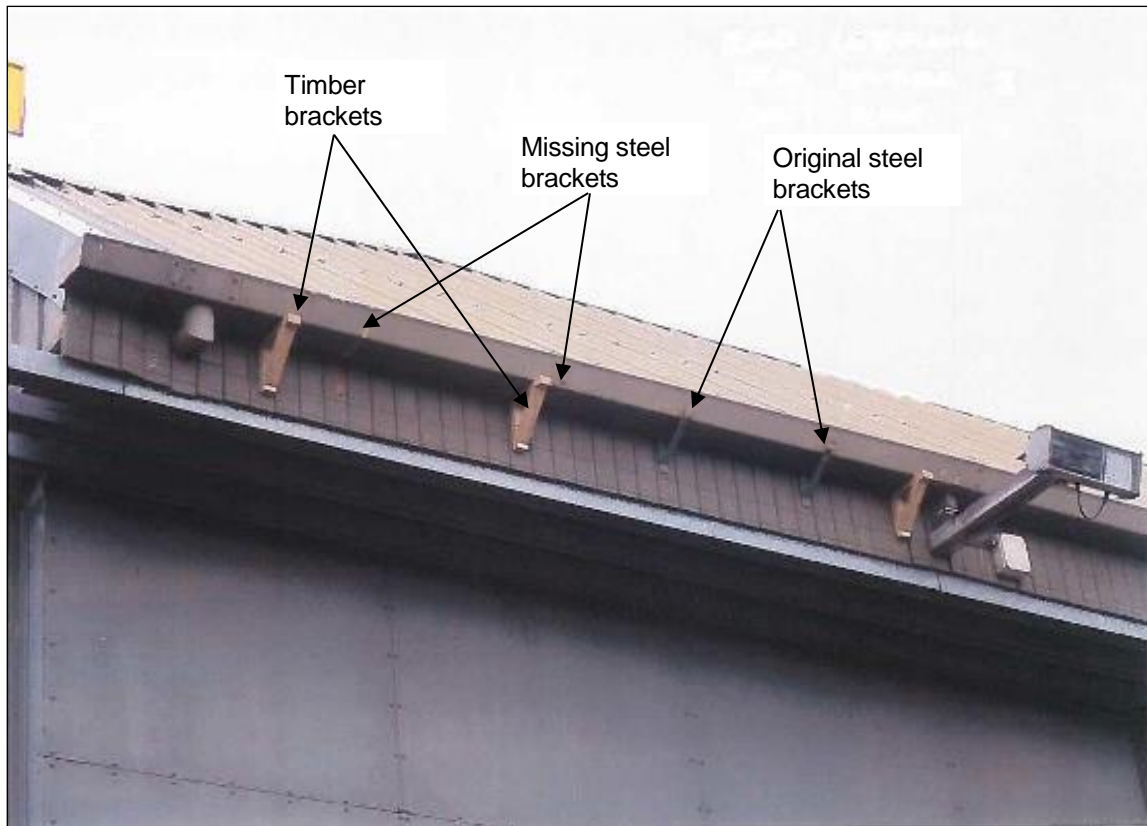
7. Type C (1938) hangars have roof eaves gutters over the hangar doors at each end. There has been a recent failure whereby a 1kg steel support bracket fell to ground from a height exceeding 10m, which could have resulted in serious injury or fatality. On investigation the bracket in question was found to be fixed by 2no. 25mm wood screws which had failed. These screws were fixed to the tongued and grooved timber fascia to the eaves above the hangar doors. The condition of this fascia was also suspect in places.
8. Whilst the exact failure mode is undetermined, the bracket in question failed following the installation of adjacent wooden bracket. It is suspected that this action may have contributed to the failure.
9. Available records indicate that Type C(1938) hangars are at the following locations:

10. The photograph indicates where original steel brackets are missing and where timber brackets have been installed. These gutters are subject to significant wind loading, and in heavy rainfall conditions they are estimated to weigh some 50kg per linear metre, requiring a robust high integrity support system.

- a. Inspect all eaves gutters and their supports for adequacy. This should include a check on screw length, firmness of fixing, suitability of fascia and its support framing etc. The level of intrusive checking of the brackets will depend on the findings at each location, but must be sufficient to provide an appropriately representative assessment; however, at least a 10% sample is advised. Particular attention should be paid to any lengths of sagging gutter or instances of distorted fascia boarding.

- b. Where defects are found, a risk assessment should be undertaken to identify any mitigations required prior to the completion of suitable remediation or other actions necessary to address identified hazards and risks. Temporary remediation may include increasing the screw length and providing additional brackets, noting the original failure may have in part been caused by repair works disturbing brackets which appeared firm at the time.
