AAIB Bulletin

9/2017

Published 14 September 2017

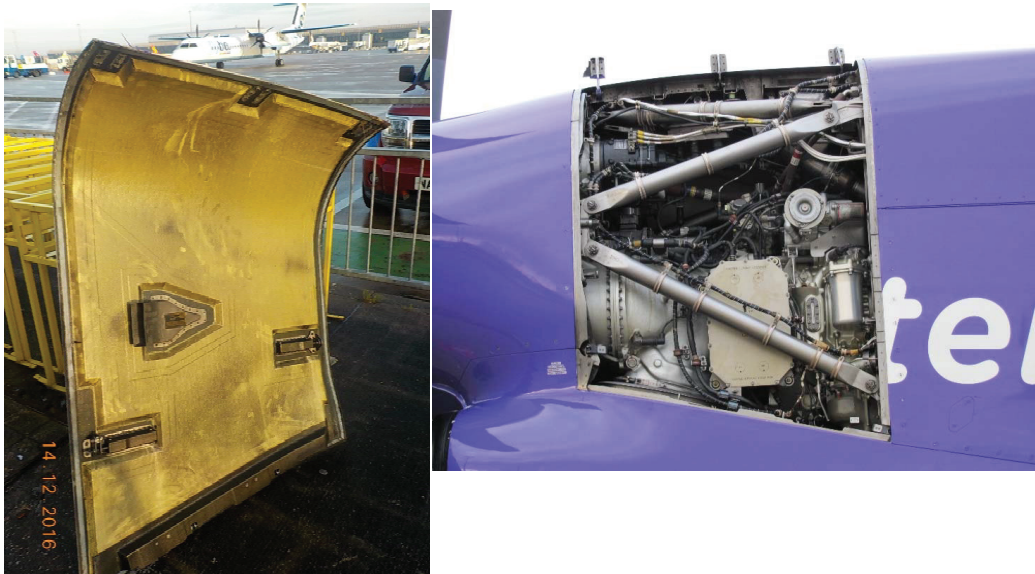
Figure 3

On inspection of the recovered panel all four latches were found to be in the closed and latched position. There was no damage to the latch bolts or the receiving fixtures on the nacelle (Figure 3).

Engine access panel and nacelle

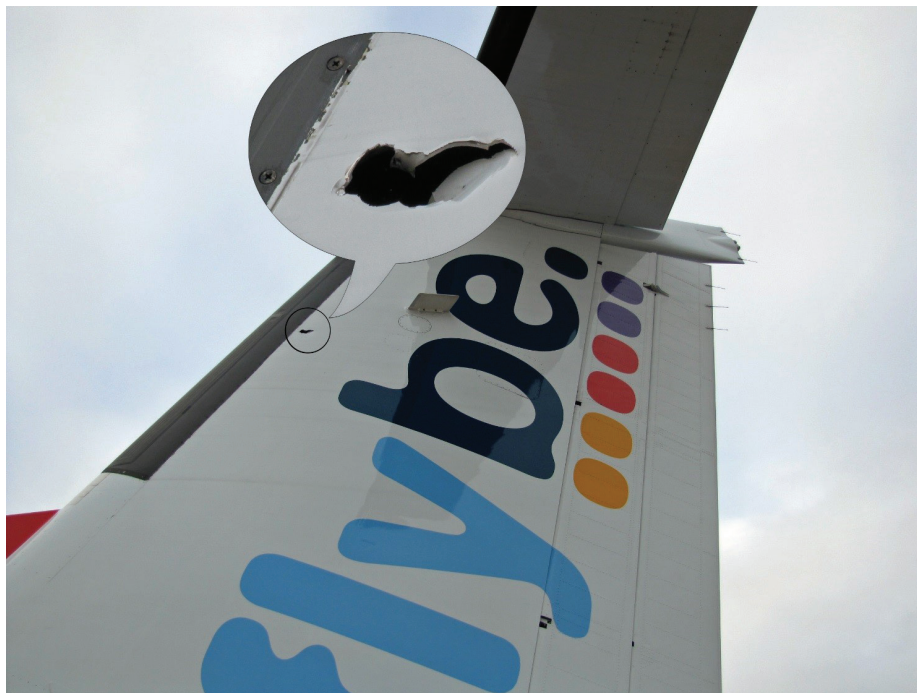
Figure 4

Inspection of the aircraft vertical stabiliser showed puncture holes in the skin on both sides, with impact marks also present on the leading edge de-icing boot. There was also impact damage to both VOR/LOC antennas.

Damage to vertical stabiliser (similar damage occurred on both sides of the vertical stabiliser)

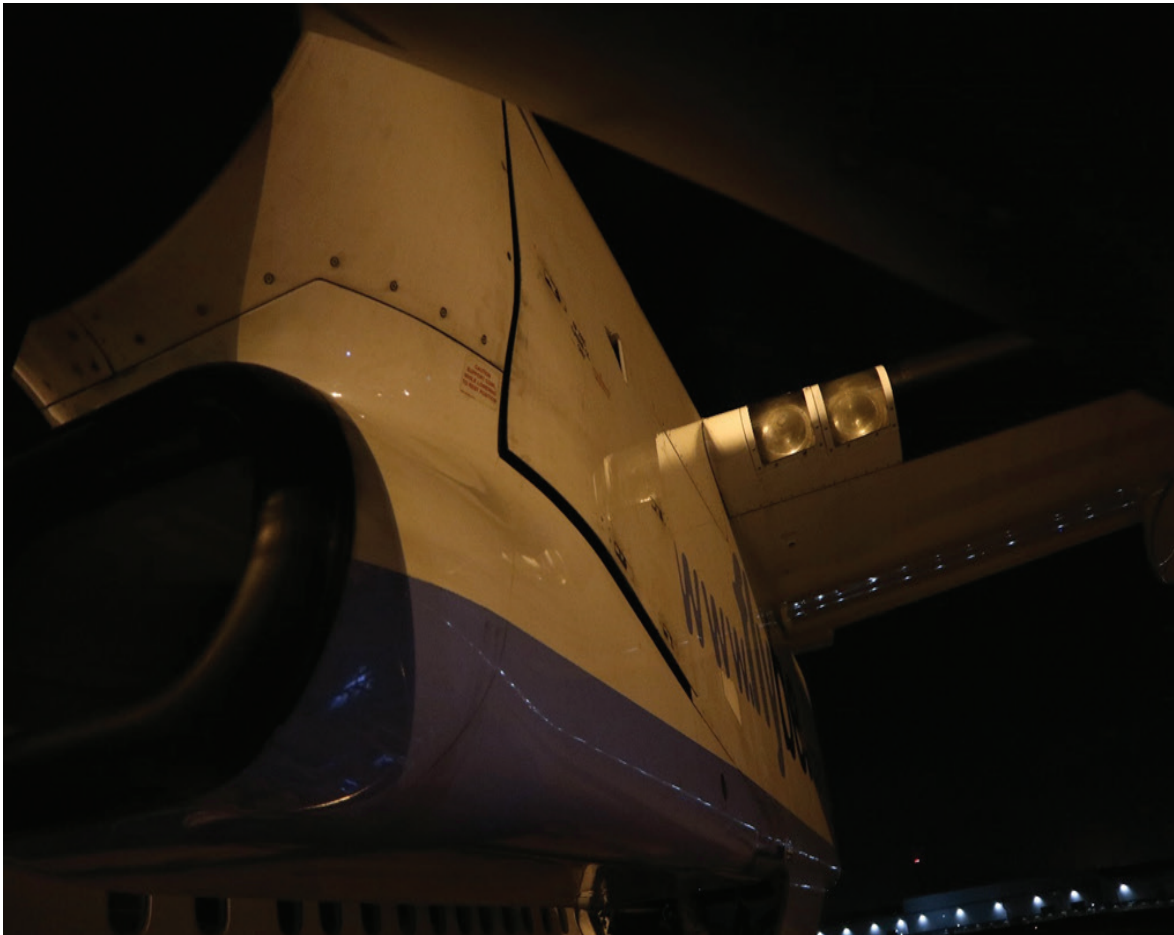
Figure 5

upper latch pins. Significant force could then be applied to the bottom of the panel while the lower latches were closed, but the pins would not engage in their receiving fixtures. The only external visual confirmation of the incorrect closure of the panel, was a small gap between the access panel and the surrounding nacelle panels (Figure 5).

Panel gap resulting from an incorrectly latched panel (viewed from the ground under similar lighting conditions to both incidents)

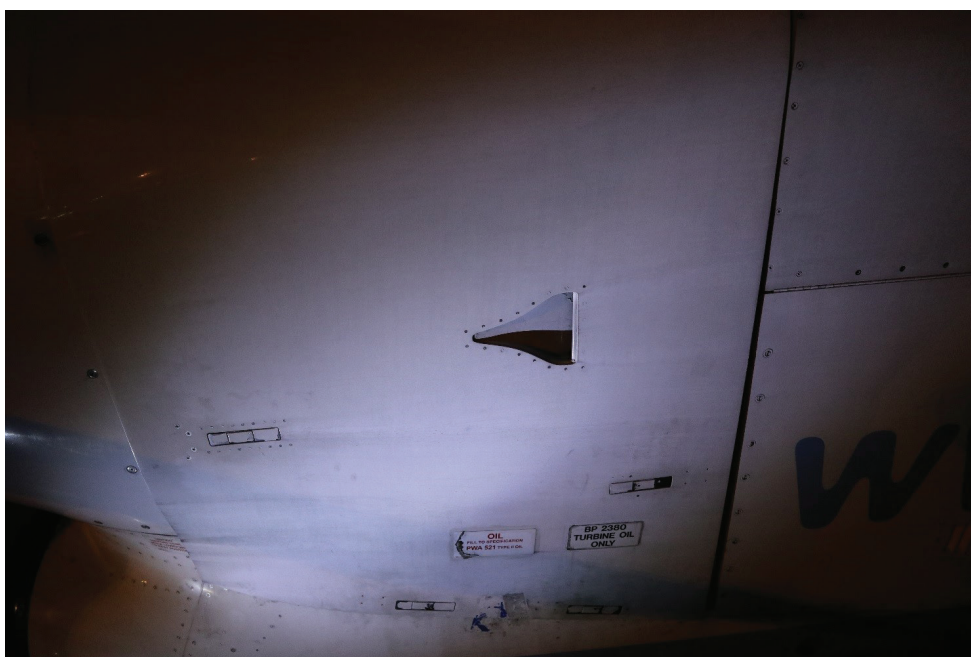
The engineers in both incidents involving G-PRPC were standing on steps to access the engine which meant once the access panel was closed, they were looking downwards at the panel and using a head torch to supplement the ambient lighting on the stand. Figure 6 shows how the perspective of the gap in the panel changes, when viewed under these circumstances. This would have been further exacerbated on the incident aircraft as the surrounding panels were painted purple rather than white, providing much less contrast to the shadow cast by the access panel.

View of the panel gap following incorrect closure, from the perspective of the engineer conducting the task.

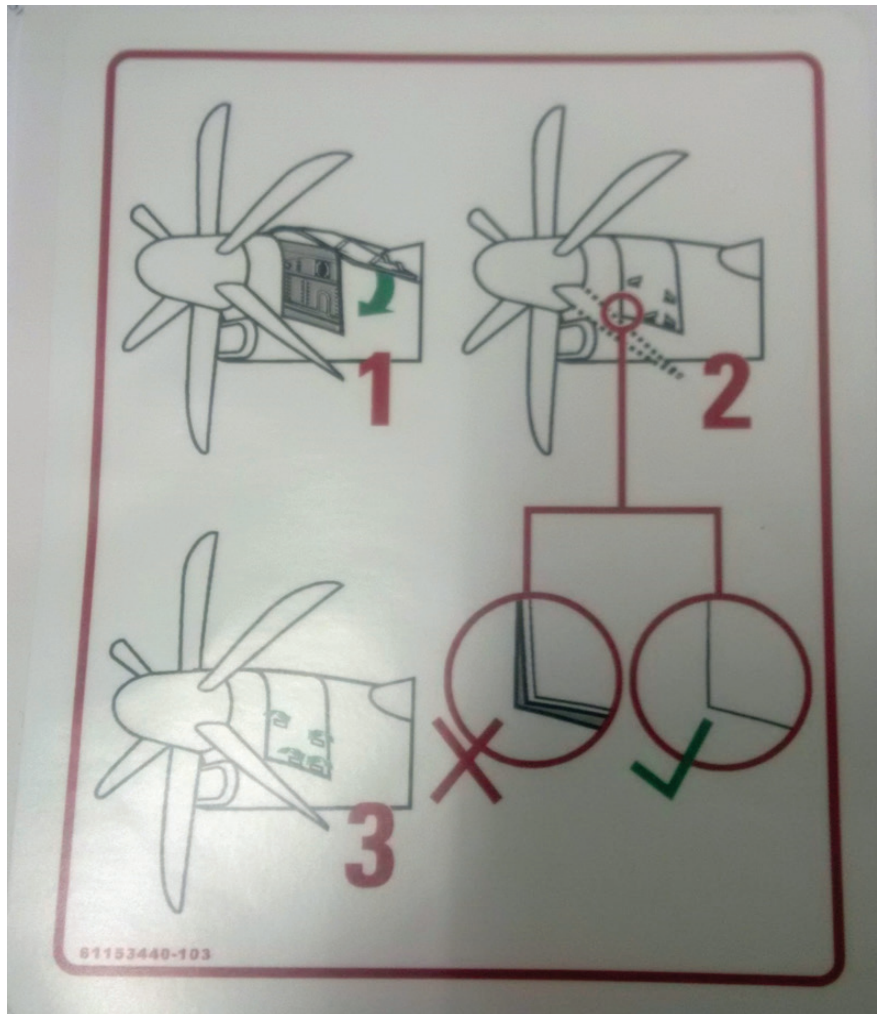
Figure 7

Advisory label modification

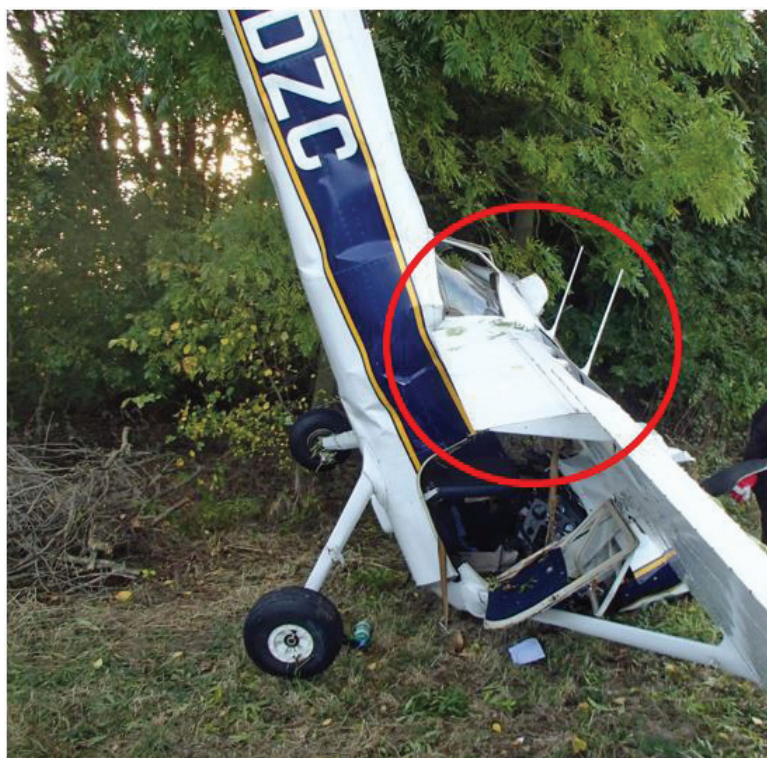
Figure 3

It was observed that the flaps were at their maximum deflection of 40°. The inboard end of the right flap was in contact with the right hand side of the rear windscreen and the fuselage skin immediately below, causing distortion. There were no scrape marks or abrasion damage to either; it was therefore concluded that the flaps were in this position prior to impact (Figure 3).

As-found flap position, showing damage to rear windscreen and sill structure below

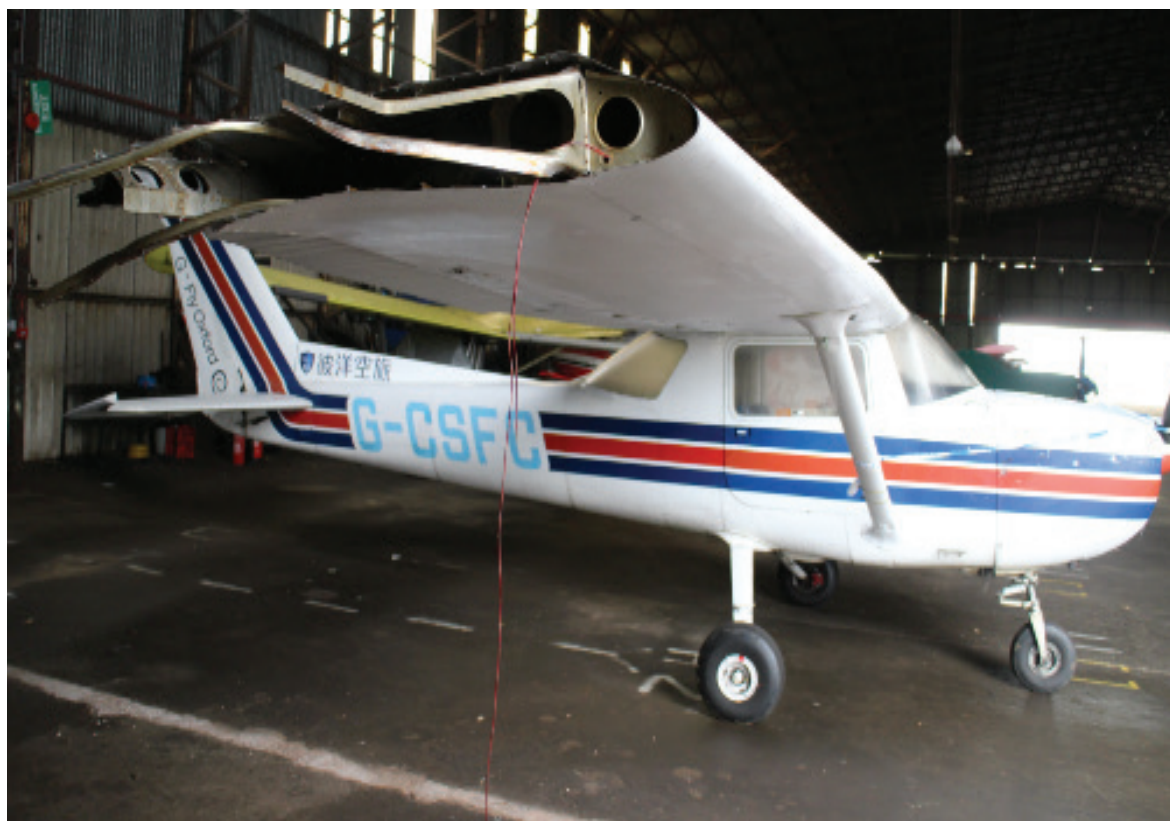
Figure 4

G-CSFC was inspected at Leicester Airport (Figure 4). The outboard 60 cm of the right wingtip was missing and there was significant local damage to the outboard right wing.

Image of G-CSFC at Leicester Airport

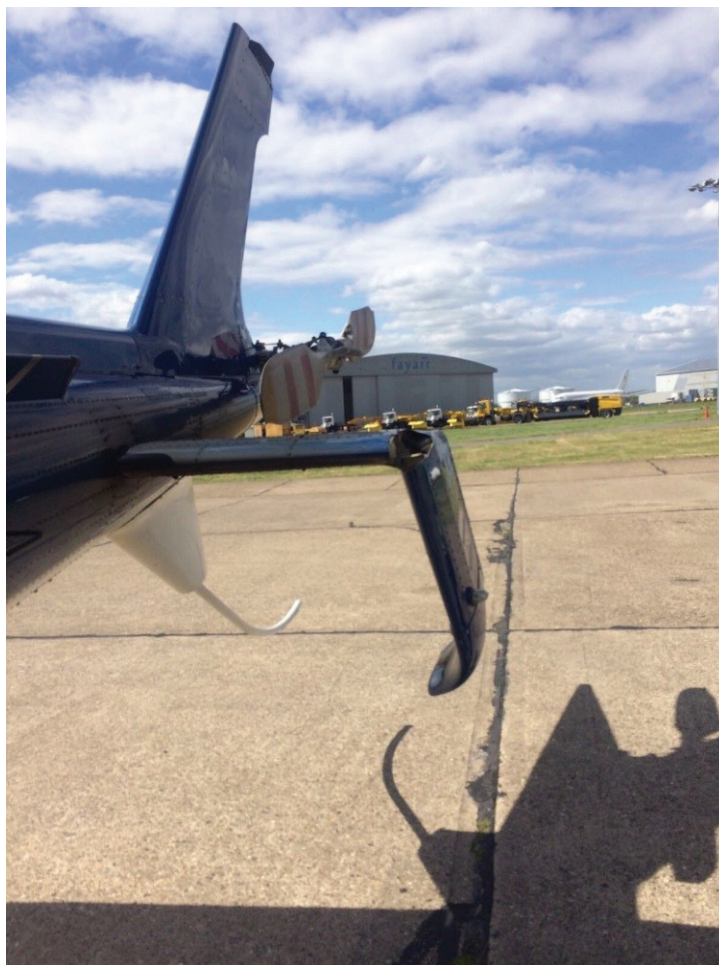
Figure 1

On arrival the ground staff indicated there was a problem with the aircraft. On inspection, the pilot observed that the left side horizontal stabiliser had failed at approximately mid-span. The failed portion had remained attached by sections of its skin and electrical cabling, (Figure 1).

View of failed horizontal stabiliser, looking aft

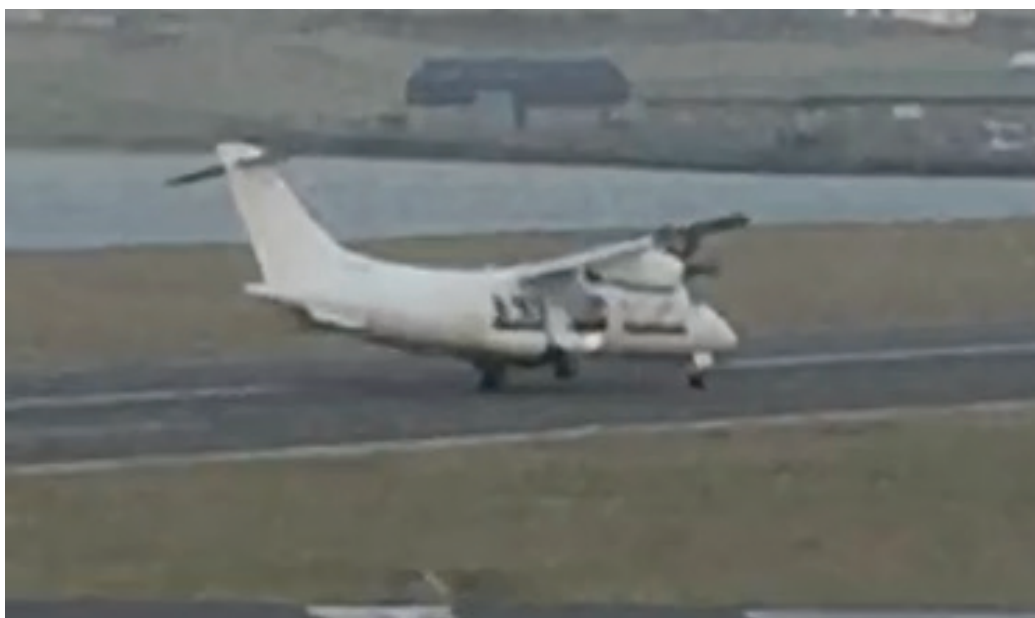
Figure 1

The PF reported that, on the final landing, the aircraft touched down slightly to the left (downwind) of the runway centreline after which he selected GROUND IDLE power. The aircraft moved right, towards the centreline, but, when the PF applied left rudder to maintain runway heading, it had no effect and the aircraft began to drift to the right side of the runway. In an attempt to regain directional control and prevent runway excursion, the pilot applied left brake. At the same time, he inadvertently relaxed his aileron input, and the aileron deflection reversed from a 'roll right' to a 'roll left' sense. This caused the right wing to lift and the right main landing gear to lift off the runway (Figure 1). Thinking that this was due to his brake application, the pilot ceased differential braking and re-applied right aileron. The bank angle reduced and the right mainwheel touched down again. Thinking that he had "applied reverse thrust and that this might have reduced rudder effectiveness", the PF moved the power levers forward to what he thought would be GROUND IDLE. In fact, he had moved the power levers to FLIGHT IDLE, thereby increasing power, and the PM immediately returned them to GROUND IDLE and applied maximum reverse thrust.

Right main landing gear lifting off the runway

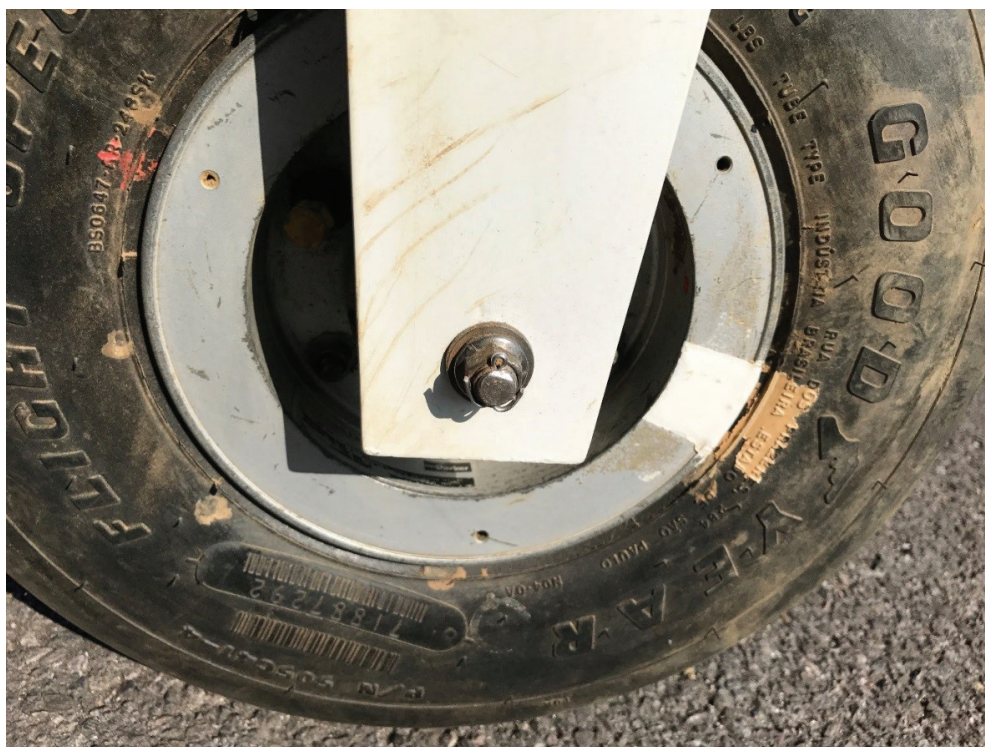
Figure 1

Safety split pin outboard of the K-nut

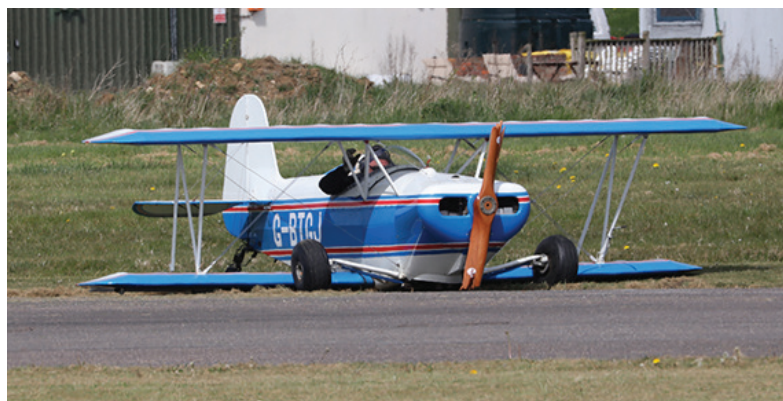
**Figure 1**

During the landing flare on the asphalt Runway 25 at Henstridge the pilot lost sight of an aircraft landing ahead. He pushed forward on the control column to check the runway in front was clear, and then pulled the column back to continue the flare. He believes that because he did not apply any power during this manoeuvre, the airspeed reduced too much and the aircraft stalled and descended quickly towards the runway. Both main landing gear legs collapsed on impact and the wooden propeller shattered. The aircraft then slid a short distance along the runway until the tip of the lower right wing contacted the surface and the aircraft span right through 180°. It came to rest on grass area beside the runway (Figure 1) and the uninjured pilot climbed out without assistance.

G-BTGJ after it came to a halt with collapsed main landing gear legs and shattered propeller.
Photo reproduced courtesy of Mr Martin Rendall

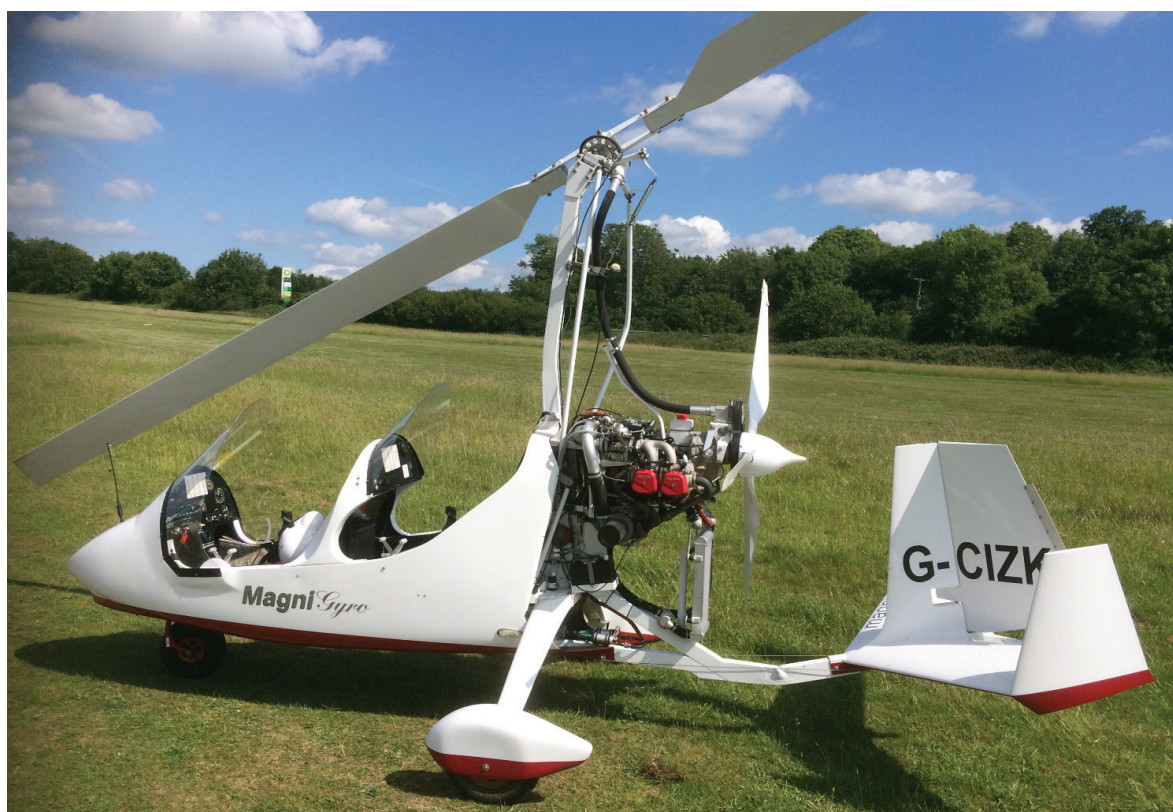
Figure 1

After watching the accident, the instructor commented that a normal landing involves touching down on the mainwheels and then moving the control stick back gradually, to initially keep the nosewheel off the ground as the gyroplane slows. On this occasion the student rapidly moved the control stick fully back and he then lost control.

Magni M16C Tandem Trainer, G-CIZK after the accident with distortion of the rotor system and control rods evident

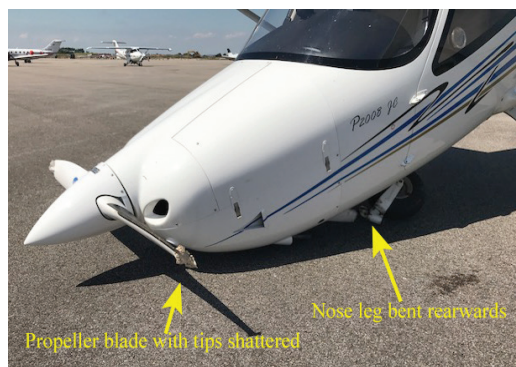
Figure 2

The student pilot was undertaking a solo cross-country flight to Lydd Airport where, accompanied by his instructor, he had landed a few days previously. Runway 21 was in use and the reported wind was from 110° at 8 kts so there was a crosswind from the left and a slight tailwind. The pilot believed he approached at the correct airspeed but, when he flared, the aircraft ballooned and then sank. Although he tried to reduce the descent rate by adding power, the aircraft bounced and when it contacted the runway a second time, the nose leg collapsed rearwards, the propeller blade tips shattered and the engine stopped before the aircraft came to a halt on the runway (Figures 1 and 2).

G-OLIC pictured after the accident

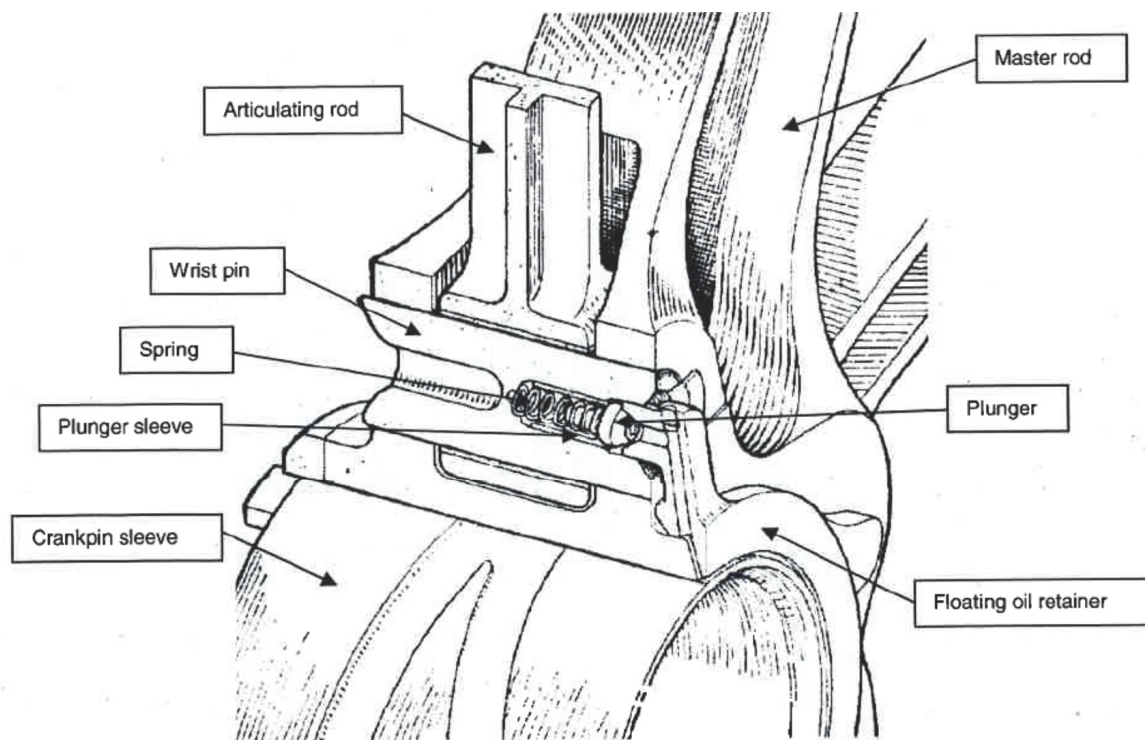
Figure 2

The oil system in G-RNHF contained a sufficient quantity of lubricating oil and samples taken at the time showed that the oil had suffered some adulteration during the engine failure, but this is not considered causal or contributory to the engine failure.

Crankpin sleeve and wrist pin assembly
