AAIB Bulletin

1/2018

Published 11 January 2018

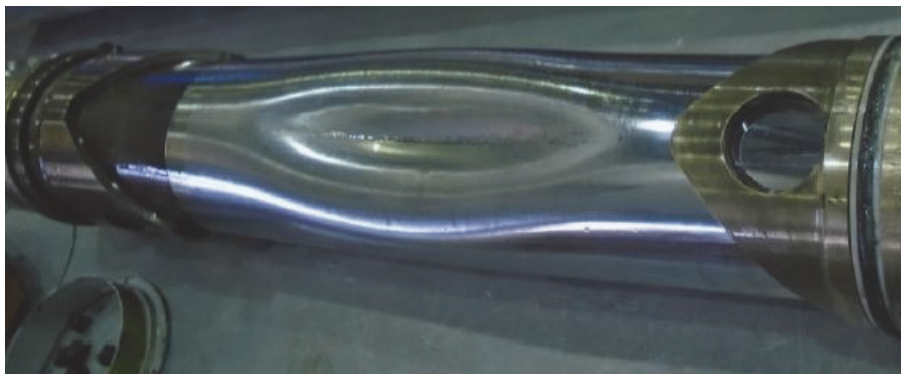
Figure 1

The aircraft was inspected for a Severe Hard Landing as required by the manufacturer's Aircraft Maintenance Manual. This inspection revealed damage to the nose landing gear and the right main landing gear as well as some cracking of the paint and sealant in the nose gear bay and avionics bay. The inspection showed there was no other damage to the aircraft.

On the advice of the manufacturer, all three landing gears on the aircraft were replaced and sent for detailed inspection. These inspections revealed that both the nose landing gear and the right main landing gear had suffered excessive loads during the landing and could not be returned to a serviceable condition. The nose landing gear shock-absorber cylinder was found buckled (Figure 1) with the barrel and forestay lower arm pin found to be out of tolerance. The right main landing gear sliding tube and shock-absorber were also found to be outside acceptable tolerances when measured. The left main gear was undamaged.

Nose landing gear shock absorber cylinder

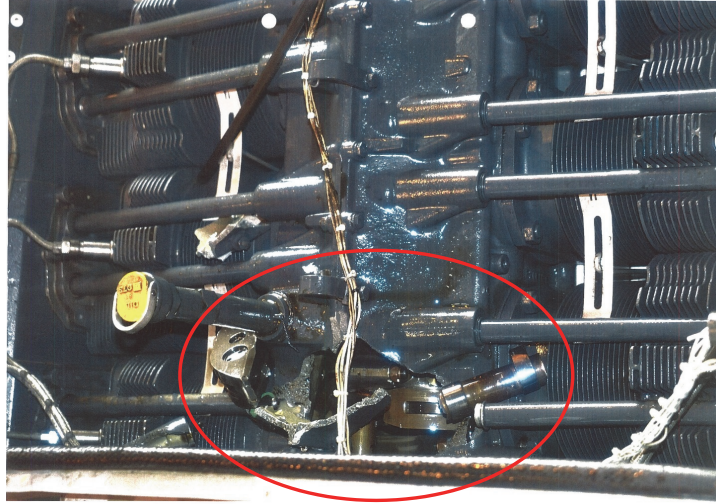
Figure 1

Initial inspection found a hole in the left engine top cowling. When the cowling was removed, a hole in the crankcase and some liberated internal engine parts were apparent (Figure 1).

View of top of left engine showing hole in crankcase and liberated parts

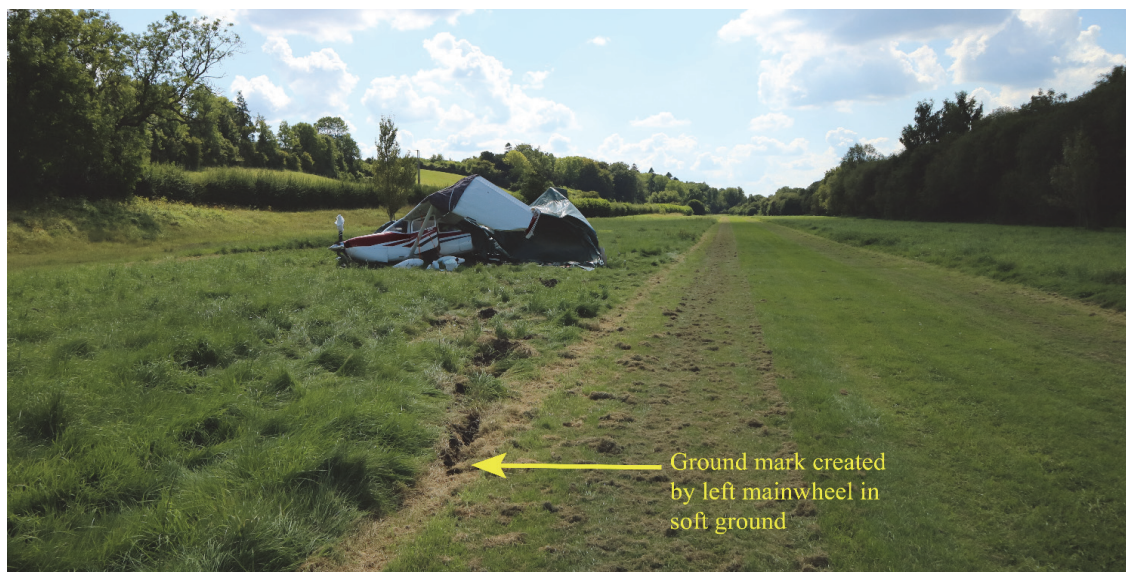
Figure 2

Photographs taken after the accident indicated the grass airstrip had been cut to a width of approximately eight metres. An engineer who examined the aircraft found evidence that the left mainwheel deviated into long grass on the left side of the strip before the left wing and the propeller struck the ground. This caused the aircraft to spin around to the left quickly and shock-loaded the engine and the airframe. Both wings were damaged, the fuselage was distorted and the nose and right main landing gear legs were detached, while the left main landing gear collapsed (Figure 2).

A southerly view along Runway 18, showing the aircraft pointing to the north-east, with the left wing severely damaged and with a tarpaulin over the rear fuselage

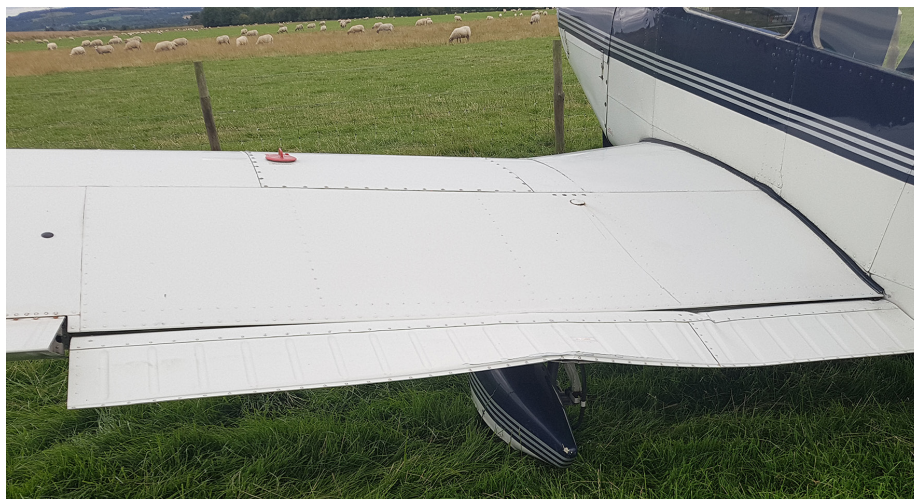
During the subsequent ground roll several sheep ran in front of the aircraft and one was hit, causing the damage shown in Figures 1 and 2. The aircraft was stopped close to a second fence and the electrics and fuel were then turned OFF before the crew exited through the door. Some unidentified debris was later found in the carburettor but the examining engineer was unsure if this was sufficient to have caused the engine failure.

Figure 1
Damage to left flap

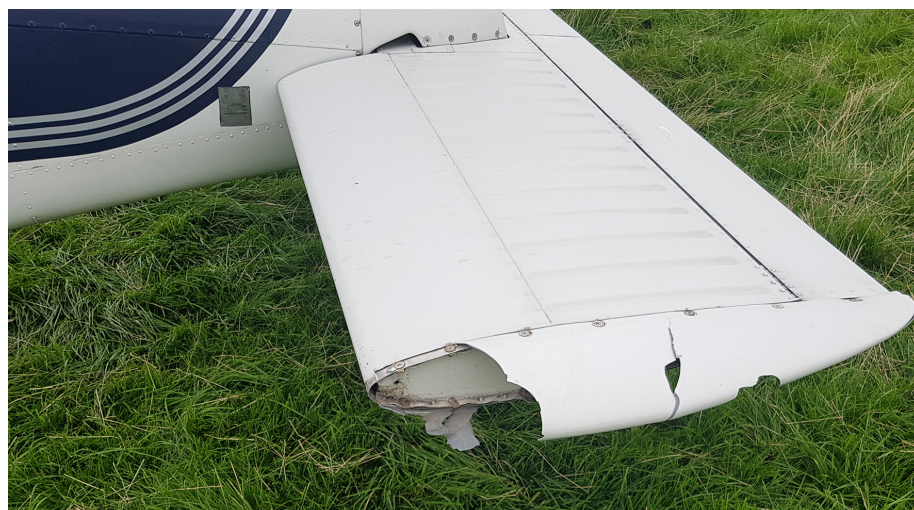
Figure 2
Damage to tip of left stabilator

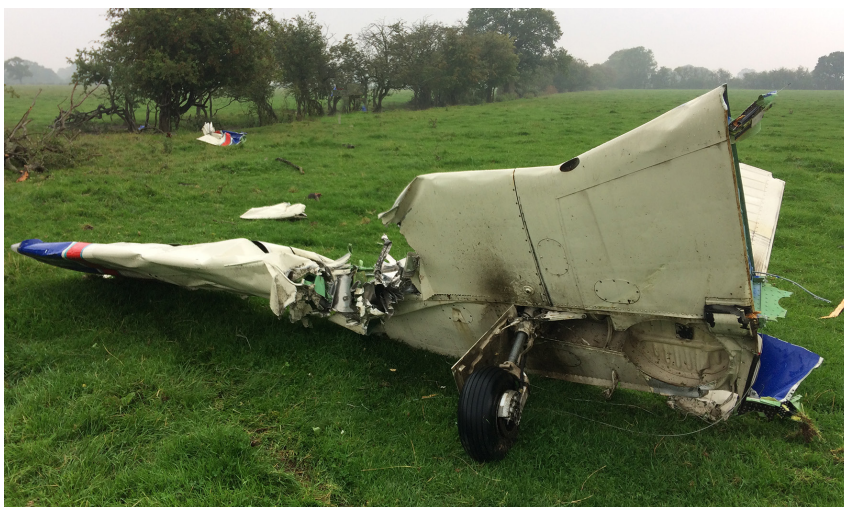
Figure 1

Detached right wing with trees which the aircraft hit in the background

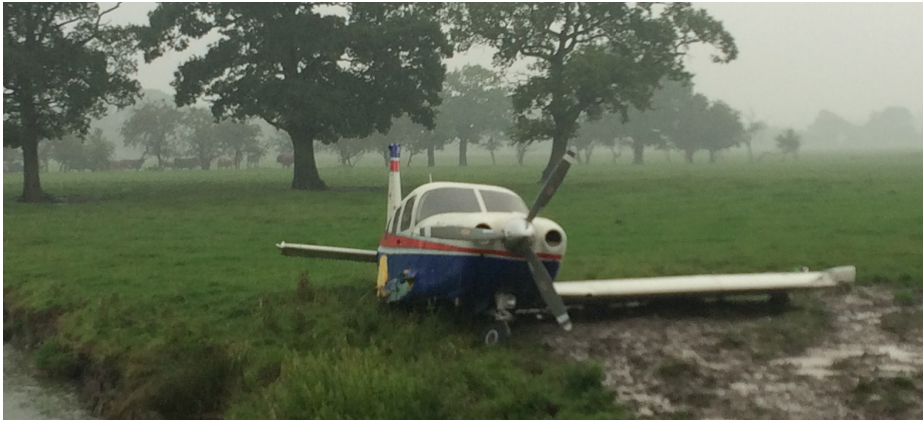
Figure 2

The aircraft came to a halt approximately one metre from the edge of one of the ponds (Figure 2) and the pilot, who was uninjured, escaped through the door without difficulty. He checked the left wing tank and estimated it still held 25 gallons of fuel but the tank in the right wing had burst and he was unable to determine how much fuel it contained at touchdown.

Final position of N414AG close to the pond

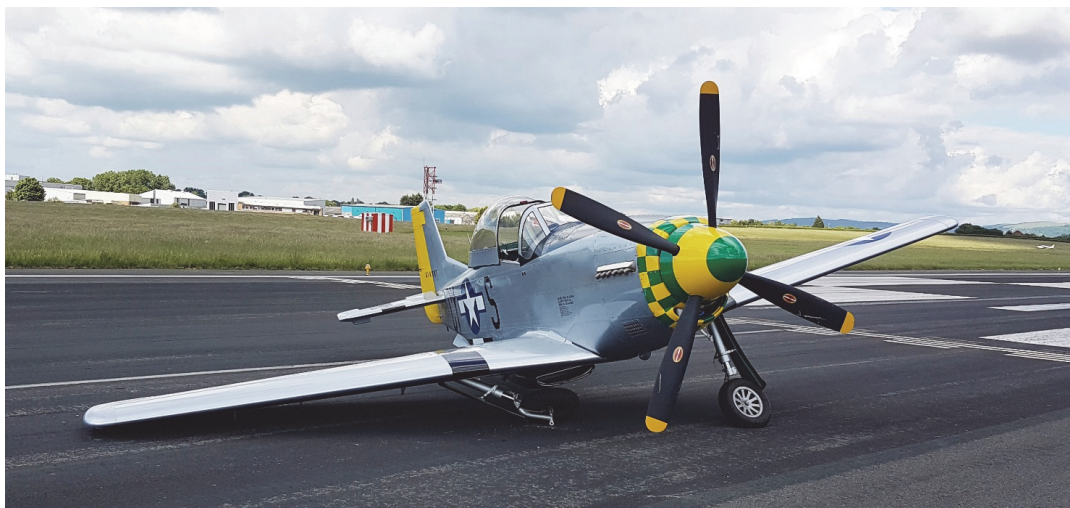
Figure 1

Following a local flight in good weather conditions, with light winds, the pilot landed the aircraft normally on Runway 27. As the aircraft slowed to approximately 10-15 mph at the end of the landing roll the pilot gently applied the brakes, but as he did so the aircraft yawed to the left which he could not control using right rudder and right brake. The pilot reported that the wings remained level as the aircraft yawed to the left. The weight transferred to the right main landing gear leg, which collapsed inwards, causing the propeller and right wingtip to contact the runway as the aircraft came to a stop, Figure 1.

G-DHYS following the collapse of the right main landing gear

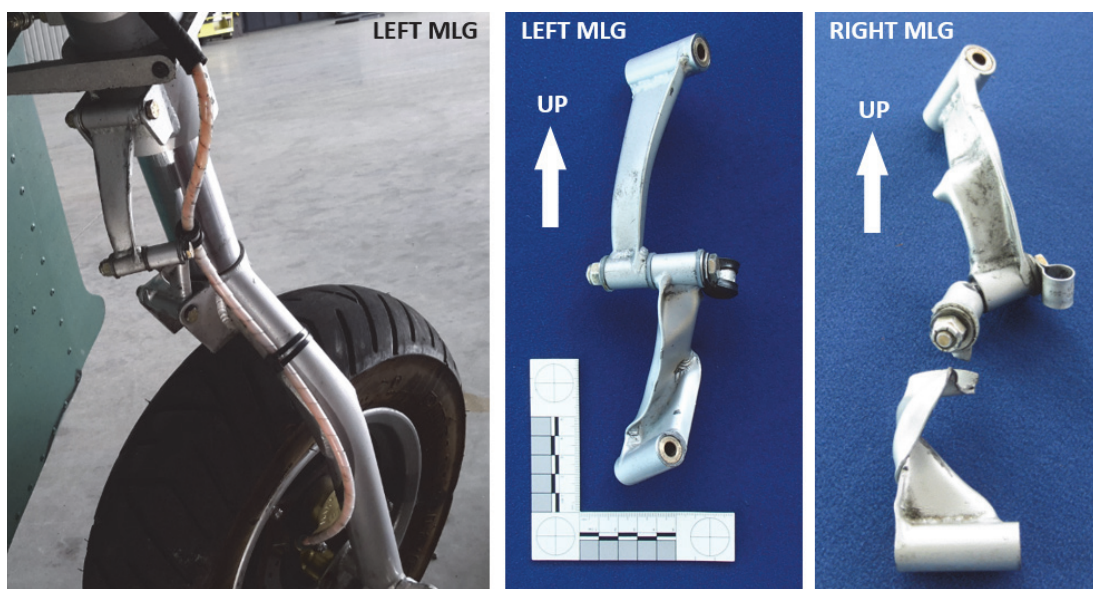
Figure 2

G-DHYS left MLG leg (left), left MLG torque link (centre) and right MLG torque link (right)

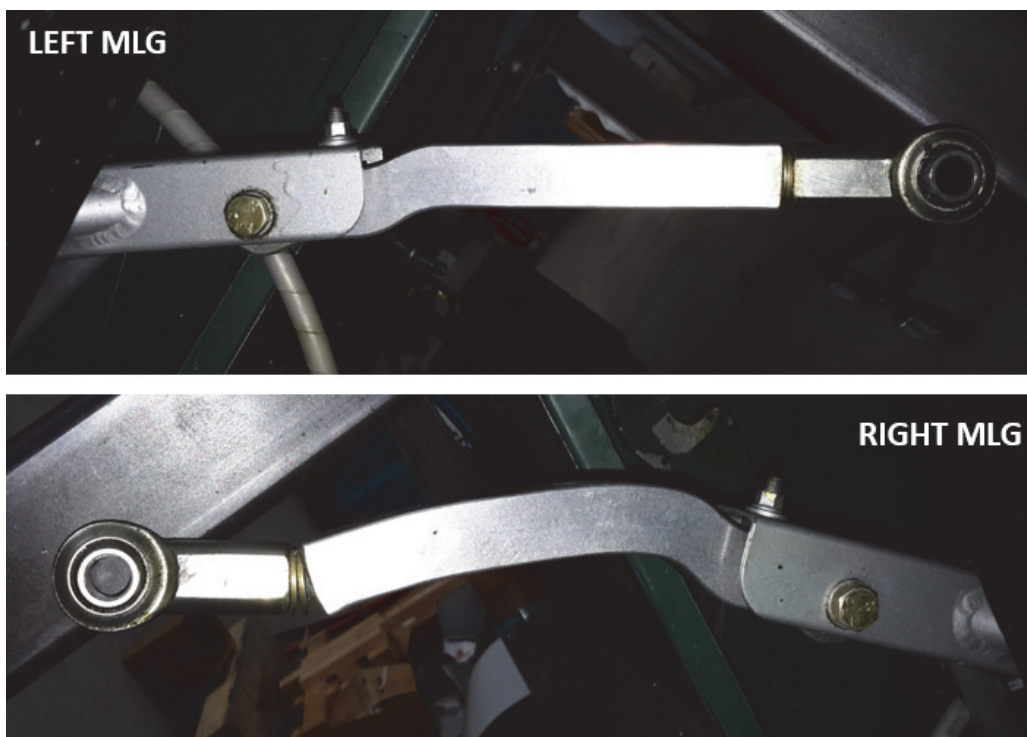
Figure 3

Examination of the aircraft revealed that the right MLG torque links had buckled, allowing the right mainwheel to rotate inwards. This would have caused an inboard side-loading on the MLG leg. The right MLG adjustable-body link was damaged due to excessive bending, caused by the right MLG collapsing inwards whilst the landing gear hydraulic actuator remained in the 'down' position, Figure 3.

The left MLG adjustable-body link was undamaged, consistent with the left MLG remaining locked down during the event. The left MLG torque links were buckled due to excessive side loading, as a consequence of the collapse of the right MLG leg.

G-DHYS left MLG adjustable-body link (top), and overload-damaged right MLG adjustable-body link (bottom)

The aircraft kit manufacturer stated that they were aware of four cases of T-51 Mustang MLGs collapsing; in their opinion each case was caused by improper adjustment of the adjustable-body link.

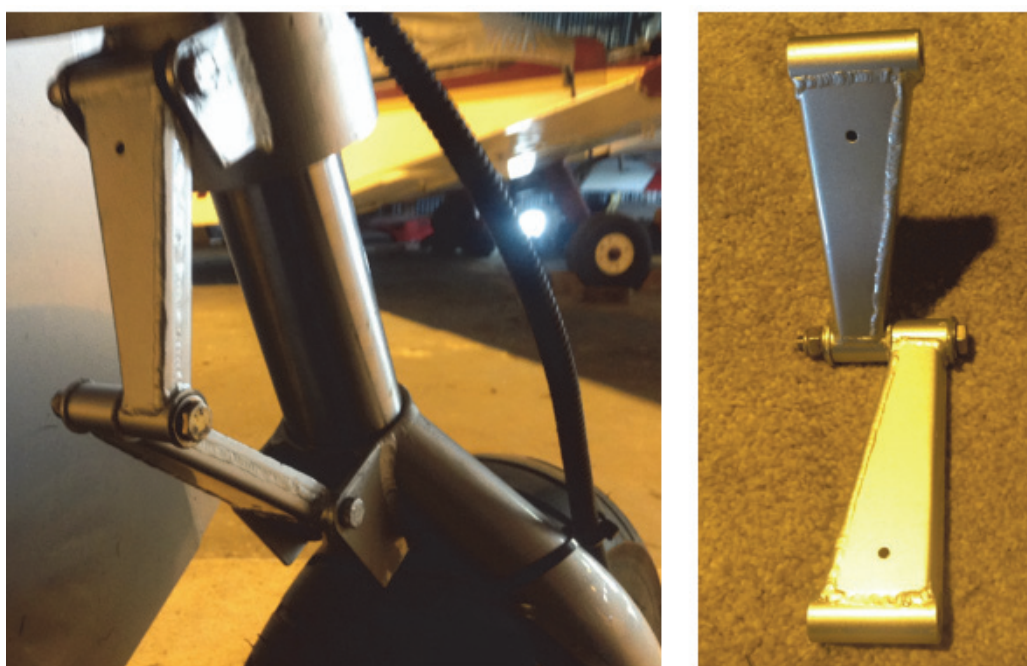
Figure 4

Strengthened MLG torque links installed on G-FION

The LAA has approved a set of modified torque links, Figure 4, for installation on G-FION, another T-51 Mustang aircraft that is currently under construction. The modified stronger torque links were developed as an LAA modification as a result of concerns raised by the accident with G-DHYS. If this modification is successful, the LAA will require that T-51 Mustang aircraft, powered by the Suzuki V6 engine and operating on an LAA Permit to Fly, are modified in this manner.

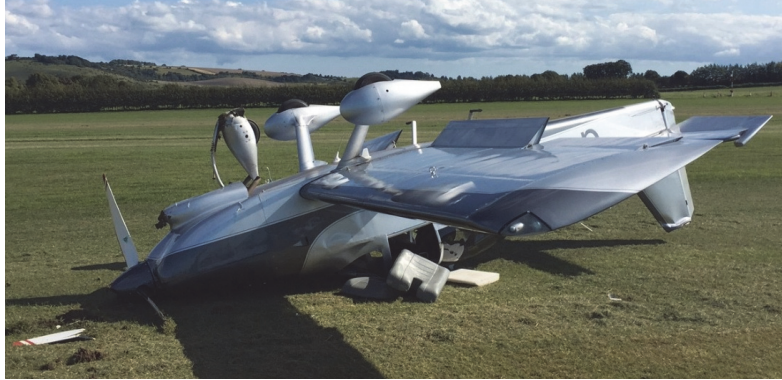
Figure 1

G-CCVS after the accident

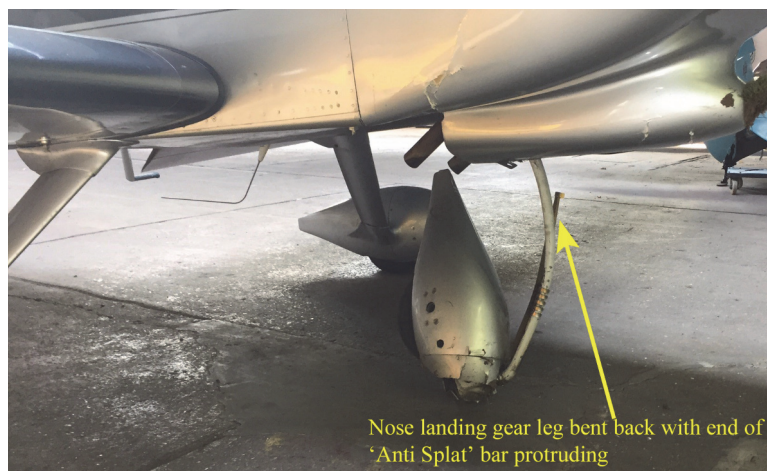
Figure 2

The AAIB has reported on several previous accidents in which the nose landing gear leg of a Vans RV series aircraft has bent back or collapsed. AAIB Bulletin 3/2017 contains a report concerning G-RPRV, an RV-9A that flipped upside down, and a list of other recorded instances in the UK during which the nose landing gear leg bent back. The report also mentions an 'Anti Splat' kit (Figure 2) which is intended to restrain the nose landing gear leg from tucking under.

An 'Anti-Splat' kit was fitted to the nose landing gear

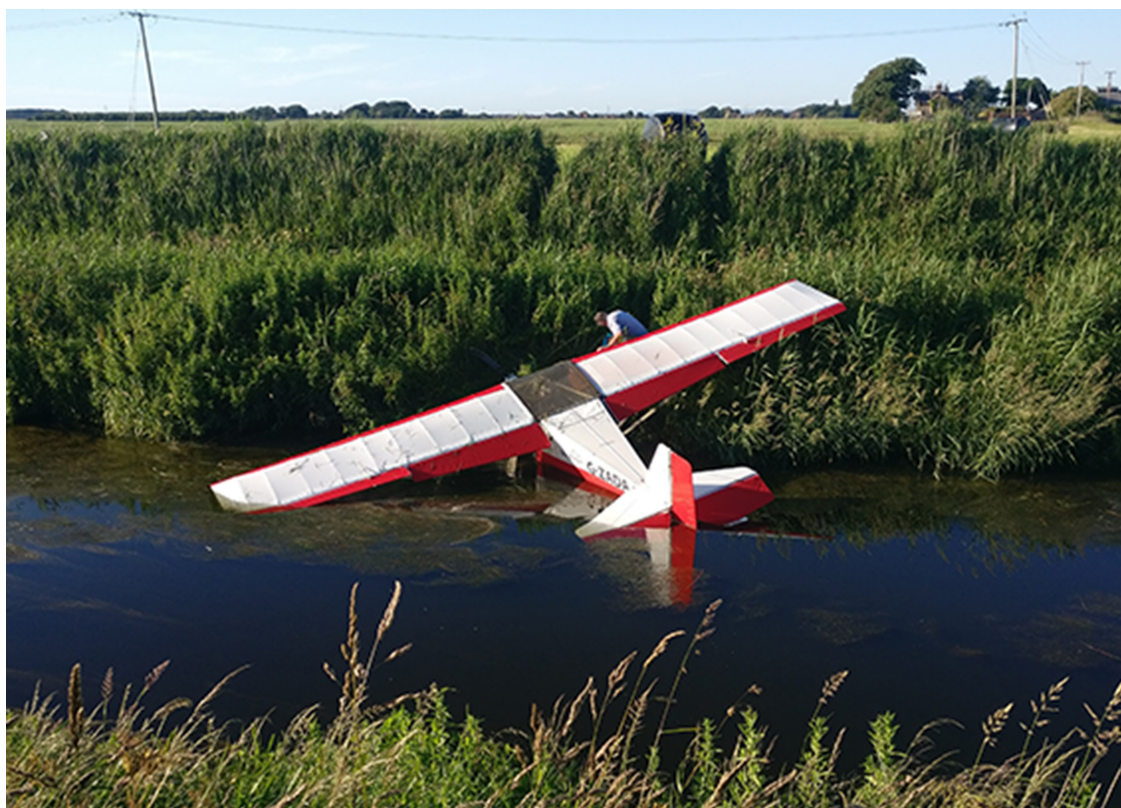
Figure 1

Once on the runway the pilot applied maximum braking but was unable to halt the aircraft before the end of the runway, where there is a steep river bank. The aircraft overran the runway and crossed over the shallow river, which was approximately 10 m wide, before hitting the far bank and coming to rest (Figure 1). The occupants had no difficulty escaping from the aircraft but the passenger subsequently experienced chest pains and was later diagnosed to have fractured a rib.

View of the aircraft in its resting place by the north bank of the River Alt.
Note power lines which cross the extended centreline of Runway 36
